LIDAR Quality Report

from the National Geospatial Technical Operations Center
in Support of the 3D Elevation Program

[LA_Catahoula_Concordia_1_2017](#)

2021-01-12

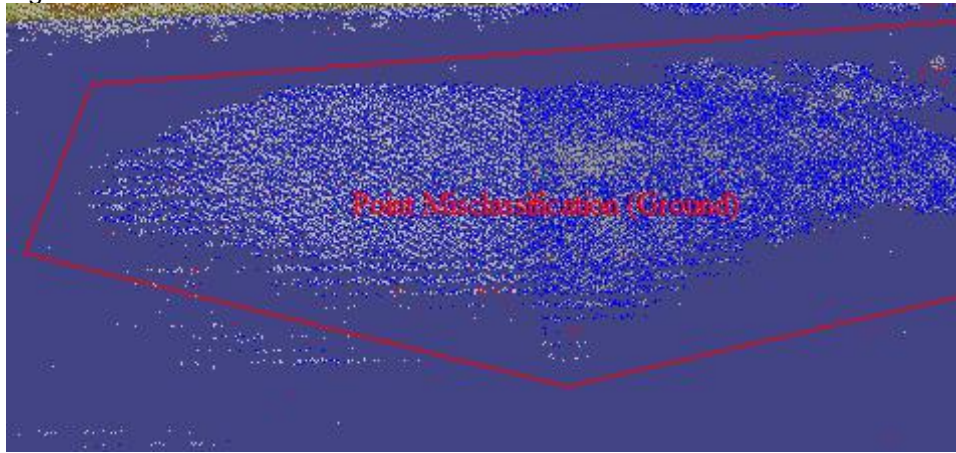
Deliverable	Error Type	Subtype	Quantity	Examples
Classified Pointcloud	Point Mis-classification	Ground	1	Figure 1
Error Comment(s): An island is classified as water in the lidar point cloud				
Classified Pointcloud	Point Properties	Intensity	1	Figure 2
Error Comment(s): 82 las files have suspect intensity values				
Classified Pointcloud	Processing	Other	1	
Error Comment(s): 2 lpc tiles are missing from the work unit. "15RXQ3959", "15RXQ4476"

Error Type: Point Mis-classification, Error Subtype: Ground

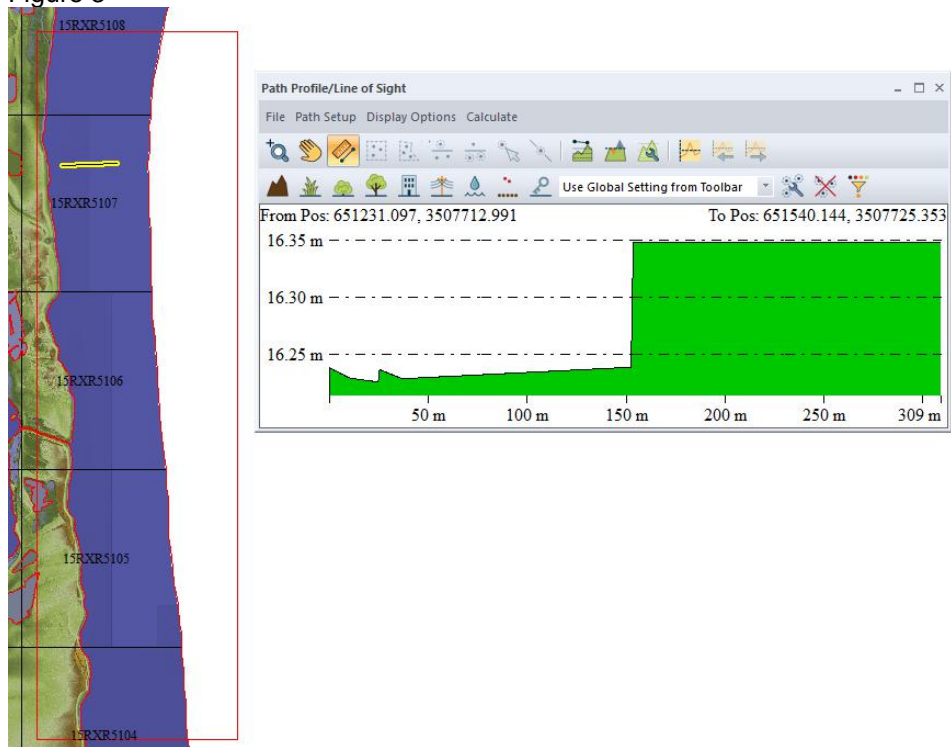
Deliverable	Error Type	Subtype	Quantity	Examples
DEM	Breakline Enforcement	None	10	Figure 3 Figure 4 Figure 5 Figure 6 Figure 7 Figure 8 Figure 9 Figure 10
Error Comment(s): 1. Large segment of coastline has breakline enforcement issues 2. Large segment of coastline is missing breakline enforcement 3. A pit is present in a waterbody in the DEM 4. A segment of waterbody is missing breakline enforcement 5. A segment of river is partially missing breakline enforcement 6. A waterbody is missing breakline enforcement 7. A segment of river has an enforcement error due to breaklines 8. A segment of river is missing breakline enforcement likely due to misplaced breaklines 9. A segment of river is missing breakline enforcement likely due to misplaced breaklines 10. A segment of waterbody is missing breakline enforcement likely due to misplaced breaklines				
DEM	DEM Properties	NoData Value	1	Figure 11

Error Type: Breakline Enforcement, Error Subtype: None

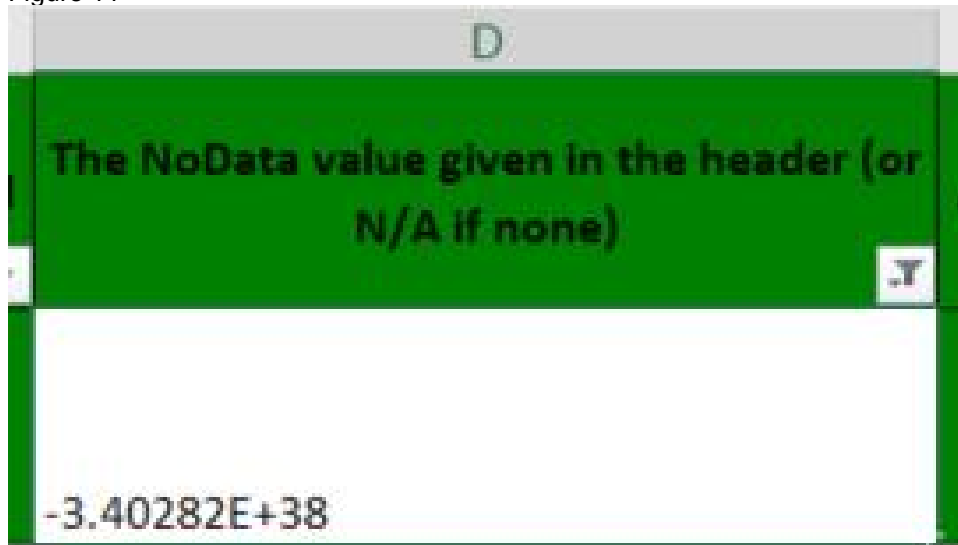
Figure 11

Error Comment(s): Tile "15RXR2332" has a NoData value of -3.40282E+38				
DEM	Suspect Values	DEM Void	1	Figure 12
Error Comment(s): A data void is present in the DEM

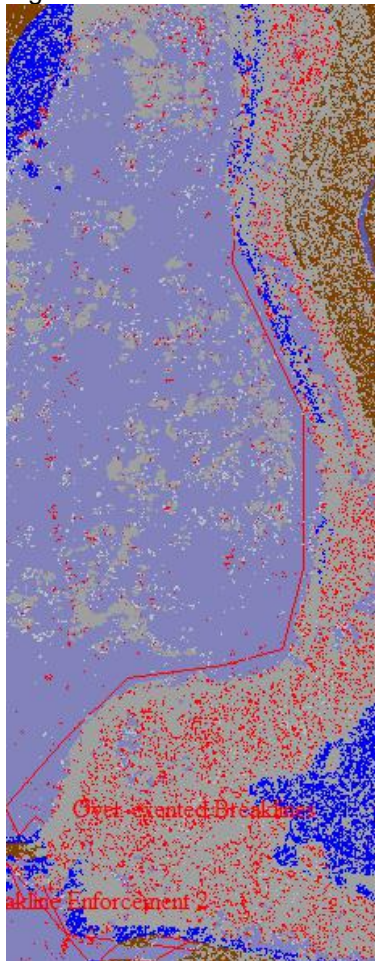
Hydroflattened Polygon Breaklines	Geometry Error	Overextended	1	Figure 13
Error Comment(s): A waterbody's breaklines over-extend water and reach land				
Hydroflattened Polygon Breaklines	Missing Feature	Waterbody	5	Figure 14 Figure 15 Figure 16
Error Comment(s): 1. A waterbody is present and missing breaklines 2. A waterbody is present in the DEM and missing breaklines 3. A waterbody present in the DEM is missing breaklines 4. A waterbody present in the DEM is missing breaklines 5. A waterbody is missing breaklines				
Hydroflattened Polygon Breaklines	Geometry Error	River/Stream Segment	2	Figure 17 Figure 18
Error Comment(s): 1. A segment of river has a geometry error likely due to misplaced breaklines 2. A segment of river has a geometry error likely due to a bridge removal.				
Hydroflattened Polygon Breaklines	Geometry Error	None	2	Figure 19 Figure 20
Error Comment(s): 1. Breaklines have been misplaced and causing a breakline enforcement issue in the river 2. Breaklines have been misplaced and causing a breakline enforcement error

Error Type: Geometry Error, Error Subtype: Overextended

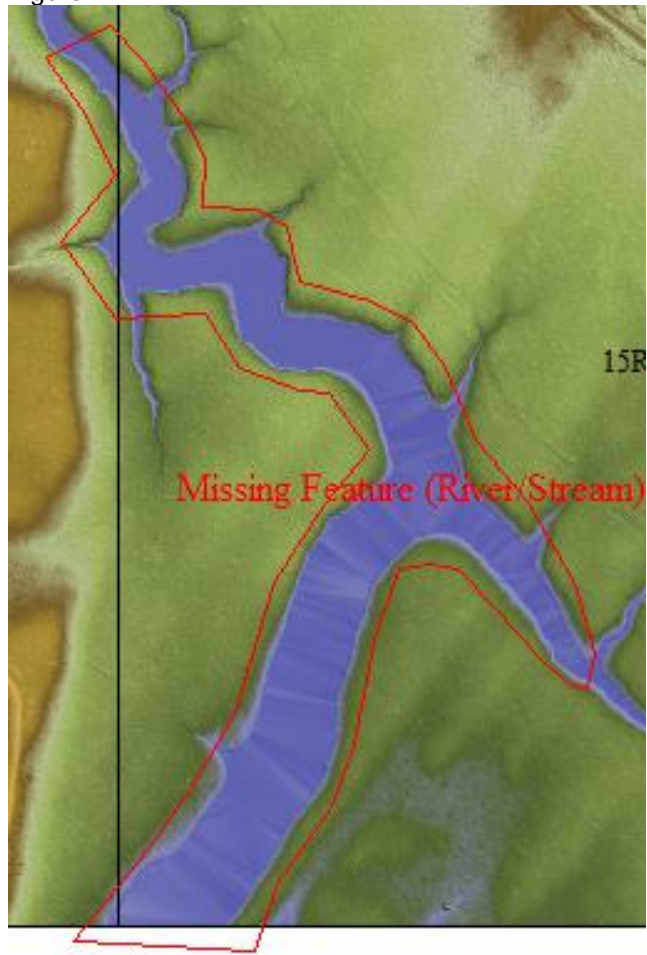
Hydroflattened Polygon Breaklines	Missing Feature	River/Stream	3	Figure 21 Figure 22
Error Comment(s): 1. A river/stream is missing breaklines 2. A river/stream is missing breaklines 3. A segment of river/stream is missing breaklines
