Dewberry Response to USGS Review of the Virginia Fairfax County Lidar Project

Produced for U.S. Geological Survey

USGS Contract: G16PC00020

Task Order: 140G0218F0214

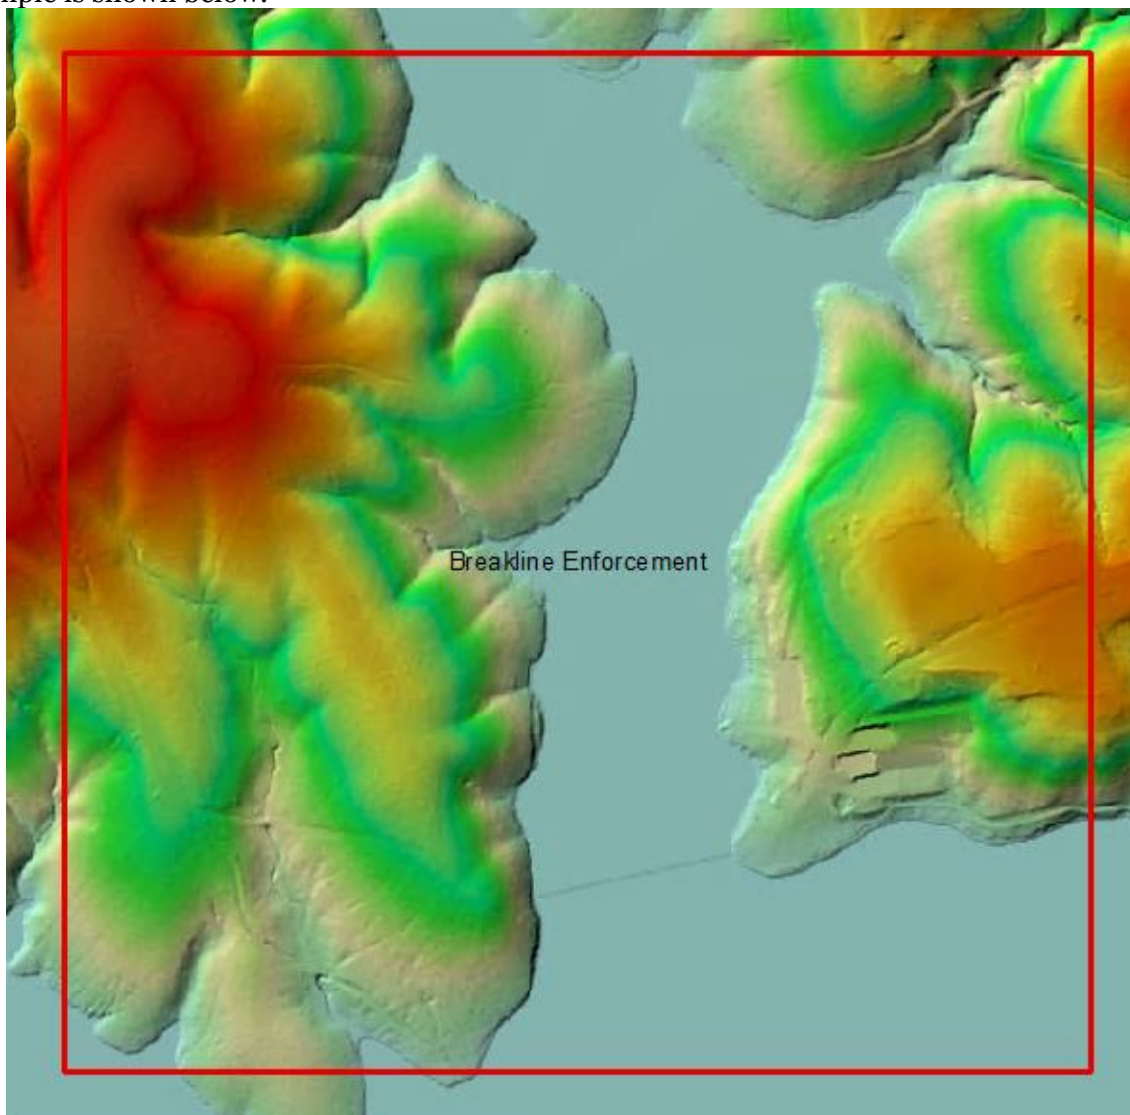
USGS made three (3) calls where a waterbody was not hydroflattened to a single elevation value. Dewberry has addressed these calls and the ~~LAS~~ breaklines and DEMs were corrected. An example is shown below.

Figure 2 – Tiles e1599n1900 and e1600n1900. The image above is an overview of the DEM where USGS made a call that a waterbody was not hydroflattened to a single elevation.

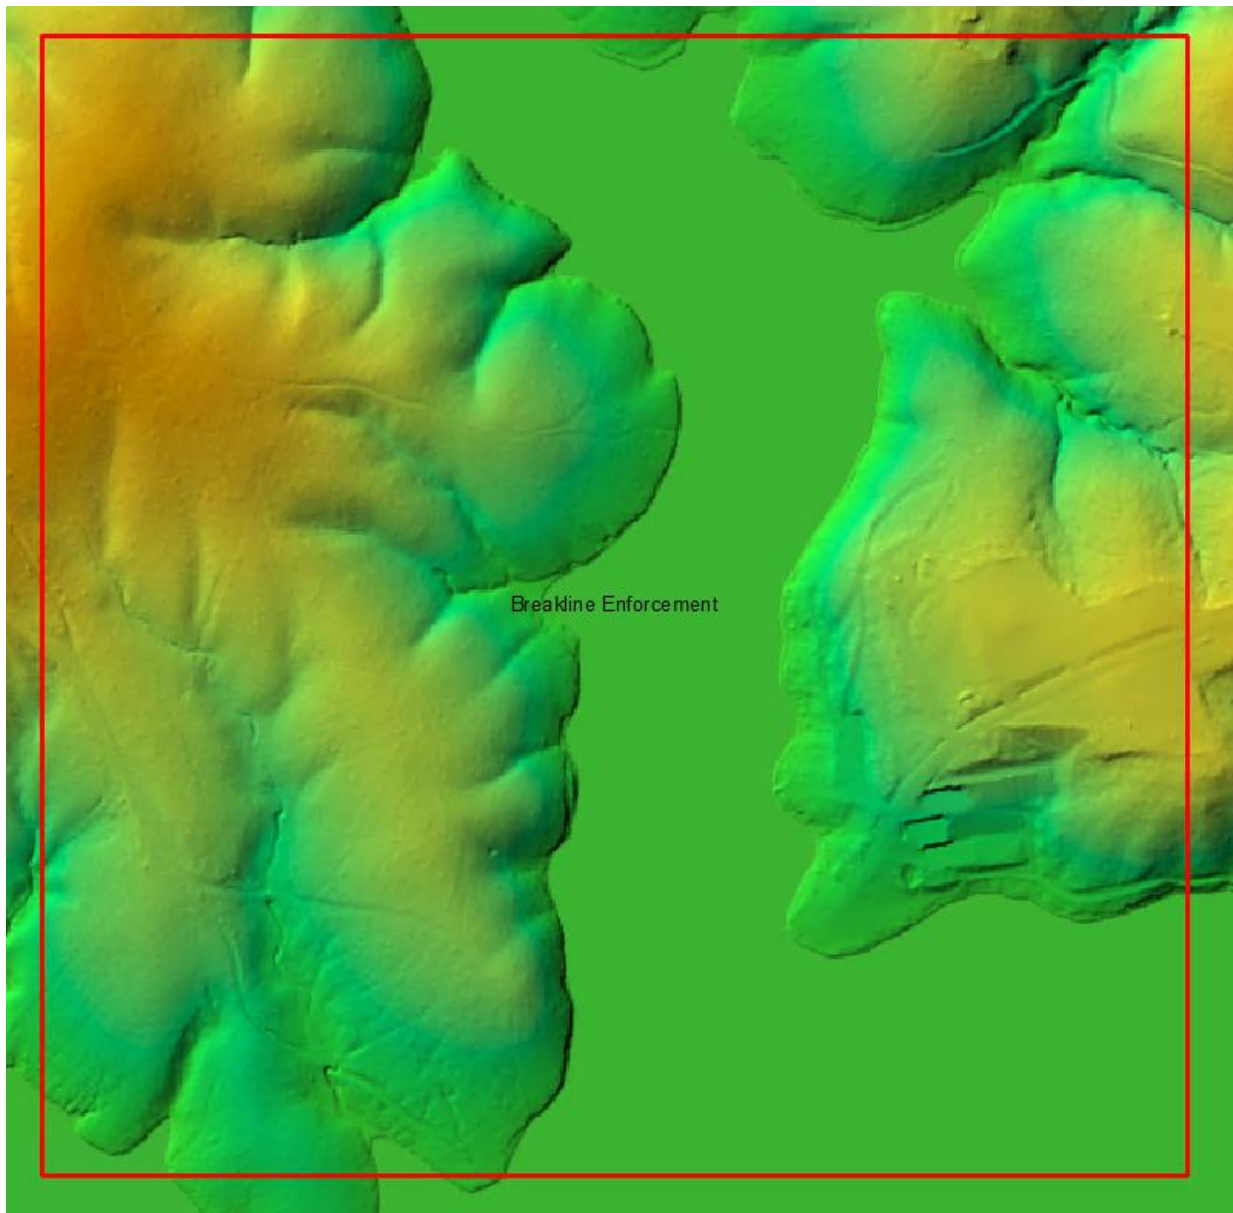
Figure 3 – Tiles e1599n1900 and e1600n1900. The image above is an overview of the corrected DEM.

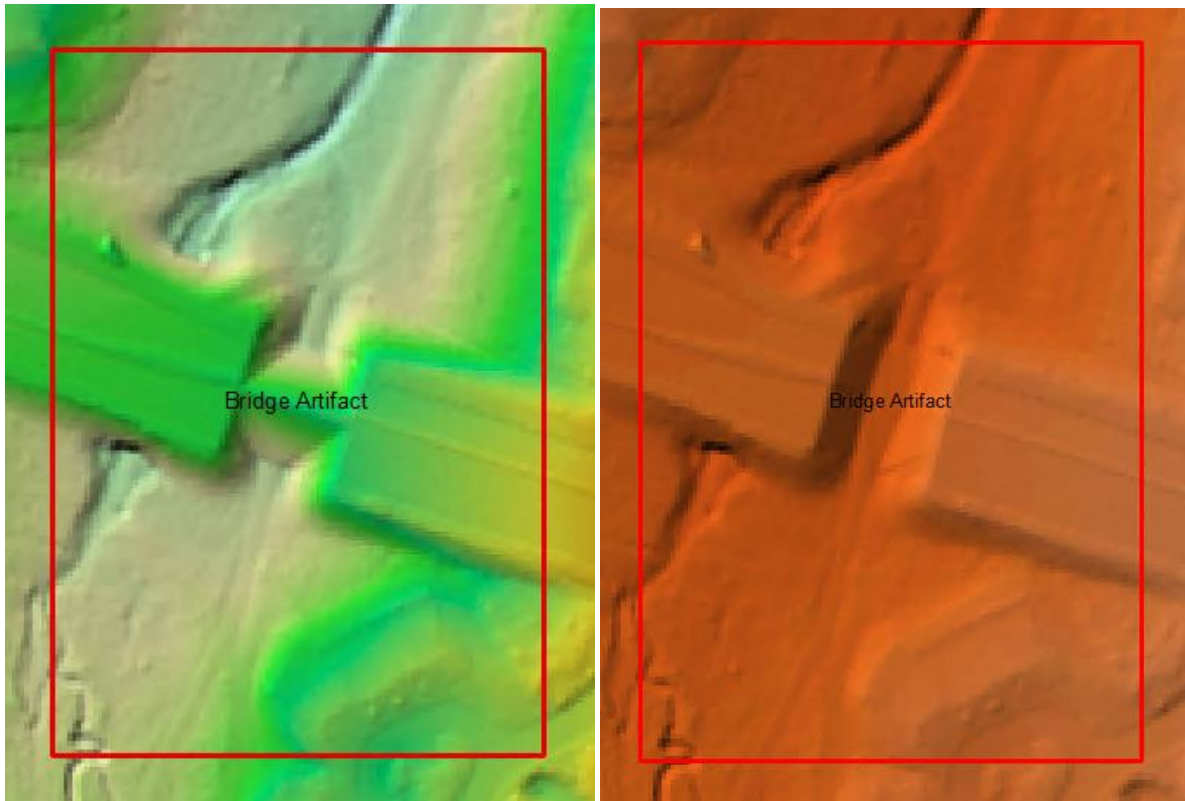
USGS made ten (10) calls where there was a bridge artifact visible on the DEM after the bridge was removed. Dewberry has addressed these calls and the bridge saddle LAS breaklines and DEM_s were corrected. An example is shown below.

Figure 4 – Tile e1591n1929. The image on the left is an overview of the DEM where USGS made a call that there was a bridge artifact visible on the DEM after the bridge was removed. The image on the right is an overview of the corrected DEM.

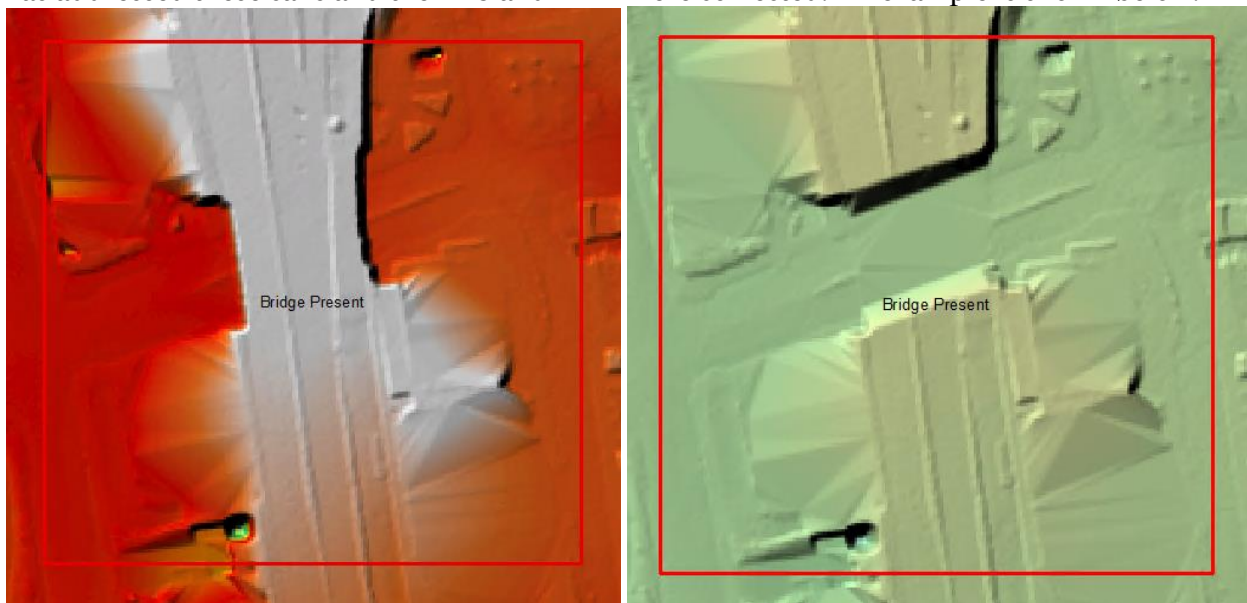
USGS made eight (8) calls where a bridge deck was not removed from the DEM surface. Dewberry has addressed these calls and the LAS and DEM were corrected. An example is shown below.

Figure 5 – Tile e1591n1929. The image on the left is an overview of the DEM where USGS made a call that a bridge deck was not removed from the DEM surface. The image on the right is an overview of the corrected DEM.

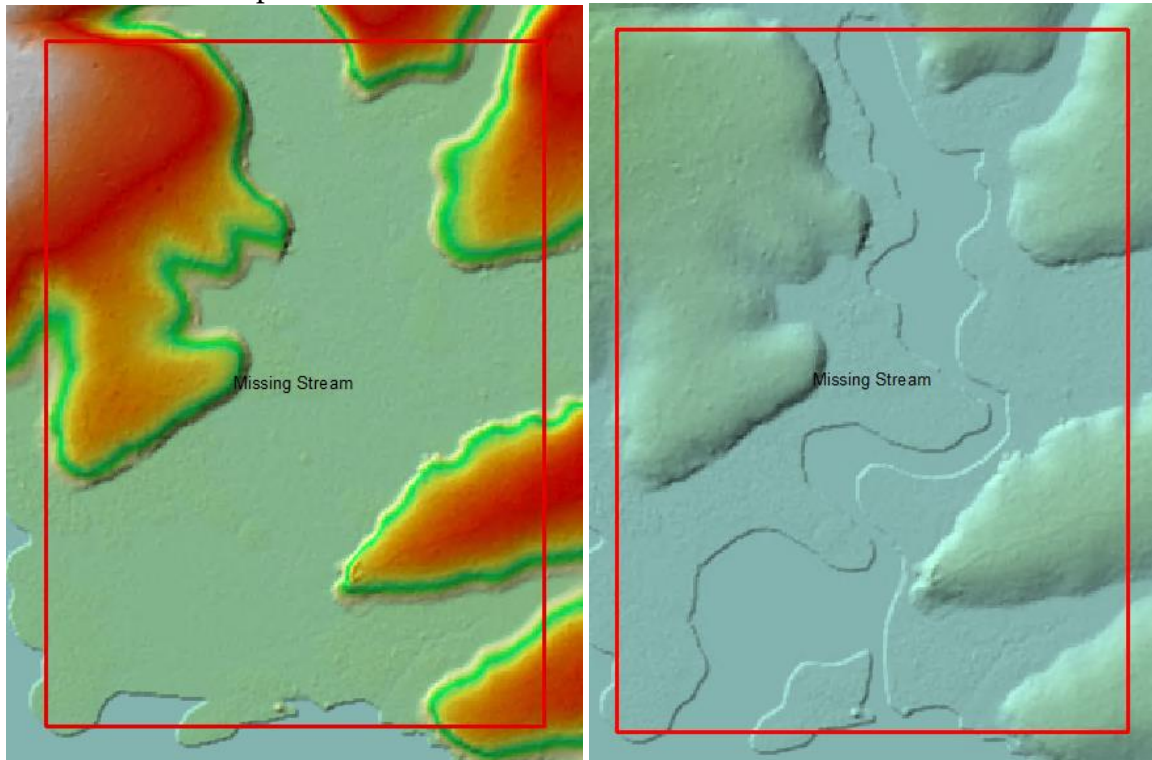
USGS made two (2) calls where a stream wider than 30m did not have breaklines and was not hydroflattened. Dewberry has addressed these calls and the LAS, breaklines, and DEMs were corrected. An example is shown below.

Figure 6 - Tiles e1613n1894, e1613n1895, e1614n1894, e1614n1895. The image on the left is an overview of the DEM where USGS made a call stating that a stream wider than 30m did not have breaklines and was not hydroflattened. The image on the right is an overview of the corrected DEM.

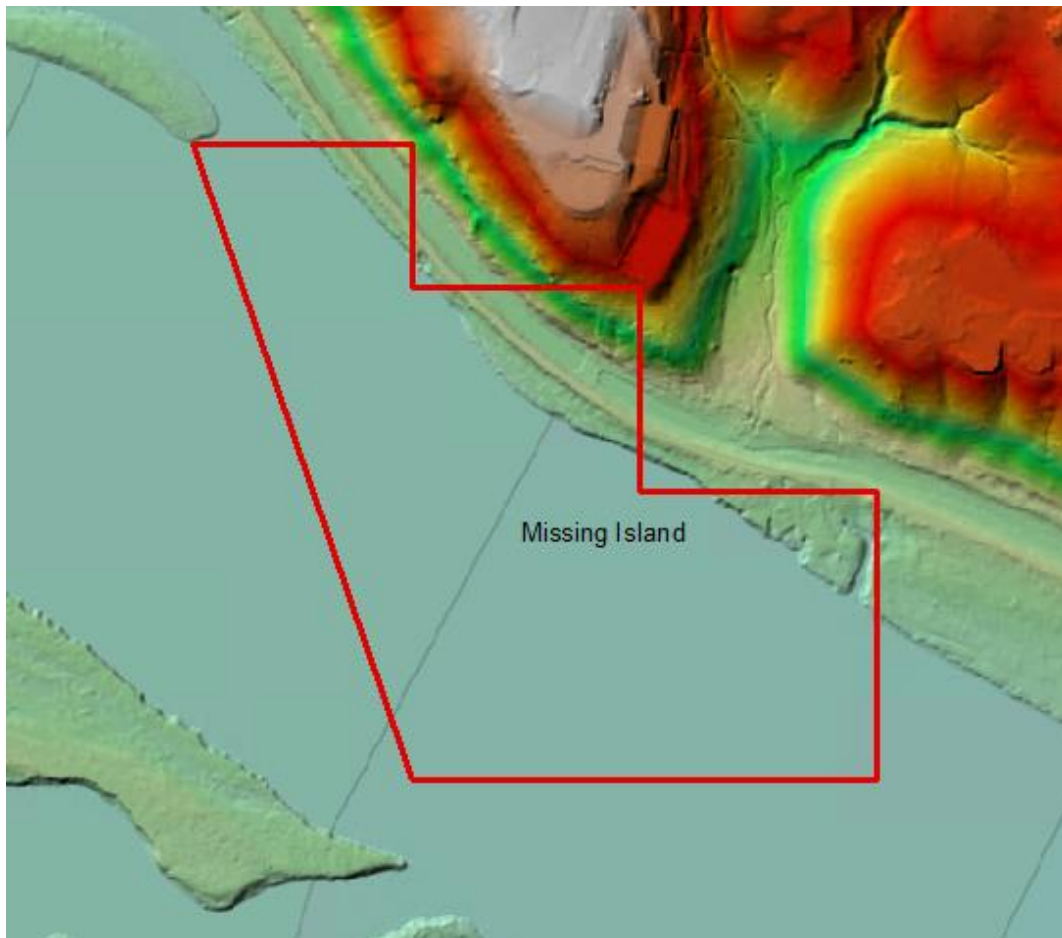
USGS made one (1) call where only part of an island was marked with breaklines. Dewberry has addressed this call and the LAS, breaklines, and DEMs were corrected.

Figure 7 – Tiles e1597n1936 and e1595n1936. The image above is an overview of the DEM where USGS made a call stating that only part of an island was marked with breaklines.

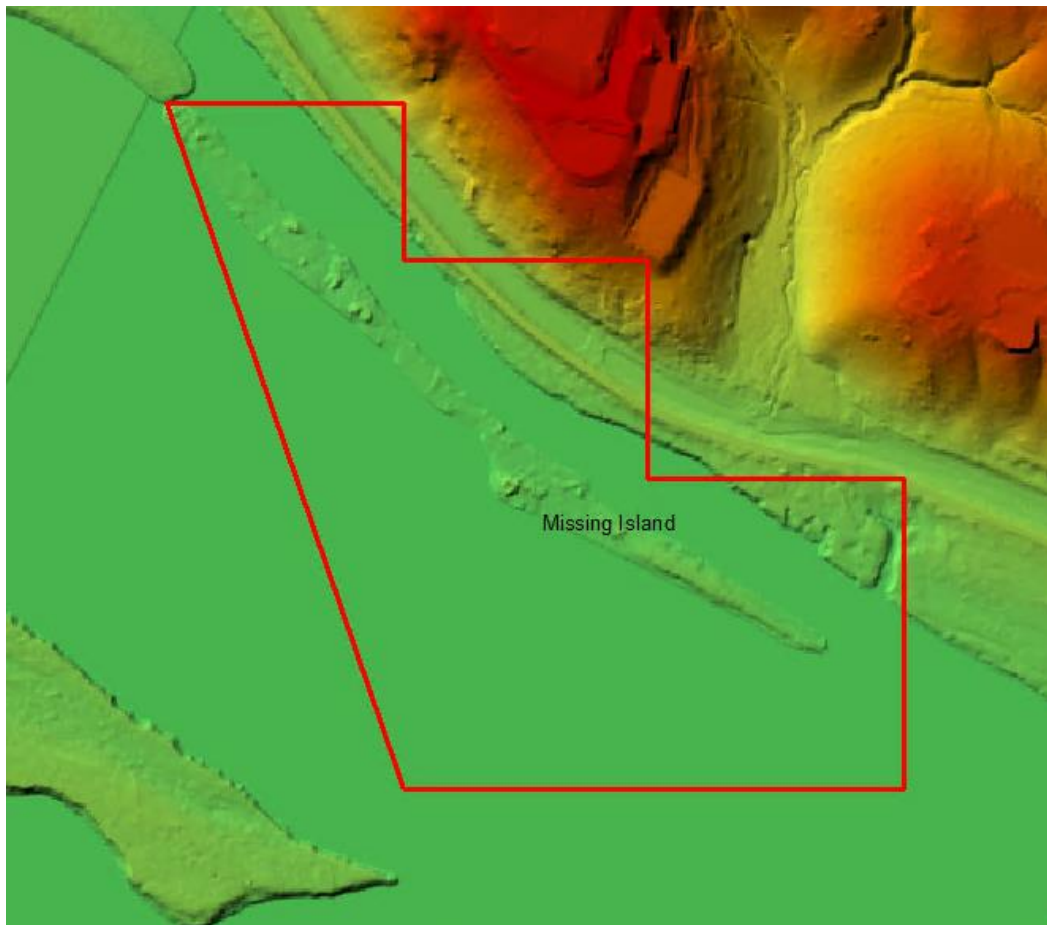
Figure 8 – Tiles e1597n1936 and e1595n1936. The image above is an overview of the corrected DEM.

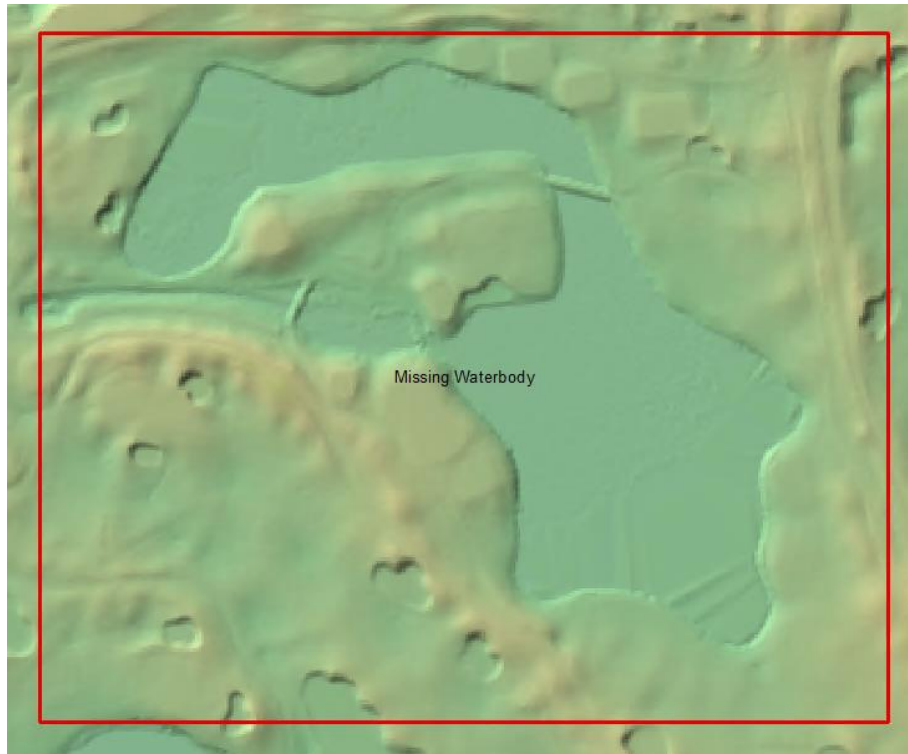
USGS made one (1) call where a waterbody larger than 2 acres was missing breaklines and was not hydroflattened. Dewberry has addressed this call and the LAS, breaklines, and DEMs were corrected.

Figure 9 – Tiles e1588n1937 and e1588n1938. The image above is an overview of the DEM where USGS made a call stating that a waterbody larger than 2 acres was missing breaklines and was not hydroflattened.

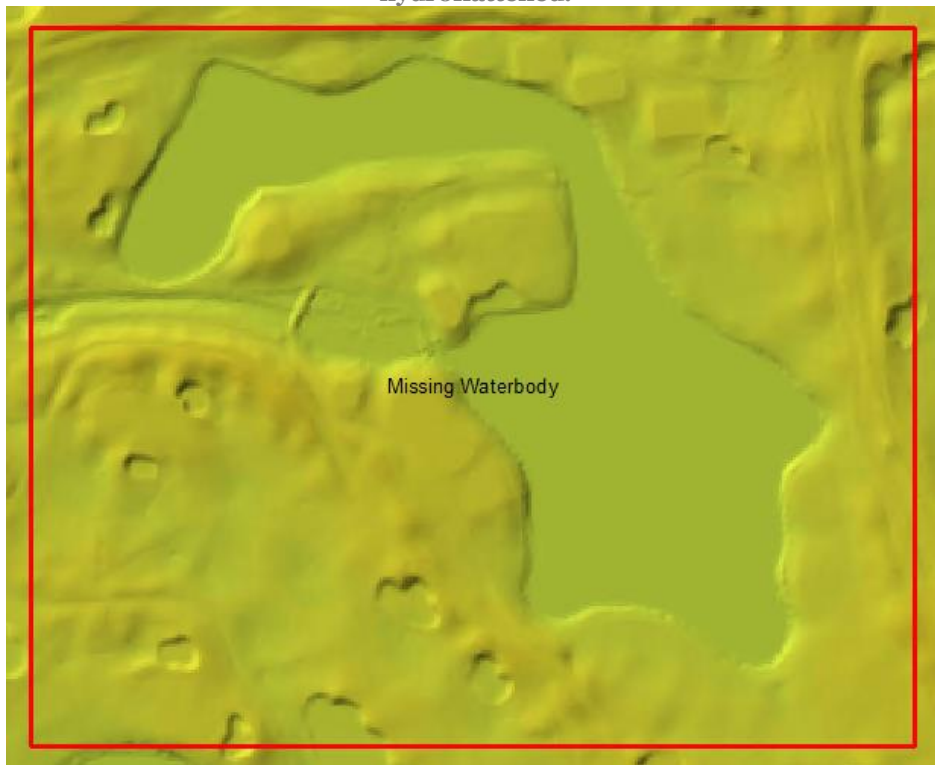
Figure 10 – Tiles e1588n1937 and e1588n1938. The image above is an overview of the corrected DEM.

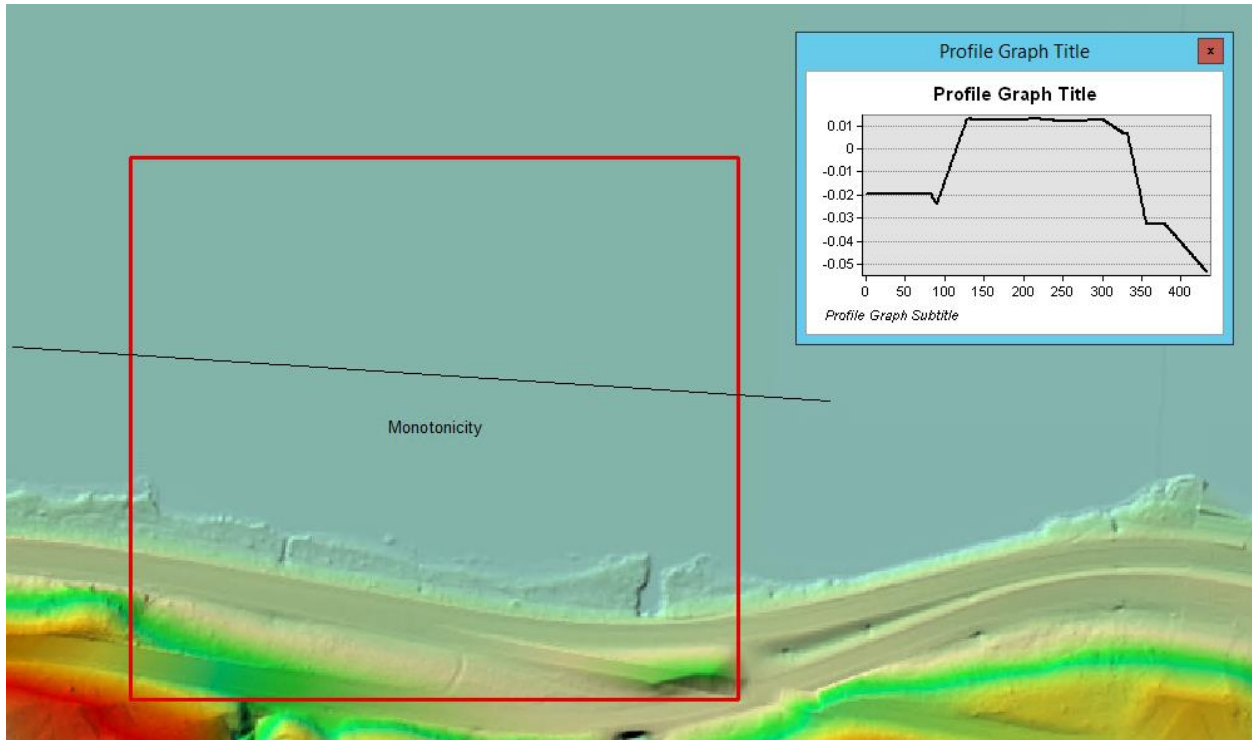
USGS made two (2) calls where a stream was not properly hydroflattened in a downstream manner. Dewberry has addressed these calls and the LAS, breaklines, and DEMs were corrected. An example is shown below.

Figure 11 – Tile e1615n1925. The image above shows an overview of the DEM where USGS made a call stating a stream was not properly hydroflattened in a downstream manner.

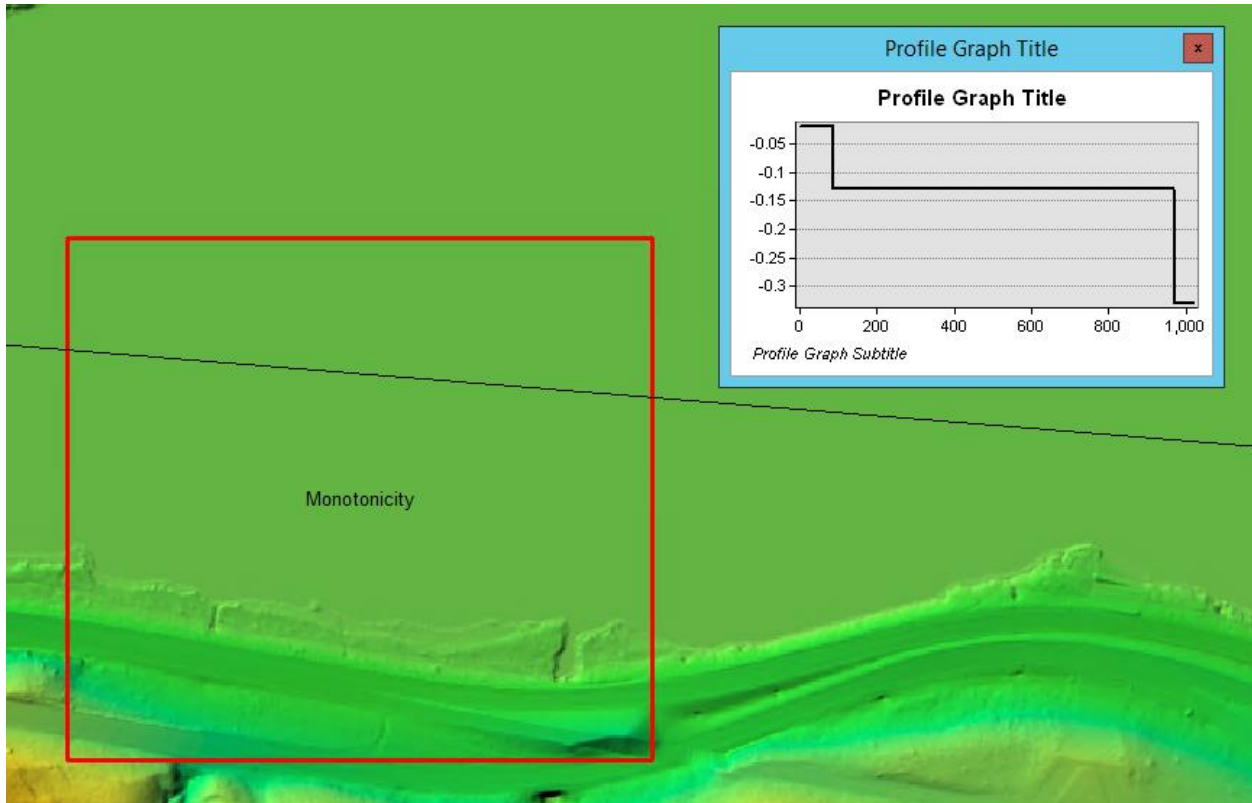
Figure 12 – Tile e1615n1925. The image above shows an overview of the corrected DEM.

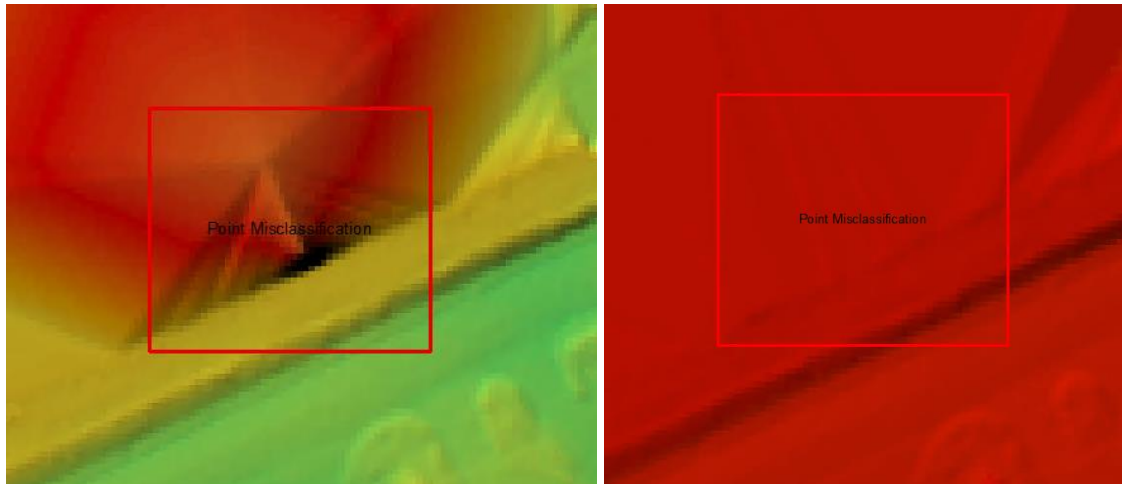
USGS made three (3) calls where there were building points mistakenly classified as ground points. Dewberry has addressed these calls and the LAS and DEMs were corrected. An example is shown below.

Figure 13 - Tile e1584n1918. The image on the left shows an overview of the DEM where USGS made a call stating that there were building points mistakenly misclassified as ground points. The image on the right is an overview of the corrected DEM.
