# Dewberry Response to USGS Review of the Eastern Shore Virginia QL2 LiDAR BAA Project

Produced for U.S. Geological Survey

USGS Contract: G10PC00013

Task Order:G15PD00284

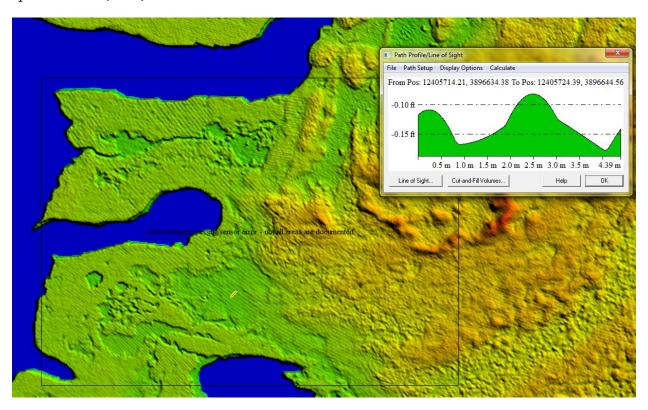
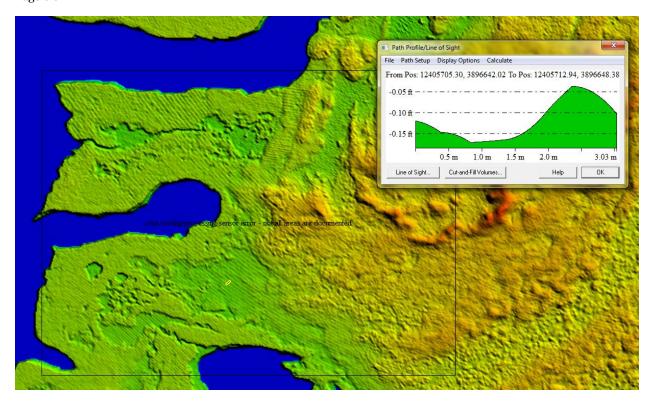
USGS made five cornrowing calls. The cornrowing was not previously called although it existed in the initial delivery. Dewberry reviewed the LAS and found that the cornrowing was within specifications (8 cm).

Figure 2- DEM\_S23\_4809. The above image is an overview of the DEM from the original project delivery on February 11, 2016. The below image is an overview of the DEM from the second project delivery on March 22, 2016. The cornrowing is within the <8 cm specifications.

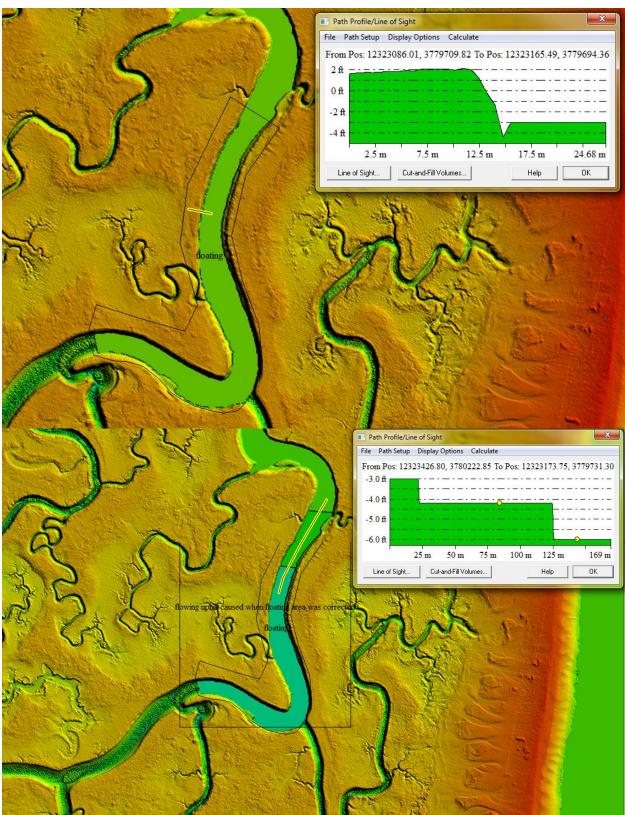
USGS made a call in a tidal area about the direction of the flow. This area was previously corrected due to a floating call on the DEM tile from the original project delivery. Dewberry corrected the area by lowering the elevation in this portion of the tidal. The tidal had to be adjusted to flow downhill to remove the floating. The USGS Lidar Base Specification v1.2 allows for vertical discontinuities within the tidal waterbodies that can be retained in the DEM. Dewberry did not deem it necessary to adjust the DEM tile.

Figure 3- DEM\_S23\_3728\_10 and DEM\_S23\_3727\_20. The above image is an overview of the DEM from the original project delivery on February 11, 2016 with the floating call from USGS's first

review. The below image is an overview of the DEM from the second project delivery on March 22, 2016 with the tidal adjusted to correct the floating call.

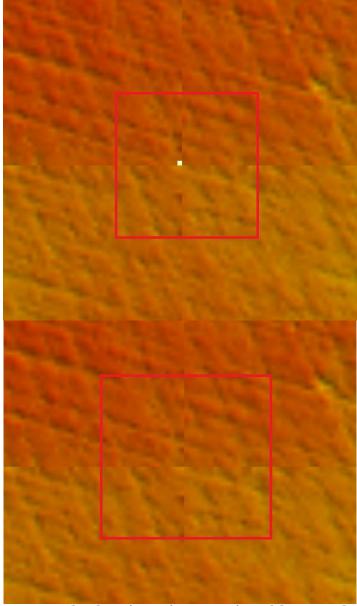
USGS made one void calls. Dewberry confirmed that the void was created during processing and has recreated the DEM tile that contained a void.

Figure 4- DEM\_S23\_2754\_20. The above image is an overview of the DEM where USGS made a data void call. The below image is an overview of the reprocessed DEM with the data void removed.

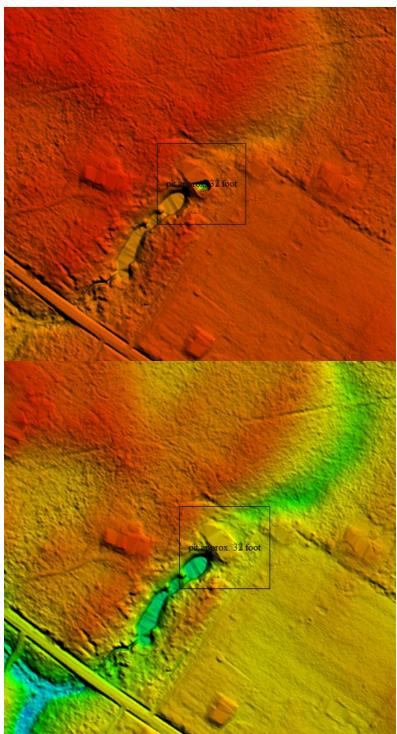
USGS made four additional DEM calls. Dewberry has corrected all the locations. An example is provided below.

Figure 5- DEM\_S23\_3822\_40. The above image is an overview of the DEM where USGS made a DEM call to remove a 32 foot pit. The below image is an overview of the reprocessed DEM with the pit removed.

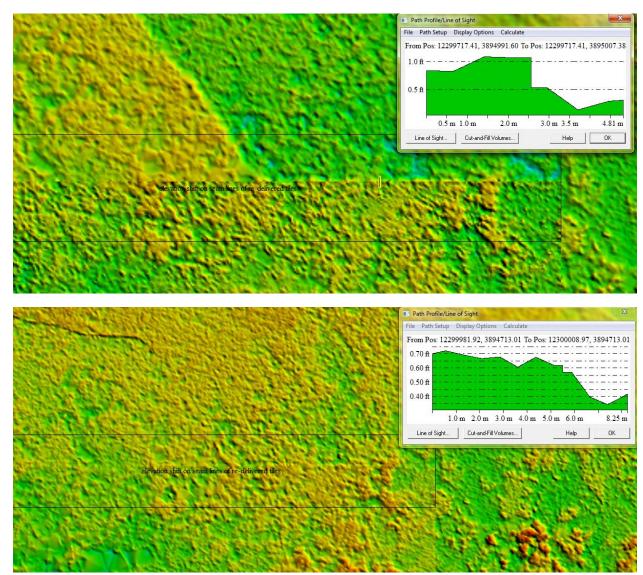
USGS made one call of an elevation shift along redelivered tiles. The elevation shift occurs on the extra tiles that are outside of the client provided boundary but within the boundary that Dewberry created. Dewberry adjusted the tile to minimize the elevation difference.

Figure 6- DEM\_S23\_3799\_30x and DEM\_S23\_3799\_40x. The above image is an overview of the DEM where USGS made a DEM call of an elevation shift causing a seamline. The below image is an overview of the reprocessed DEM with the elevation shift minimized.
