Dewberry Response to USGS Review of the Eastern Shore Virginia QL2 LiDAR BAA Project

Produced for U.S. Geological Survey

Task Order:G15PD00284

Report Date: 03/22/2016

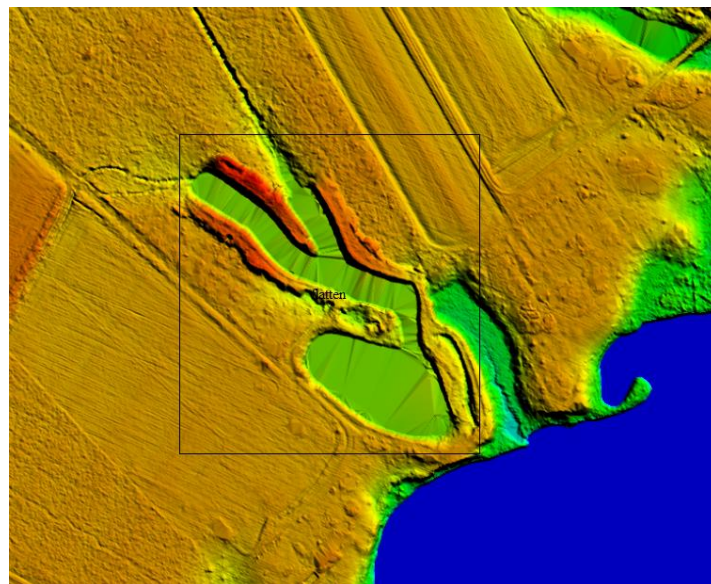
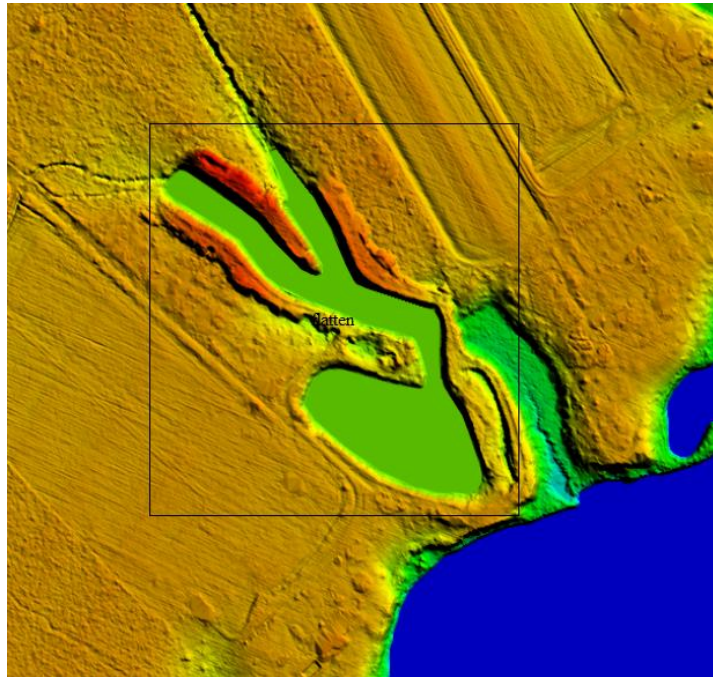
USGS made twenty four hydro-flatten calls. Fifteen of those calls were of lakes greater than two acres that need to be flattened. Dewberry agrees with these instances and they have been corrected. An example is shown below.

Figure 2- DEM_S23_2767_20. The above image is an overview of the DEM where USGS made a call to hydro-flatten a lake greater than 2 acres in size. The bottom image shows an overview of the DEM after Dewberry hydro-flattened the lake.

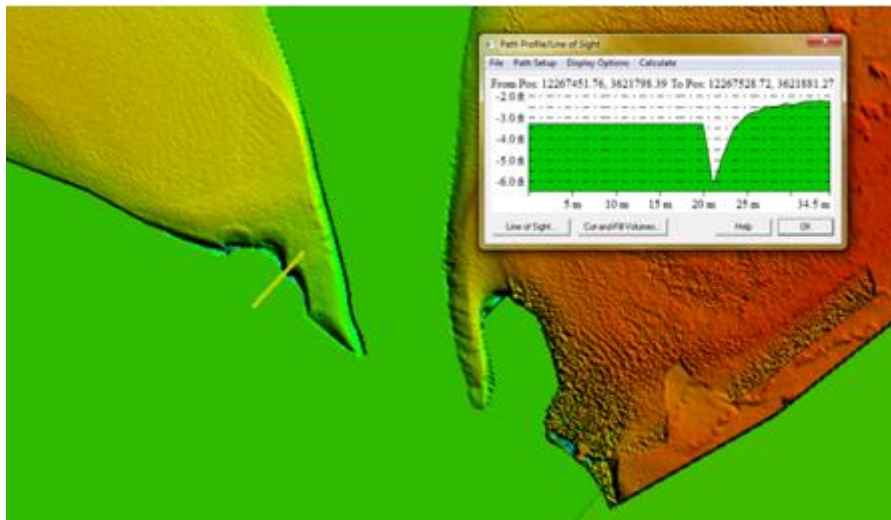
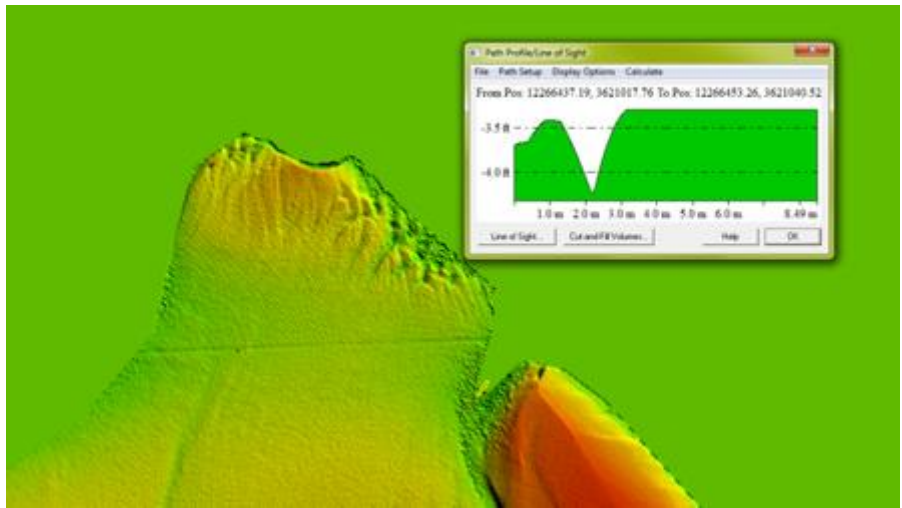
USGS made nine additional hydro-flatten calls with requested elevations. Dewberry adjusted the elevation to USGS' request which caused areas of the waterbody to be floating. Dewberry decided to keep the original stair stepped elevations in the tidal. The USGS Lidar Base Specification v1.2 allows for vertical discontinuities within the tidal waterbodies that can be retained in the DEM.

Figure 3- DEM_S23_2662_40. The above images is an overview of the DEM where USGS made a call to hydro-flatten a tidal area to an elevation of -3.3. This elevation change caused floating in two areas.

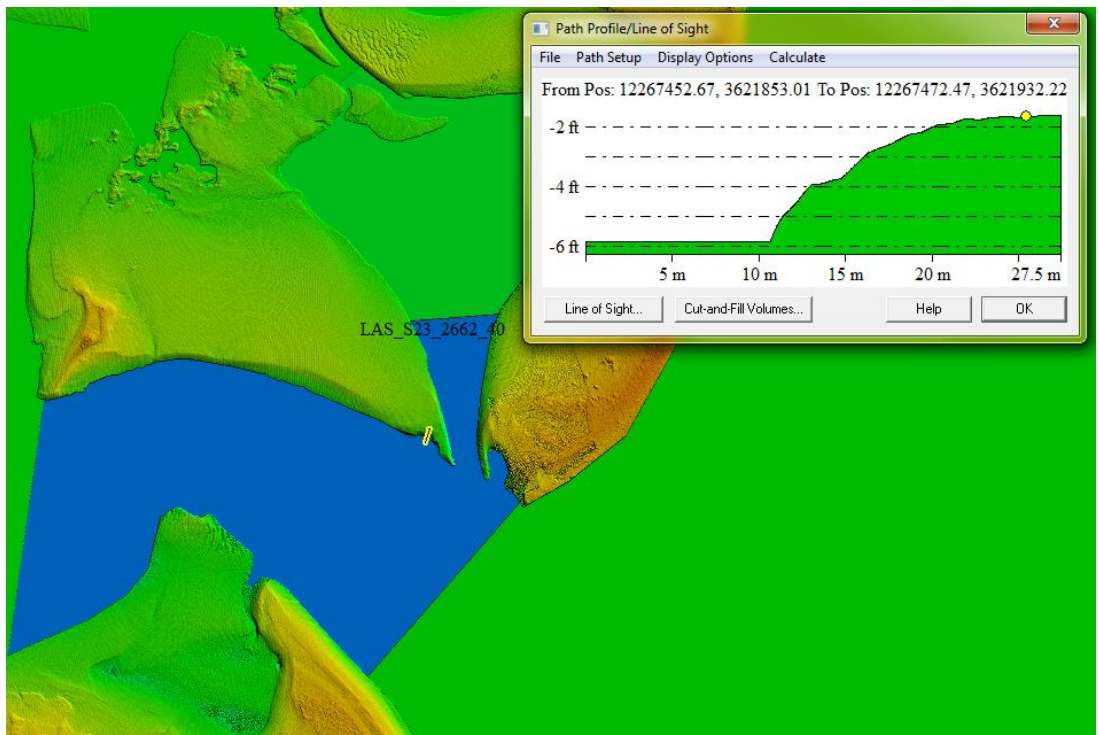
Figure 4- DEM_S23_2662_40. The above image is an overview of Dewberry's DEM set with the original elevations.

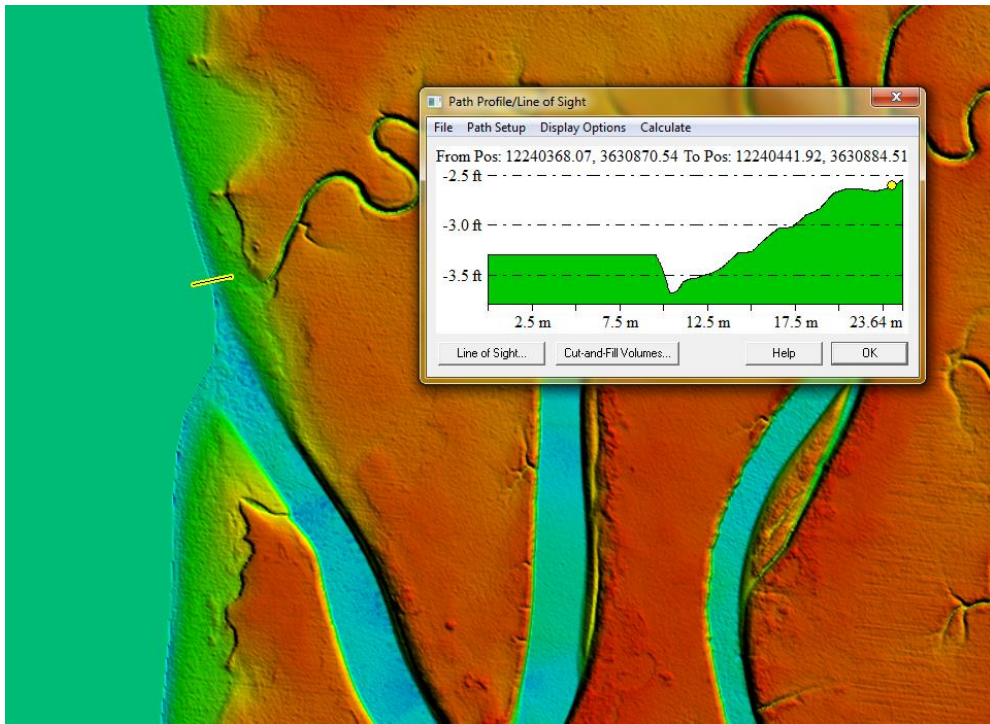
Figure 5- DEM_S23_2643_10. The above image is another overview of the DEM where USGS made a call to hydro-flatten a tidal area to an elevation of -3.3 feet. This elevation change caused floating.

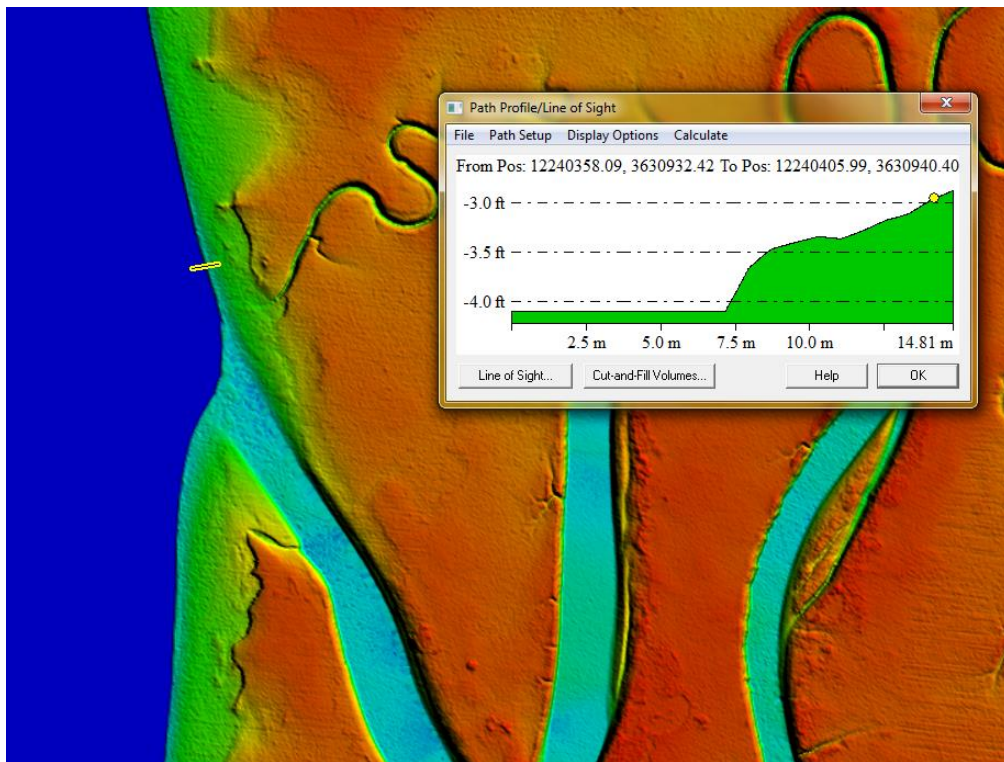
Figure 6- DEM_S23_2643_10. The above image is an overview of Dewberry's DEM set with the original elevations.

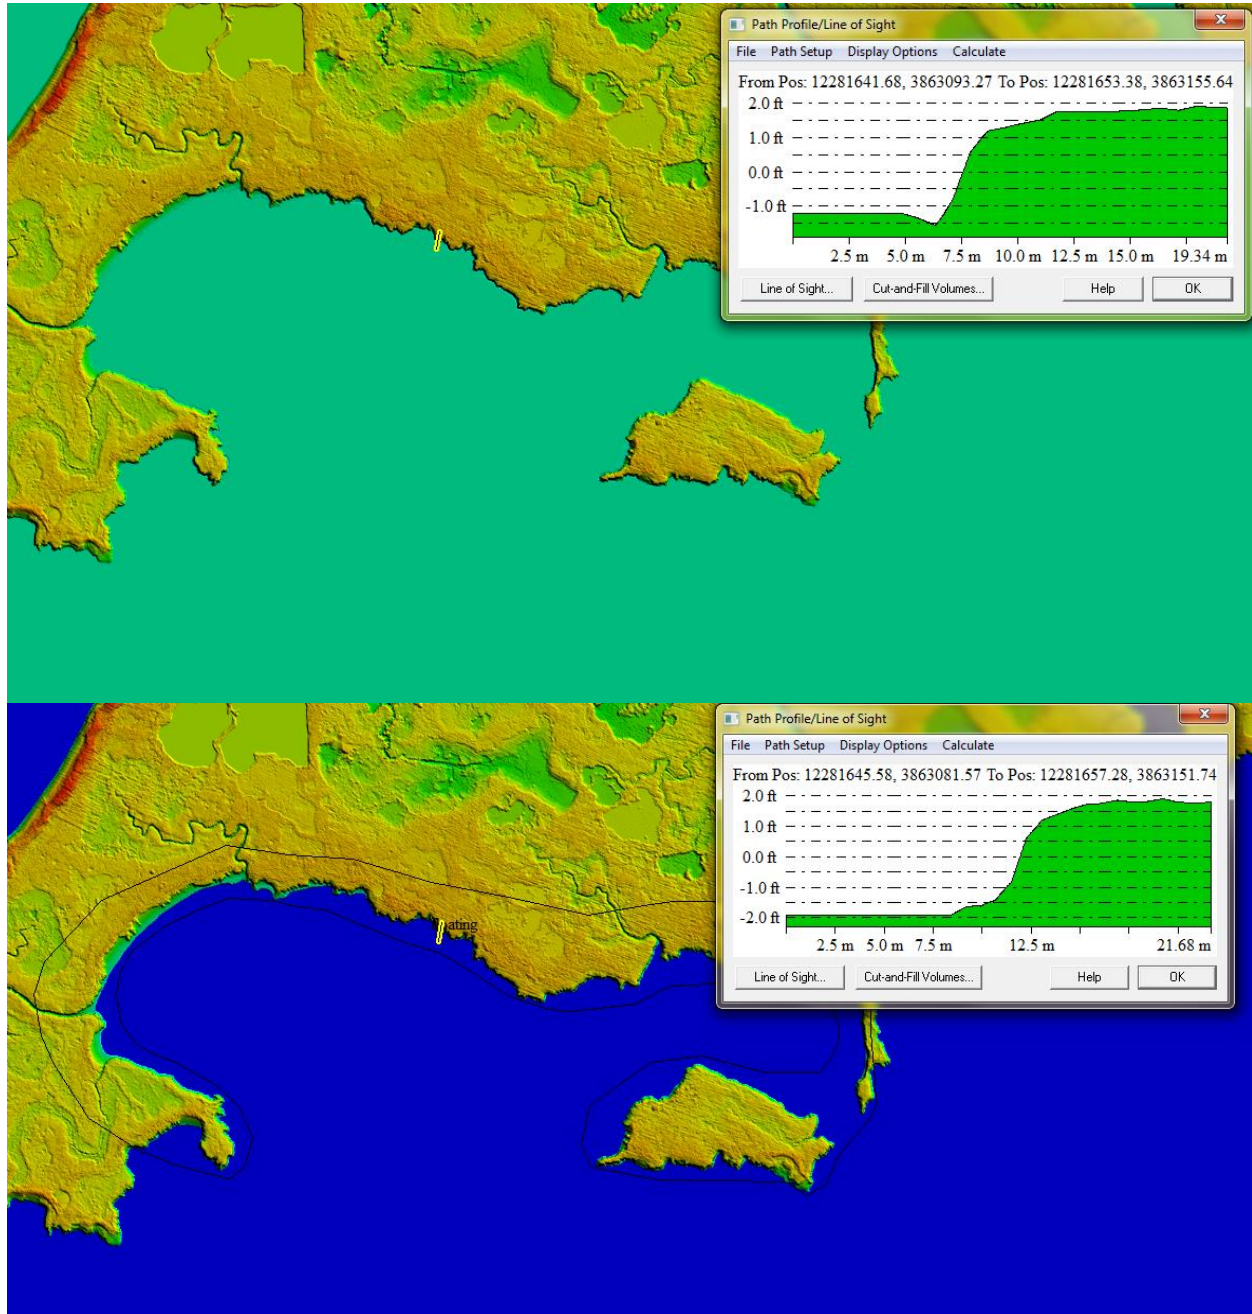
USGS identified twenty two areas that needed breakline adjustments due to floating areas of water. Dewberry agrees with these instances and they have been corrected. Below is an example.

Figure 7- DEM_S23_2886_10. The top image is an overview of the DEM where USGS made a call to fix a floating waterbody. The bottom image is an overview of the DEM with the adjusted breakline elevation.

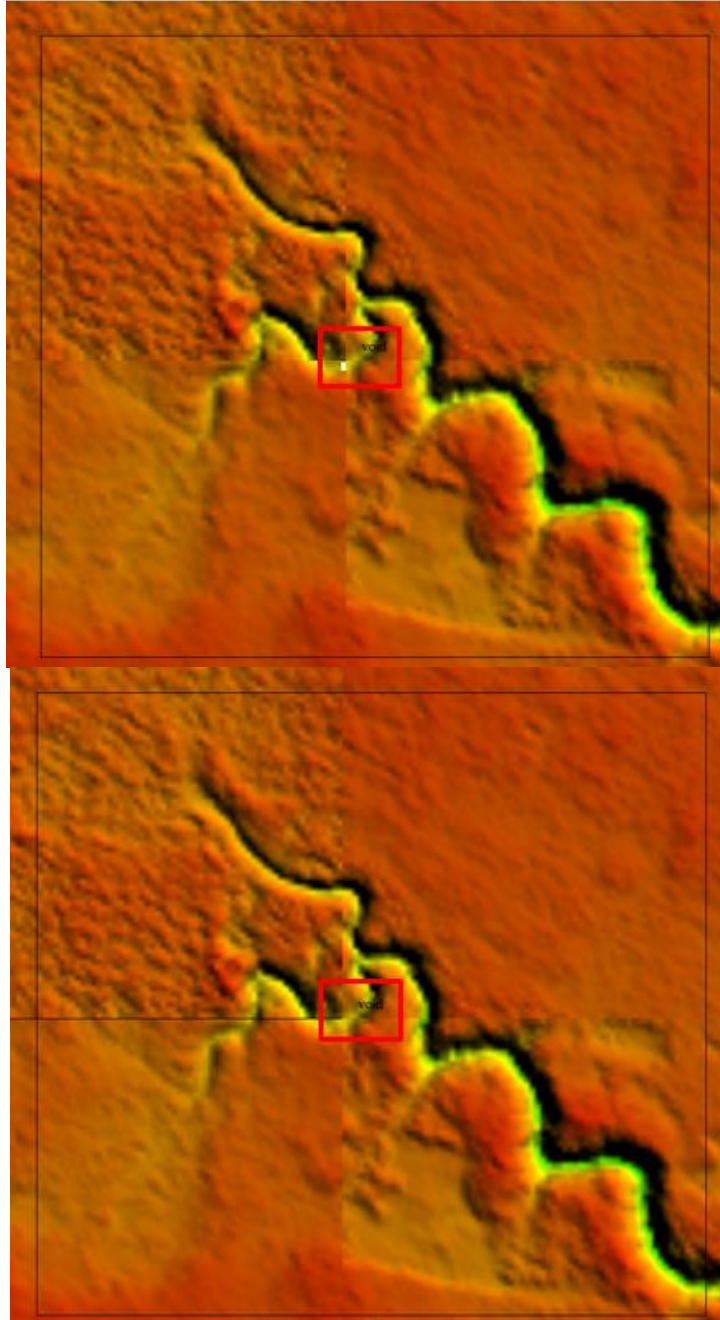
USGS made fifty eight data void calls. Dewberry confirmed that the voids were created during processing and have recreated the DEM tiles that contained voids.

Figure 8- DEM_S23_2783_30. The above image is an overview of the DEM where USGS made a data void call. The below image is an overview of the reprocessed DEM with the data void removed.

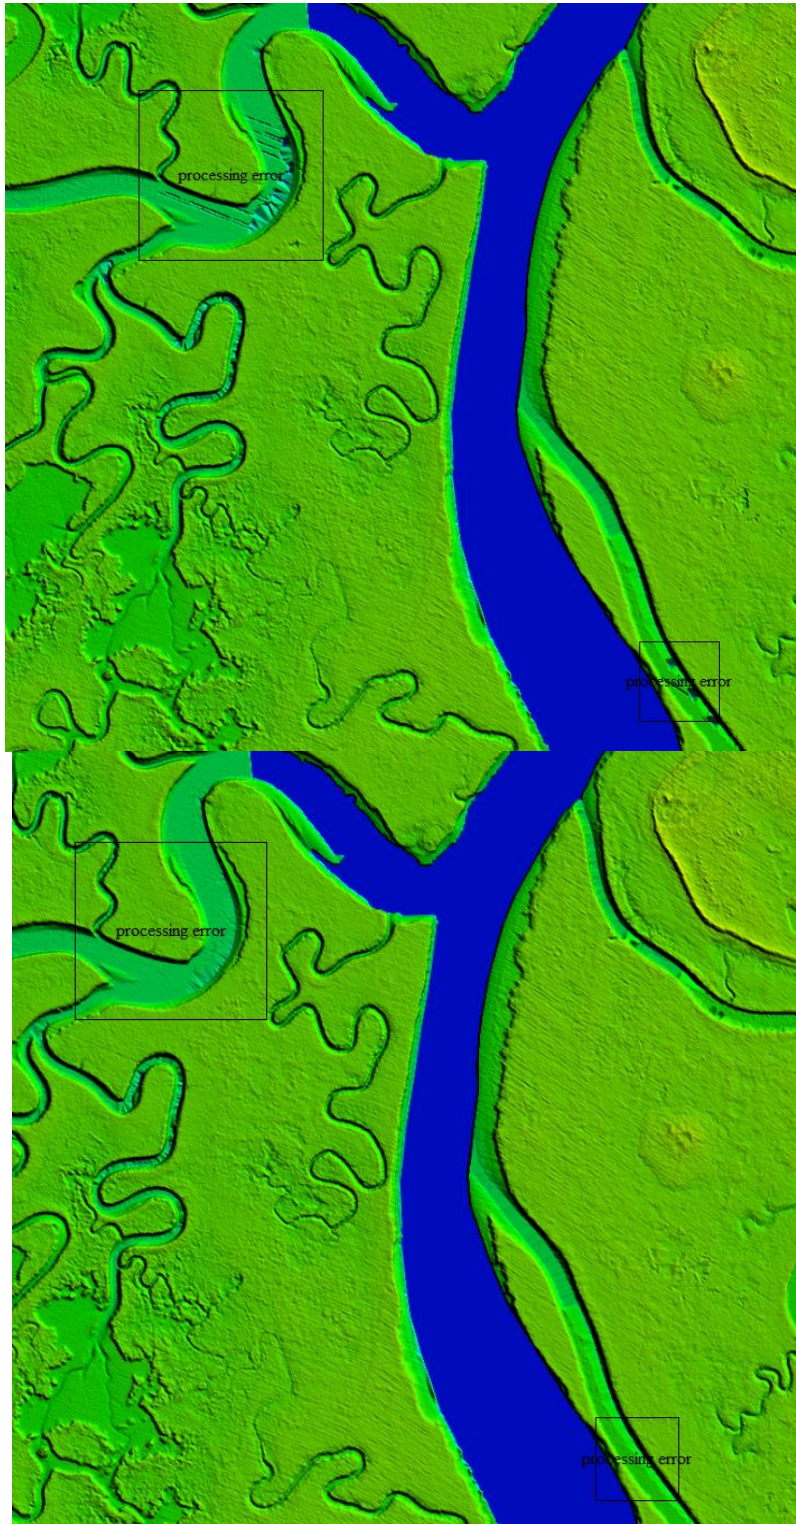
Figure 9- DEM_S23_3854_20. The above image is an overview of the DEM where USGS made two processing error calls. The below image is an overview of the reprocessed DEM with the processing error removed.

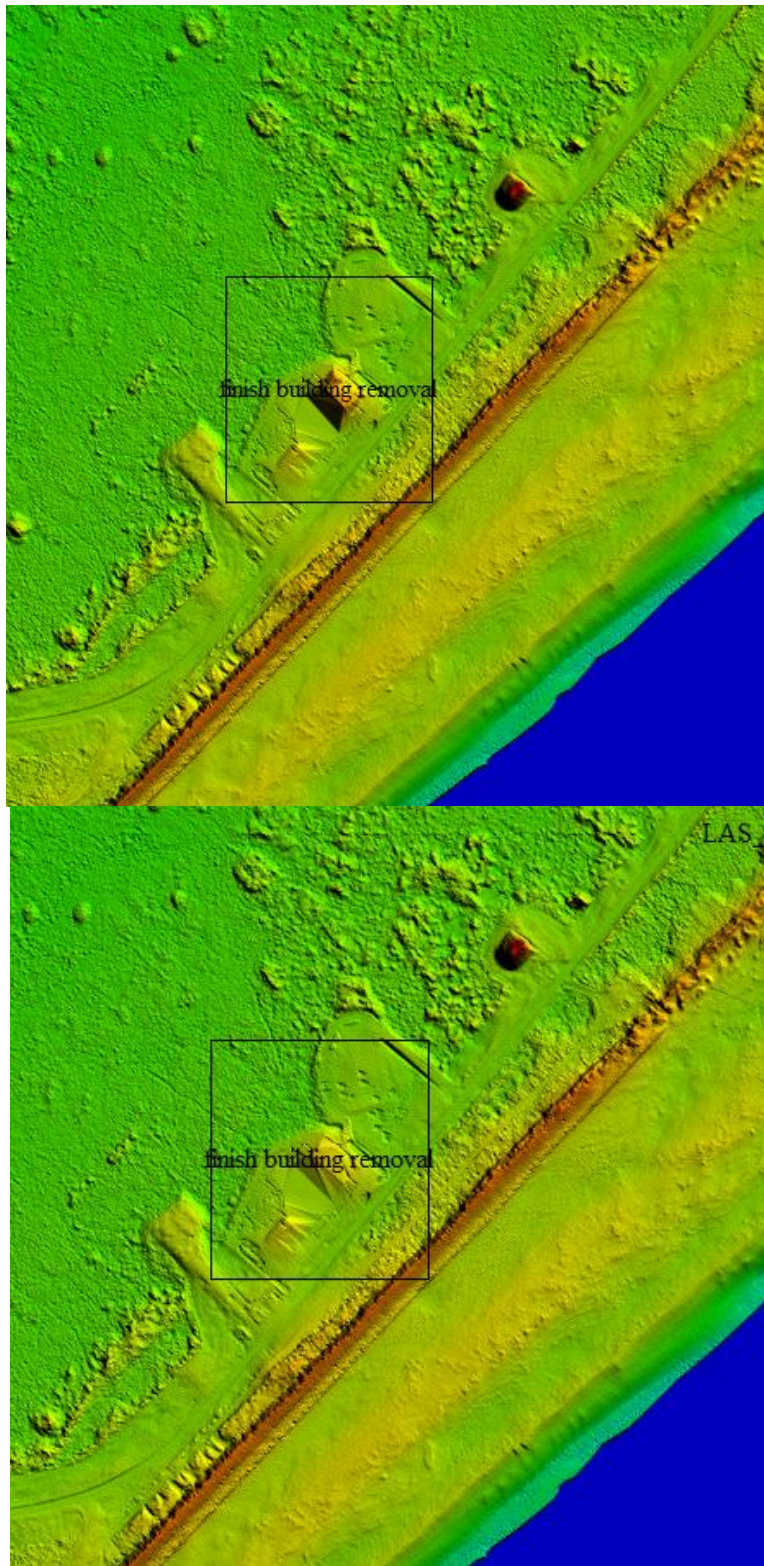
Figure 10- DEM_S23_3865_10. The above image is an overview of the DEM where USGS made a building removal call. The below image is an overview of the reprocessed DEM with the building completely removed.

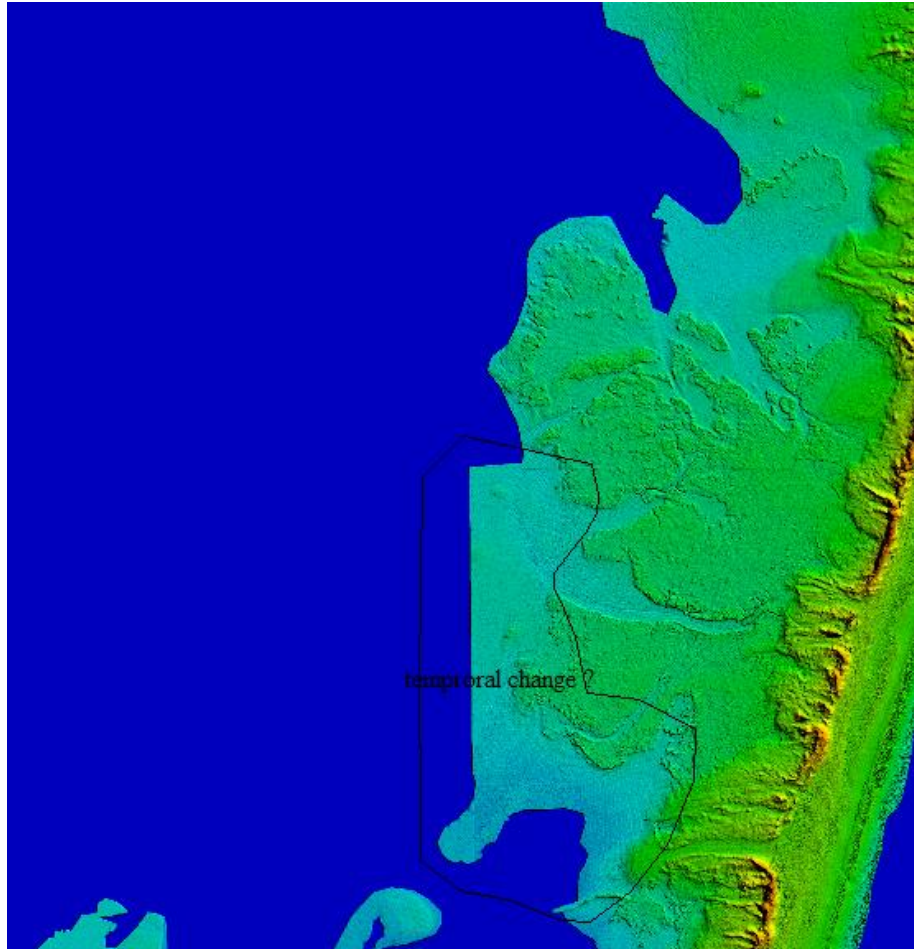
USGS made one call to confirm a location was temporal. Dewberry reviewed the call and determined that the area is temporal and cannot be adjusted. Dewberry added this area to the Temporal Calls shapefile located in the Other Ancillary Data folder.

Figure 11- DEM_S23_3729_30. The above image is an overview of the DEM where USGS made a temporal call.
