Dewberry Response to USGS Review of NY Great Lakes- Chautauqua LiDAR Project

Produced for U.S. Geological Survey

USGS Contract: G10OC00013

Report Date: 1/12/2015

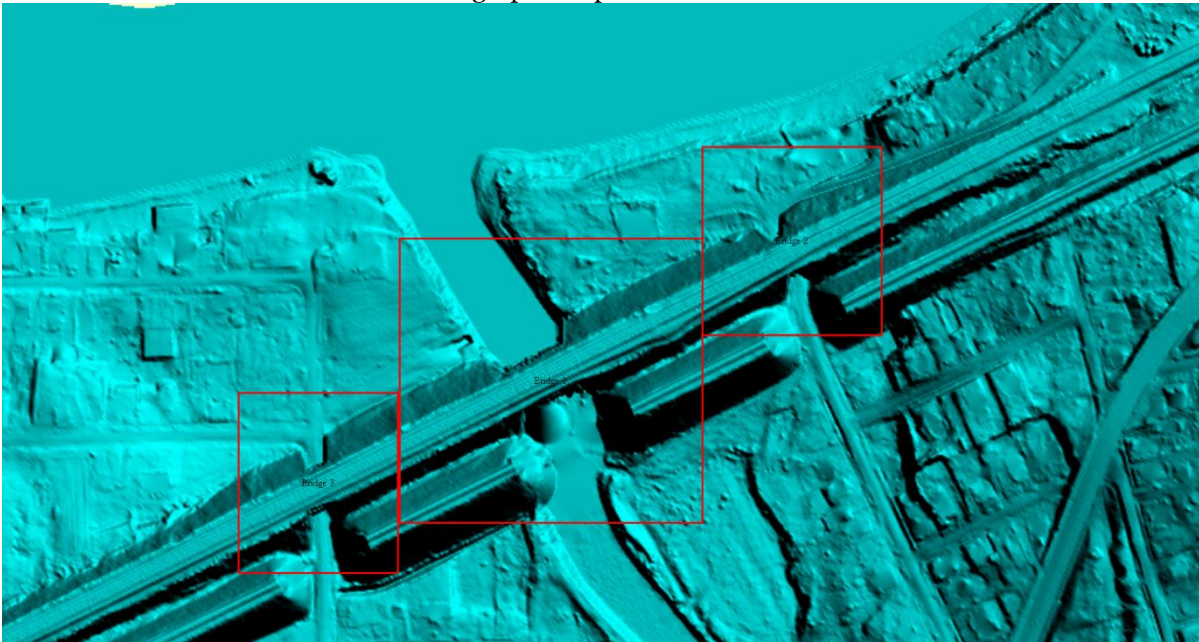
Figure 2 – USGS Screen Shot

USGS identified these three bridges within one area as being left in the ground model. Dewberry found that these three structures are culverts. Photographic explanations can be found below.

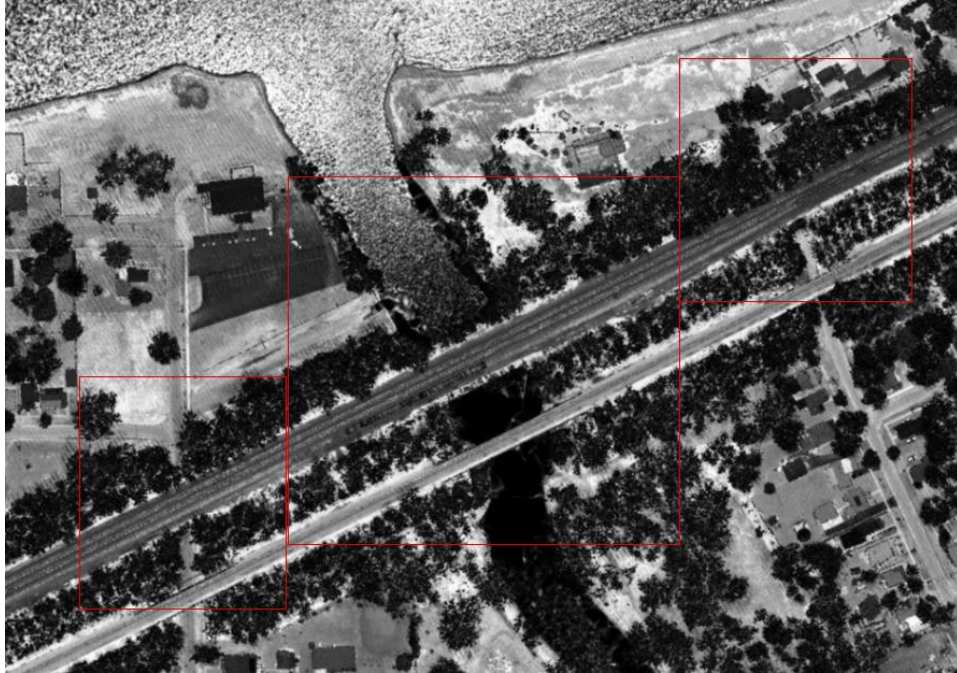
Figure 3 - Tile 17TPH565180. Full Point Cloud Intensity Imagery of the features.

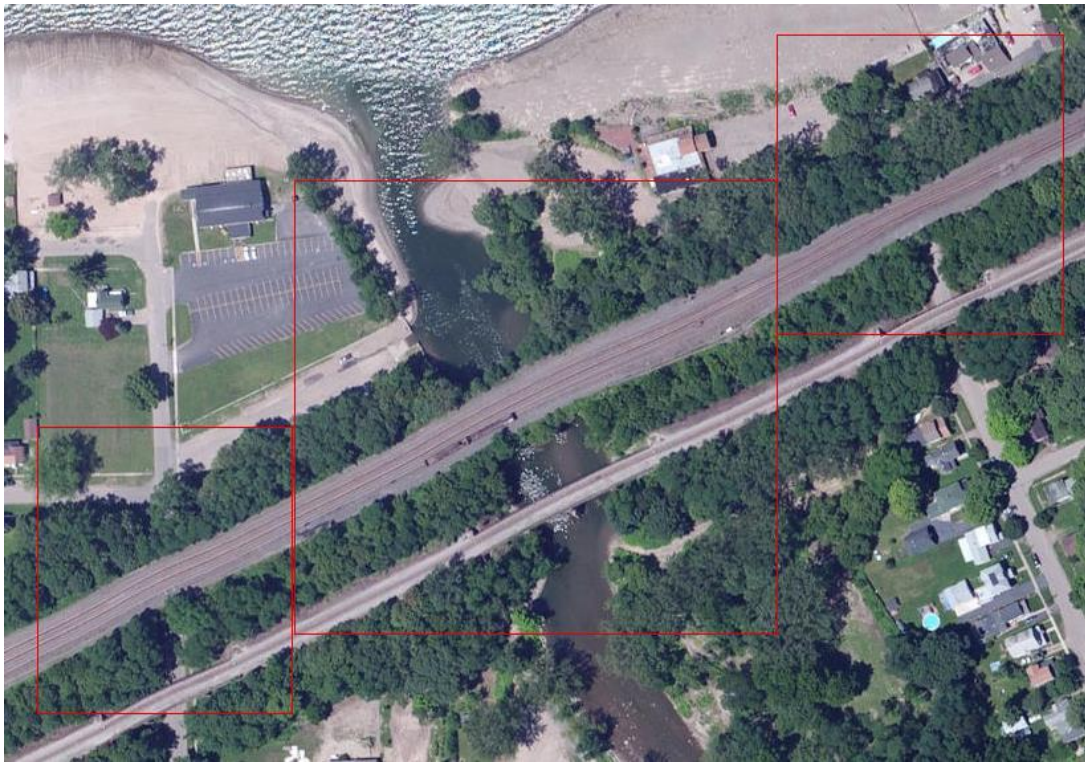
Figure 4 - Tile 17TPH565180. Bing Imagery shows that there are cinders/ ground between the railroad tracks and along the sides of the track. These three features are culverts and remain modeled in the ground surface.

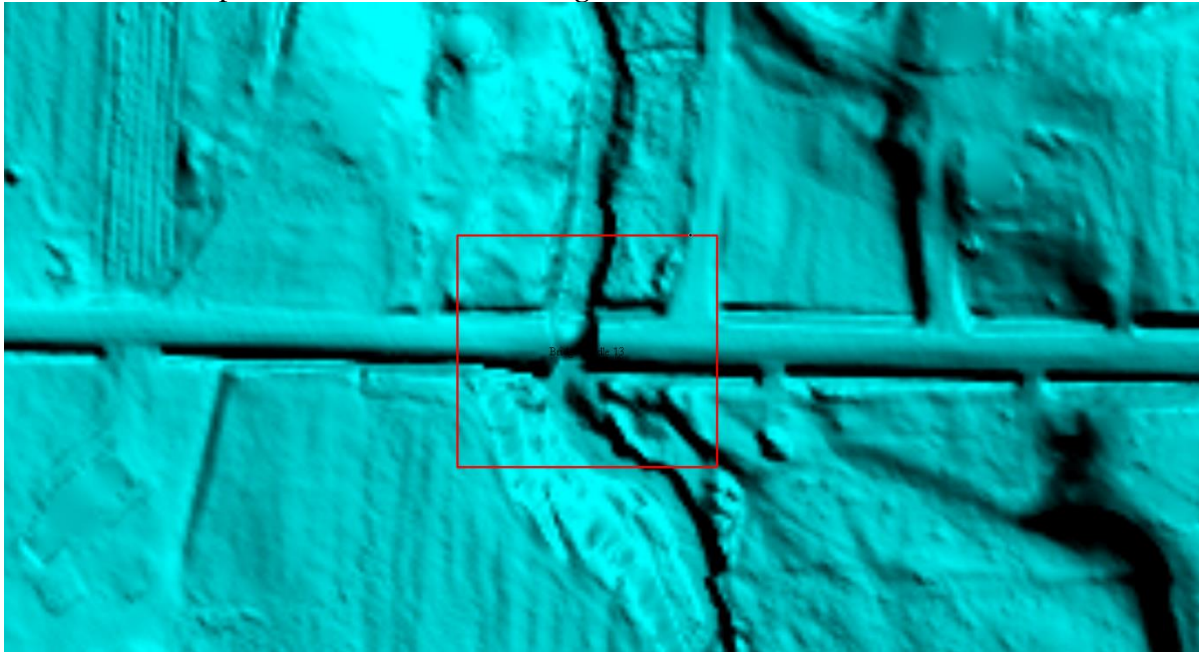
USGS marked 31 bridges that had saddles across the bridge expanse. Breaklines were added at these locations to help enforce the DEM and Contours in these areas. Delivered products and metadata were updated to reflect these changes.

Figure 5 – USGS Image of DEM with bridge saddle.

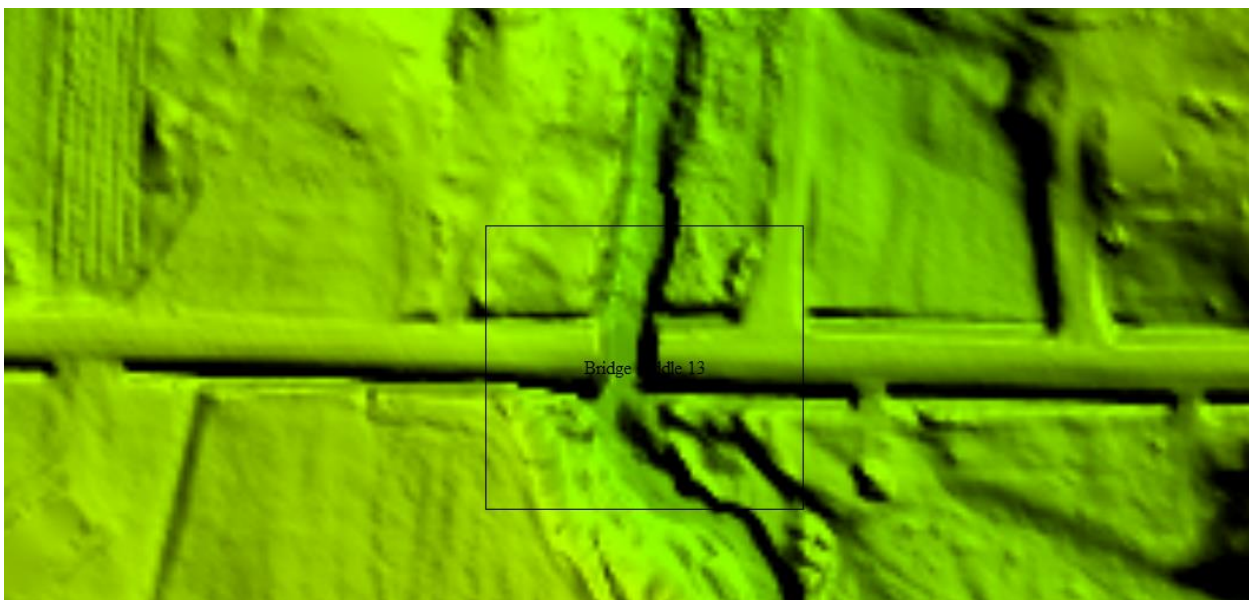
Figure 6 – Tile 17TPH490120 DEM with bridge saddle fix.

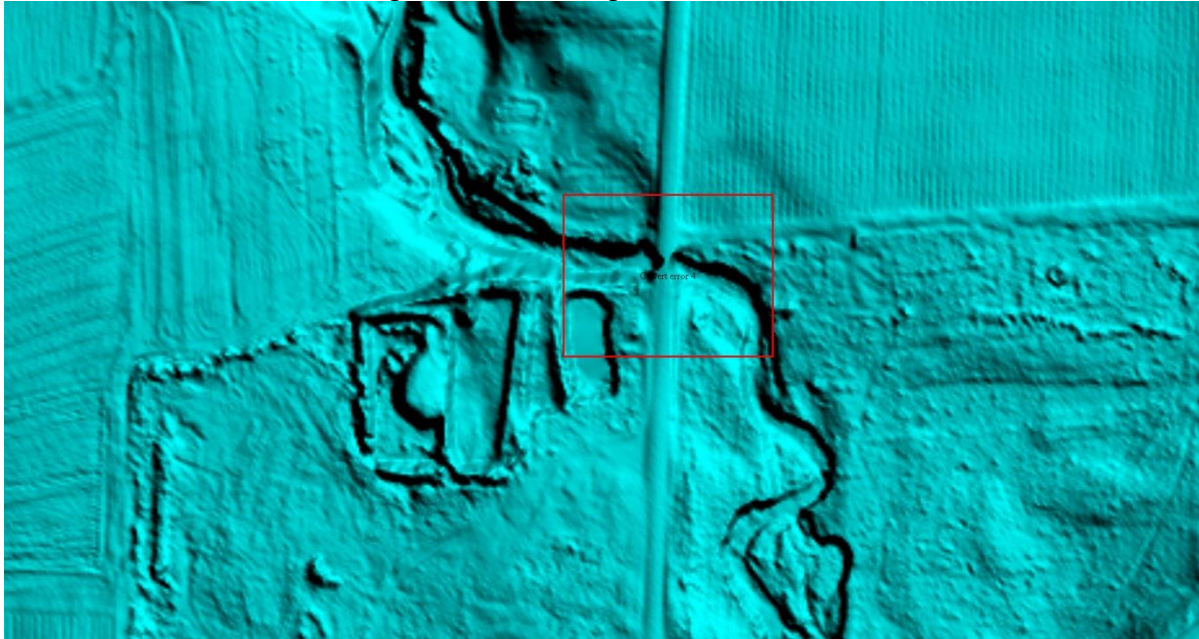
Figure 7 – USGS Screen Shot

USGS found four (4) instances where box culverts had been removed from ground. Dewberry agrees that these should be returned to the ground surface model; the LAS has been re-classified and the DEMs and contours updated. An example can be found below

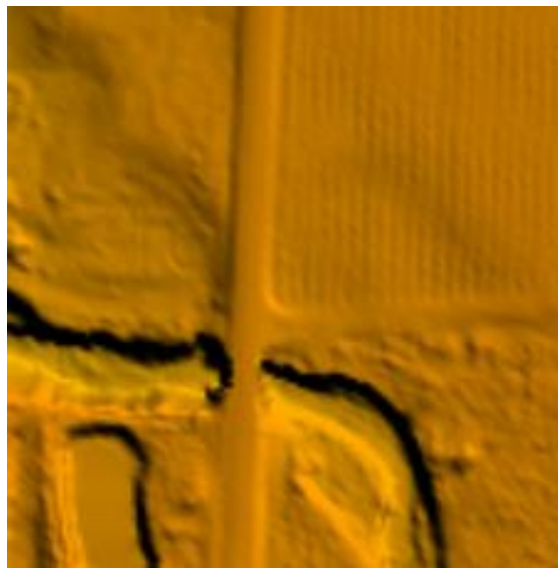
Figure 8 – DEM Tile 17TPG310000- Culvert points have been returned to ground.

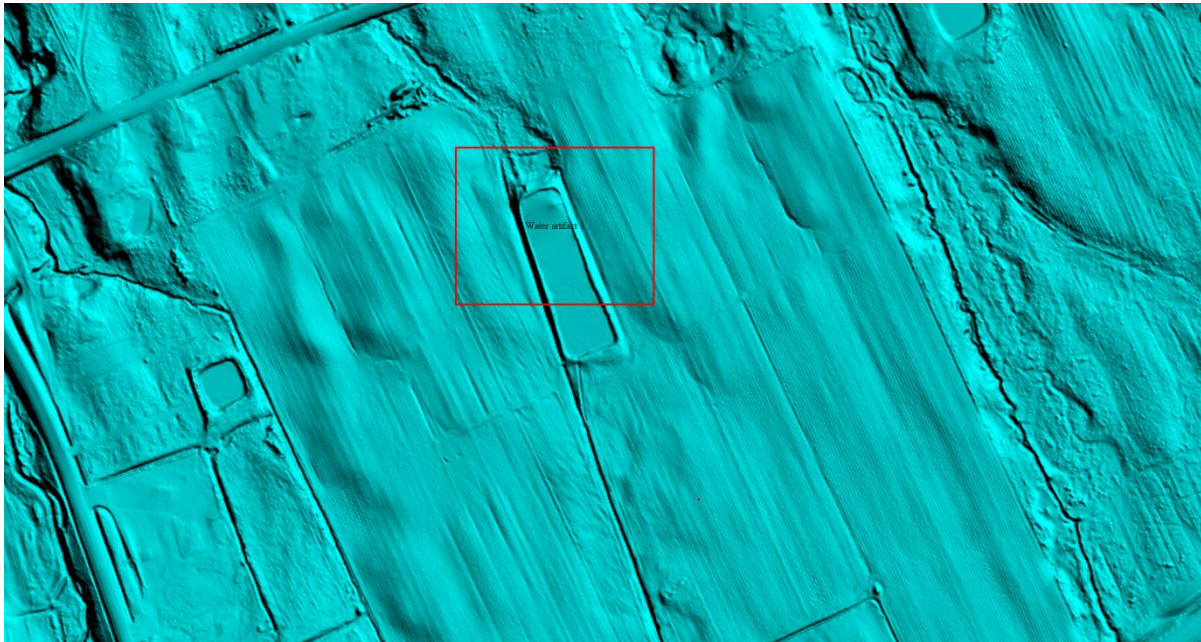
Figure 9 –USGS Screen Shot

USGS identified one (1) pond that was below the 2 acre collection criteria that had a sizeable artifact and one (1) pond over 2 acres that had an elevation discrepancy between tiles. Dewberry has corrected these artifacts. Examples are shown below.

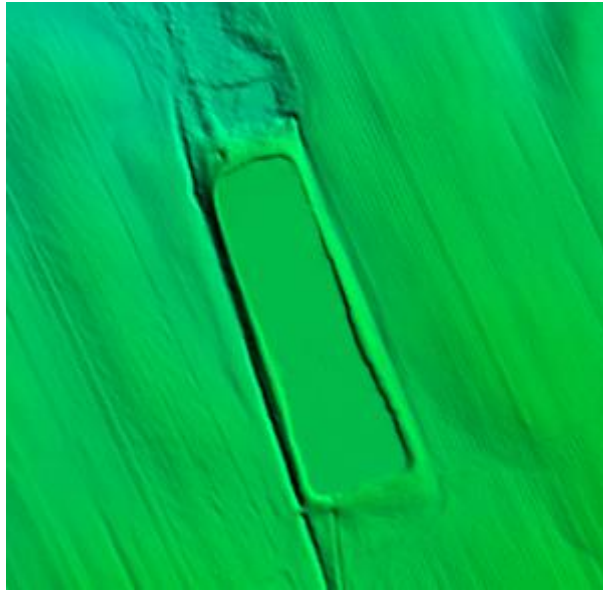
Figure 10 - Tile 17TPG085895. The artifact has been removed from the LiDAR and DEM.

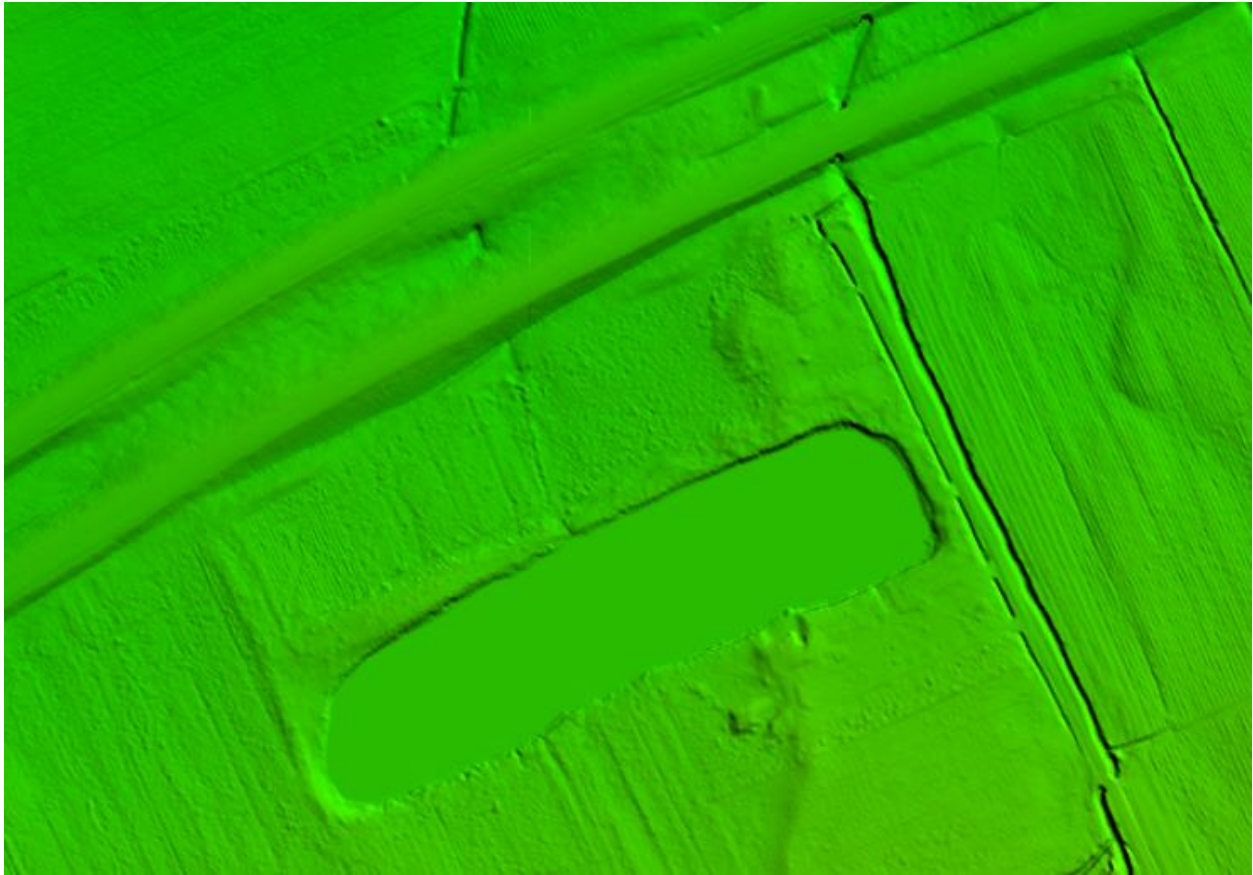
Figure 12 - Tile 17TPG100895 and 17TPG085895. The elevation change artifact between tiles has been corrected.

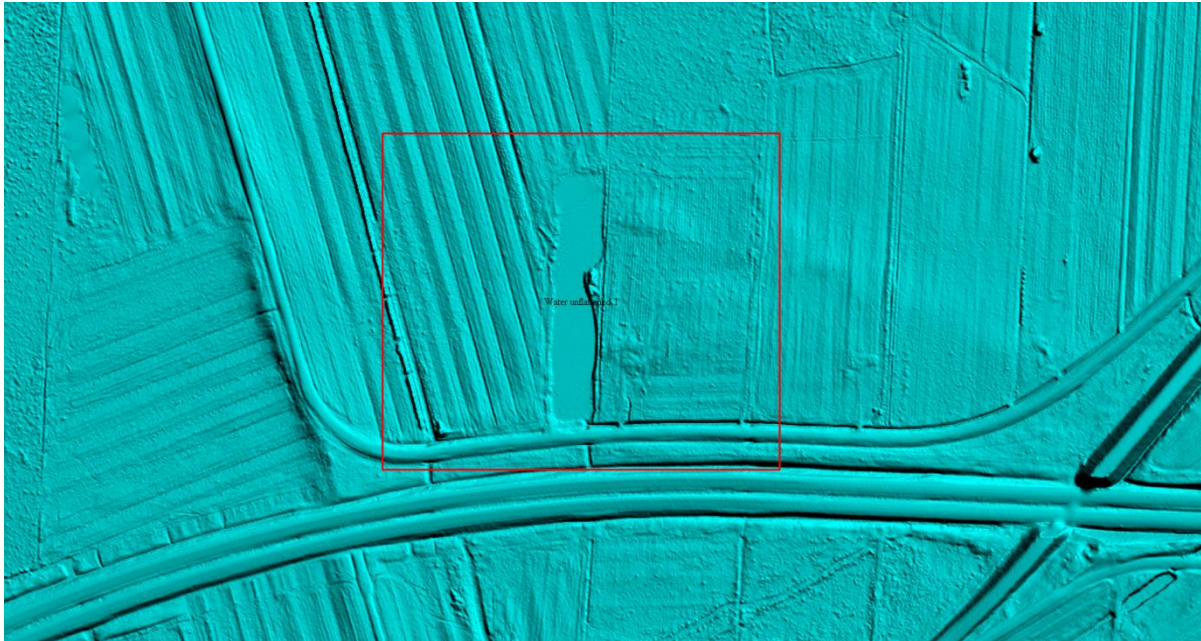
Figure 13 – USGS Screenshot.

USGS identified one (1) pond greater than 2 acres in size that had not been collected with breaklines and flattened in the DEMs. This feature has been corrected in both the breaklines and DEMs. Examples are shown below.

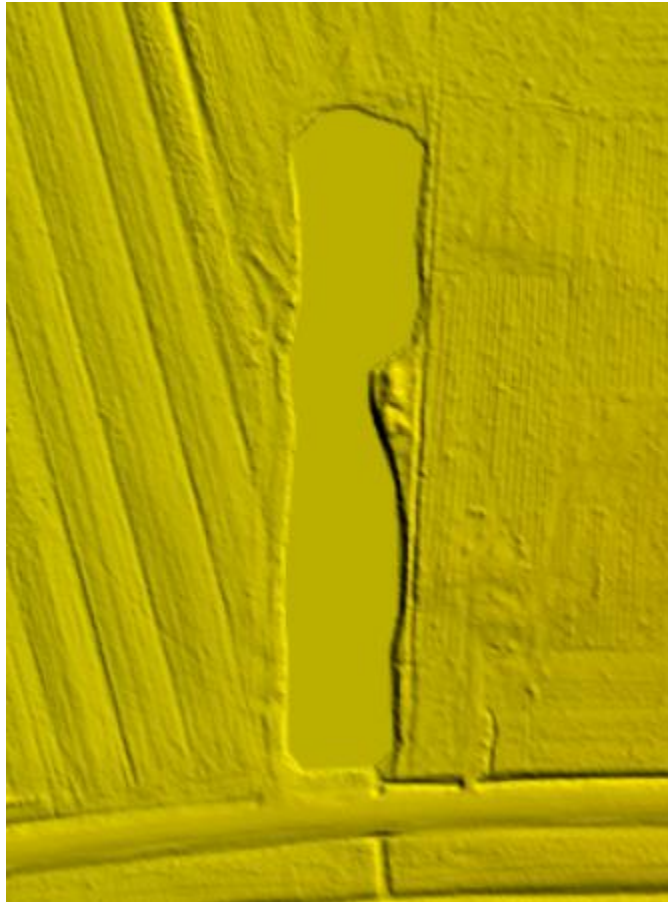
Figure 14 –Tile 17TPH550150. Breaklines have been added, the LiDAR hydro-classified and the DEM hydro flattened.

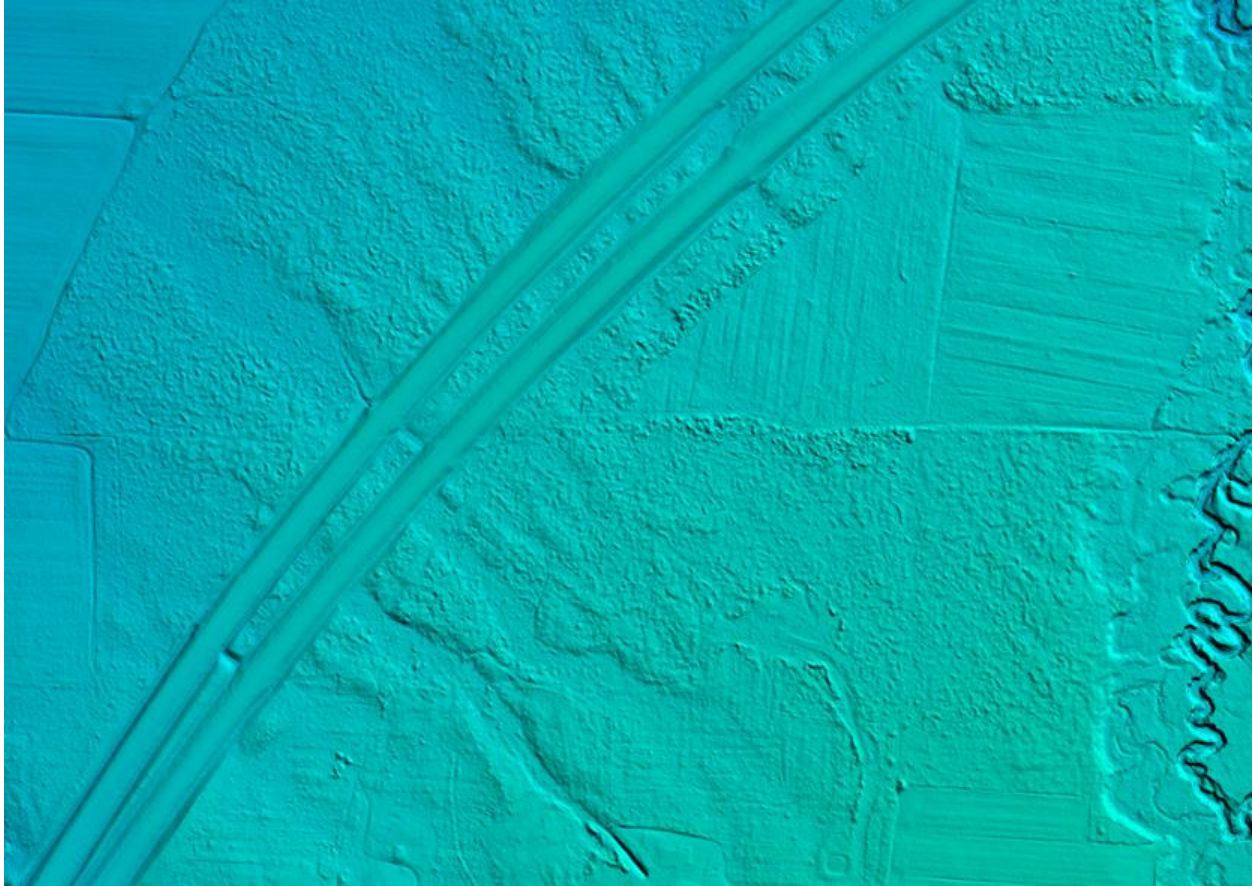
Tinning issues were not mentioned in the USGS review document but two areas were flagged in the Error Shapefile. The areas flagged with tinning occur in vegetated areas. As the profile examples below indicate, there are no additional points that can be classified to ground and all vegetation is classified to default, class 1.

Figure 15 - Tile 17TPH40090 and 17TPG40075. Screen shot of the DEM in area flagged by USGS as containing tinning.

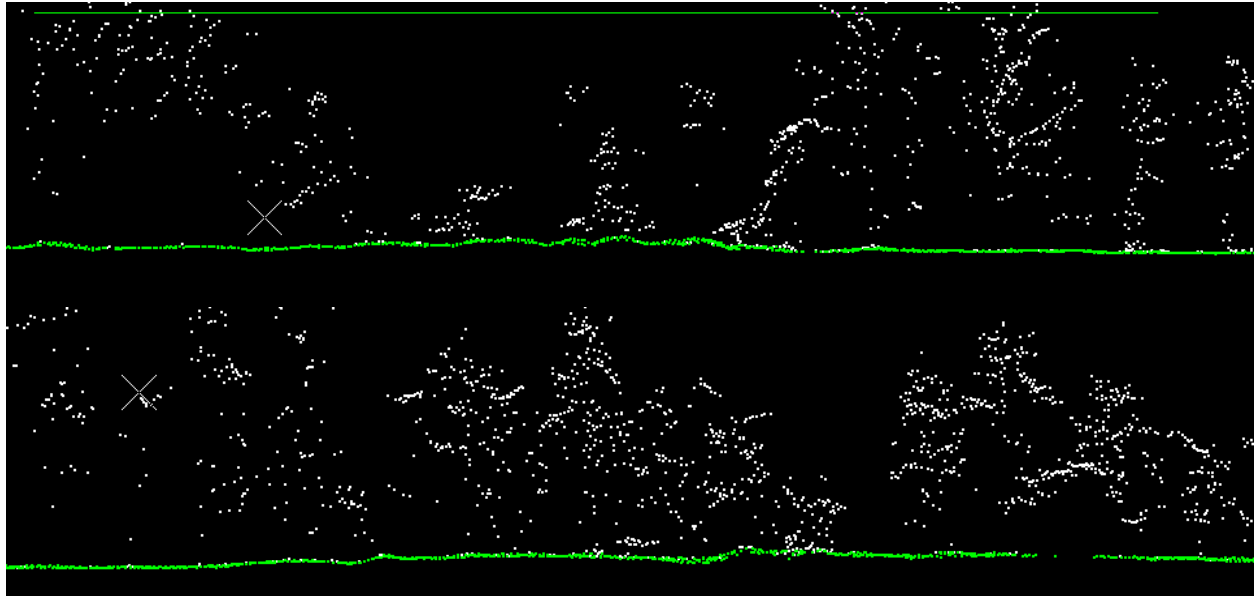
Figure 16 - Tiles 17TPH40090 and 17TPG40075; Unclassified – White, Ground- Green. The top screenshot is an example from the LiDAR tile 17TPH40090 and the bottom screenshot is an example from the LiDAR tile 17TPG40075. There are no additional points available to re-classify to the ground class and all vegetation is appropriately classified to class 1.
