Dewberry Response to USGS Review of the FL Panhandle Block 1 2018 Lidar Project

Produced for U.S. Geological Survey

USGS Contract: G16PC00020

Report Date: 12/10/2018

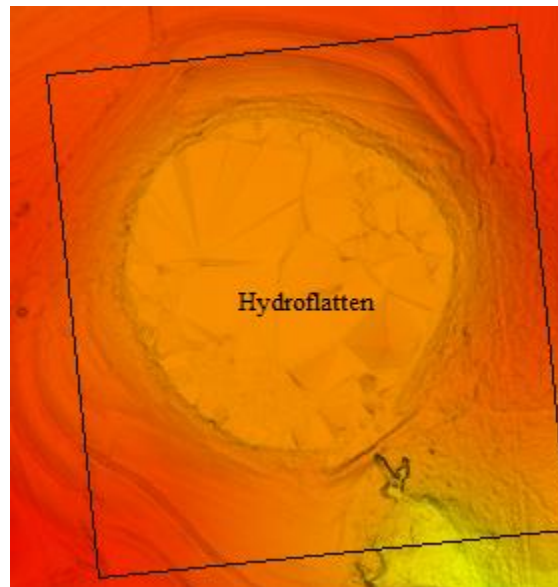
USGS made 38 calls for missing waterbodies requiring hydroflattening. Of the 38 calls, five (5) features were corrected in the LAS and hydroflattened in the final DEMs.

Figure 2 – Location of USGS call for missing waterbody.

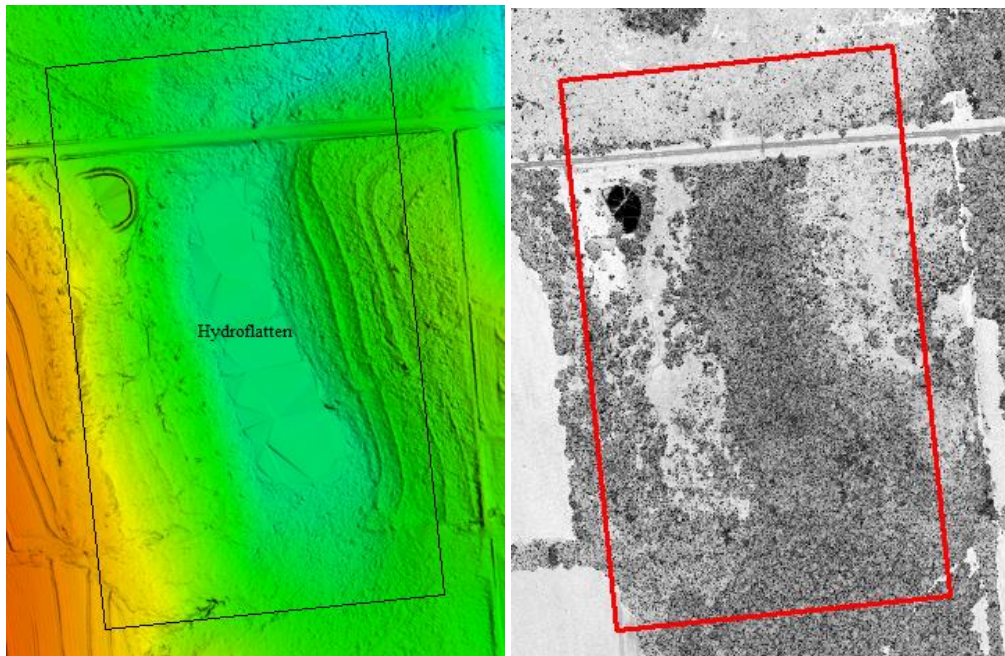
Of the 38 missing waterbody calls, 30 were investigated by Dewberry and determined to be swamps/bog features. These features did not appear wet in the corresponding intensity imagery

Figure 4 – Location of USGS call for missing waterbody (left) and corresponding intensity imagery (right). These swamps/bog features were investigated by Dewberry and determined to be dry, heavily vegetated locations.

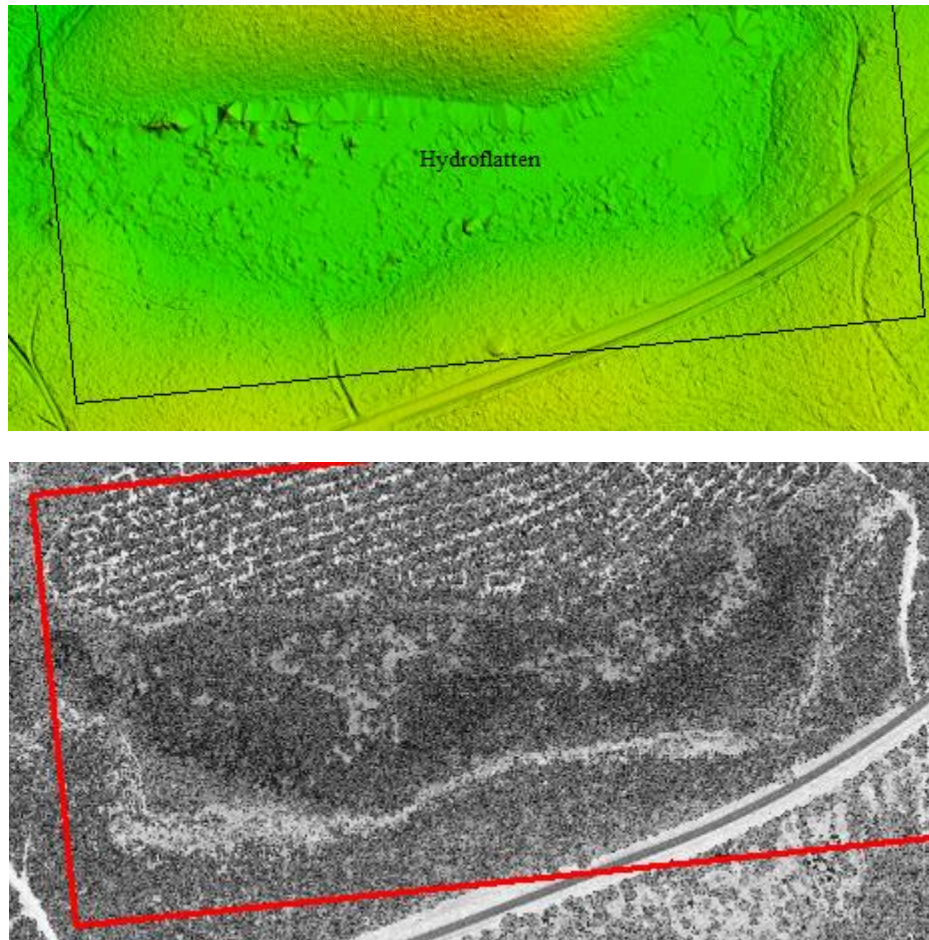
Of the 38 missing waterbody calls, three (3) were investigated by Dewberry and determined to be swamps/bog features. These features did not appear wet in the corresponding intensity imagery and remain modeled as ground. Points were not available to reclassify to ground to improve density in the lidar, so no changes were made to the original lidar and DEMs.

Figure 6 – Location of USGS call for missing waterbody (top) and corresponding intensity imagery (bottom). These swamps/bog features were investigated by Dewberry and determined to be dry, heavily vegetated locations. There were, however, no ground points available to reclassify in the lidar to increase density. No changes were made.

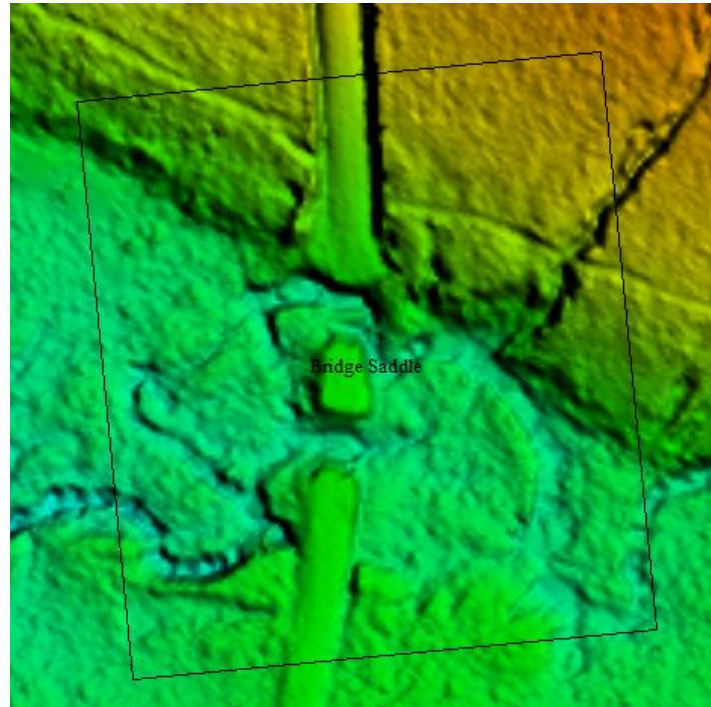
USGS made two (2) bridge saddle calls in the DEMs. Dewberry added bridge saddle breaklines for one of the two bridge saddle calls. The bridge saddles have been corrected.

Figure 7 – USGS call location for bridge saddles in the DEM.

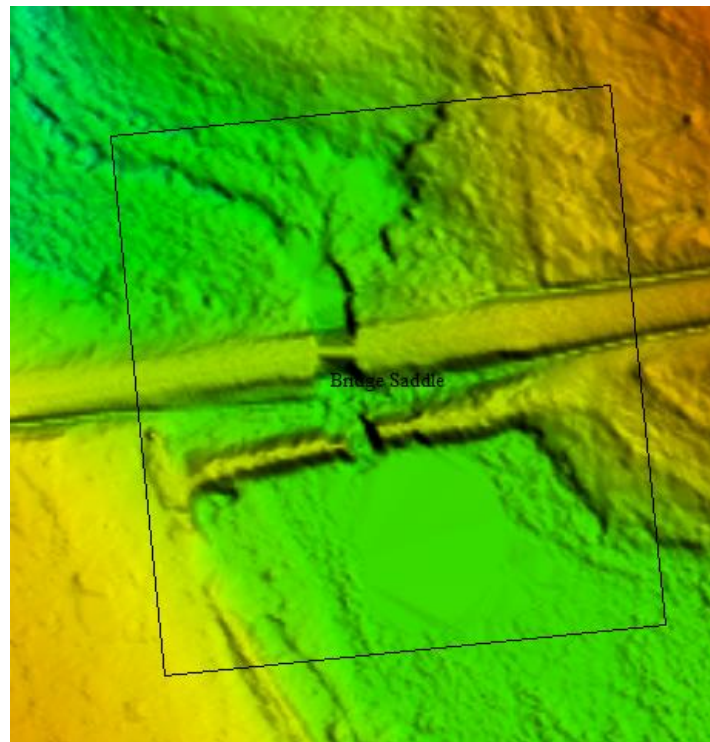
In the second bridge saddle call identified by USGS, the feature was investigated by Dewberry and determined to be a culvert. The feature was reclassified in the lidar to ground.

Figure 9 – USGS call location for bridge saddles in the DEM.

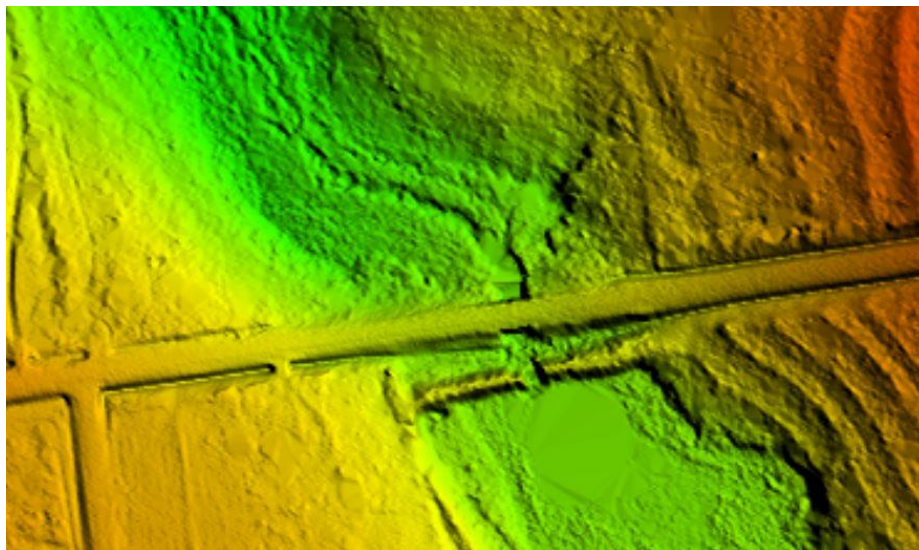
Figure 10 - The area was examined and determined to be a culvert. The bridge points were reclassified to ground to represent a culvert. Bridge saddle breaklines were not required.
