**CONTRACT: 140G0120C0007  
USGS NY HUDSON RIVER REGION LIDAR  
CORRECTION CYCLE 2 FEEDBACK**

**L3HARRIS DISPOSITION OF USGS FEEDBACK**

May 10, 2022

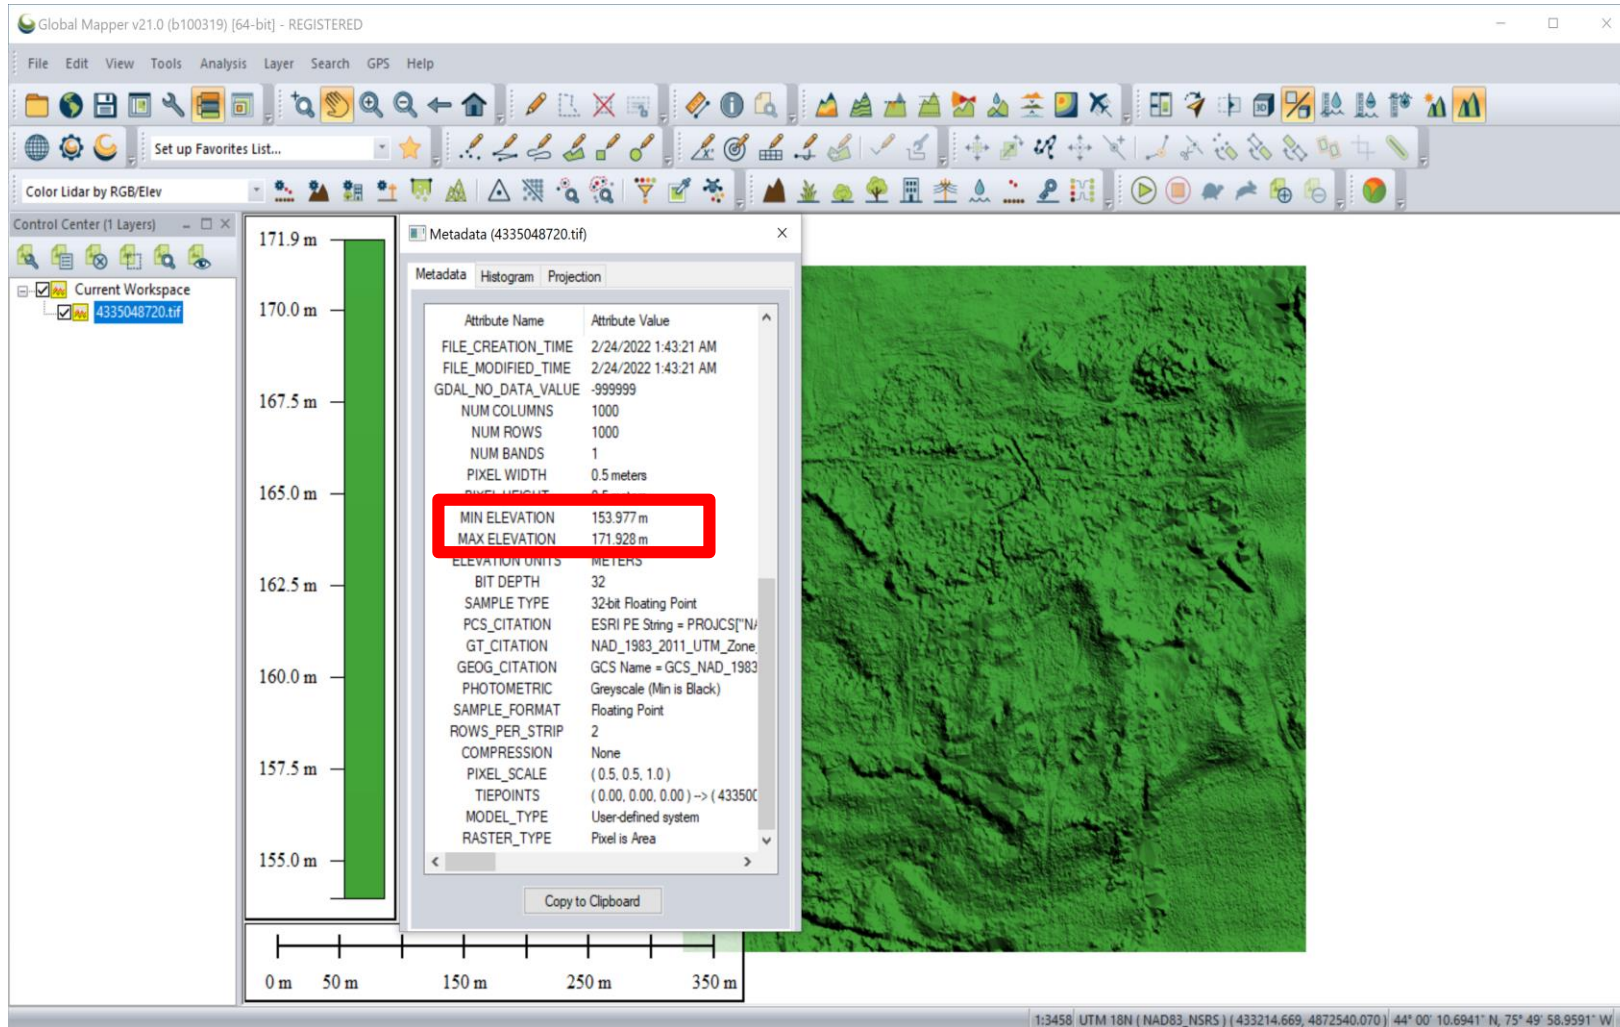
Elevation tile 4335048720.tif was flagged as having suspect values of -9999

Loaded into Global Mapper v21.0 valid heights being reported in the metadata as well as the elevation scale bar are:

- **Min Elevation: 153.977**
- **Max Elevation: 171.928**

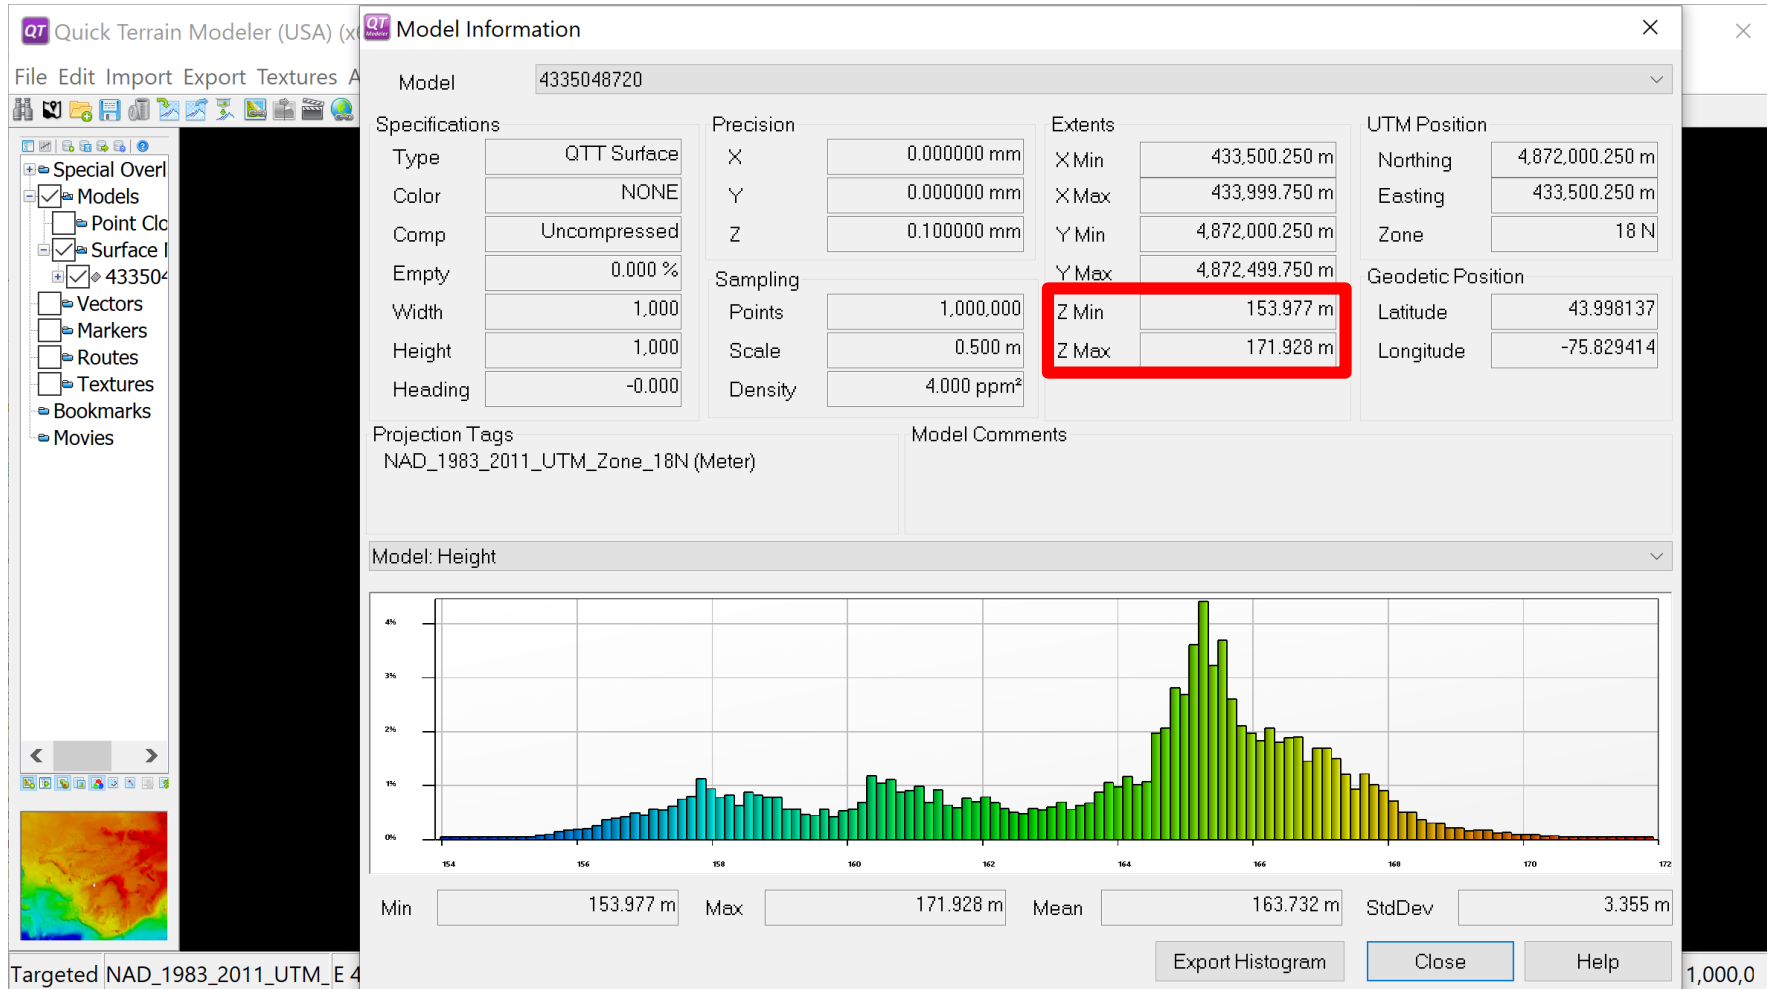
**Elevation tile 4335048720.tif was flagged as having suspect values of -9999**

Loaded into QT Modeler v8.0.7.2 valid heights being reported in the Model Information as well as the elevation scale bar are:

- **Min Elevation: 153.977**
- **Max Elevation: 171.928**

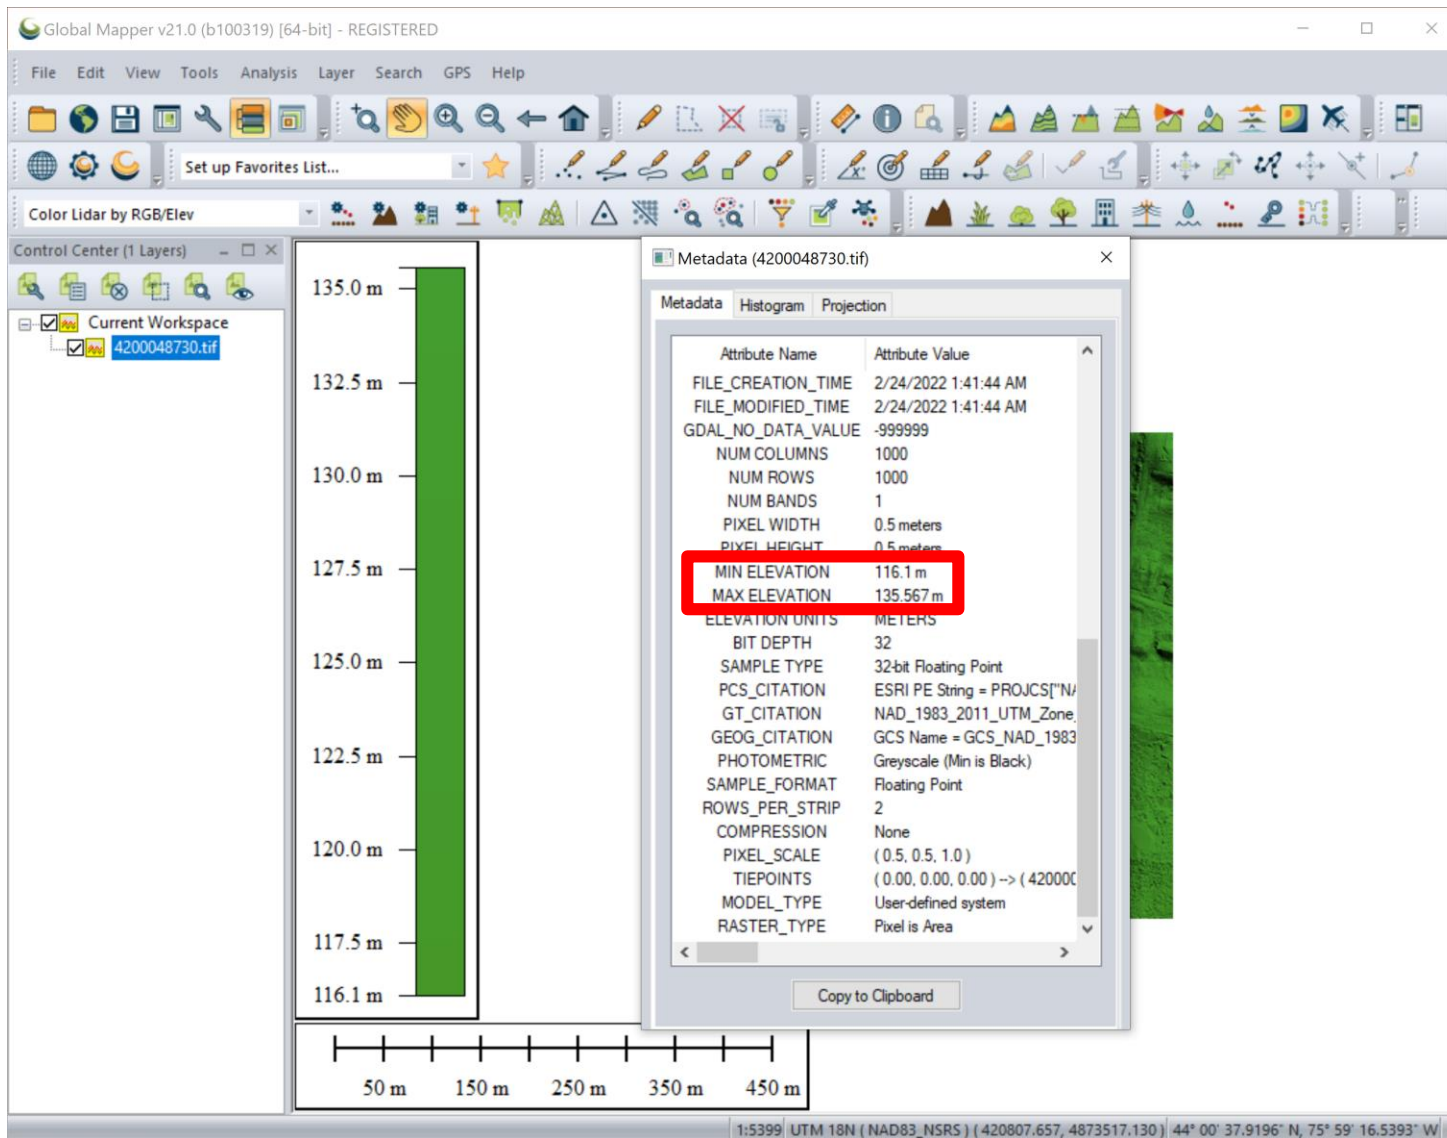
**Elevation tile 4200048730.tif was flagged as having suspect values of -9999**

Loaded into Global Mapper v21.0 valid heights being reported in the metadata as well as the elevation scale bar are:

- **Min Elevation: 116.1**
- **Max Elevation: 135.567**

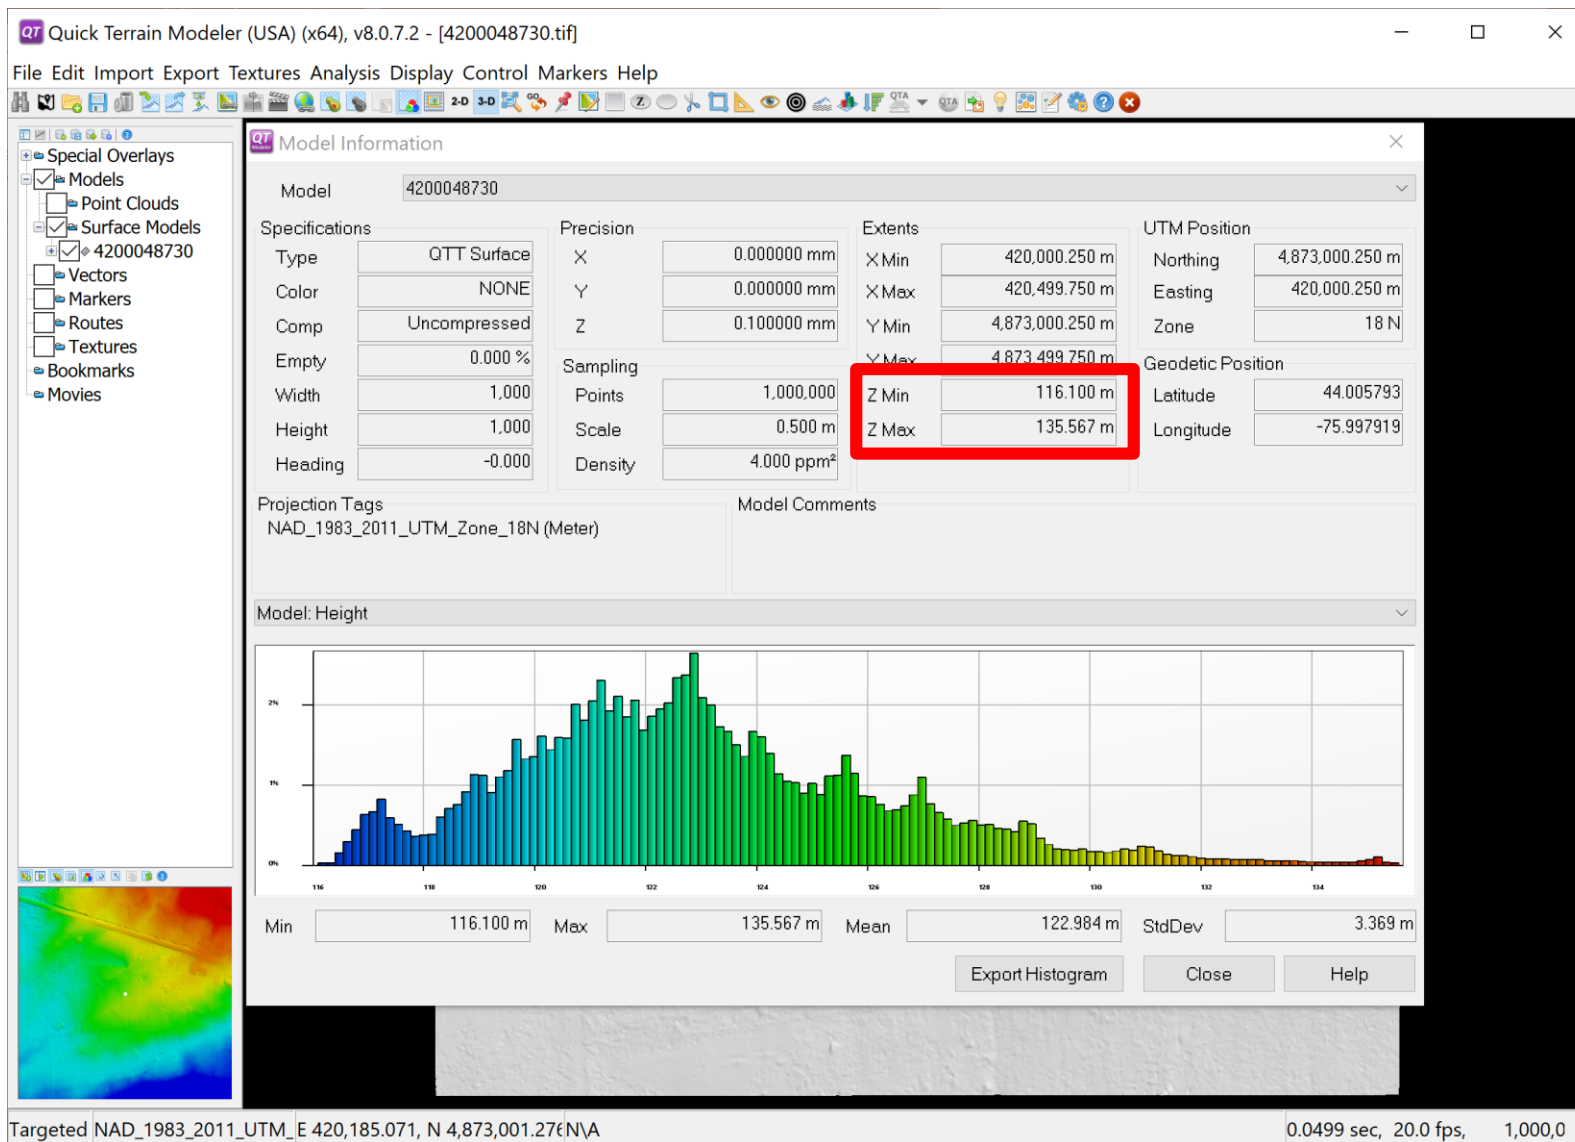
Elevation tile 4200048730.tif was flagged as having suspect values of -9999

Loaded into QT Modeler v8.0.7.2 valid heights being reported in the Model Information as well as the elevation scale bar are:

- **Min Elevation: 116.100**
- **Max Elevation: 135.567**

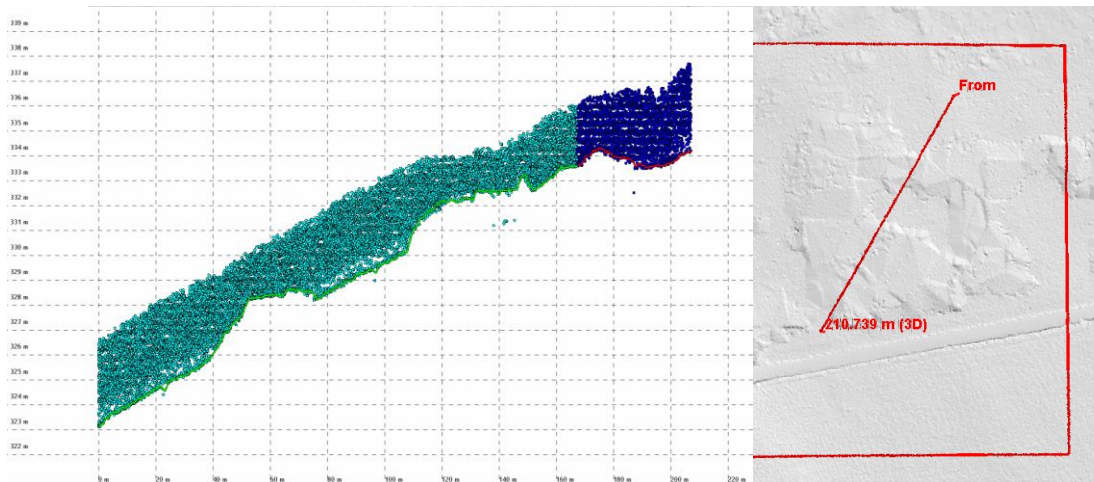
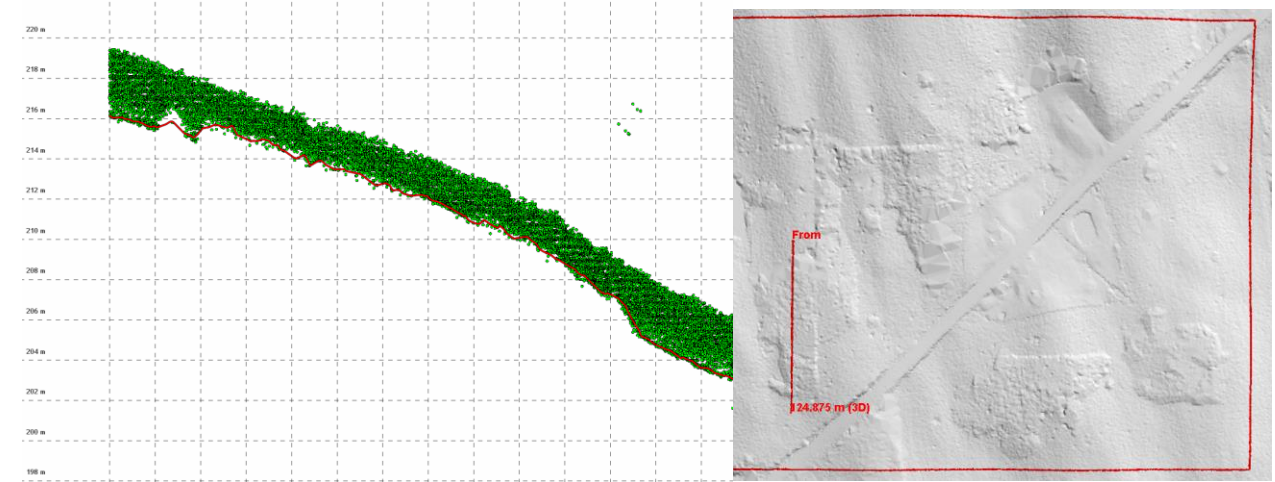
3	3190	163 - Point Mis-classification	Pointcloud	7373	Point Mis-classification	None	Issues with classification for vegetation/ground is endemic throughout the project. There are areas of tinning where ground points exist but were left unclassified, and there are areas where there aren't many ground points collected, but the vegetation was classified as ground.	Resolved	Fixed LAS & DEM

These are examples of calls with FID 1 and FID 2. These 4 areas were revisited and manually corrected

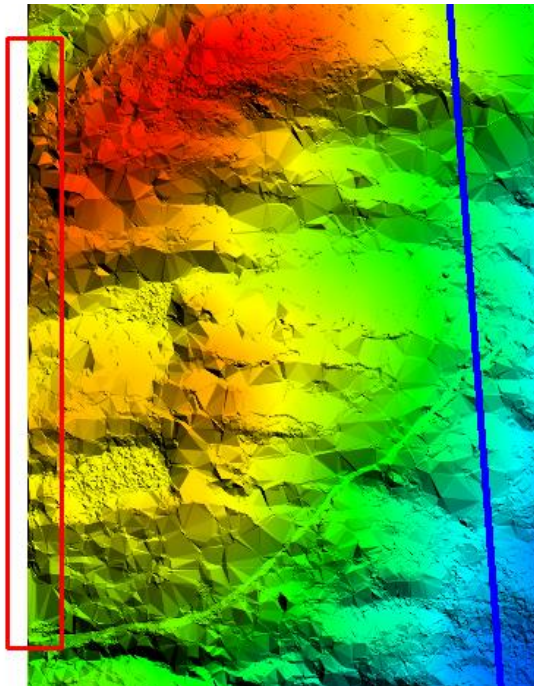
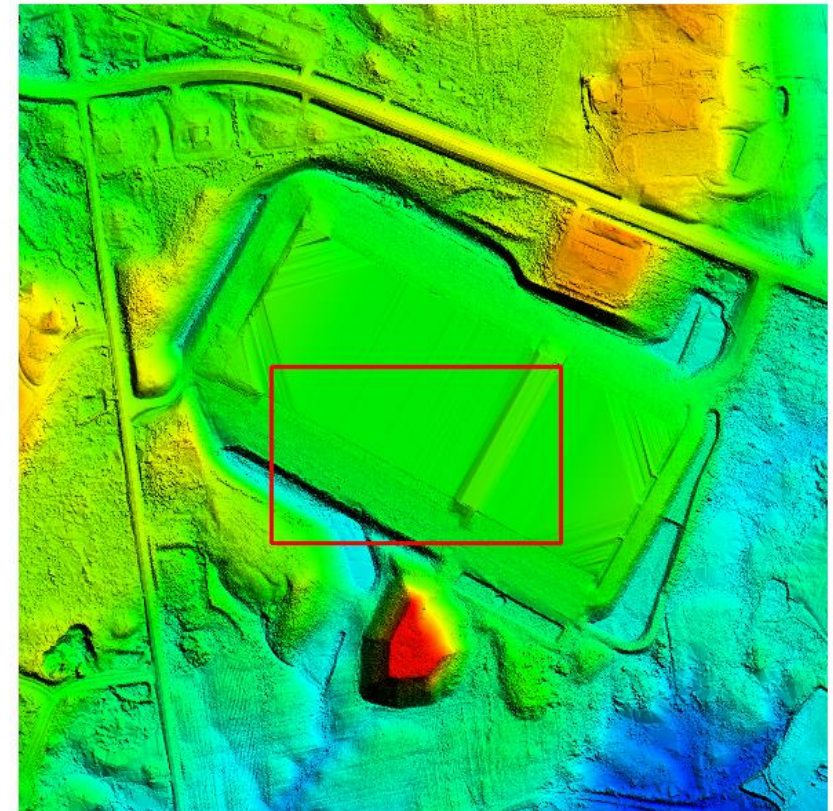
fid_	error_id	location_i	deliv_type	deliv_id	type	subtype	desc_	L3Harris Resolution	L3Harris Comments
13	3188	70 - Export, Mismatch	DEM	7374	Export	Mismatch	Artifact in DEM where two or more tile edges meet	Resolved	Fixed LAS & DEM
14	3188	76 - Export, Mismatch	DEM	7374	Export	Mismatch	Artifact in DEM where two or more tile edges meet	Resolved	Fixed LAS & DEM

FID #13 was outside the 3,174 square mile AOI, but was updated and delivered

These 2 items have been corrected and affected products will be redelivered

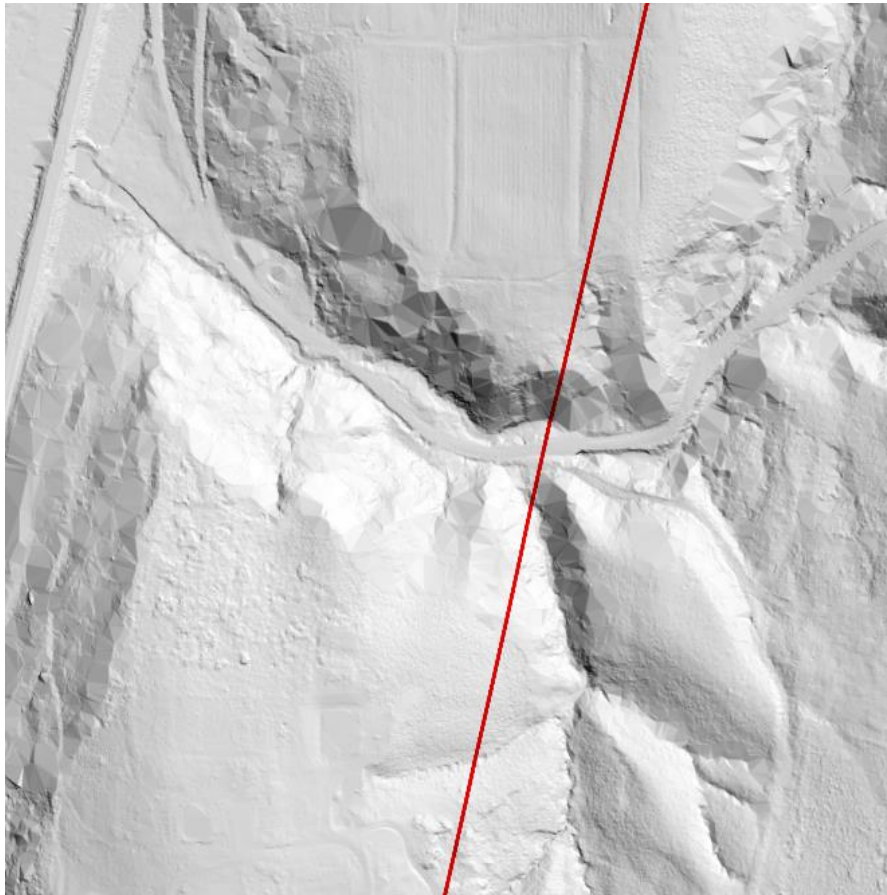
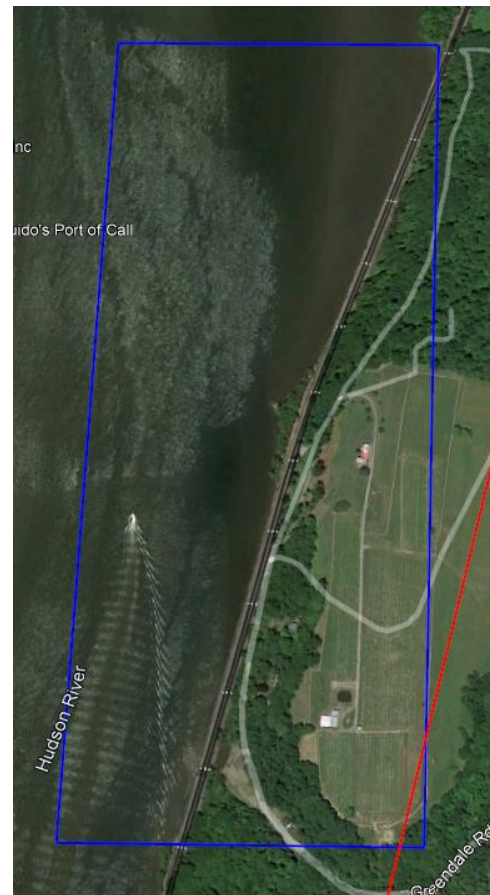
# FID 15 – Incomplete Feature Collection

The examples on this and the following chart provide details where calls were outside the contract-specific project boundary

15	4715	1 - Missing Feature, River/Stream	Breaklines	9864	Missing Feature	River/Stream	resolved	Outside of agreed upon AOI
----	------	-----------------------------------	------------	------	-----------------	--------------	----------	----------------------------

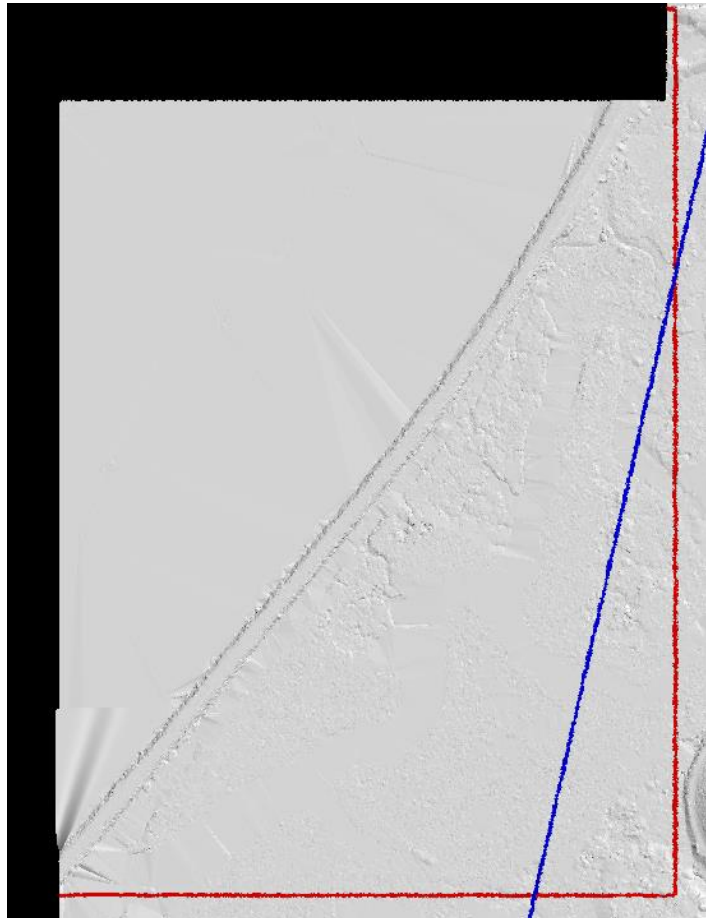
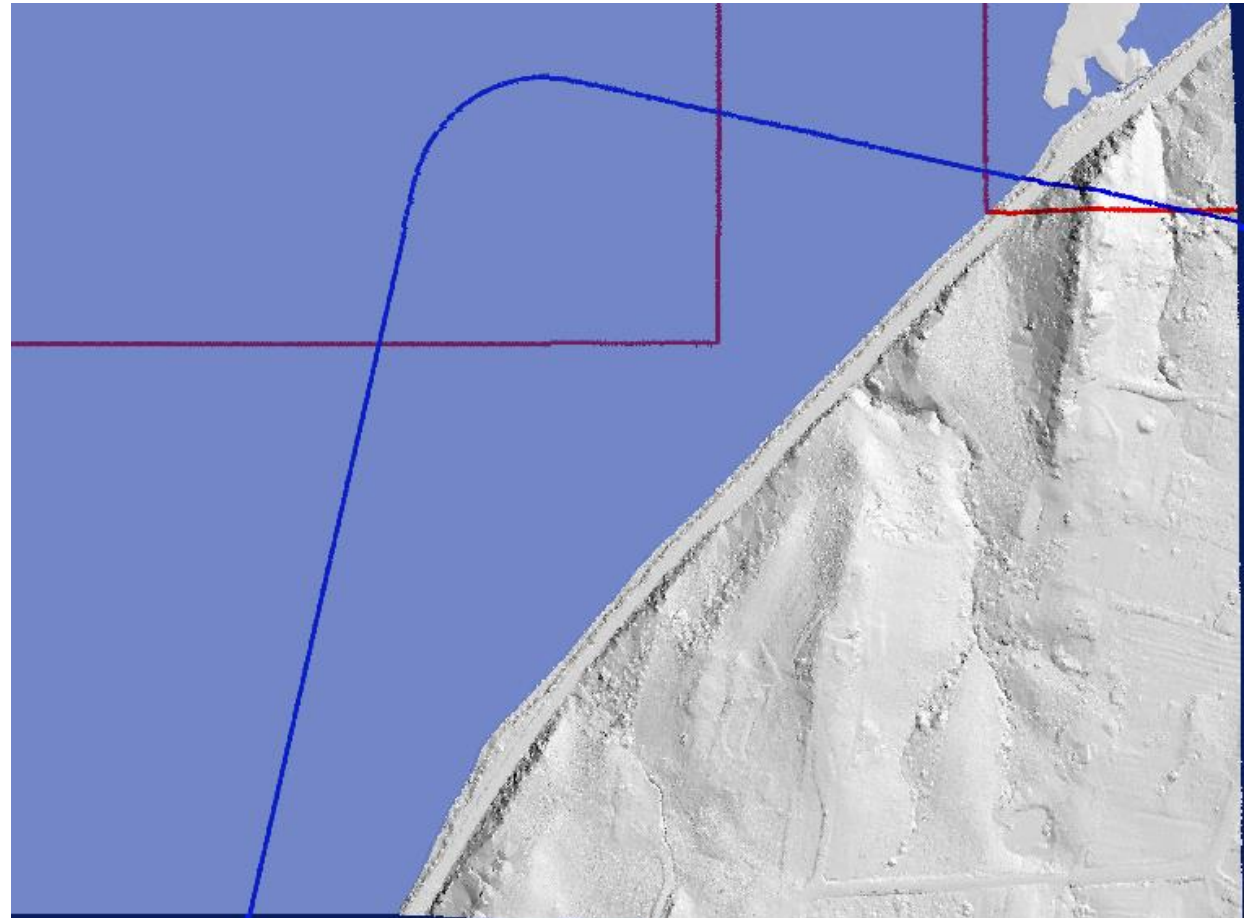
# FID 16, 18 – Incomplete Feature Collection

16	4715	2 - Missing Feature, River/Stream	Breaklines	9864	Missing Feature	River/Stream		resolved	Outside of agreed upon AOI
18	4712	3 - Geometry Error, Downstream Constraint	Breaklines	9864	Geometry Error	Downstream Constraint	Multiple downstream constraint issues were found at tile edges that have breakline polygons associated with them.	resolved	Outside of agreed upon AOI

**Blue lines outline project boundary. Red lines depict is USGS call.**
