# Dewberry Response to USGS Review of the Texas Neches Lidar Project

Produced for U.S. Geological Survey

USGS Contract: G16PC00020

Task Order: TO# G16PD00324

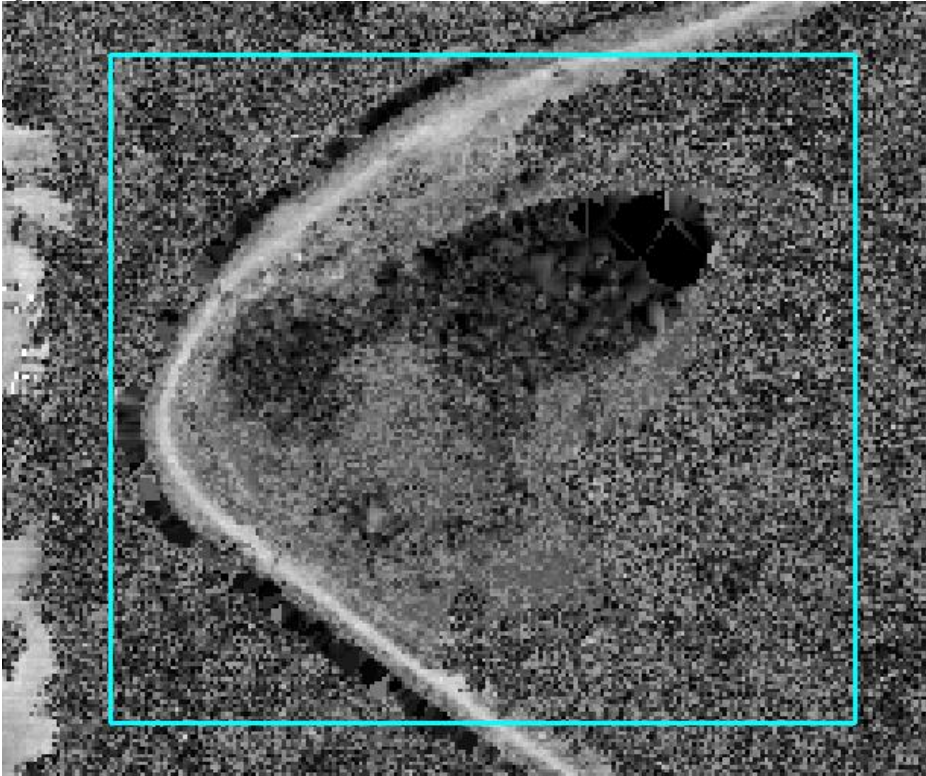
Figure 2 - Tile 15RVP4023345-- This waterbody does not meet -collection requirements as a portion of the feature is dry at the time of acquisition and the “wet” portion is less than 2 acres in size. This waterbody was not collected for consistency purposes.

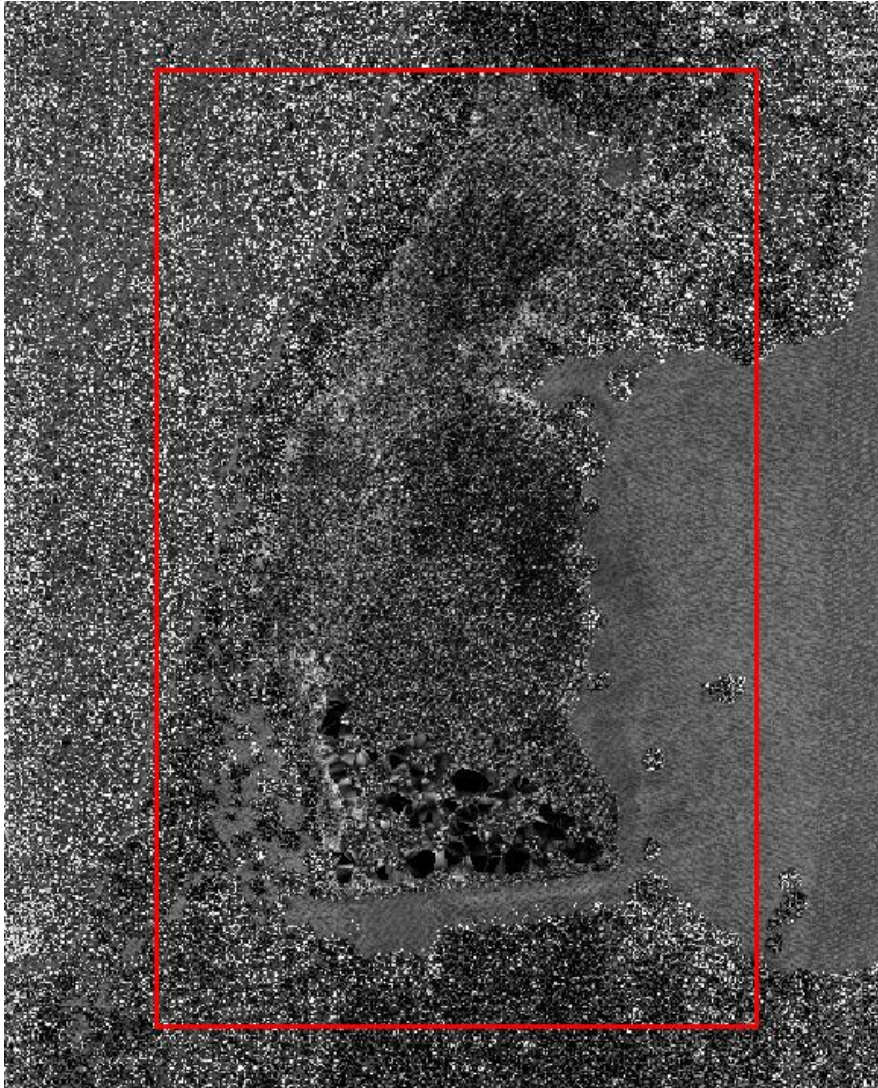
Figure 3 - Tile 15RUP3603990-- This waterbody does not meet collection requirements as it is mostly dry at the time of acquisition. This waterbody was not collected for consistency purposes

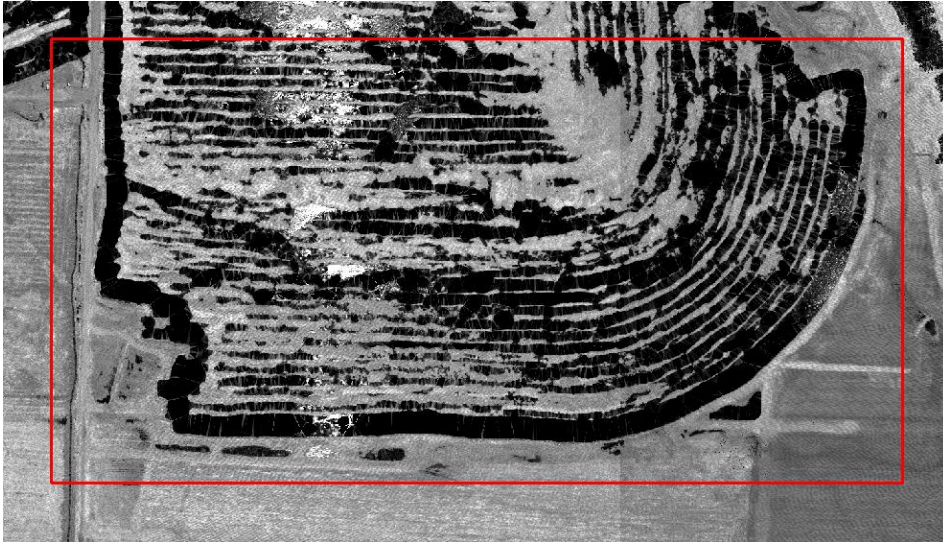
Figure 4 - 14SQA1785850 and 14SQA1775850—This feature is not a waterbody but a flooded field.  
This feature was not collected for consistency purposes.

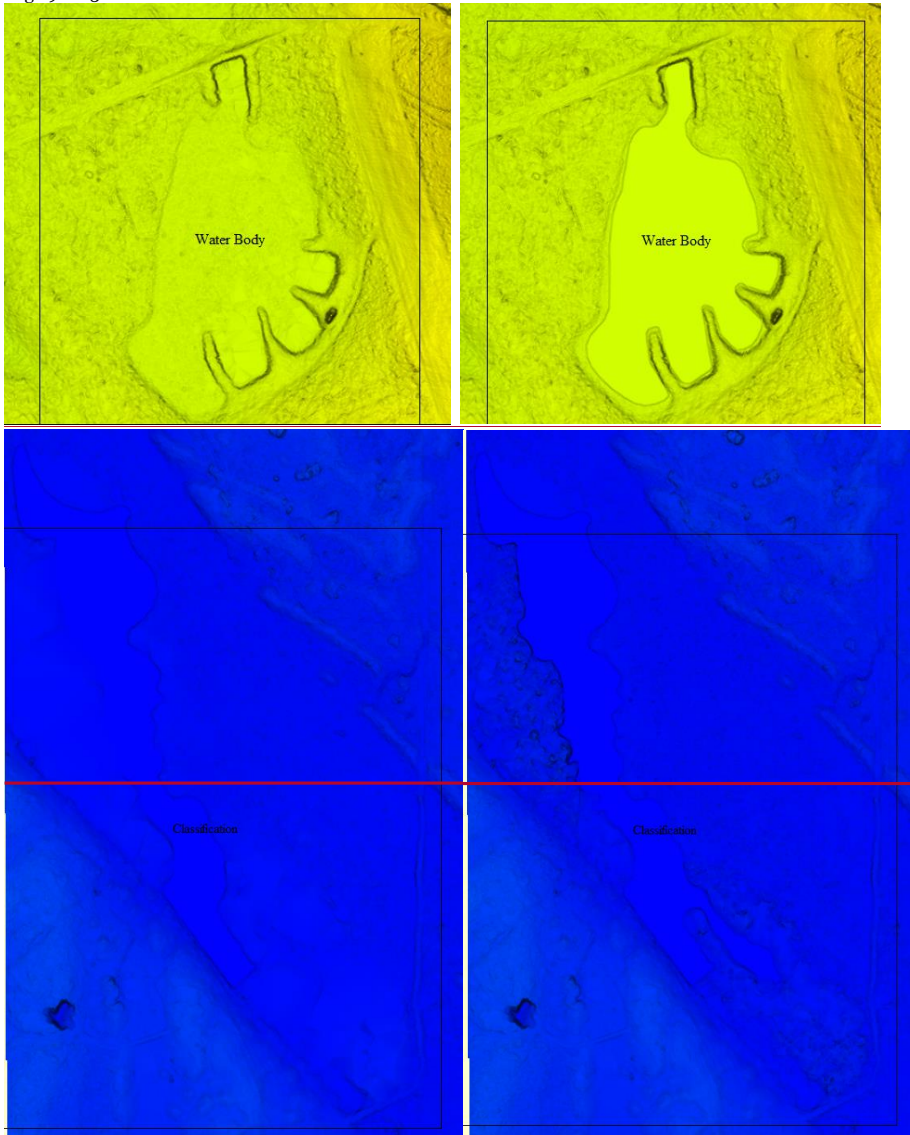
Figure 6 | ~~15RTR2385220xxx~~ Most hydro calls identifying features for hydro-flattening have been corrected. This feature is greater than 2 acres in size-breaklines have been updated, LAS hydro-classified, and the DEM hydro-flattened.

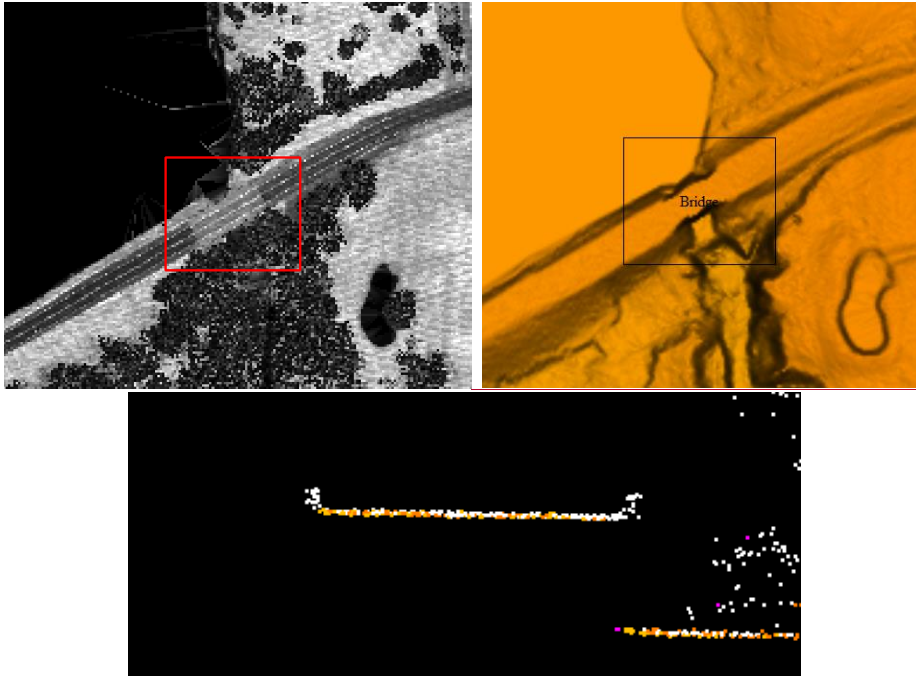
**Figure 6 - 15STR2375685—Box culvert should remain in ground class. The left image shows the box culvert in the intensity imagery. The right image shows the box culvert remaining in the bare earth DEM. The bottom image is a profile of the box culvert. Ground=orange, white=unclassified, pink=low point)**

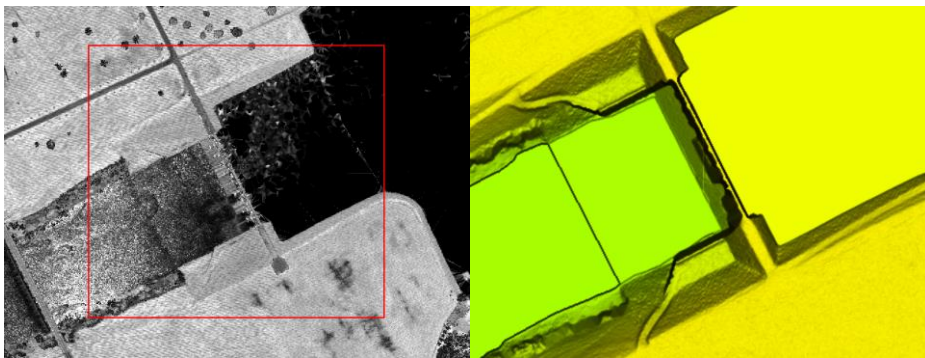
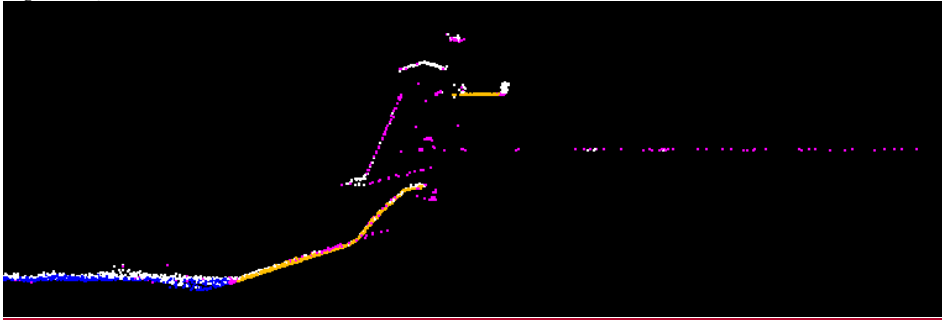
Figure 7 - 14SQA2045700 and 14SQA2025700—Dam is acting as an impoundment and should remain in ground. **The left image shows the dam in the intensity imagery. The right image shows the dam remaining in the bare earth DEM. The bottom image is a profile of the dam acting as in impoundment. Ground=orange, white=unclassified, pink=low point)**

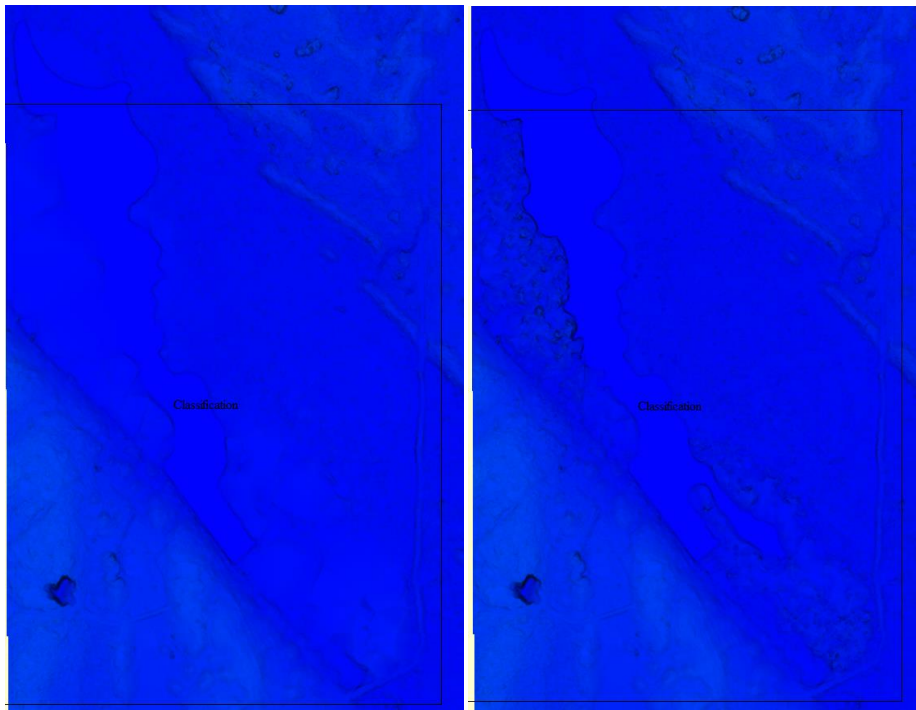
Figure 8 - 15RUP3313450 and 15RUP3303450xxx—Most of the DEM/Classified LAS calls have been corrected. In this example, **USGS made a classification call for tinning around a waterbody. Dewberry added ground points around the waterbody and adjusted the breaklines to get a more accurate representation of the bare earth surface.**

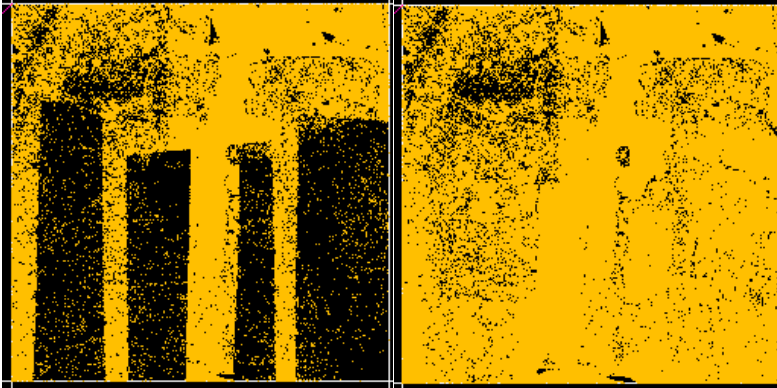
USGS made a general call about overlap points appearing to be incorrectly set. Dewberry has corrected this issue.

Figure 9-Image on left shows overlap points incorrectly set, which is causing voids in the ground classification when overlap points are turned off. Image on the right shows overlap points are correctly set and there are no longer ground voids when overlap points are turned off.
