Dewberry Response to USGS Review of the TX Red River Atascosa Lidar Project

Produced for U.S. Geological Survey

USGS Contract: G16PC00020

Task Order: G17PD00014

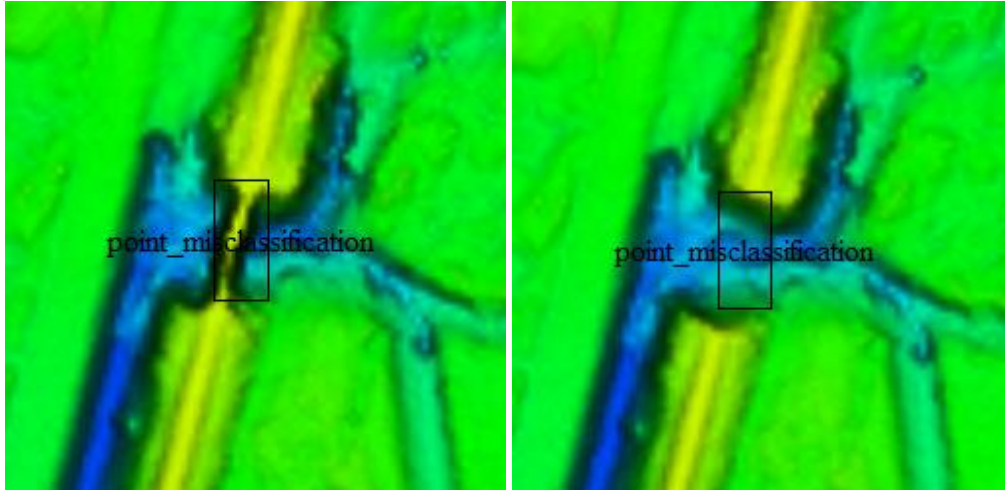
USGS identified four (4) bridges as being left in the ground model. Dewberry has reclassified the bridges to Class 17 Bridge Deck Class.

Figure 2-Tile 14RMS905965. The image on the left is an overview of the DEM where USGS made a bridge call. The image on the right is an overview of the DEM after Dewberry reclassified the bridge from ground to bridge deck.

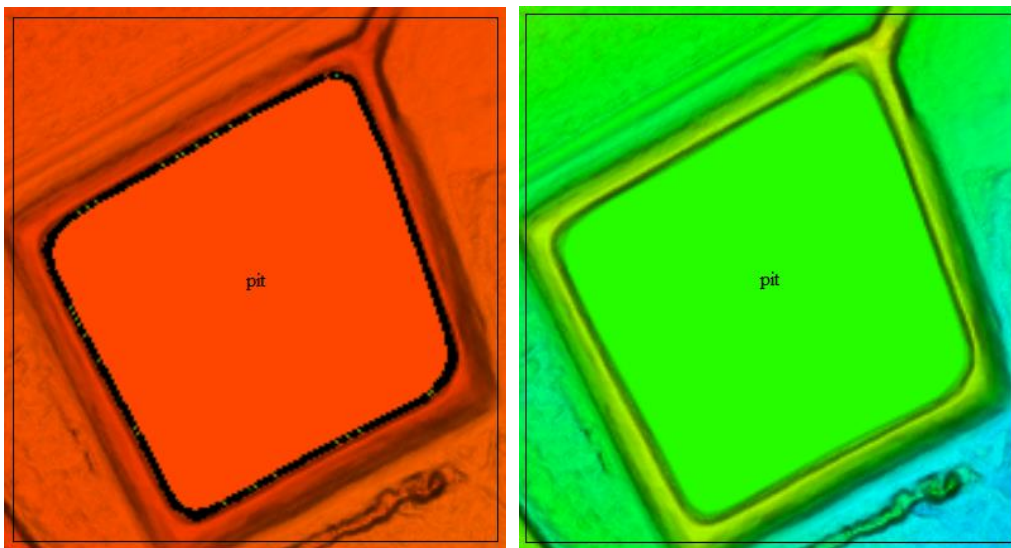
USGS made three (3) hydro calls where there was an erroneous change in elevation between the waterbody and ground. Dewberry adjusted the DEM to better represent the terrain.

Figure 3- Tile 14RNS475770. The image on the left is an overview of the DEM where USGS made a call where there was an erroneous change in elevation between the waterbody and ground. The image on the right is an overview of the DEM after Dewberry adjusted the DEM to better represent the terrain.

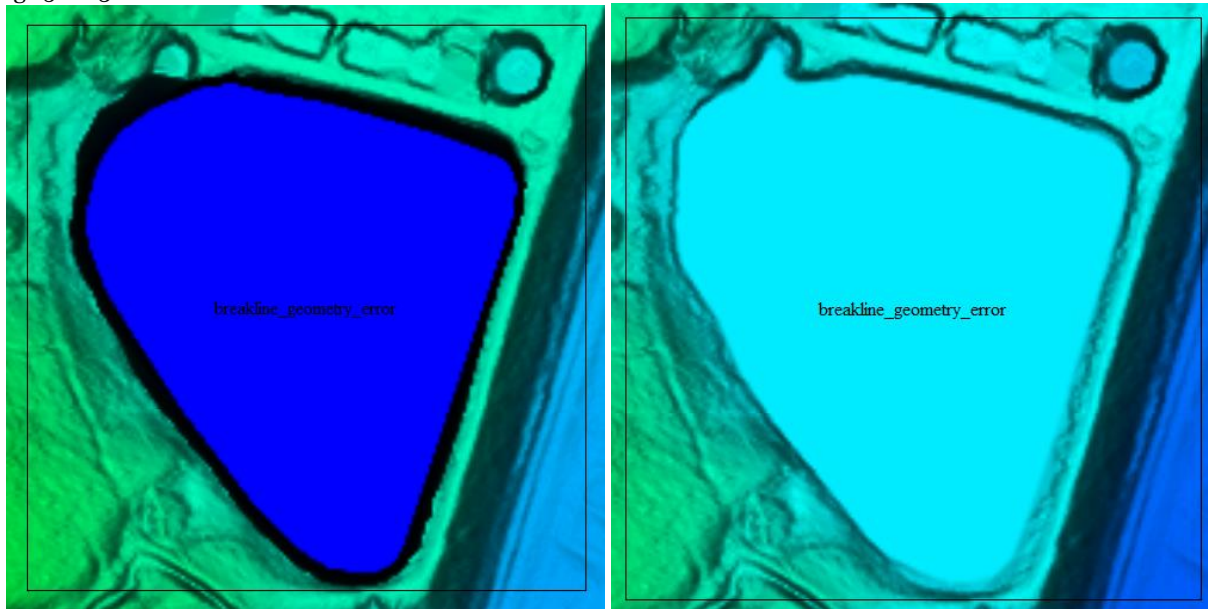
There is one (1) location where Dewberry flattened a hydrographic feature excessively. USGS identified this feature and asked that it be raised so as to more accurately portray the water surface. Dewberry agrees and it has been corrected. An example is shown below.

Figure 4- Tiles 14RNT100445 and 14RNT100460. The pond on the left was identified by USGS as an excessively digging hydrographic feature that needs to be raised to better portray the actual elevation of the water. The LAS and DEM have been corrected by changing the breakline elevations, shown on the right.

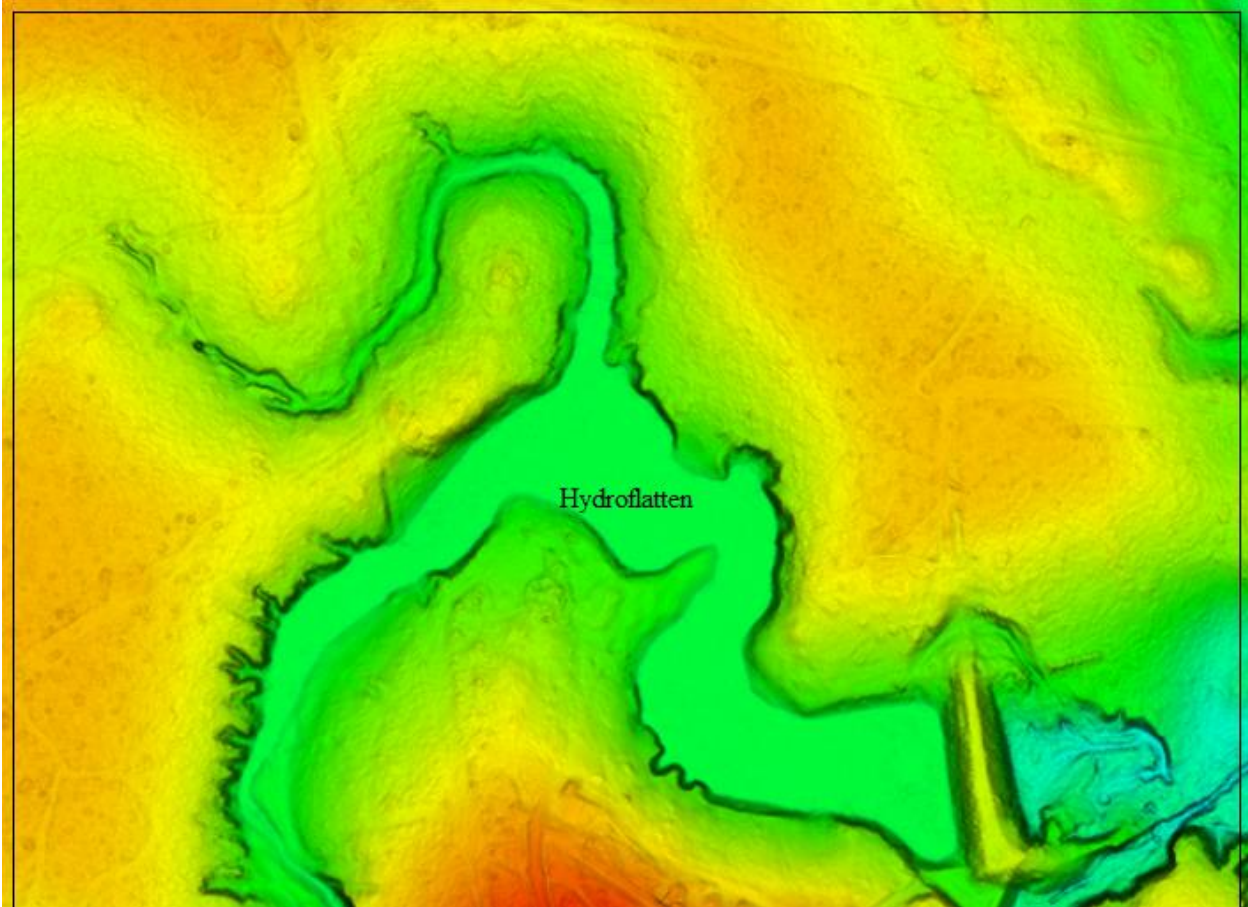
USGS identified five (5) hydro-flattening errors. The edit calls were reviewed and the breaklines, LAS, and DEMs were corrected. An example is shown below.

Figure 5- Tile 14RPS360410. The pond in the center of the image was identified by USGS as needing to be hydroflattened. The LAS, breaklines, and DEM have been corrected, shown below.

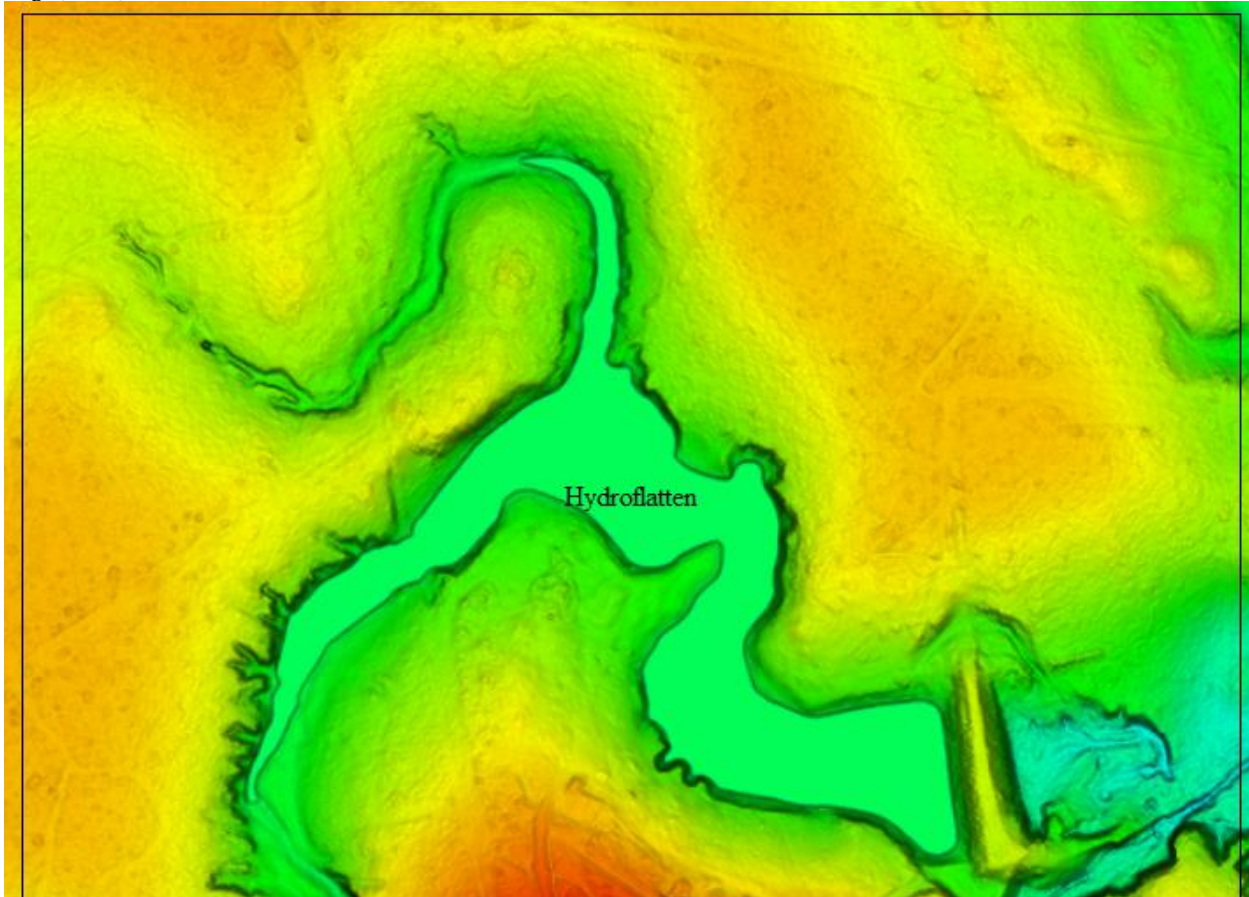
Figure 6- Tile 14RPS360410. The breaklines have been corrected to include the waterbody; the LAS and DEM were updated accordingly.

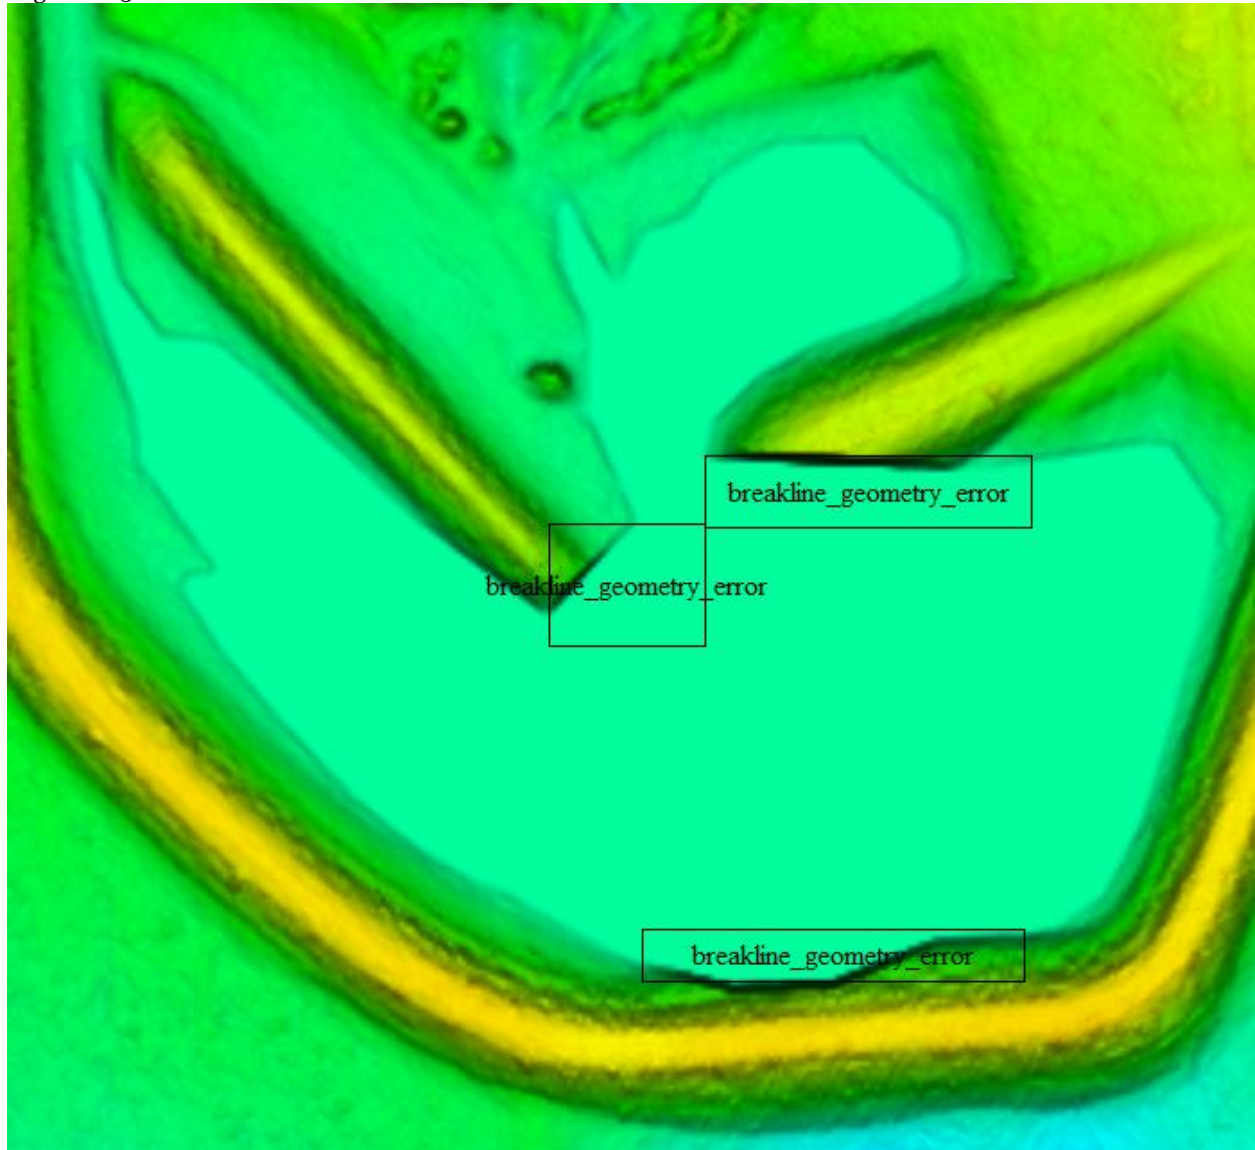
USGS identified five (5) issues where waterbodies did not accurately represent the terrain. The edit calls were reviewed and the breaklines, LAS, and DEMs were corrected. An example is shown below.

Figure 7- Tile 14RNS385875. The waterbodies in the center of the image were identified by USGS as not accurately representing the terrain. The LAS, breaklines, and DEM have been corrected, shown below.

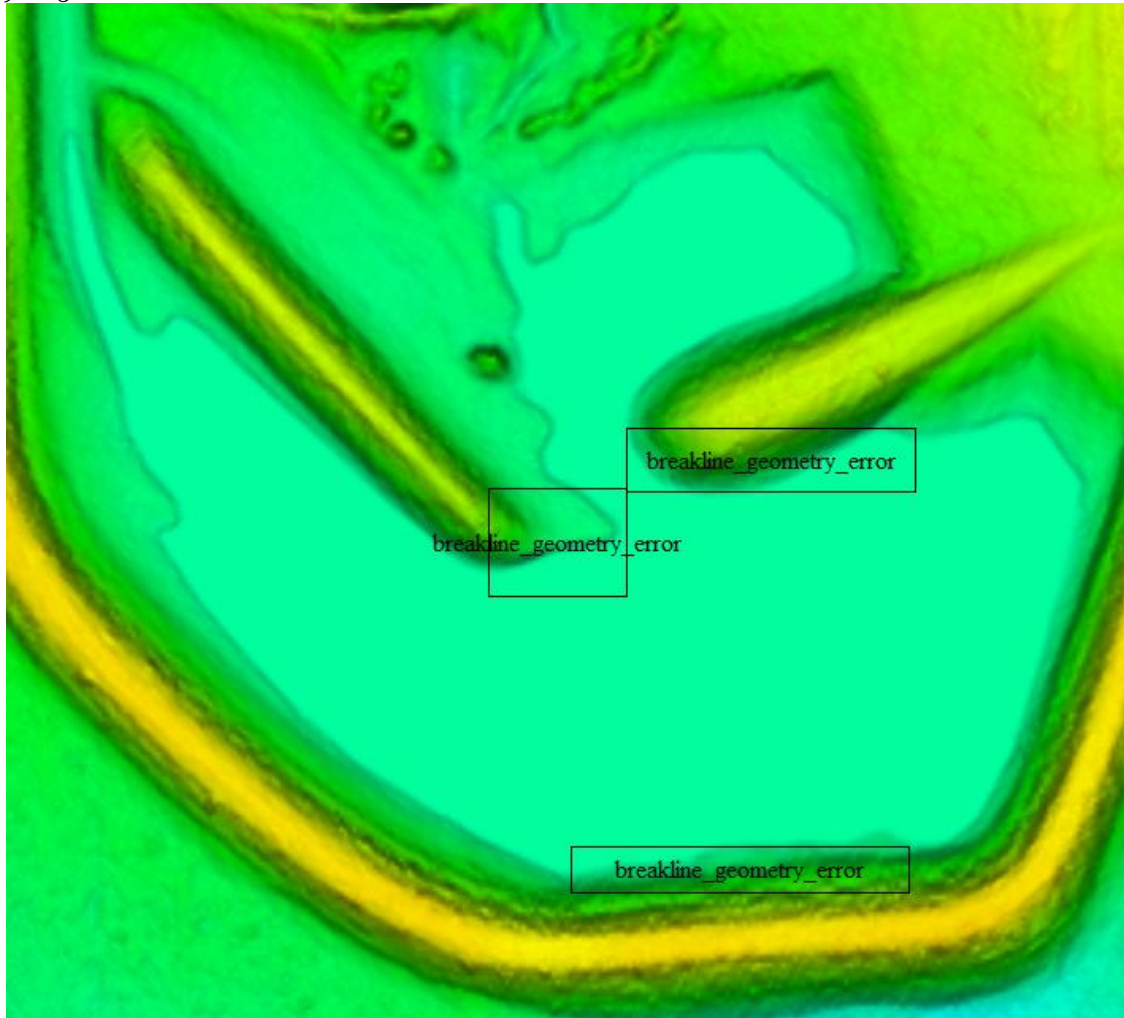
Figure 8- Tile 14RNS385875. The breaklines have been corrected to accurately represent the terrain; the LAS and DEM were updated accordingly.

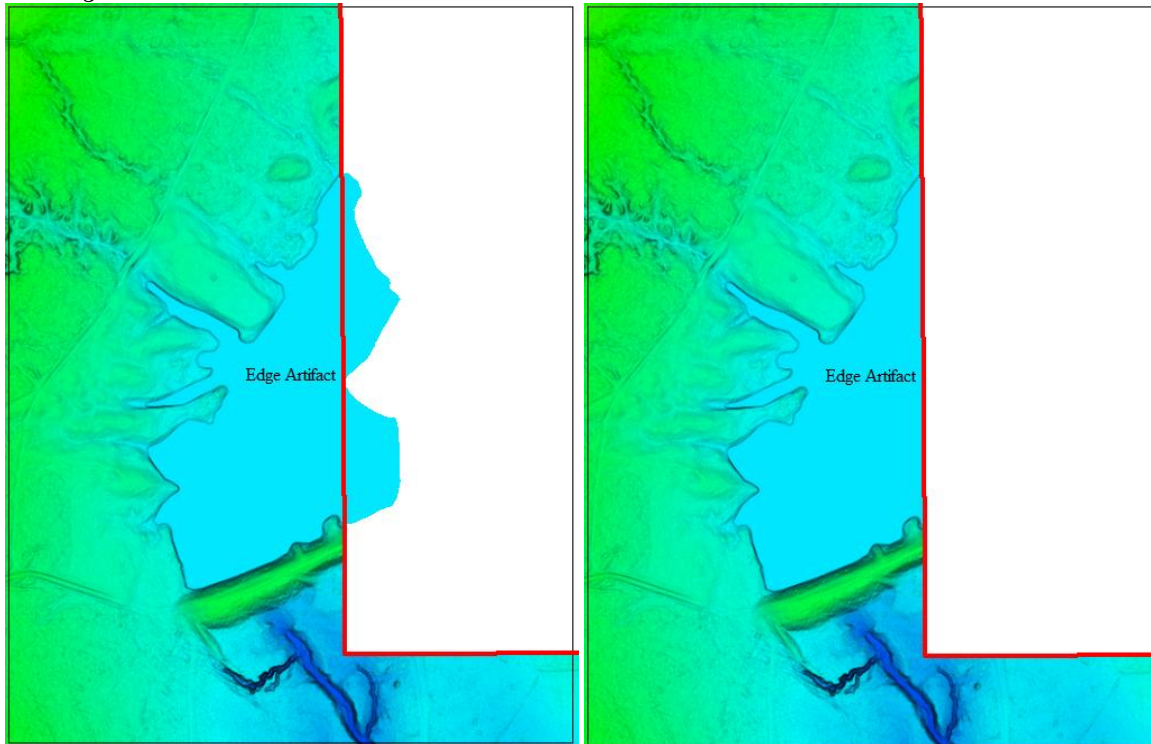
USGS made two (2) calls of areas that were not clipped to the project boundary. The edit calls were reviewed and the DEMs were corrected. An example is shown below.

Figure 9- Tile 14RNS910800. The image on the left was identified by USGS as not being clipped to the project boundary. The DEM has been clipped to the project boundary, as shown in the image on the right.

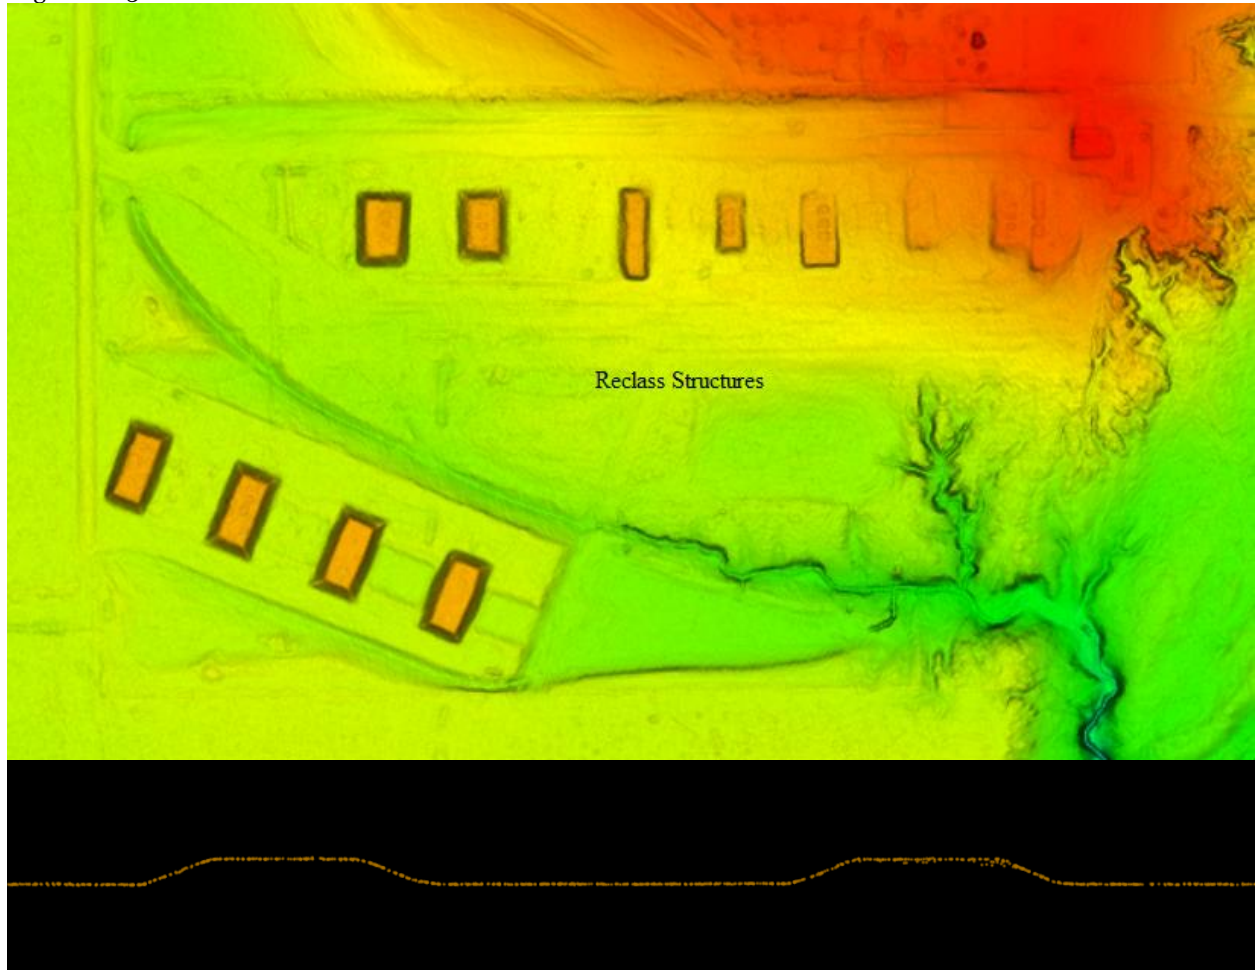
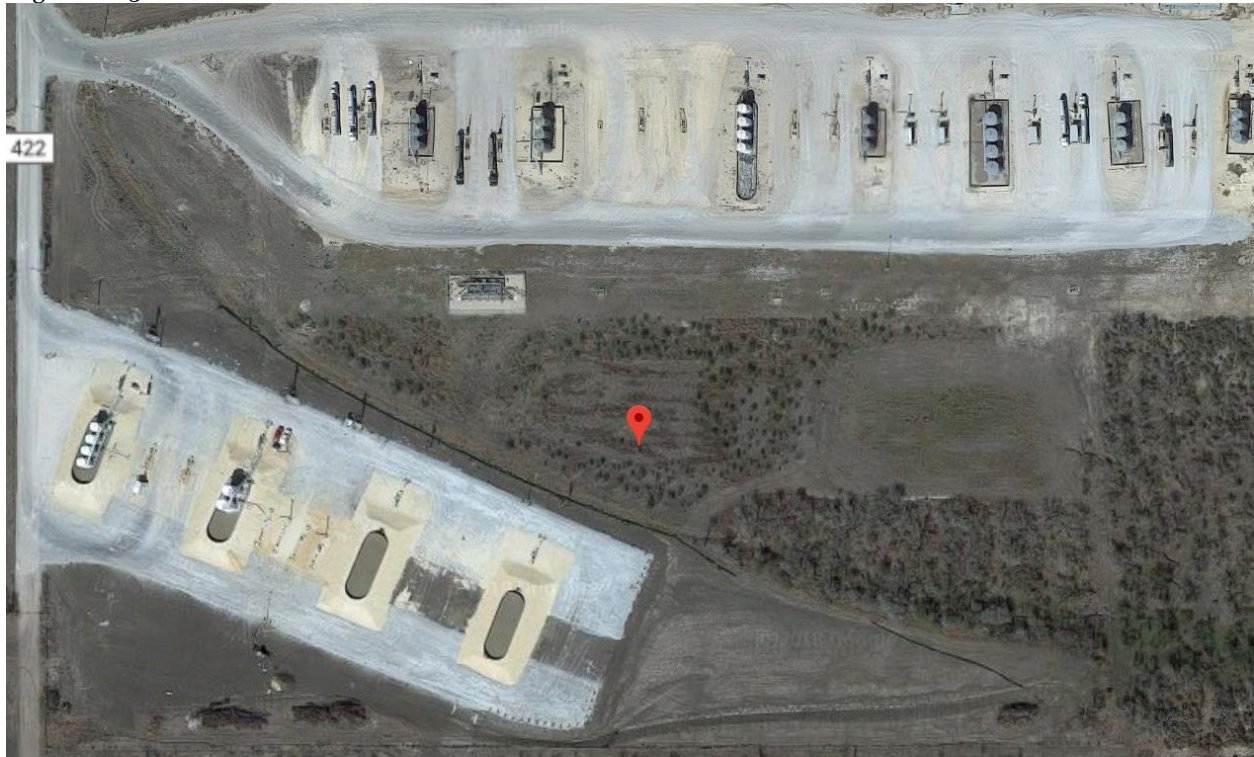
USGS made one (1) call for removal of structures. The edit calls were reviewed and Dewberry has determined that the structures are part of the ground and therefore not removed. An example is shown below.

Figure 10- Tile 14RNS775470. DEM is shown in the top image, lidar profile of ground (orange) points is shown in the middle image, and base imagery is shown in the bottom image. These features appear to be earthen mounds or foundations. The elevation change of the in-ground features are accurately portrayed in the DEM.
