DEWBERRY RESPONSE TO USGS FISH SPRINGS TOPOBATHYMETRIC LIDAR

Produced for U.S. Geological Survey

SEPTEMBER 7, 2023

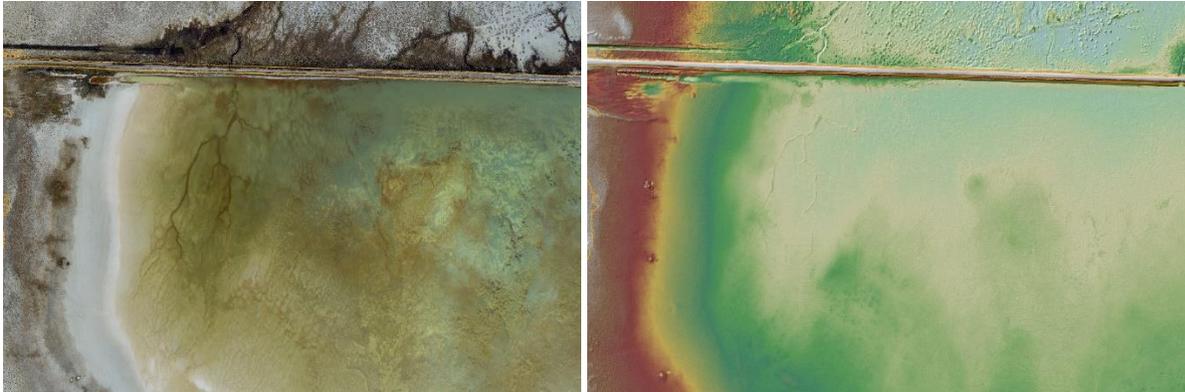
Figure 2. Images 1 and 2 from Stakeholder, showing channel in question via orthoimagery (left image) and the delivered topobathymetric DEM (right image).

The feature in Figure 2 is located in tile 12STK980190. The US Fish and Wildlife Service (USFWS) identified a channel that appeared higher in elevation in the digital elevation model (DEM). The point cloud shows a consistent, well-modeled feature, which is why Dewberry had originally classified it as bathy bottom (class 40). Dewberry investigated this channel further and verified that this feature has always been raised/elevated in all versions of data; the higher elevations were not introduced from refraction correction, or any other processing performed by Dewberry. From imagery, it appears as though the channel could be vegetated, but the point cloud does not represent variations in lidar returns typically associated with vegetation, even low vegetation. There is a potential that algae or some other smooth aquatic vegetation was present in the channel at the time of collect.

FWS did go out and get eyes on the area in question- the Gadwall drainage area, however “wind/wave action and turbid water made it difficult to get pictures of the exact area in question. It was determined that the bulk of the feature is vegetated, mostly with spiral ditchgrass, a submerged aquatic plant that is seen throughout the refuge. Tellingly, it grows in dense patches in drainages and ditches. That would align with FWS’s contention of what this feature is on the ground. Figure 5 shows the vegetation in question, but without a drone mounted camera- which is not allowed within the restricted airspace, this is all that could be provided at this time. The vegetation in question is both dense beneath the surface, and floating to the surface in patches.”

Dewberry requested a field check be conducted at this area to better quantify the area in question. Dewberry classified the channel to reflect field verification and/or client preferences which had the feature in question reclassified to water column, and to interpolate across the feature rather than void out in the DEM. Figures 3 and 4 compare the channel as delivered, modeled in bathy bottom, to a topobathymetric DEM and lidar point cloud profile of the channel when the elevated feature is reclassified to water column.

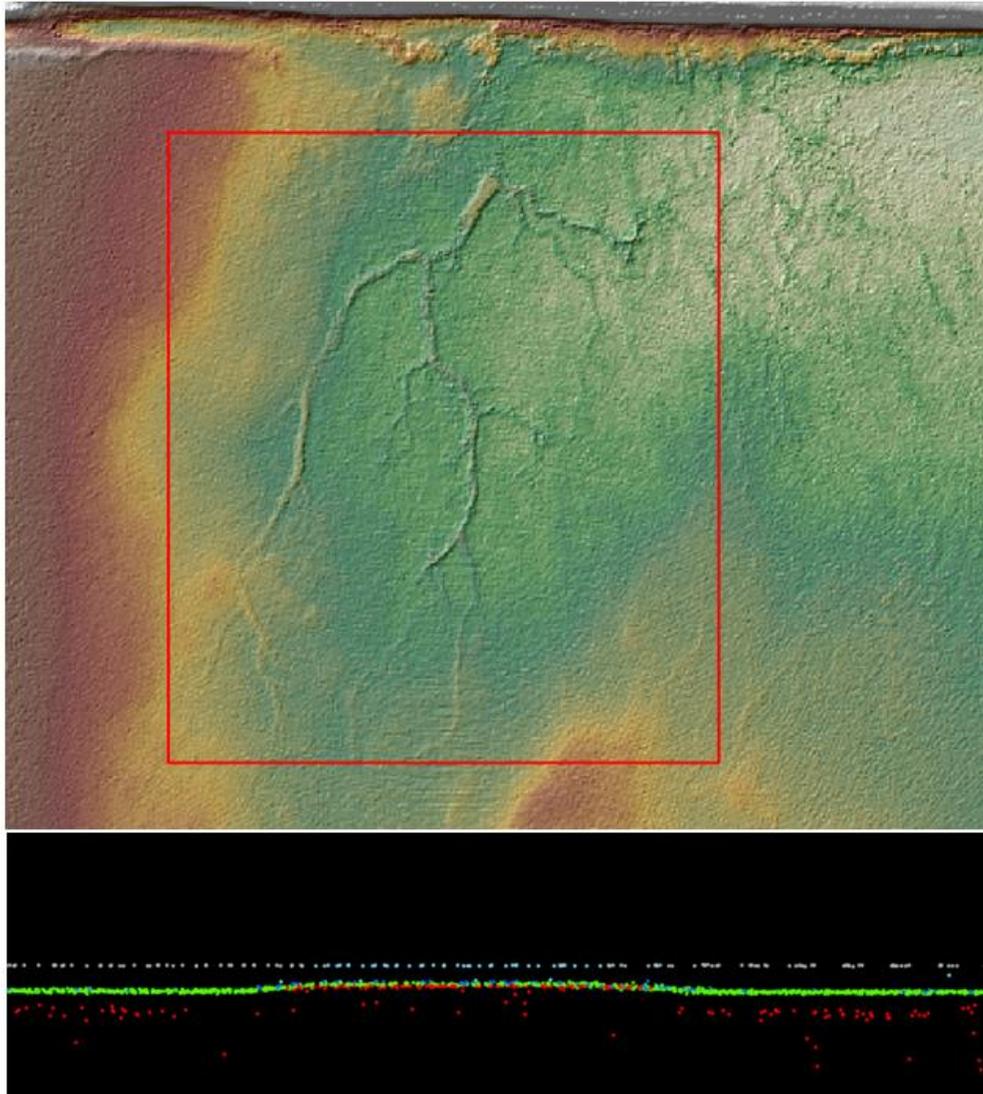
Figure 3. A lidar cross-section of the feature in question shows that the bathymetric ground surface is raised in the initial delivery. Profile shows a gradual and natural elevation gradient with no obvious indication of vegetation. Class 1 (unclassified) is shown in grey, class 7 (low noise) is shown in red, class 40 (bathymetric ground) is shown in green, class 41 (water surface) is shown in light blue, and class 45 (water column) is shown in dark blue.

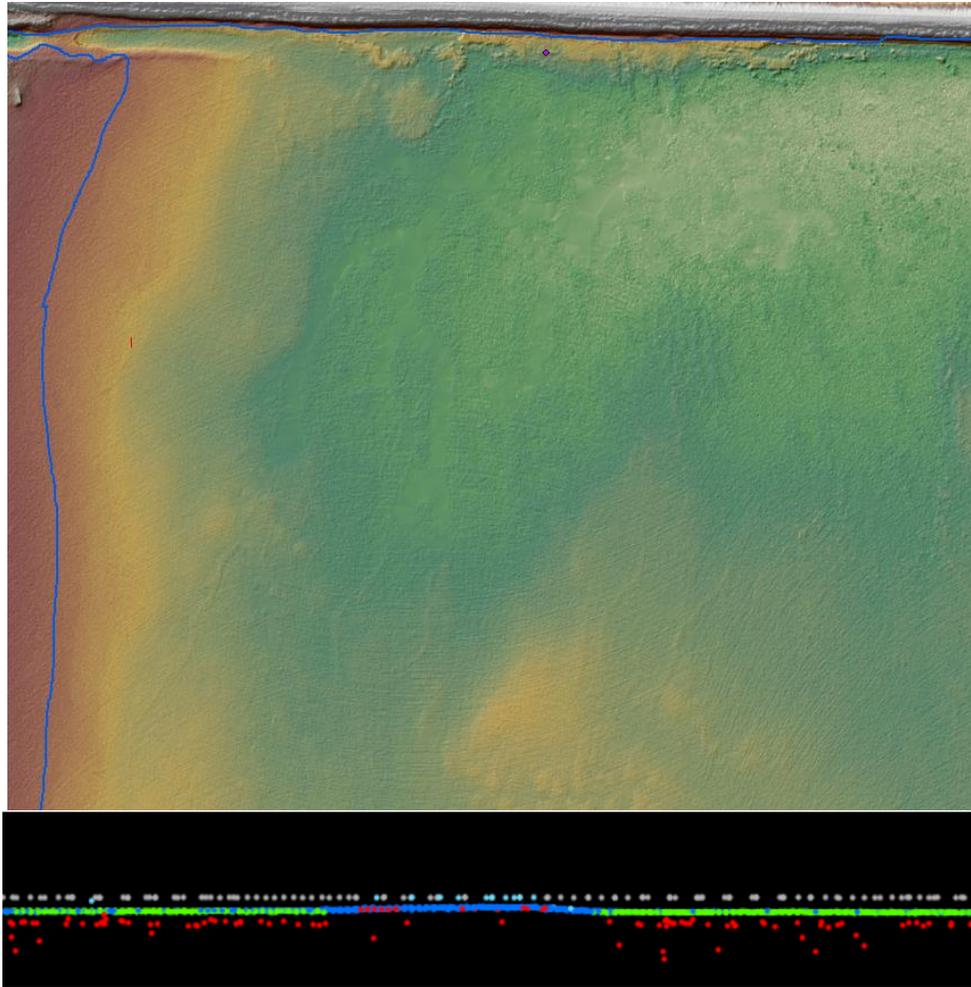
Figure 4. A lidar cross-section of the feature in question shows the results when bathymetric ground classification is adjusted to remove the slightly raised area. Additional voids are introduced in the DEM due to a lack of sufficient bathy bottom coverage. This lack of coverage is based on the assumption that the raised area is part of some sort of algae or aquatic vegetation and there does not appear to be any surface beneath to indicate bathy bottom coverage was acquired for this particular area. Class 1 (unclassified) is shown in grey, class 7 (low noise) is shown in red, class 40 (bathymetric ground) is shown in green, class 41 (water surface) is shown in light blue, and class 45 (water column) is shown in dark blue.

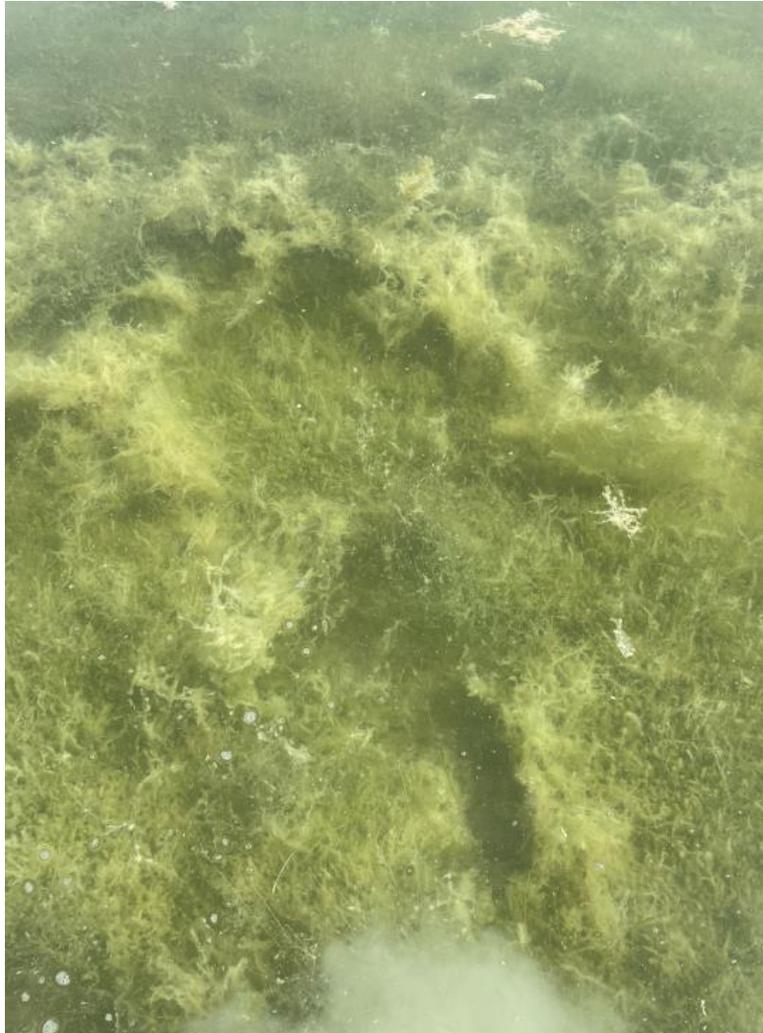
Figure 5. FWS image of spiral ditchgrass within the Gadwall drainage.

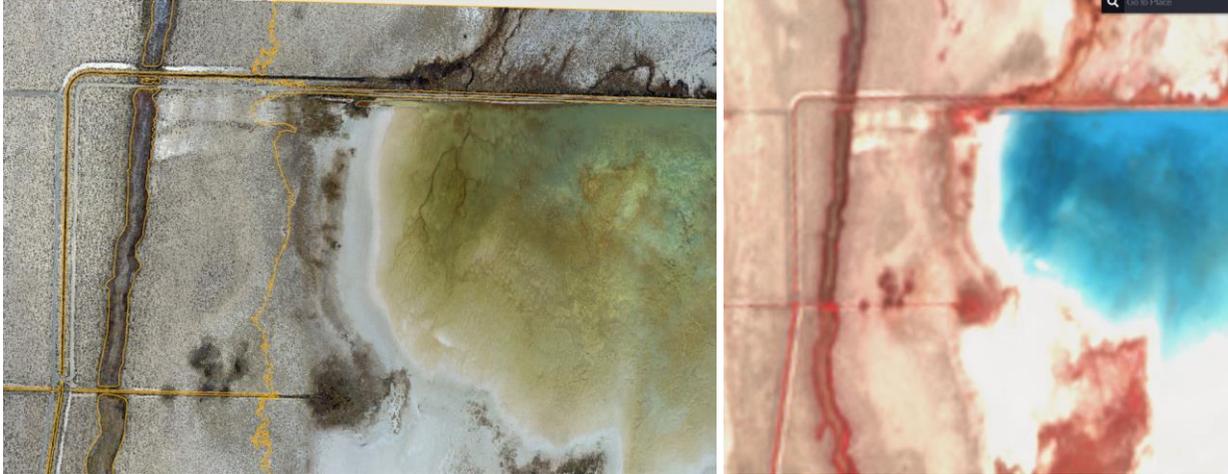
Question 2: “The remaining images demonstrate our confusion at how the Refraction polygons were created (and used) as they do not seem encapsulate what can be easily photo-interpreted in the 10 cm imagery as open water. Are we missing something here in terms of the green laser technology? We also included a CIR image from the same date captured from Sentinel 2 imagery which helps delineate standing water. Adding to the confusion is these polygons seem to directly influence the las point classification. Some open water pools are excluded while many dry channels (with vegetation) and clear upland areas are included. We would have expected the large dry basins on the north end of the refuge to be classed as ground.” See Figures 5-6.

Figure 6. Images 3 and 4 from Stakeholder.

Dewberry has verified that the refraction correction was correctly applied to the Fish Springs lidar point cloud, but that the incorrect version of refraction extents was used for the final classification steps. Dewberry has updated the lidar point cloud classification to match the correct, final version of refraction extents (Figure 12 and Figure 13). The updated lidar point cloud and correct version of refraction extents will be redelivered. The redelivered refraction extents and updated point cloud resolves questions 2 and 3. This correction does not impact the delivered topobathymetric DEMs.

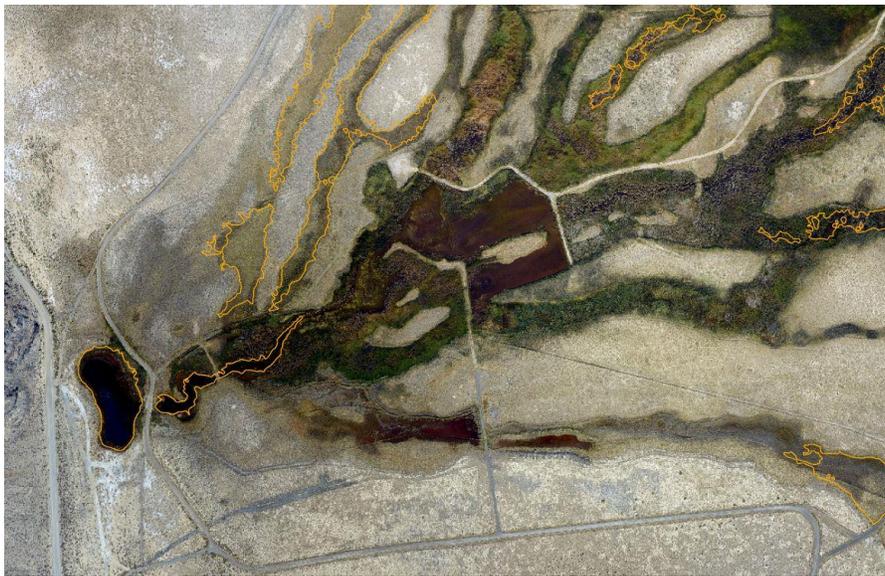
Question 3: “The last example also shows another instance where the refraction extent is drawn considerably different and its effects on the las point classification. This does not make sense to us. While the overall DEM surfaces look good and the surveys indicate the accuracy is acceptable, we have these concerns which we can’t square up.” See Figures 7-8.

Figure 7. Image 5 from Stakeholder.

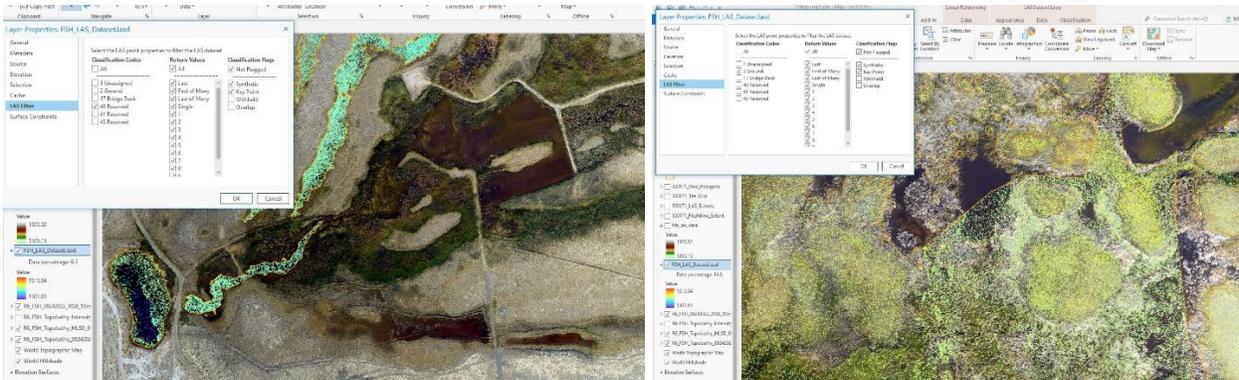
Figure 8. Images 6 and 7 from Stakeholder, showing bathy bottom (class 40) classified points within refraction extents (left image) and ground (class 2) classified points outside of refraction extents (right image).

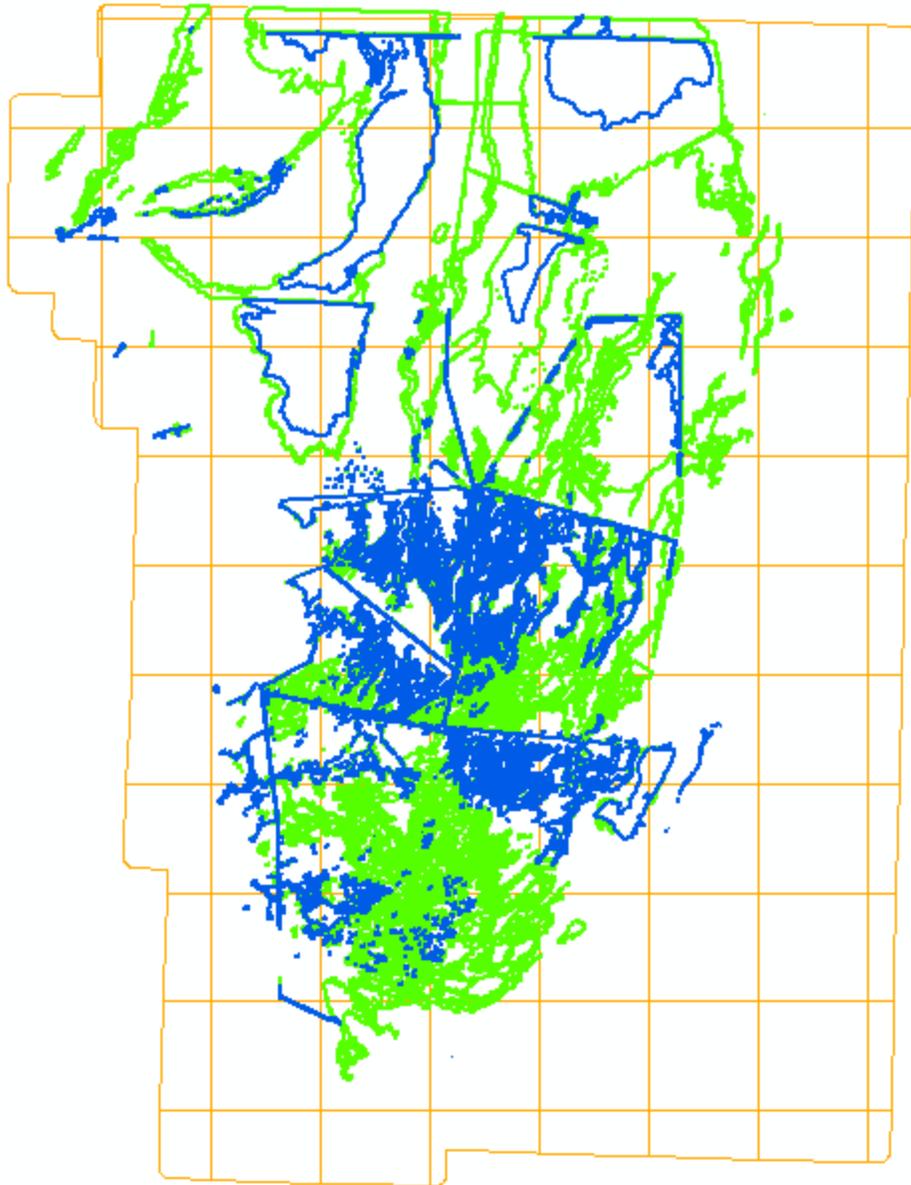
Upon further review it was determined that an incorrect, earlier version of the refraction extents was used for the final classification and delivered to USGS (Figure 9). Dewberry generates a couple different versions of refraction extents throughout our production process. The first version, incorrectly delivered, is a much more expansive version of "potential" areas requiring refraction correction. This version is used to help us determine where water may be present. This version is then reviewed and revised, using a combination of DEMs, ortho imagery, intensity, Max Height Separation Raster (MHSR), difference rasters, and additional ancillary datasets, to reflect the actual extent of bathy bottom deep enough to require refraction correction. Priority is given to substantial areas that were clearly wet or could be perceived as wet. Some nominal areas of potentially wet ground were not collected when perceived dense vegetation was also present (Figure 10). These vegetated areas often appear as darker features in the intensity but do not correlate well to the ortho imagery and/or MHSR. In addition, Dewberry did not include areas that could be perceived as dry or mostly dry floodplains as they did not meet the depth criteria for refraction corrections, nor could they be clearly perceived as wet (Figure 11).

Figure 9. An overview showing the difference between the initially derived and delivered refraction extents (green) compared to the final version of refraction extents (blue). The initial set of refraction extents (green) were generated and were to only be used internally by Dewberry to help identify areas that were potentially wet. The set of refraction extents in blue show the true areas where refraction corrections took place and includes areas that could be clearly perceived as wet.

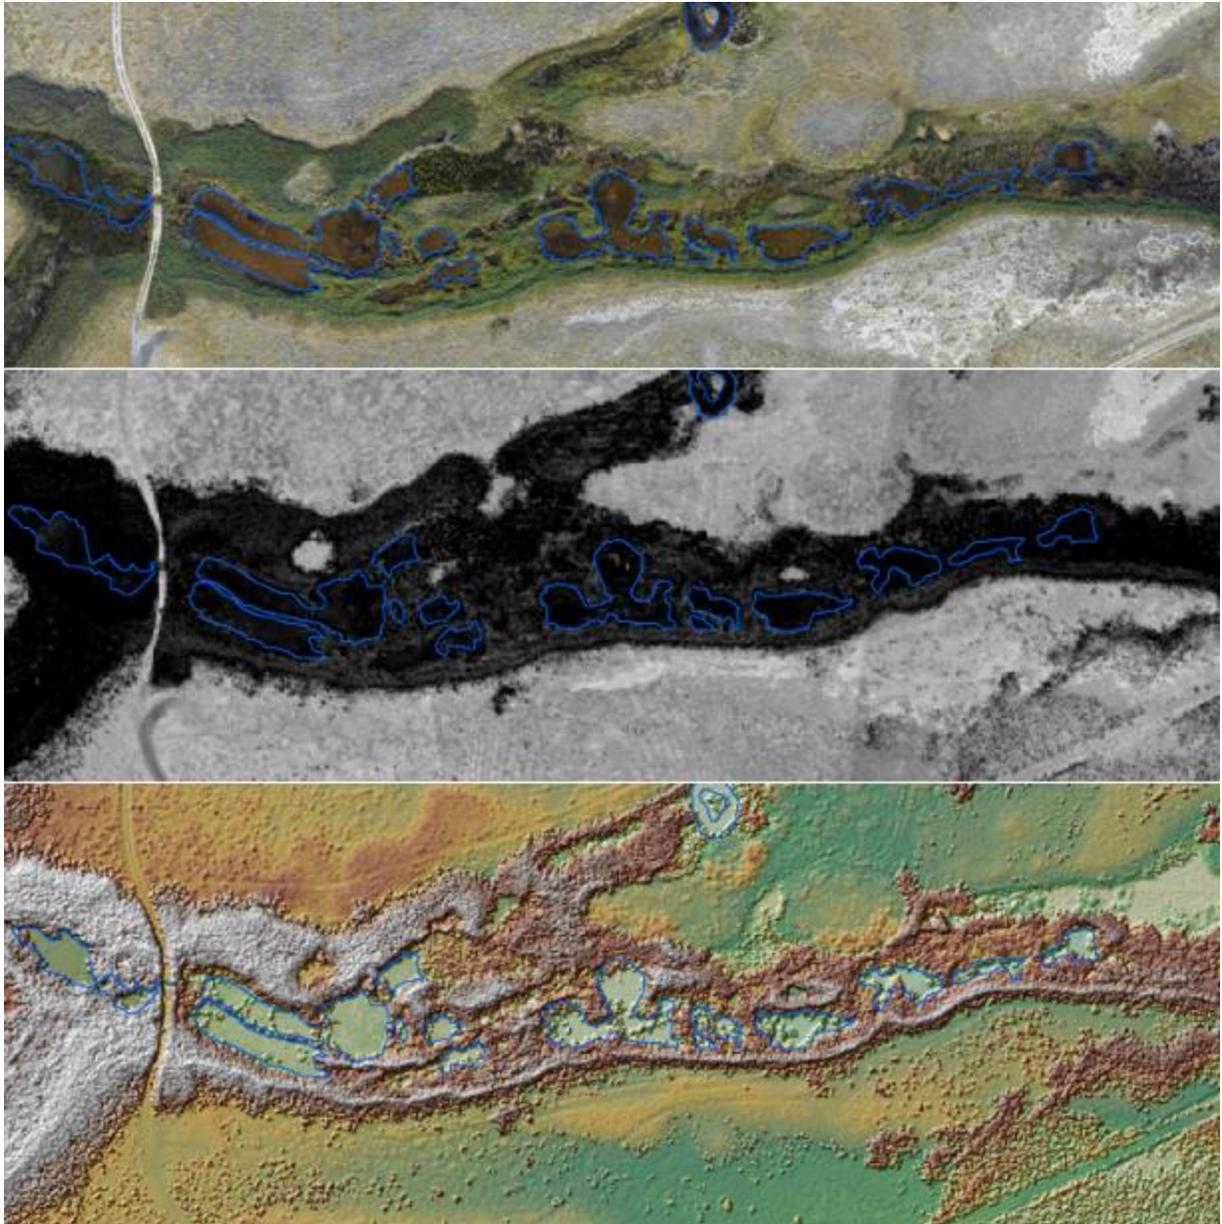
Figure 10. An example of a nominal area of potentially wet ground, as suggested by the intensity, that was not collected in the refraction extents (blue polygons) due to the perceived dense vegetation. Only the “pools” of open water containing bathy bottom and detected water surface points were refracted.

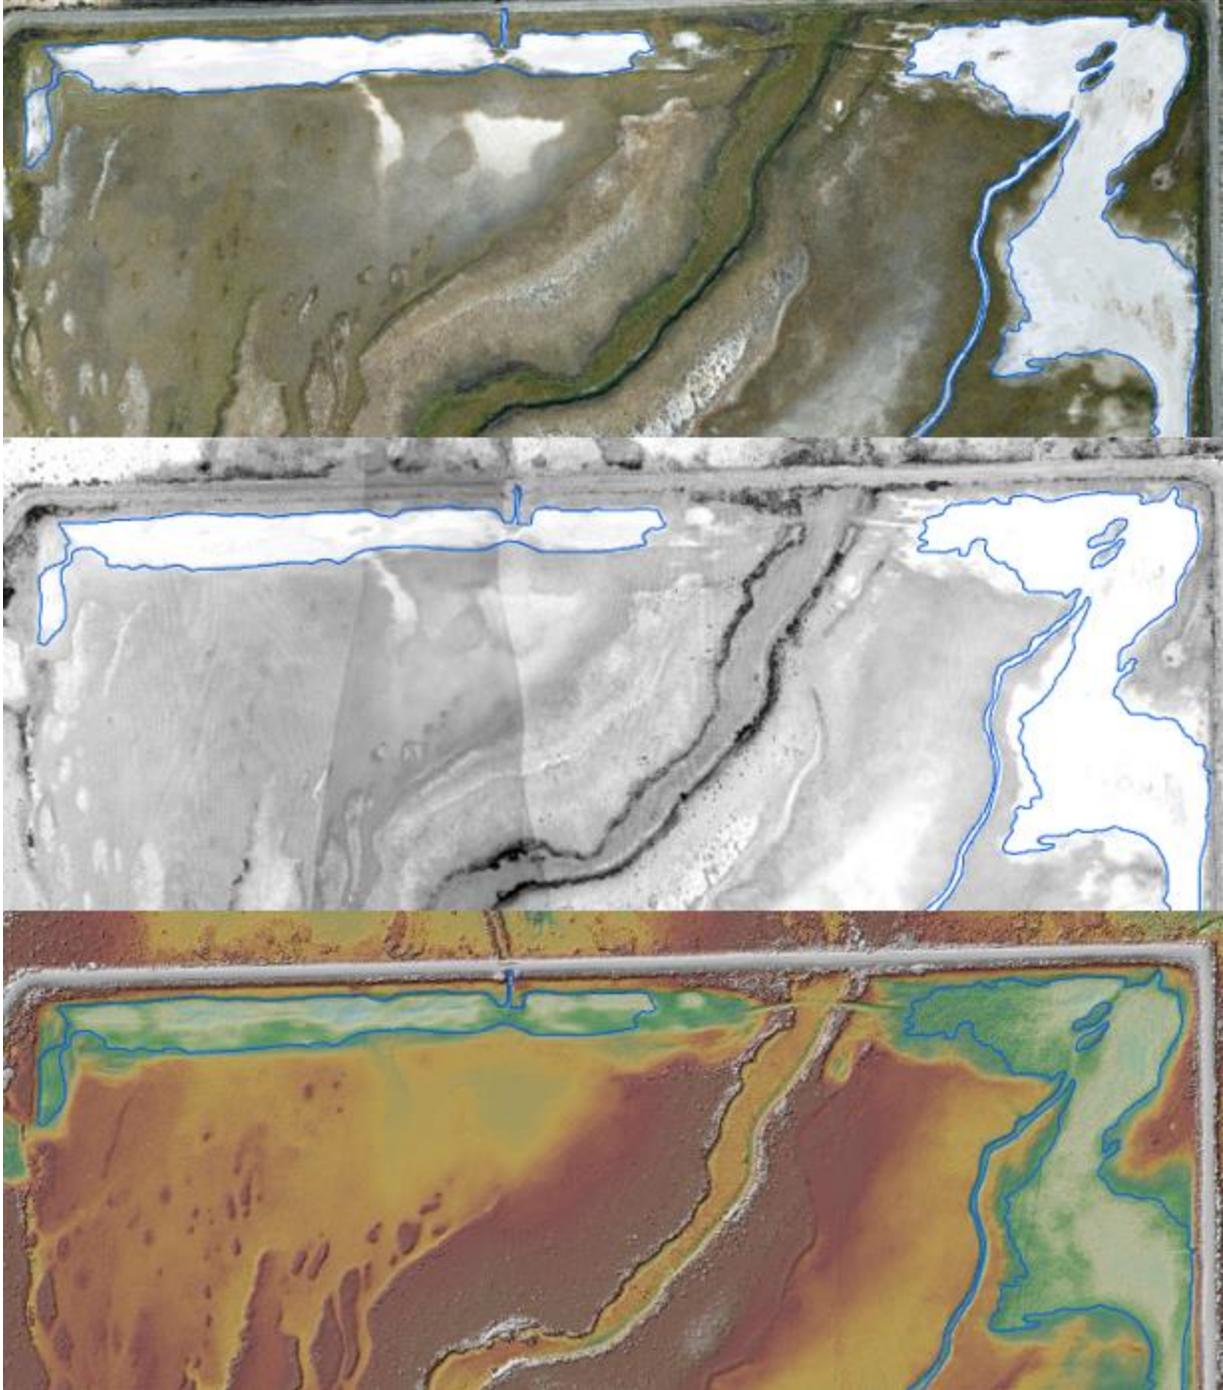
Figure 11. An example area that could be perceived as a floodplain that did not meet the criteria for refraction corrections, nor perceived as wet. The final refraction extents are represented by the blue polygons.

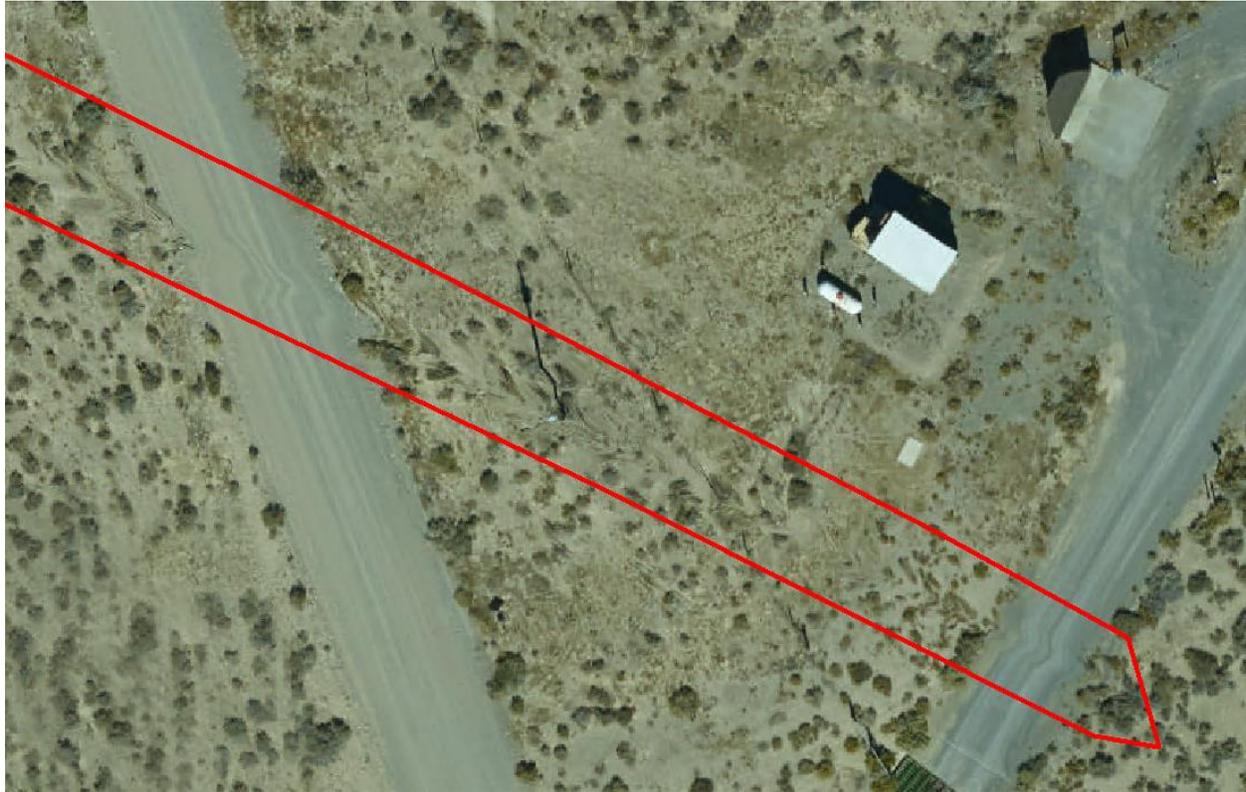
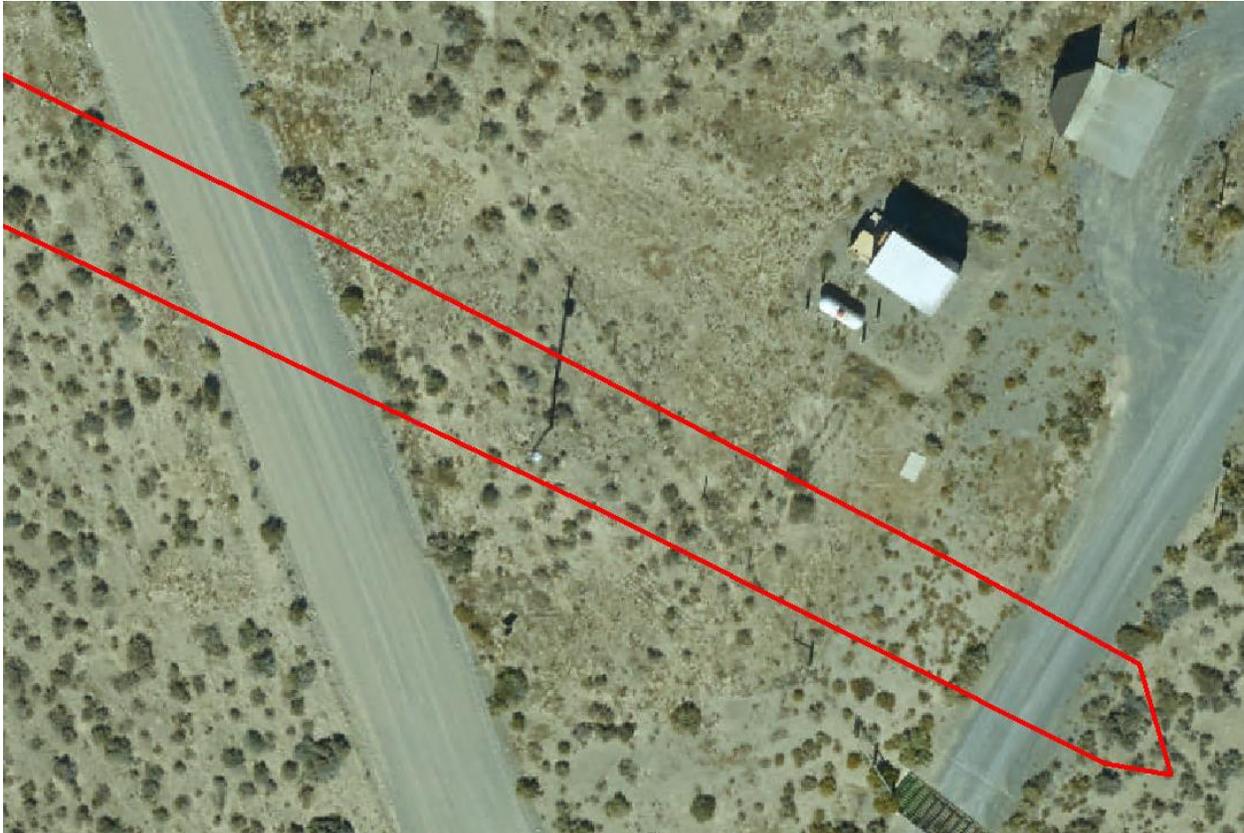
It was noted that there were several areas on the orthoimagery that contained smearing or other anomalies. The original orthos were created utilizing lidar that was not 100% finalized in order to meet the delivery deadline. Some of the above ground features that had not been completely classified out resulted in a surface that caused these anomalies. All orthos were reprocessed with the finalized lidar, which corrected the noted smears and anomalies (Figure 14).

Figure 14. An example of area that was impacted by the surface anomaly. Top image shows the warp caused by the powerlines and in the bottom image it is repaired.

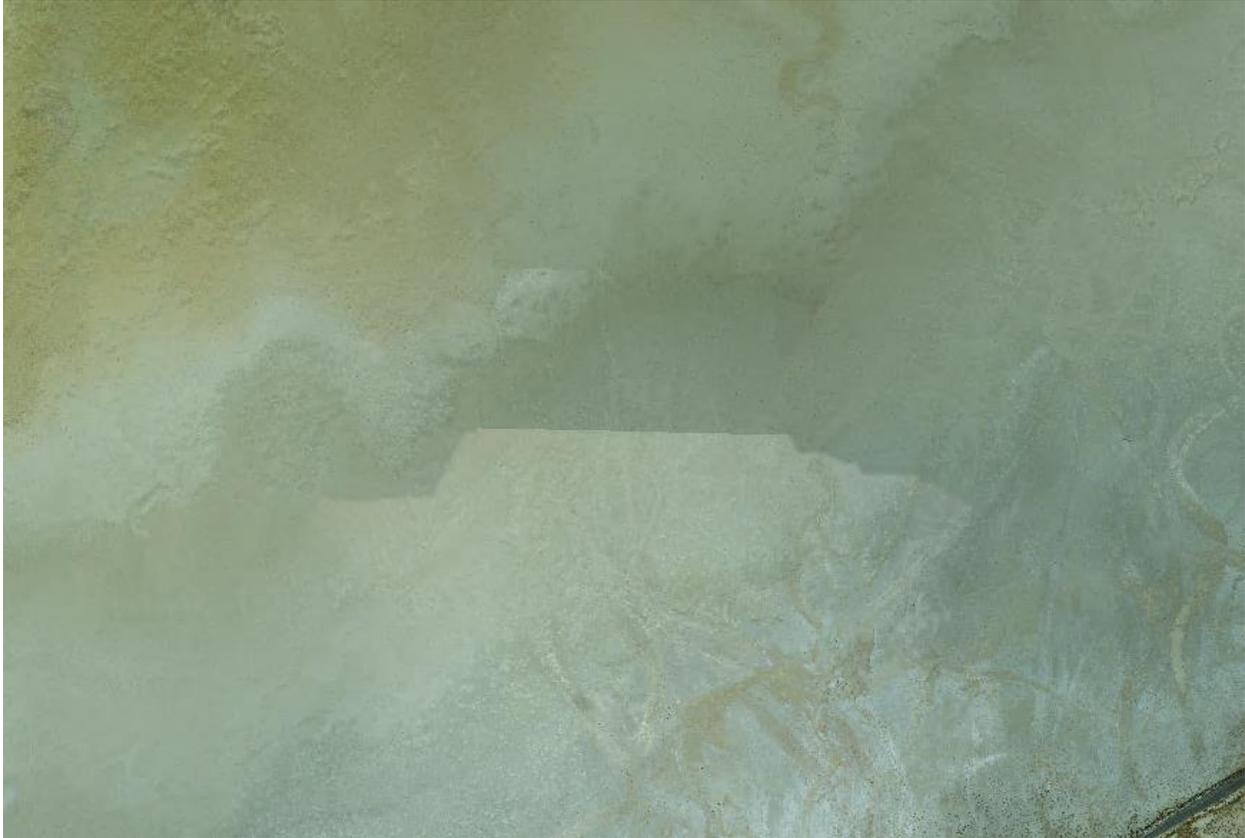
There is one area of seamlines that did not color balance and blend as well in the reprocessing (Figure 15). Due to the nature of seamlines in such a vast open and flat area such as the desert or over open water there are often visible edges similar to this. Since all orthos were reprocessed it is also not possible to use the old tiles for this area as they would not match perfectly along the edges leading to visible pixel mismatch along the edges of the tiles.

Figure 15. Area affected by seamline visibility.

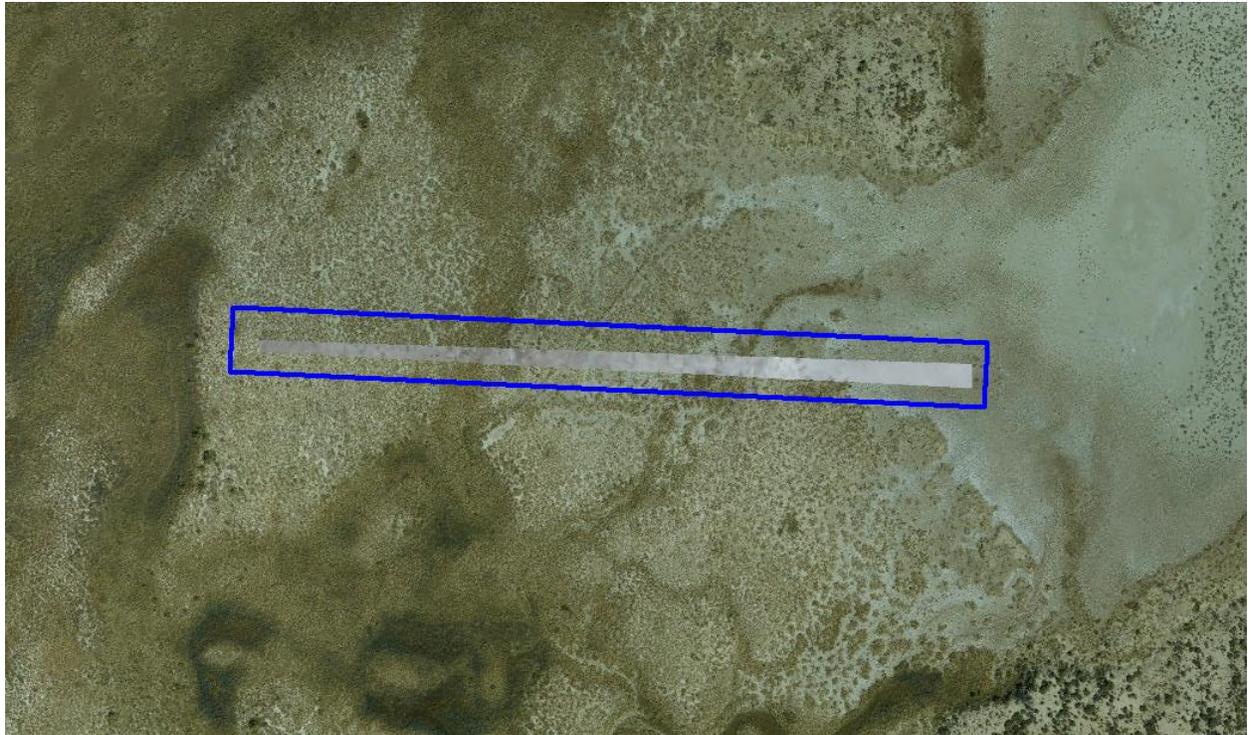
There is one void in the orthos that was previously noted as well (Figure 16). Dewberry proposed to patch in some older imagery in order to have a seamless dataset. This void is noticeable as there are temporal, color balance, and resolution differences. It was determined that the imagery could be accepted this way as the void is outside of the preserve boundary.

Figure 16. Area affected by void with patched in data.
