Dewberry Response to USGS Review of the Virginia FEMA NRCS South Central LiDAR Project– Block 1

Produced for U.S. Geological Survey

USGS Contract: G16PC00020
Task Order: G17PD01206
Report Date: 08/22/2019

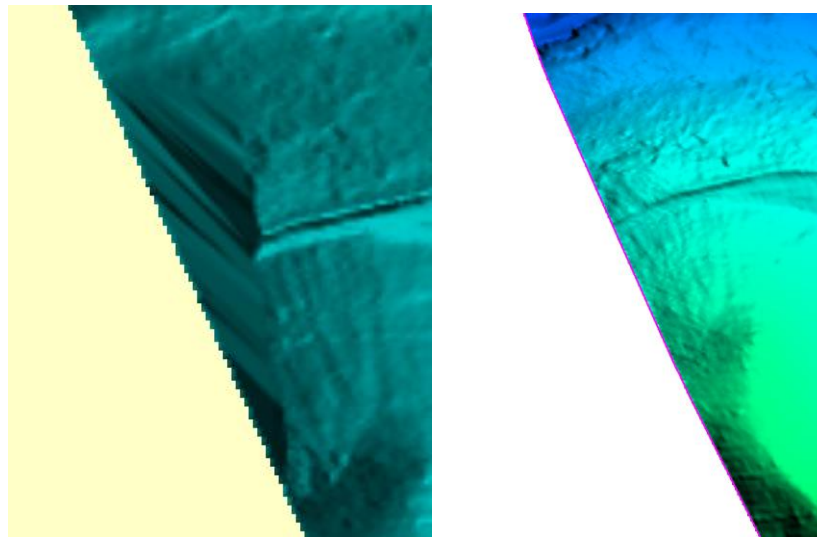
USGS made two calls for missing data. One call was on the edge of the project, that ground could be added. The other was an area of dense tree cover and there were no ground points that could be replaced. Dewberry corrected the issue with the missing ground along the edge of the project.

Figure 2 - Tile 17SLC64500750. The image on the left shows the DEM where USGS made a missing data call. The image on the right is an overview of the DEM after Dewberry clipped the tile to the project boundary.

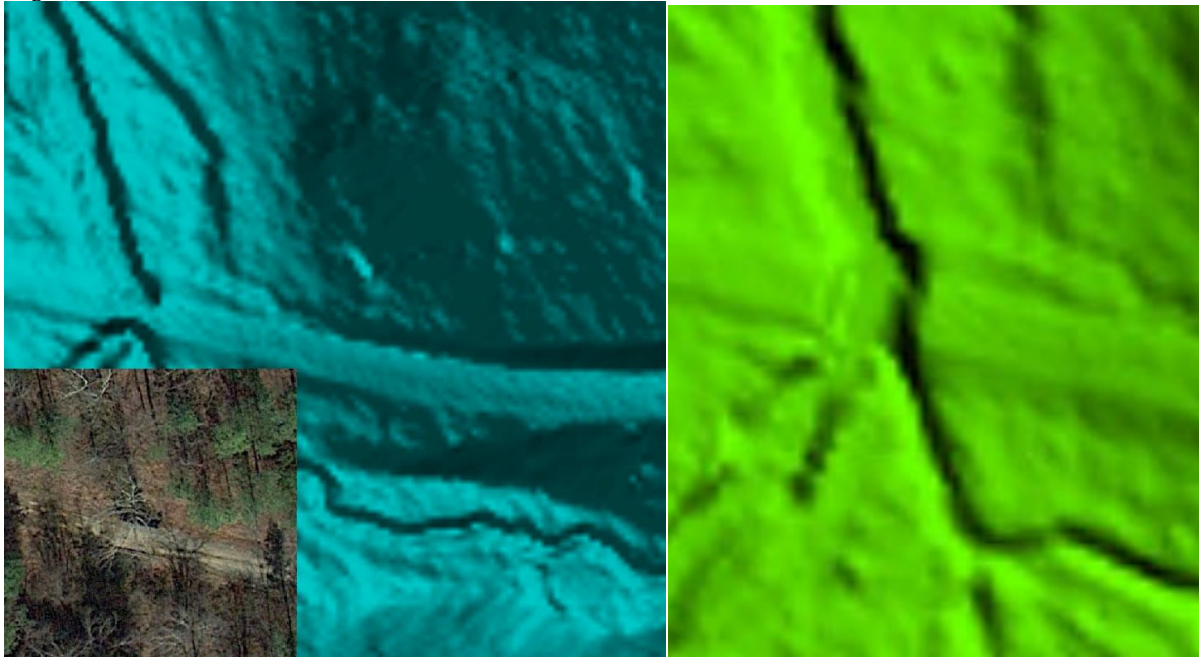
Figure 3 - Tiles 17SNA68506650. At left, a USGS screenshot of part of a bridge classified as ground. At right, the bridge has been removed from the Lidar and DEM.

USGS identified twenty-five bridge and culvert calls. The bridge points were reclassified from ground to bridge deck while the culverts had points returned to ground. The LAS was reclassified and the DEMs and contours updated. Examples are shown below.

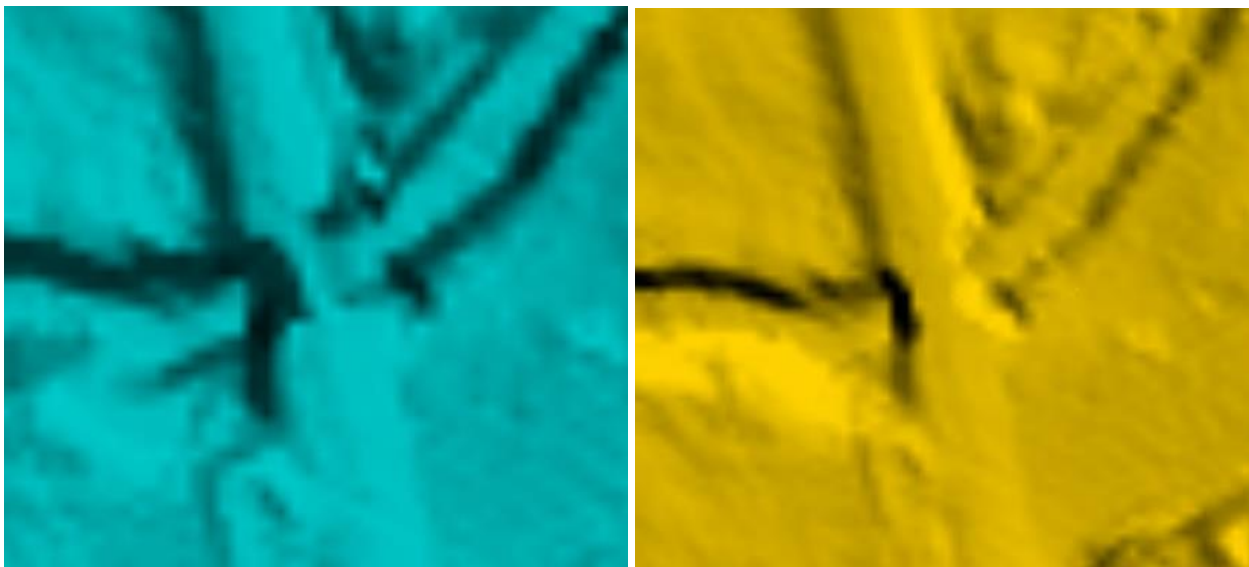
Figure 4 - Tiles 17SNB49002350. At left, a USGS screenshot shows of part of a culvert classified as bridge. At right, the culvert has been returned to ground in both the Lidar and DEM.

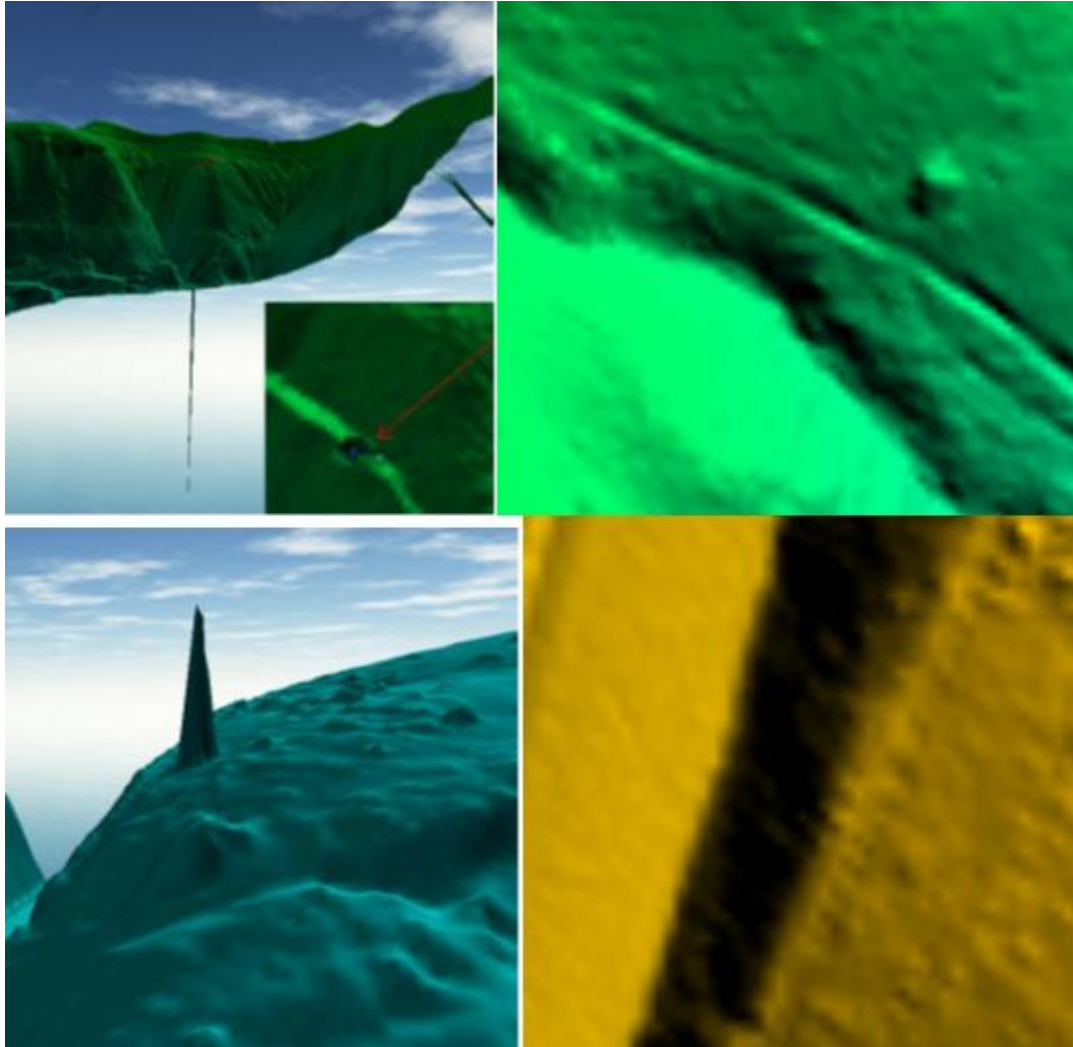
USGS identified 134 spikes and divots that needed to be removed from the ground. The edit calls were assessed and corrected. An example is provided below.

Figure 5 - Tiles 17SLC97501350 (Top) and 17SNB25000100 (Bottom) are pictured above. The top pair of images shows USGS screenshot of low points on the left and the Dewberry correction on the right. The bottom pair shows the USGS screenshot of a spike and the right the Dewberry correction.

- The low ground points were classified to Low Noise (Class 7) and the high points were classified to unclassified.
- There were 38 hydrographic calls. Hydro flattening/water level/artifact calls as well as a systematic call to raise all river breaklines by 3 feet

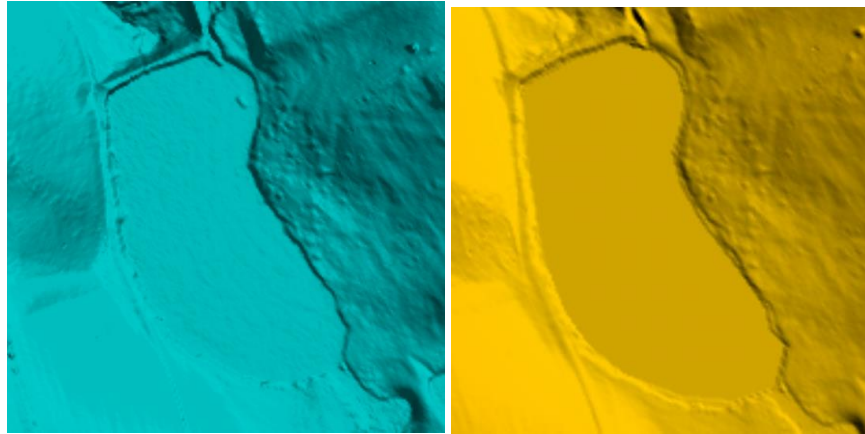
Figure 6 - Tile 17SNA41509950. The pond shown was identified by USGS as over 2 acres and needed to be hydro-flattened (left). The LAS and DEM have been corrected by adding breaklines and hydro-flattening (right).

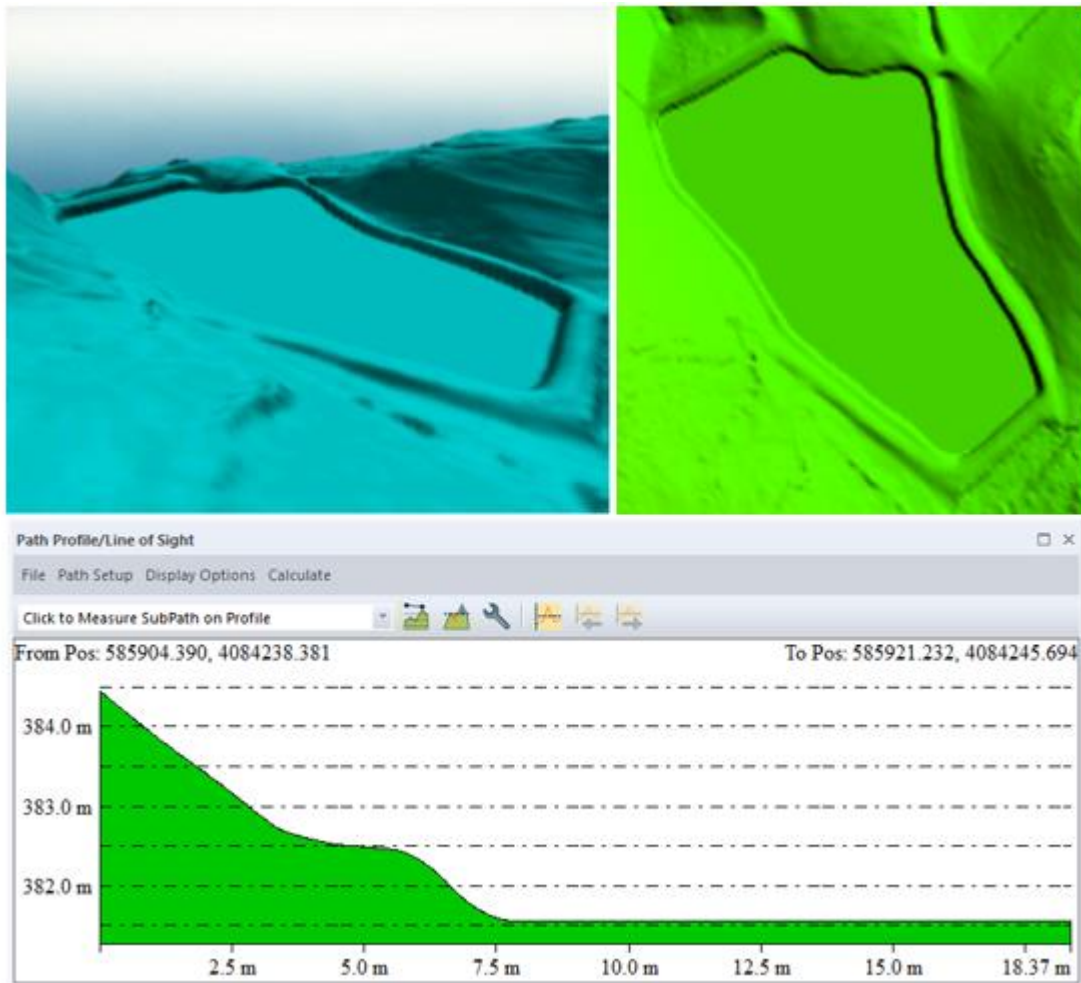
Figure 7 – Tile 17SNA85008300. The pond shown was identified by USGS digging (left). The breakline was adjusted to make sure that the water level is as high as it can be without any portions floating (right).

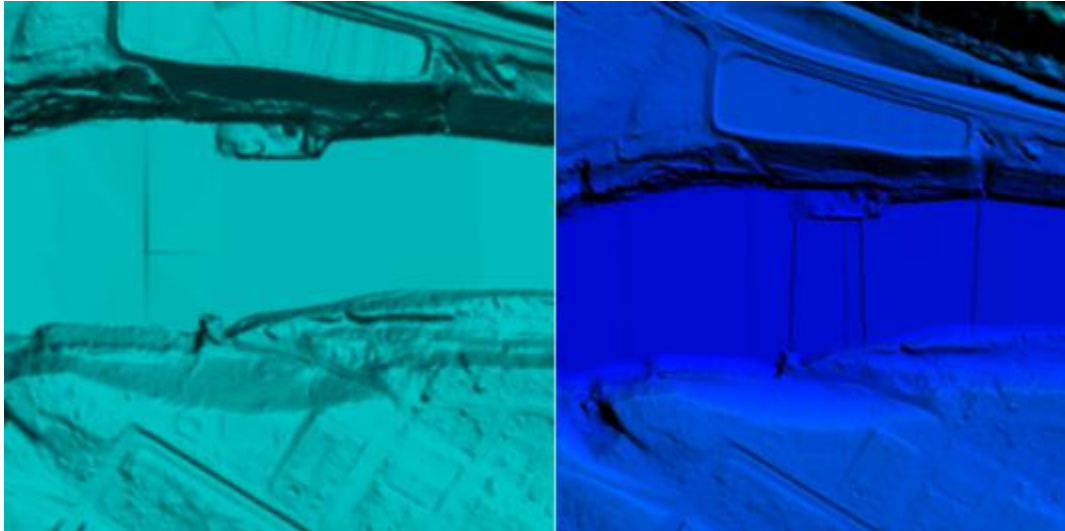
Figure 8 – Tile 17SLC58501950. The water artifact was identified by USGS digging (left). The right image shows those artifacts have been removed (right).

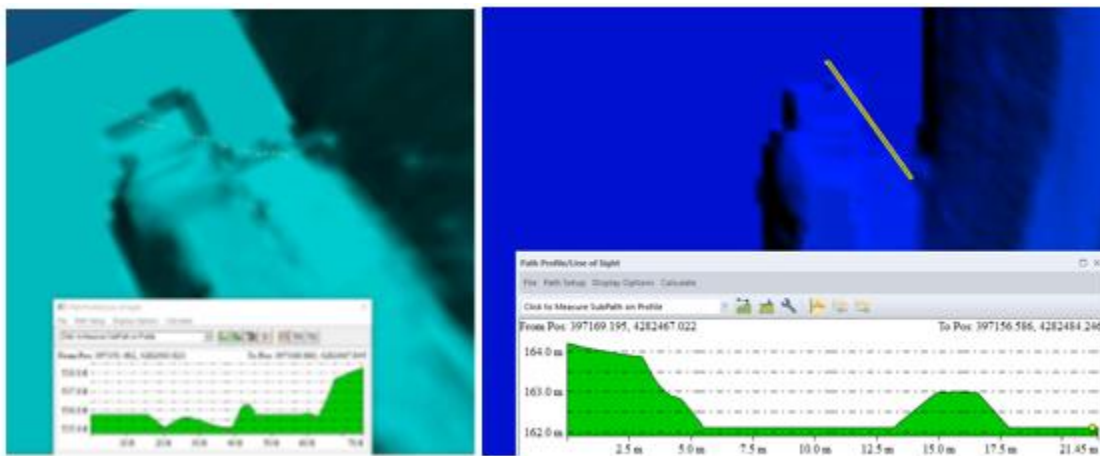
Figure 9 – 17SLC96008100. USGS call to return points to ground is shown on the left. The Dewberry update is shown on the right. All water is below ground level.

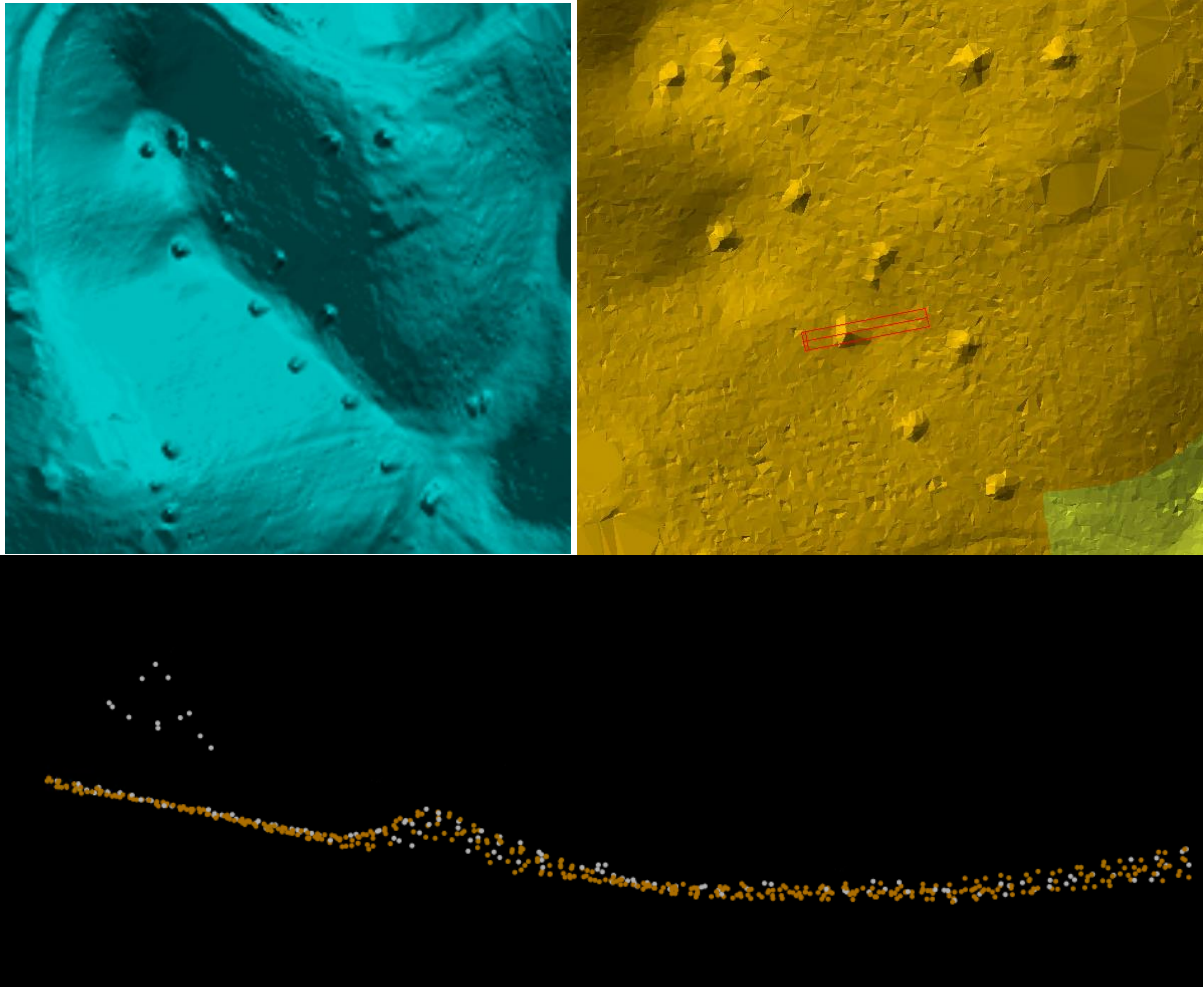
USGS identified eight artifacts to be removed from ground. Six of the calls pertained to the orchard as shown below. Dewberry found all of these areas to be an accurate representation of the ground. No updates to the Lidar/DEM were made.

Figure 10 - Tile 17SNB41501300. The top two screenshots are from USGS called “Check for Trees in Orchard.” Dewberry found that these artifacts are mounds and that no points could be removed from ground. The bottom screenshot shows the ground (orange) and unclassified (grey) points.

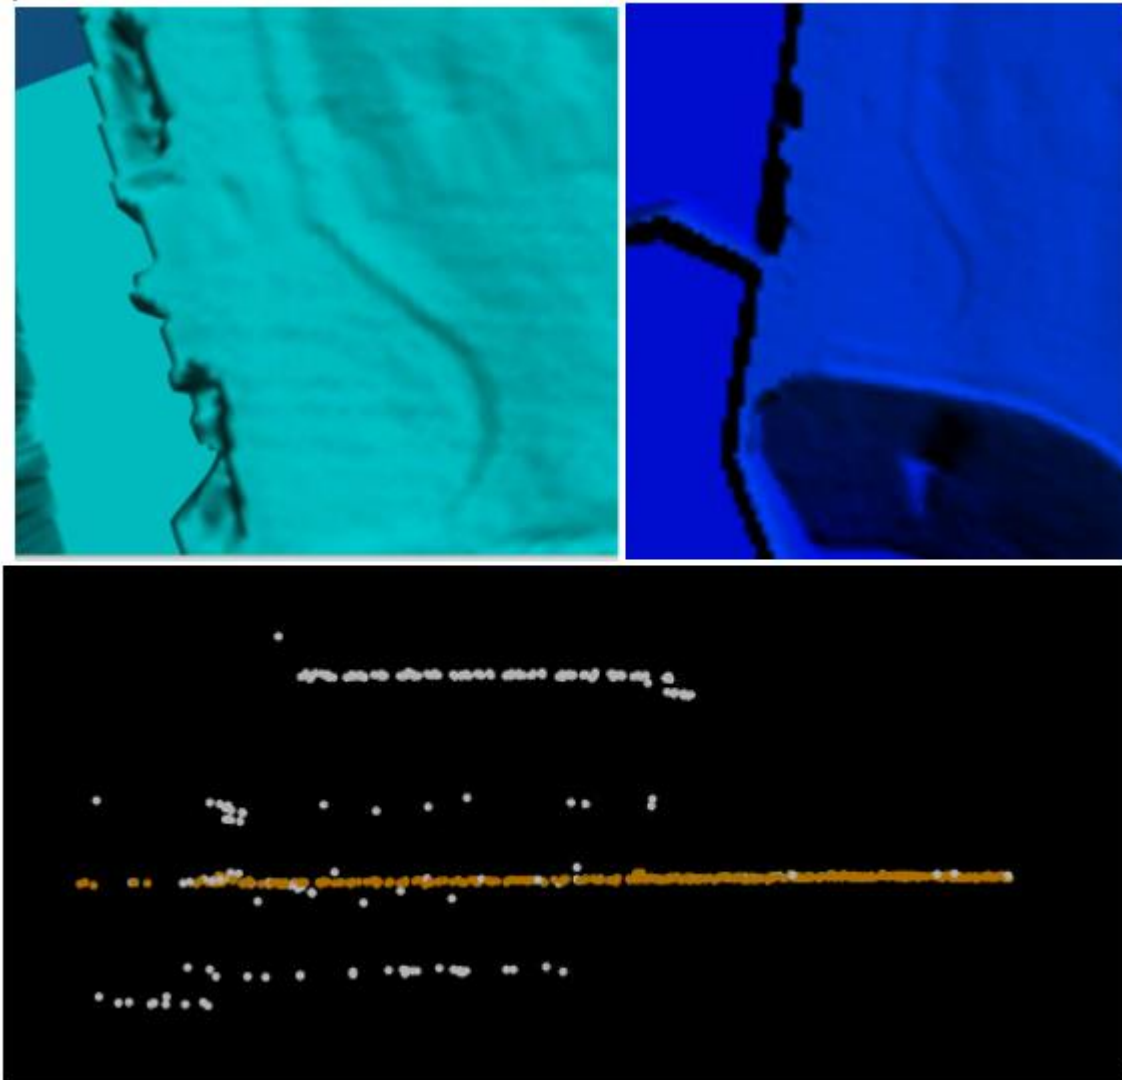
USGS identified ten areas where points needed to be returned to ground. Nine of the calls were addressed; one call did not have any points that could be moved. An example is show below.

Figure 11 – Tile 17SLC96008100. USGS call to return points to ground on the top left, Dewberry updates shown on the top right. The bottom shows a cross-section of the points where many points could be returned to ground (orange) from unclassified (grey).

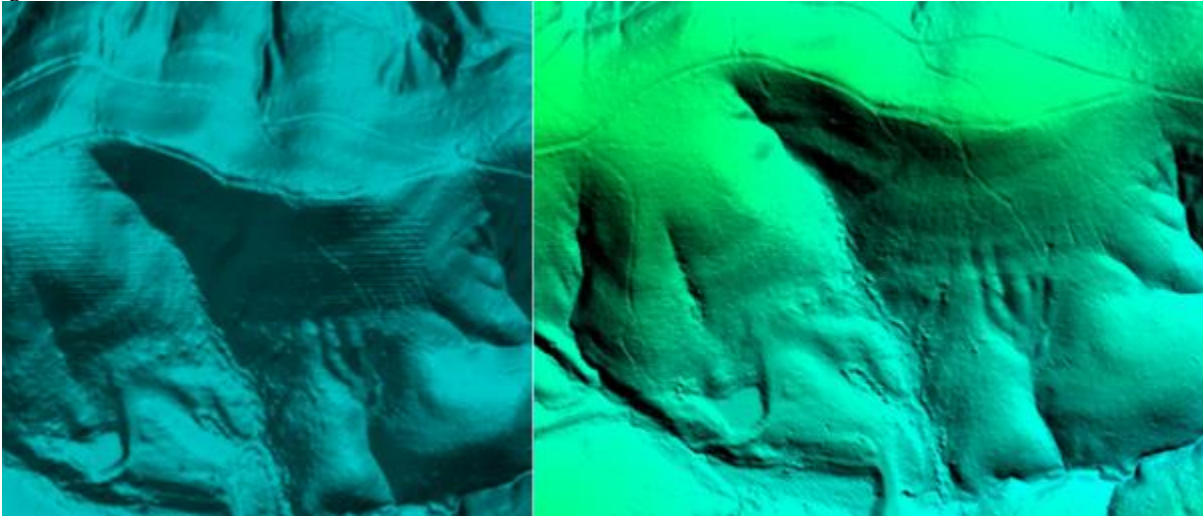
USGS identified four areas where there were some anomalies in the ground surface. An example is show below.

Figure 12 – 17SMC00503150. USGS call for cornrowing shown on the left. The Dewberry update is shown on the right. The cornrows have been smoothed out in the ground surface.

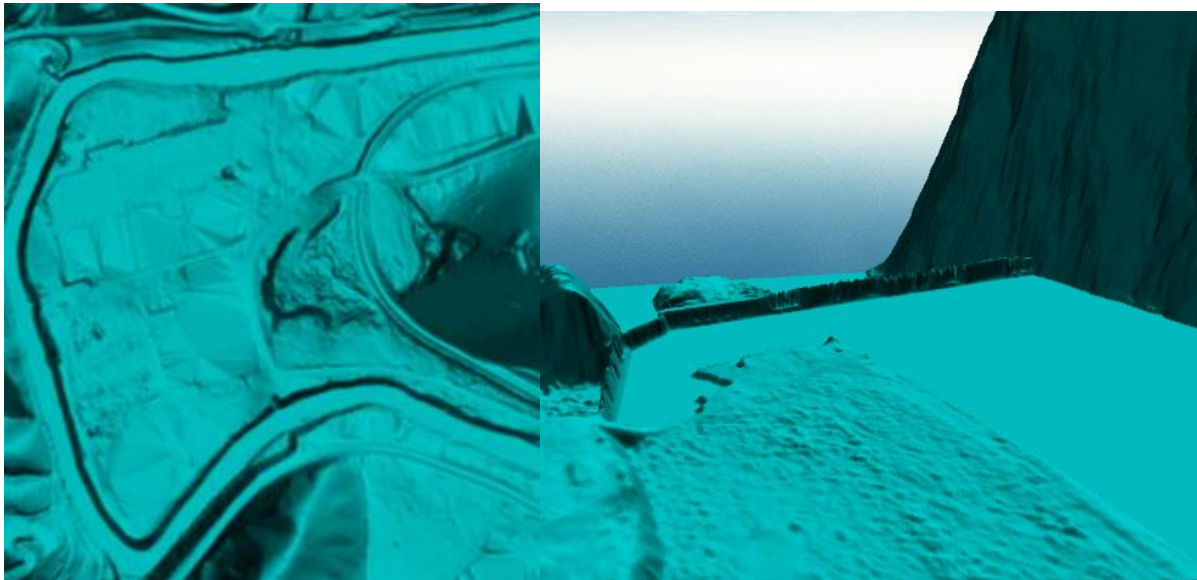
USGS made ten calls to unflatten areas of rivers and twenty one calls to remove dams to water level. After a call between the USGS and Dewberry both parties agreed to leave these areas as is. Below is an example of these calls.

Figure 13- The image on the left shows a river segment that was hydro classified. These rivers were collected in areas that were below collection spec to maintain flow and to avoid sausage linking. The image on the right shows a dam that was left in the ground. The dam stops the flow of water and are to be left as ground.
