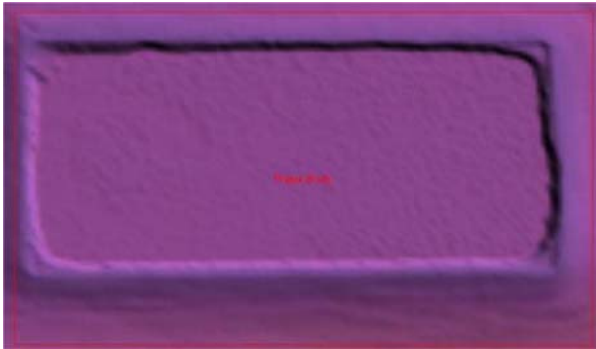
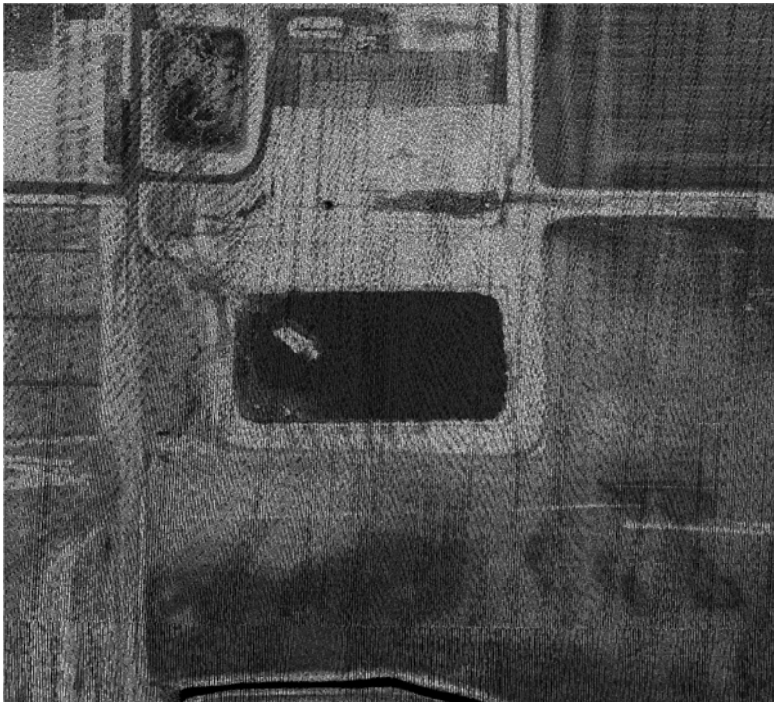
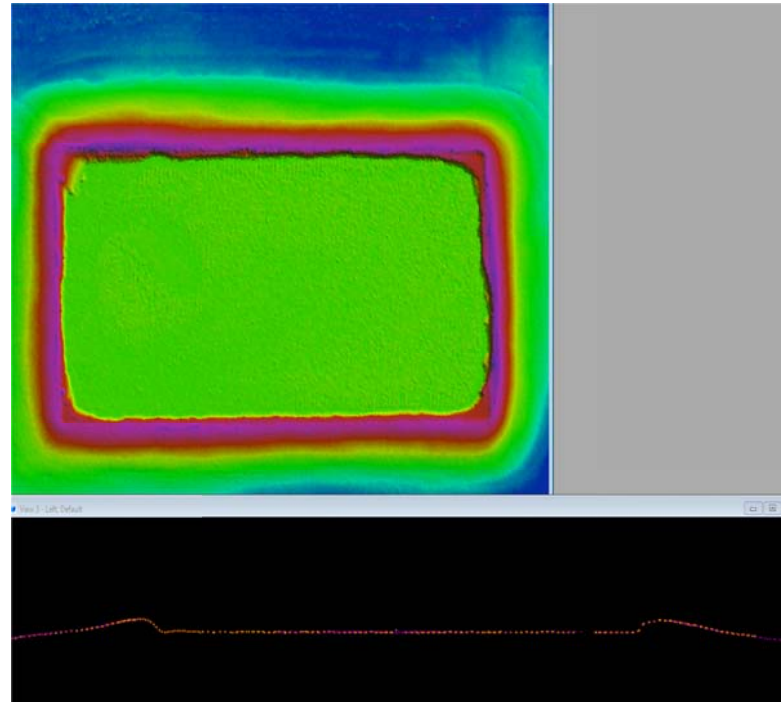
QC Call: Lake not hydro-flattened correctly (FID 3 in Errors shape file)

QSI Response: There was no water body present at the time of LIDAR collection. The points inside of the rectangular feature hold consistent elevation values, and there are no data voids delineating the possibility of a water body. There will be **no change** to this feature.

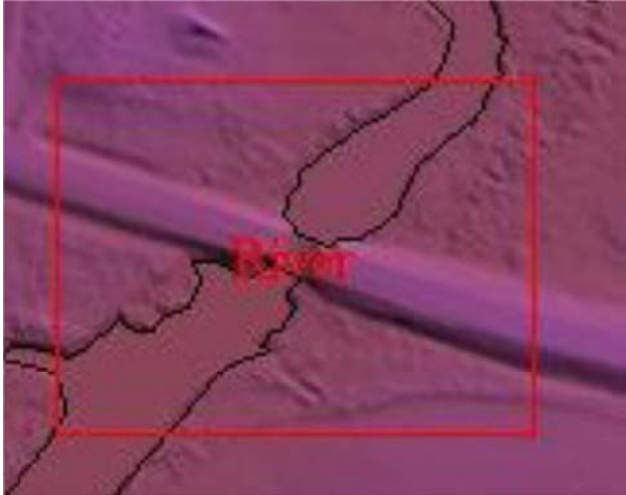
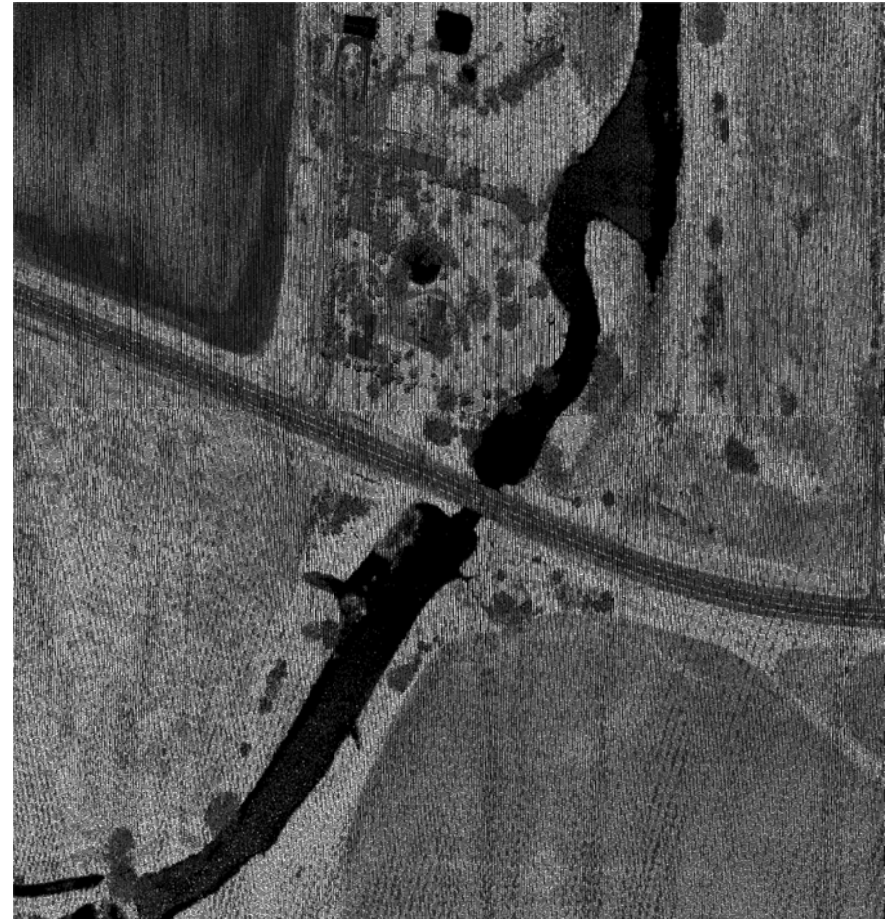
QC Call: River not connected where bridge was removed (FID 2 in *Errors* shape file)

QSI Response: Hydro breakline was improperly collected. We **will correct** the breakline attribution, as well as connect the features through the bridge. This will show a continuous double line drain feature, with monotonic elevations. The raster DEM and Contours will be regenerated to show the change to the final bare earth surface.

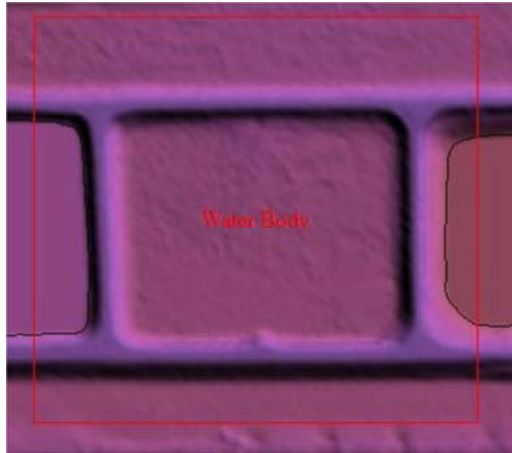
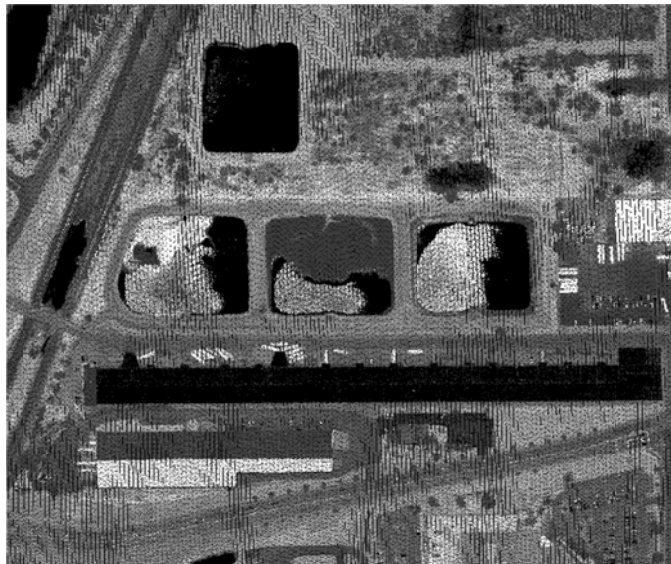
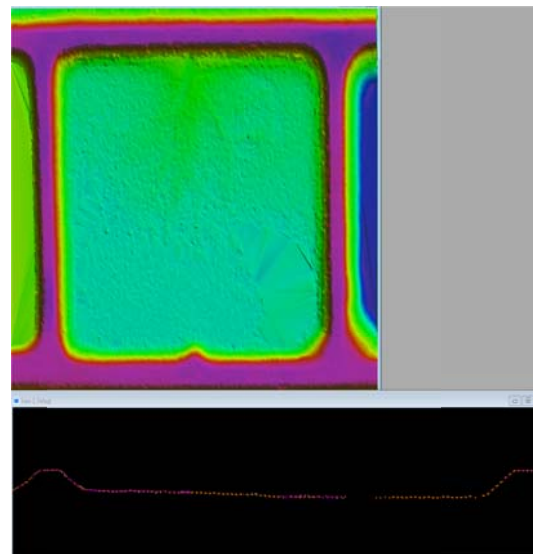
QC Call: Center Lake not hydro-flattened (FID 0 in *Errors* shape file)

QSI Response: The water body at time of LIDAR collection is less than 2 acres in size. The points to the immediate north of the water feature show elevation change to the magnitude of 1-2'. This feature **will not be collected** because it is inside of the collection specifications for hydrographic features.

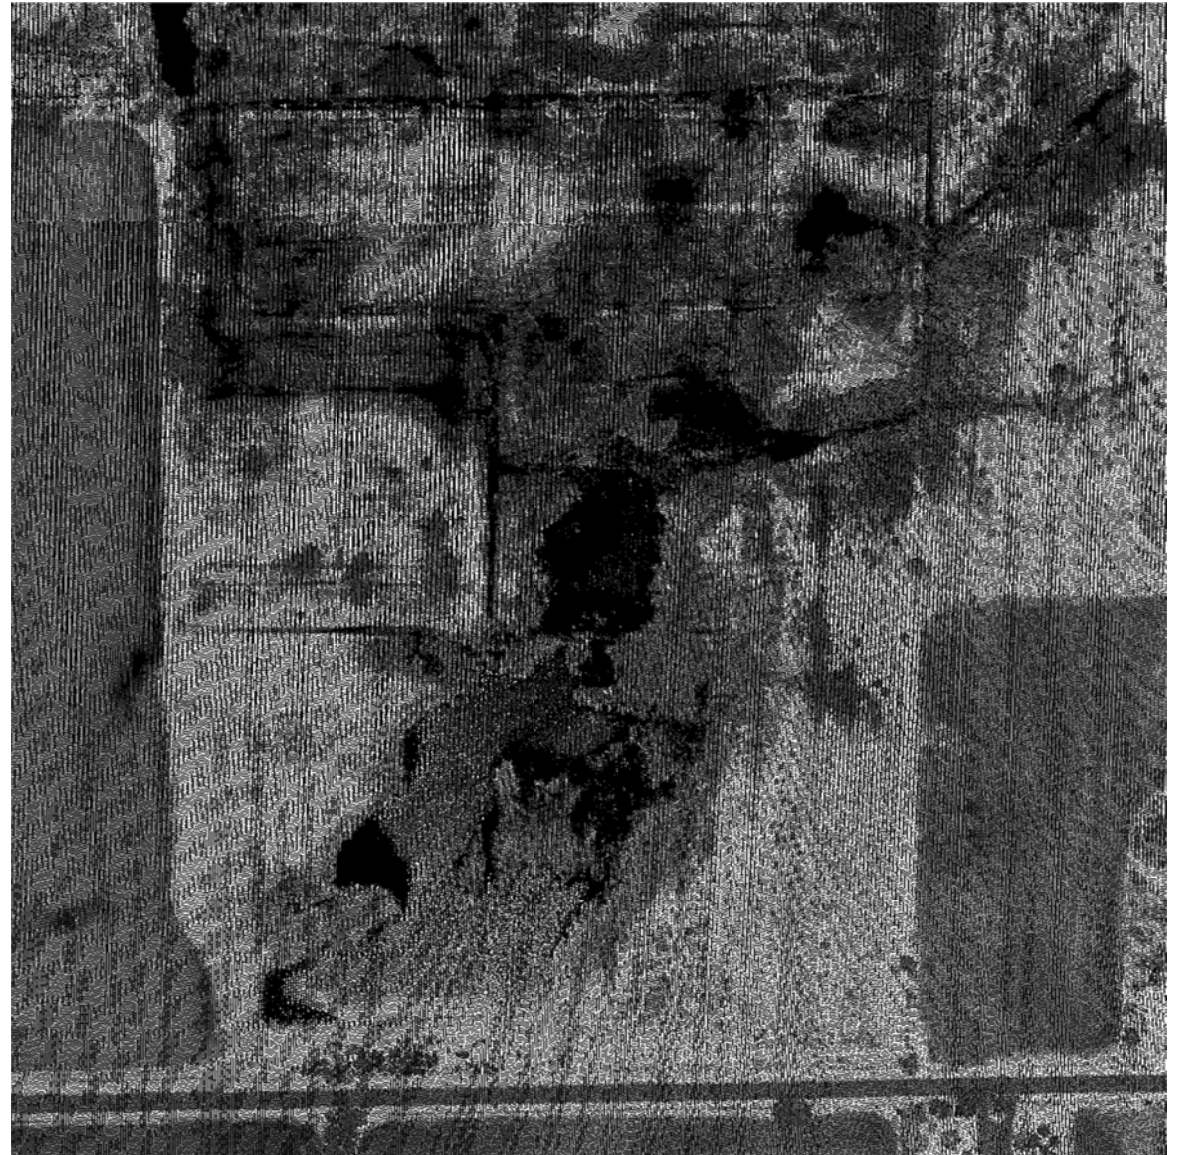
QC Call: Water body not hydro-flattened (FID 1 in *Errors* shape file)

QSI Response: As the intensity image suggests, LIDAR data voids delineate the presence of a water body that is at least 2 acres in size. **We will collect** a Lake_Pond breakline feature at a consistent elevation. The raster DEM and Contours will be regenerated to show the change to the final bare earth surface.

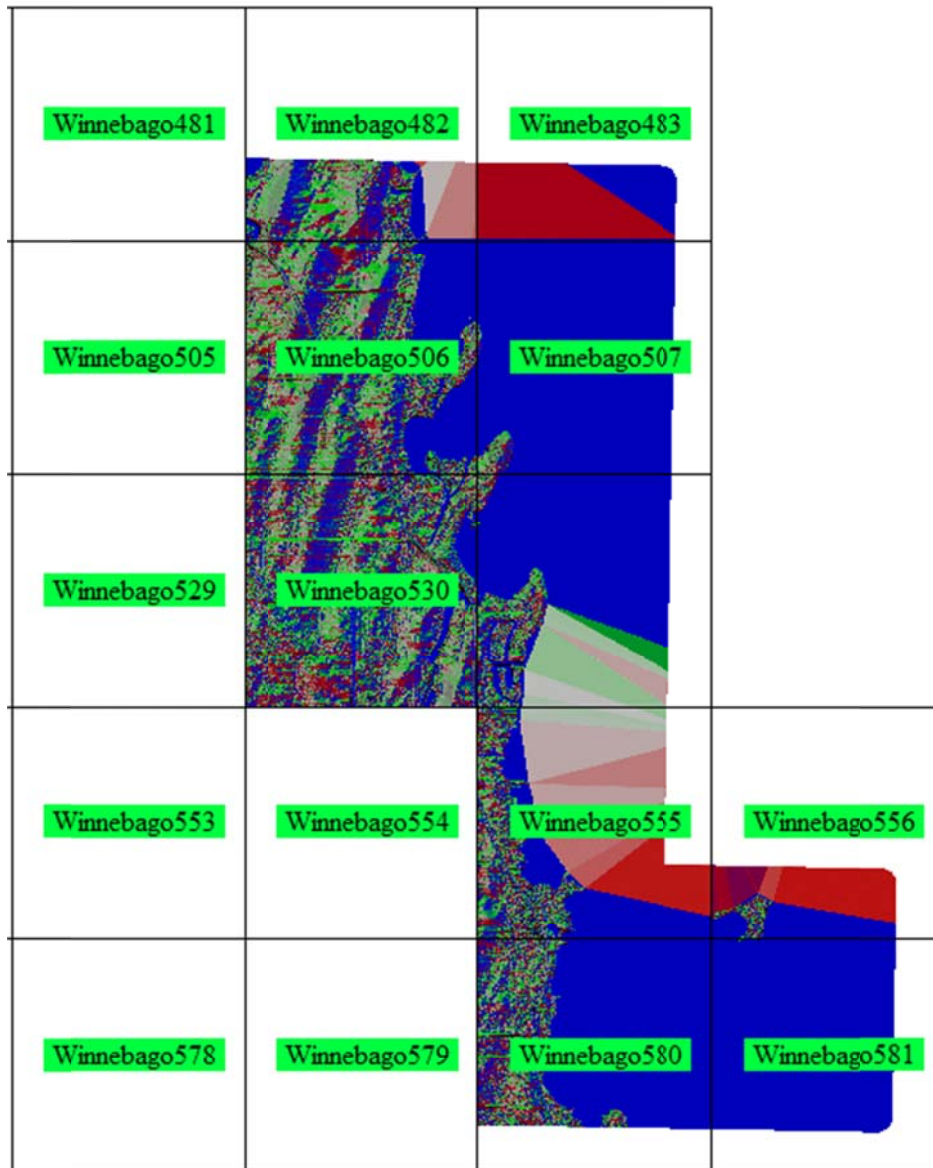
QC Call: Lake not hydro-flattened correctly (two features with two different elevations). (FID 4 in *Errors* shape file)

QC Call: DEM tiles 556 and 581 do not project with tiling scheme (different False Eastings and False Northings in the projection parameters).

OSI Response: **We will recreate** the ERDAS Imagine files for the following tiles, which will correct both issues. We are submitting a few more tiles for this call, to ensure that this area is flattened properly.
