# **Matanuska-Susitna Borough LiDAR & Imagery Project Quality Assurance Report Point Mackenzie Block**

**Written by Rick Guritz**

**Alaska Satellite Facility**

**April 15, 2012**

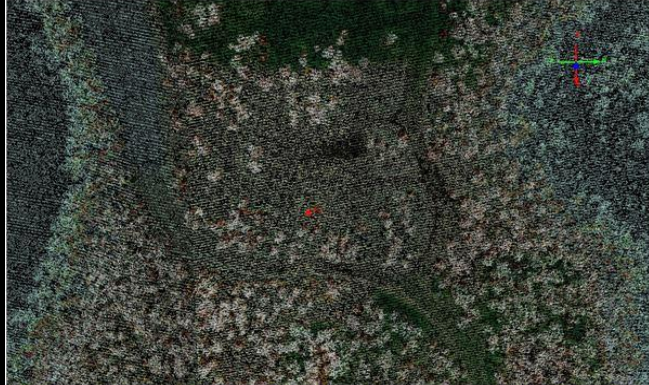
Good Alignment of point 5-875 with SE corner of outhouse roof.

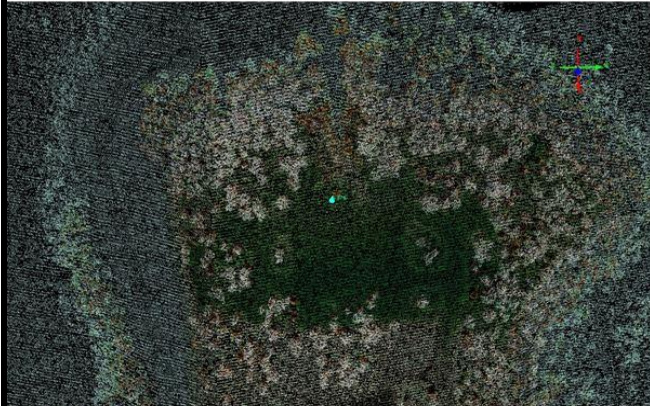
Good Alignment of point 5-876 with SE corner of outhouse roof.

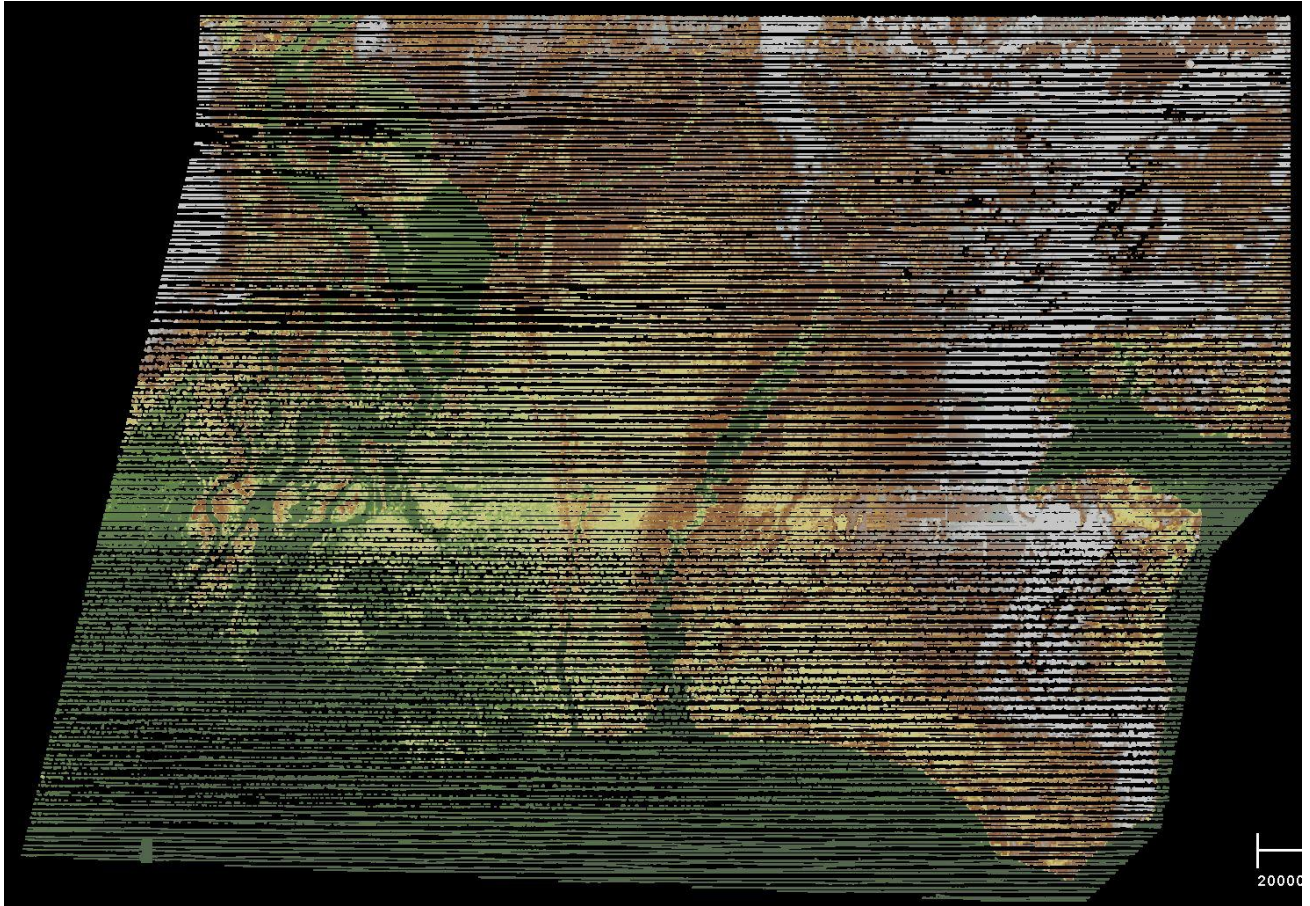
Figure 11, Class 1 – Unclassified.

**Class 1 Unclassified point counts too high** – On 12/30/2011, UAF reported point counts for unclassified (class 1) is larger than all other classes combined. The Matanuska-Susitna Borough GIS staff indicated that class 1 was in violation of the requirement to classify all LiDAR data according to the contract. In further discussion with Aerometric, it was learned that class 1 contained ends of swath data that was marked as withheld and surface clutter data that ranged from 1 to -1 feet of the surface. A compromise was reached asking Aerometric to create a new class 13 to contain the surface clutter data, and keeping the swath ends in the unclassified (class 1). This change made it easier to access either data given the separation into two different classes. It also made point density validation easier, allowing exclusion of class 1 and 7 from the point density counts.

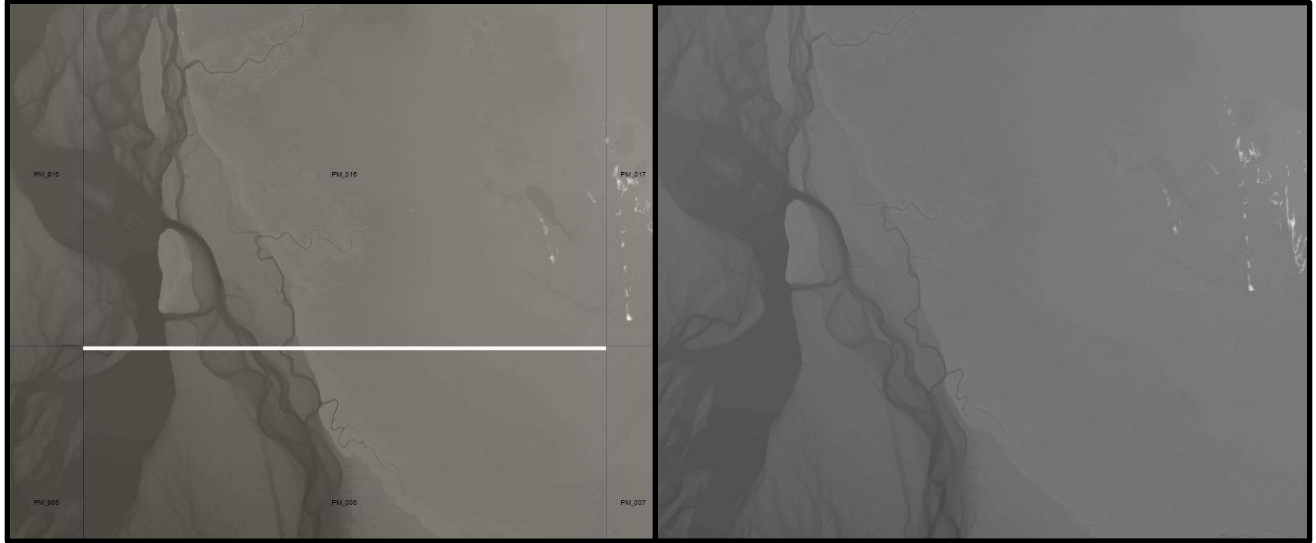
**Detected Seam in bare-Earth DEM** – On 11/09/2011, an observed seam was reported when trying to mosaic bare-Earth DEM tiles. This seam was several pixels wide running west to East between two sets of tiles (see Figure 45).

Figure 45, Seam in Bare-Earth DEM (Left) Corrected (Right).

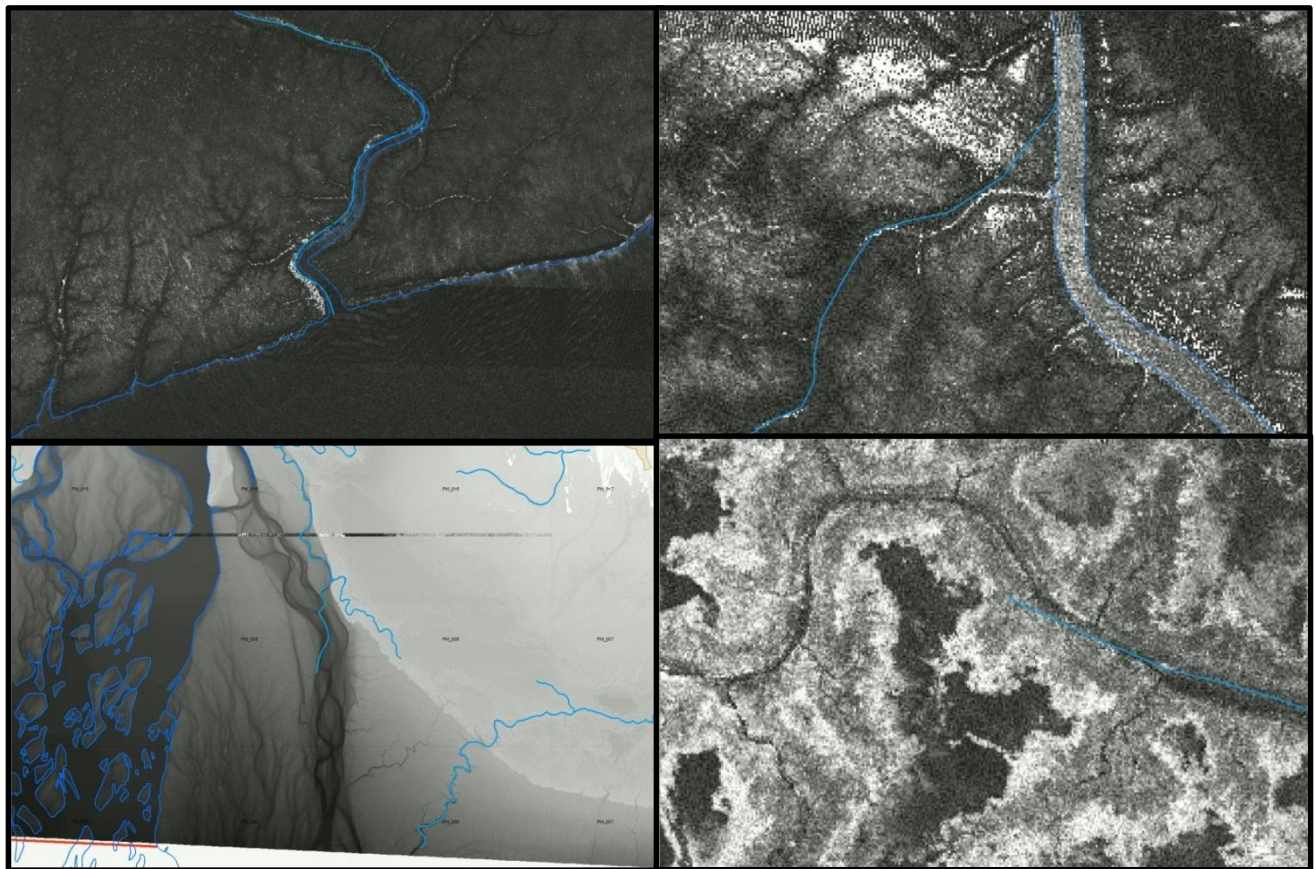
Figure 46, Single Hydro Breakline Inaccuracies.

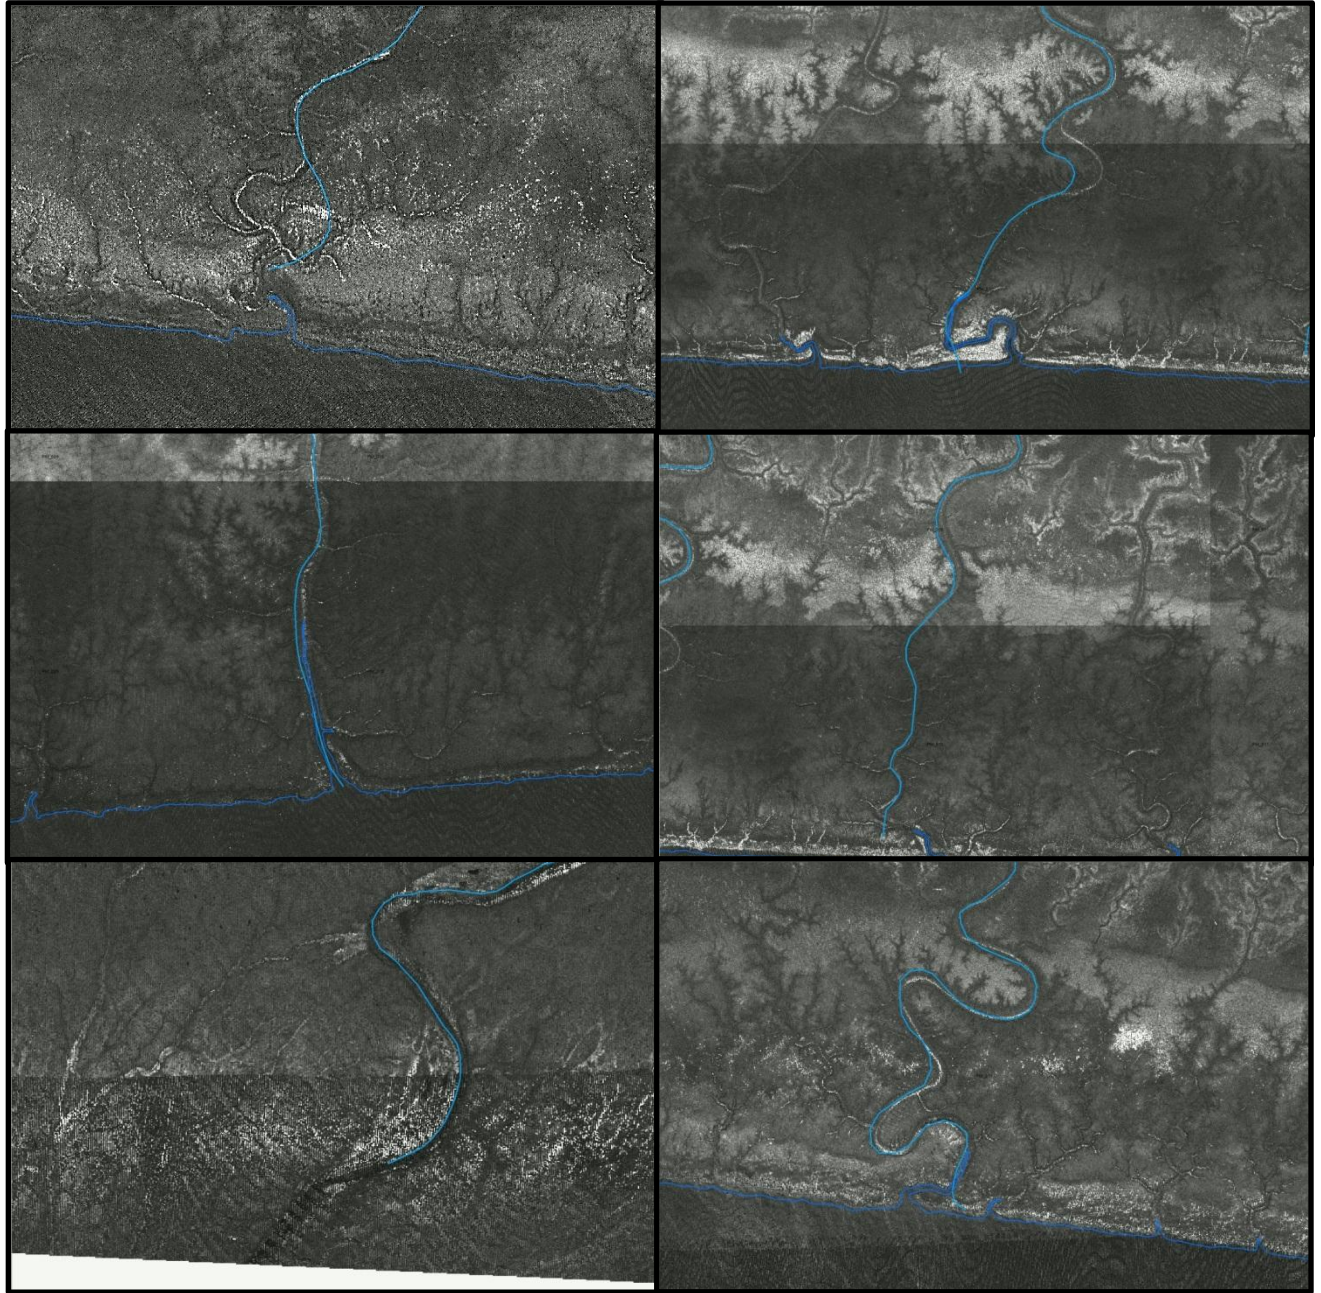
Figure 47, Single Hydro Breakline Inaccuracies.

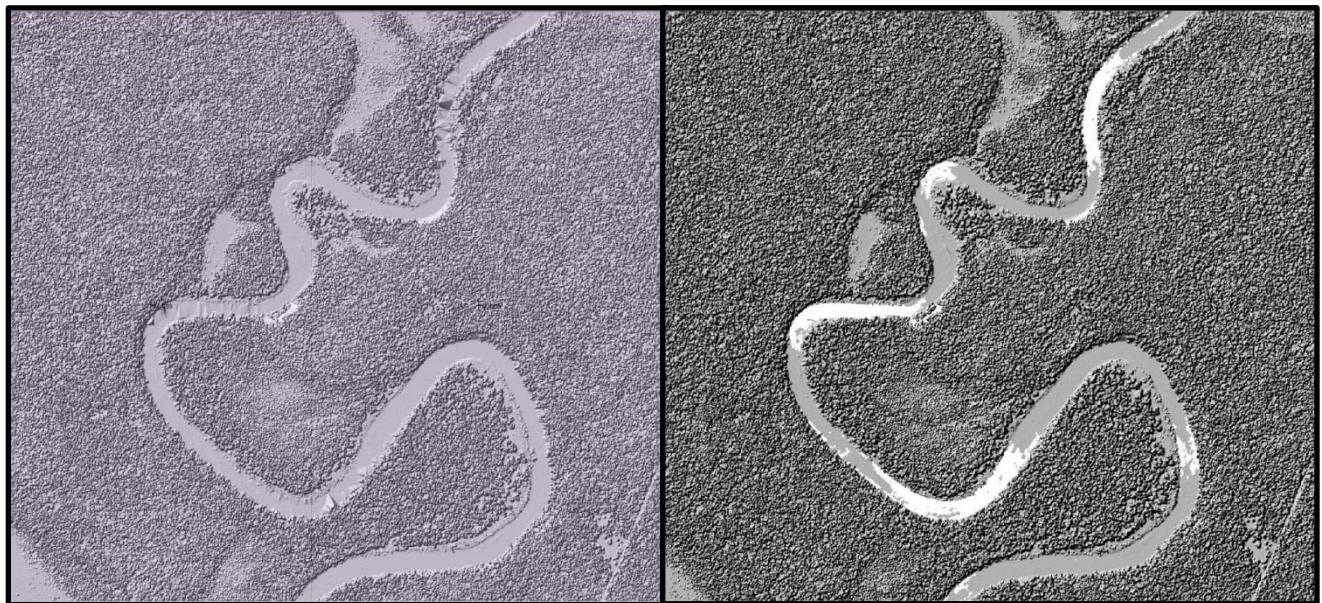
**Anomalies in First Return DSM** – On 11/11/2011, interpolation errors were observed in portions of the Little Susitna River (See Figure 49). In a true first return product, the LiDAR data should be evaluated on a cell by cell basis using the delivery grid as the basis for evaluation. All valid LiDAR returns (excluding points marked as withheld, class 1 and 7) should be evaluated for the highest return for that cell. For cells over water, there may not be a valid return for that cell, in which case the cell should be set to NoData. In discussion with Aerometric, they were using interpolation to fill holes over water which is undesirable. They were also using a gridding process that did not provide a true first return gridded product. After discussion, Aerometric was asked to change their processing methods to something that would provide a true first return product. This change was considered essential for a true canopy height product to be generated and for cross validation between gridded data and LiDAR point cloud data.

Figure 49, Interpolation Artifacts in First-Return DSM (Left), Corrected (Right).

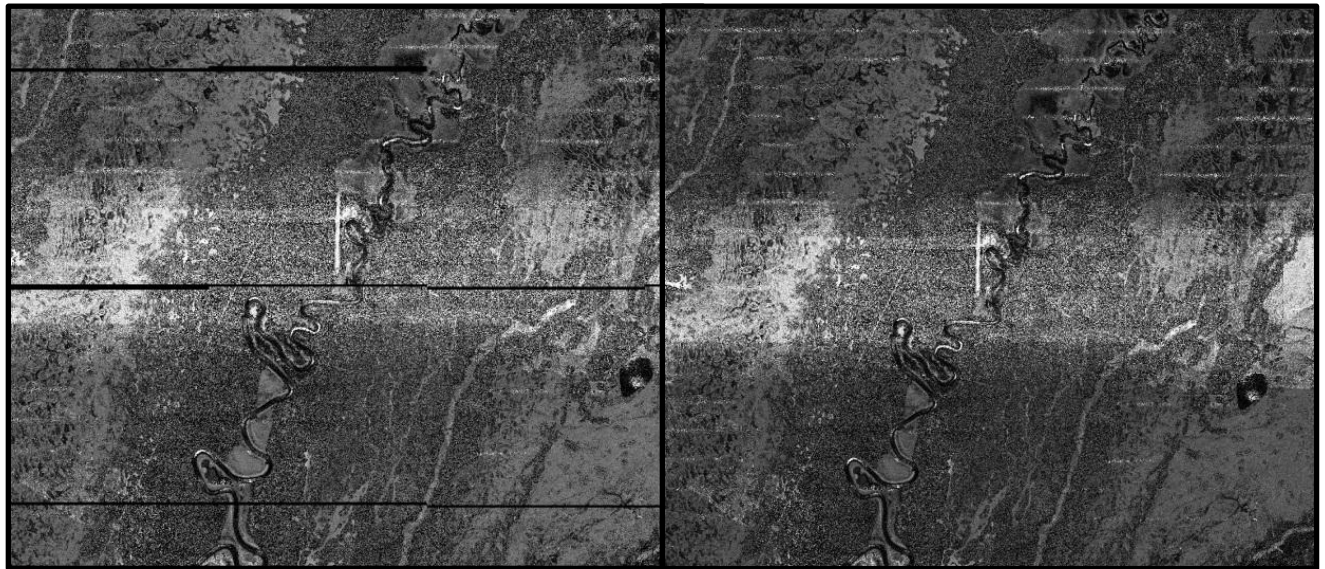
**Detected Seams in LiDAR Intensity data** – On 11/11/2011, observed seams were reported when trying to mosaic LiDAR Intensity data (see Figure 50). The seams were very obvious running from West to East and up to several pixels wide in places. After further investigation by Aerometric, they decided to use raster catalogs within the block geodatabase for all raster grids for future deliveries. This change eliminated the presence of seams in the data. It also was a much improved method for delivering raster data than what was initially used.

Figure 50, Seams in LiDAR intensity mosaic (Left), corrected (Right).

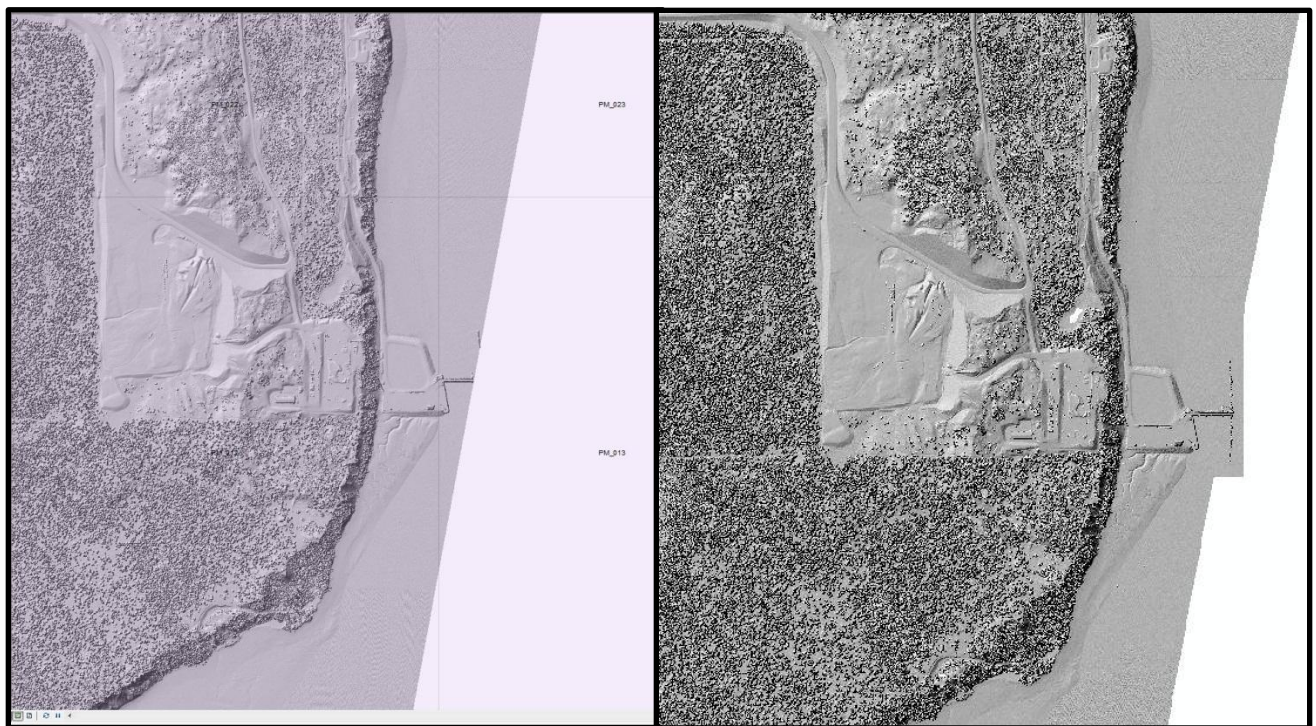
**Clipping of Point Mackenzie Dock** – On 11/11/2011, during visual assessment of the shaded relief product clipping of the Point Mackenzie dock was identified and reported (see Figure 51). An exception to the original block boundary was made to include the dock structure in both LiDAR intensity and first return DSM. This is an important structure that should be included in the resulting data. It should be noted that the original coverage requested by Matanuska-Susitna Borough GIS staff was the source of the error. Fortunately, the LiDAR coverage could be adjusted to cover the entire dock and breakwater.

Figure 51, Coverage Gap (Port) in First Return (Left), Extended (Right).

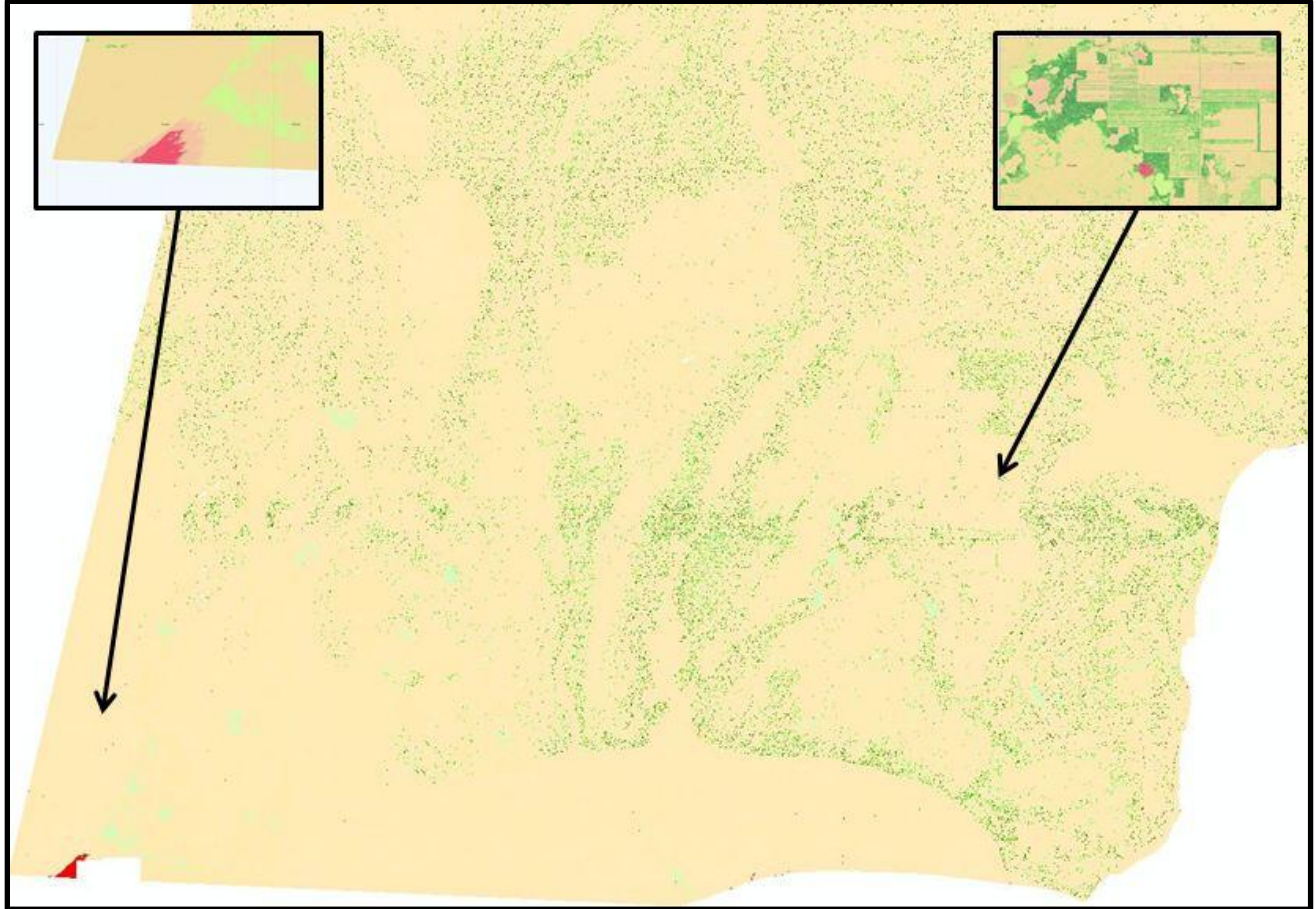
**Negative values in canopy height difference** – On 11/22/2011, negative values greater than -1 foot was observed in two locations of the Point Mackenzie block (see Figure 52). One was in the Susitna River delta, which was attributed to tidal fluctuations. The other was an area near some agricultural fields. One of these errors was eliminated when the rigorous first return DSM product was generated (See Figure 53). For our evaluation, we expect noise levels to be on the order of plus or minus one foot. Any negative values greater than one foot are not real and should be eliminated in the data.

Figure 52, Canopy Height – FR minus BE, Regions of negative values over -1.

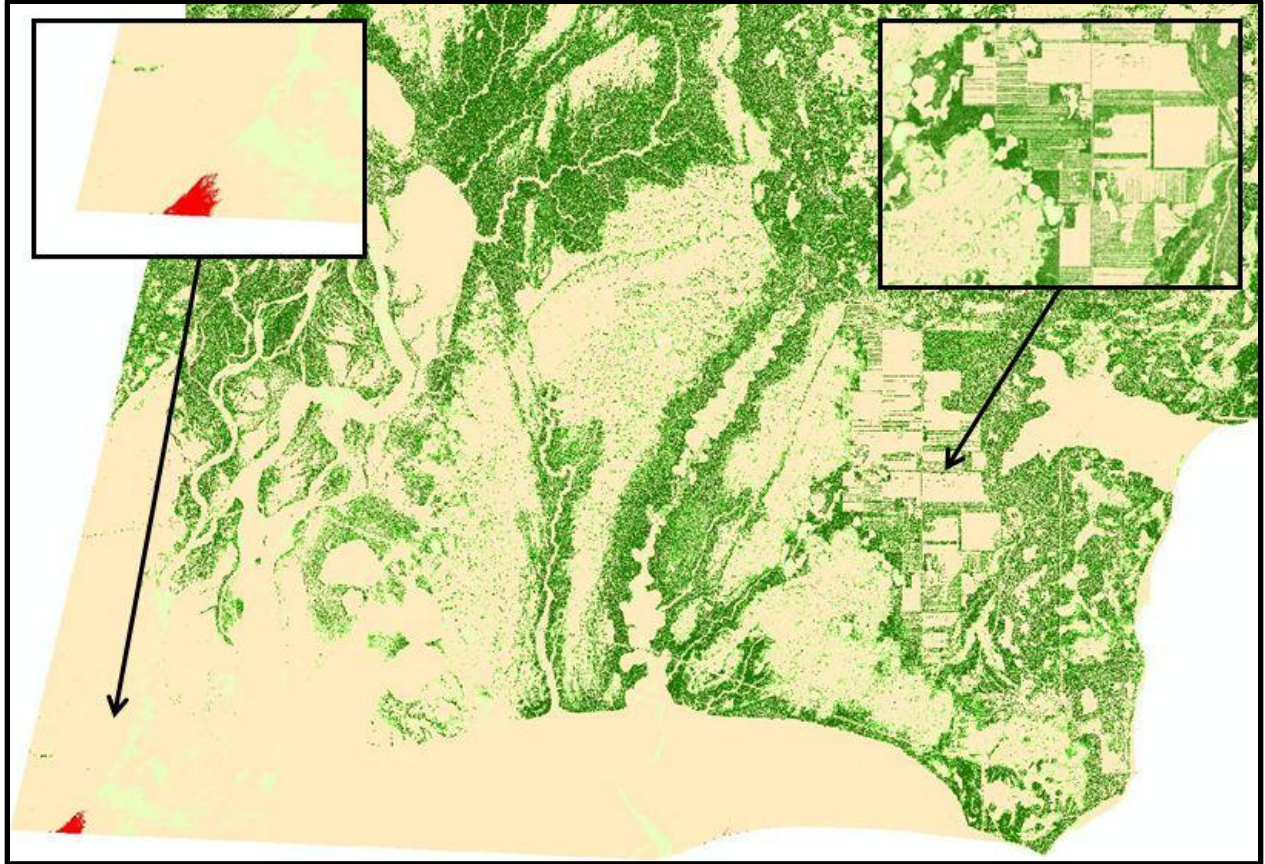
Figure 53, Corrected Canopy Height, Regions of negative values over -1.

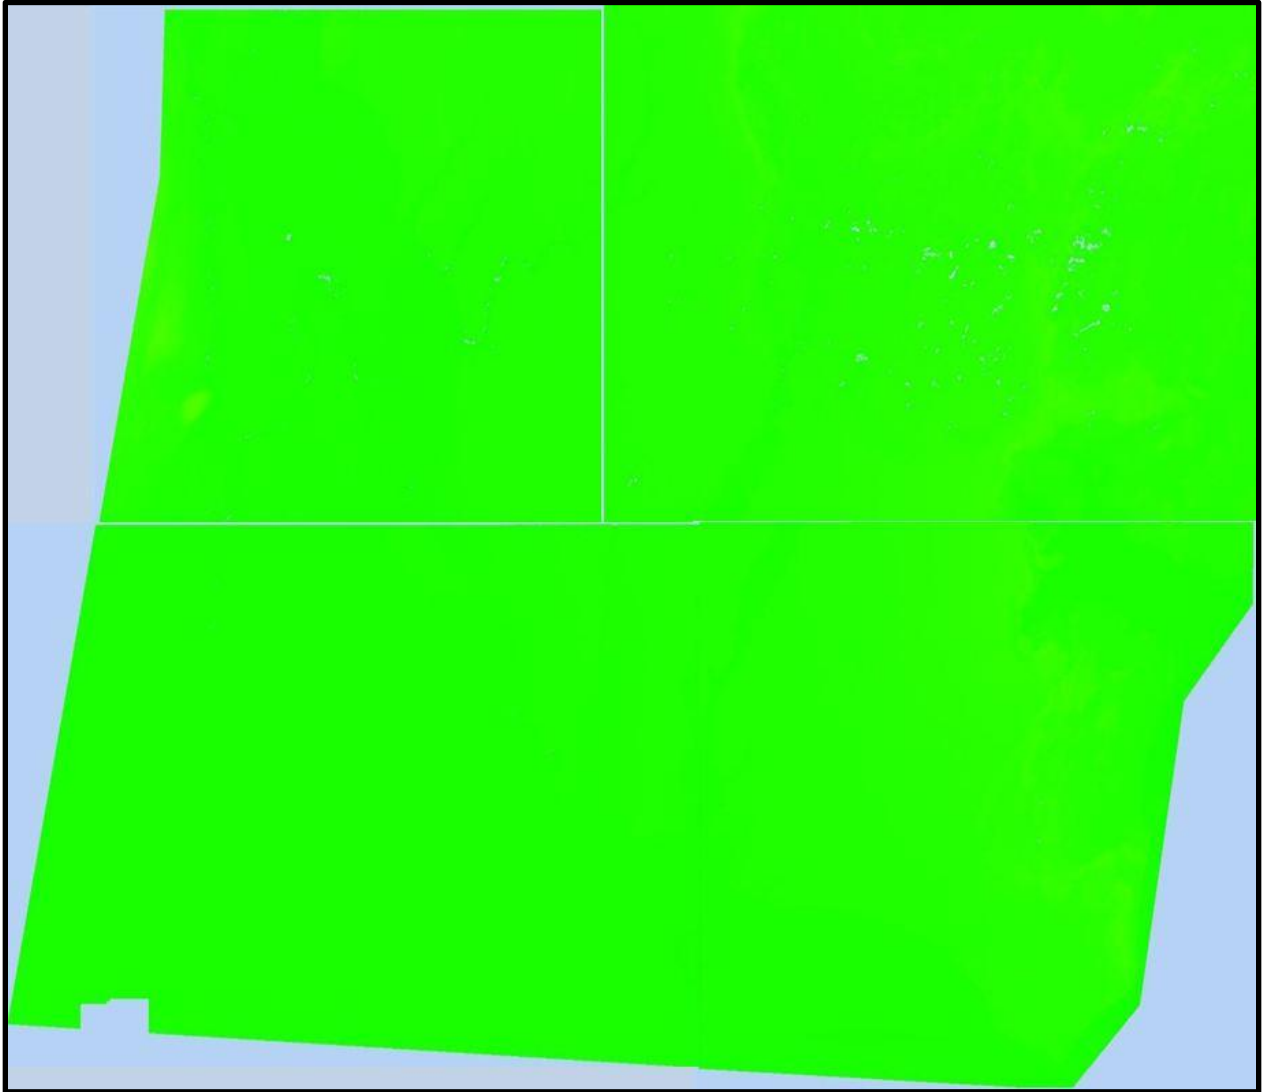
Figure 54, Initial low vegetation class not as useful at 0-6 feet because it includes ground noise.

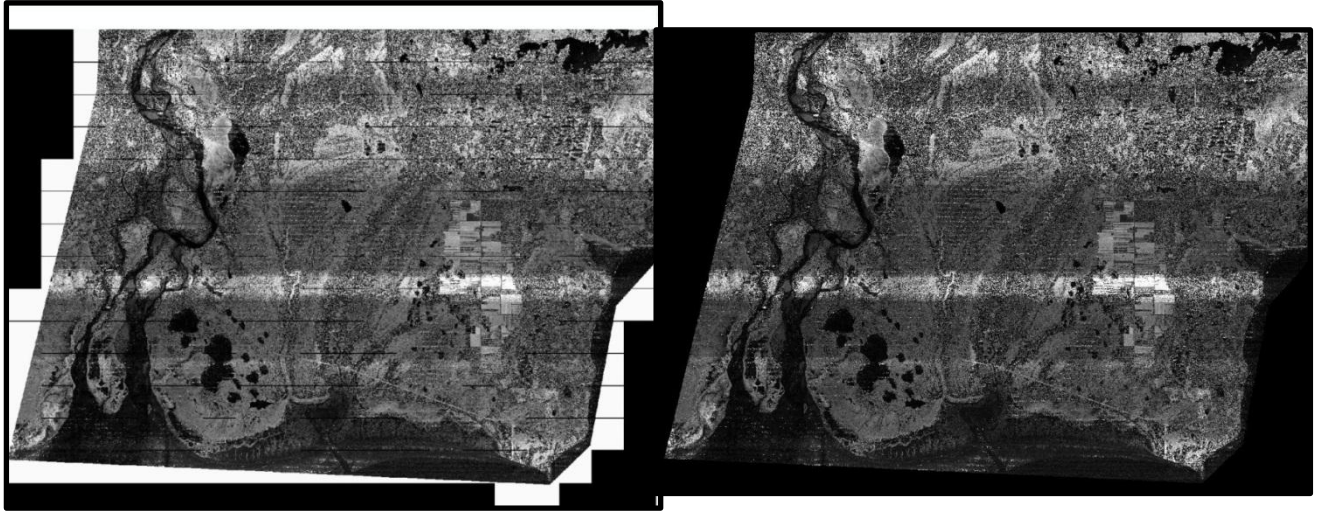
Figure 55, Fill values around good data inconsistent (Left), corrected (Right).

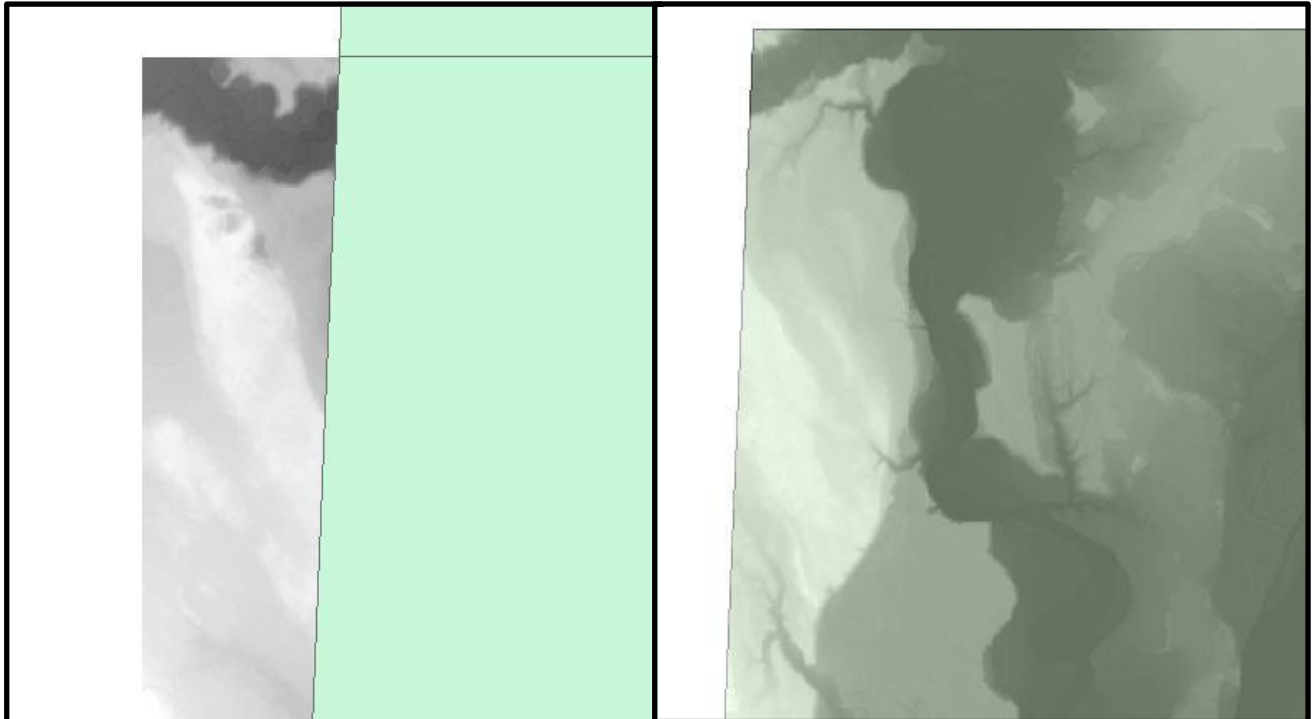
Figure 56, Bare-Earth DEM needs trimming (Left), corrected (Right).

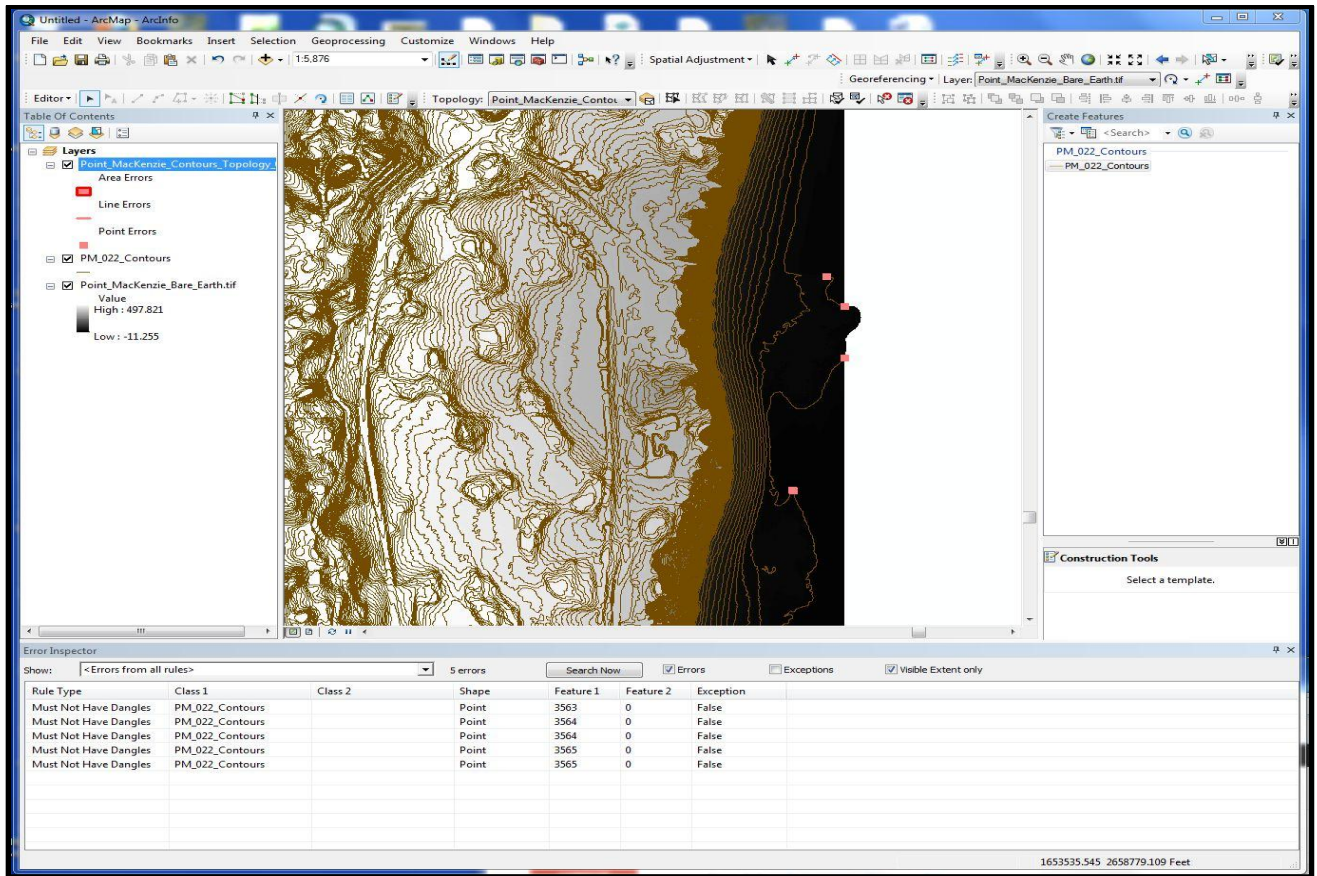
Figure 57, Topology Errors in Contours (PM022).

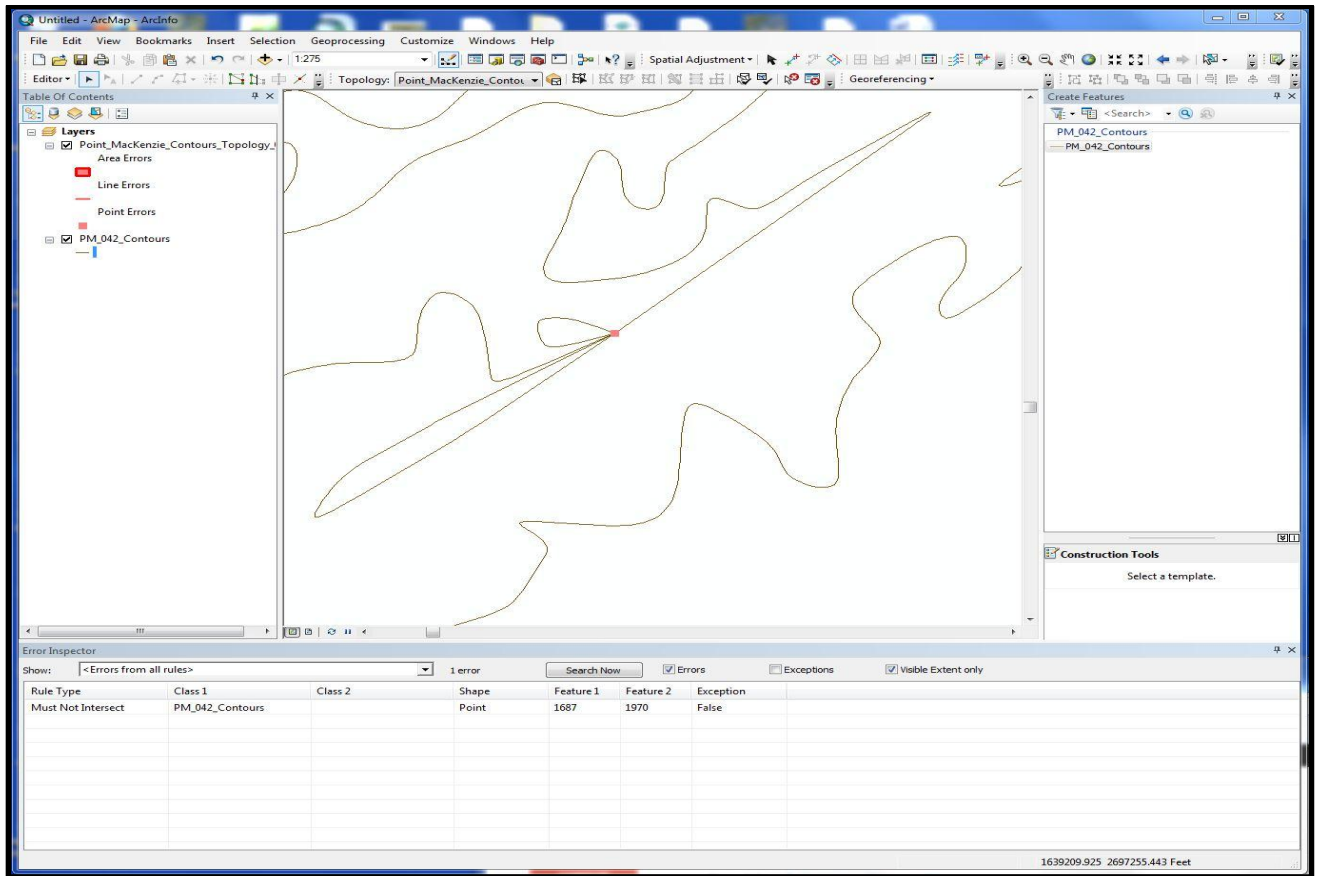
Figure 58, Topology Errors in Contours (PM042).

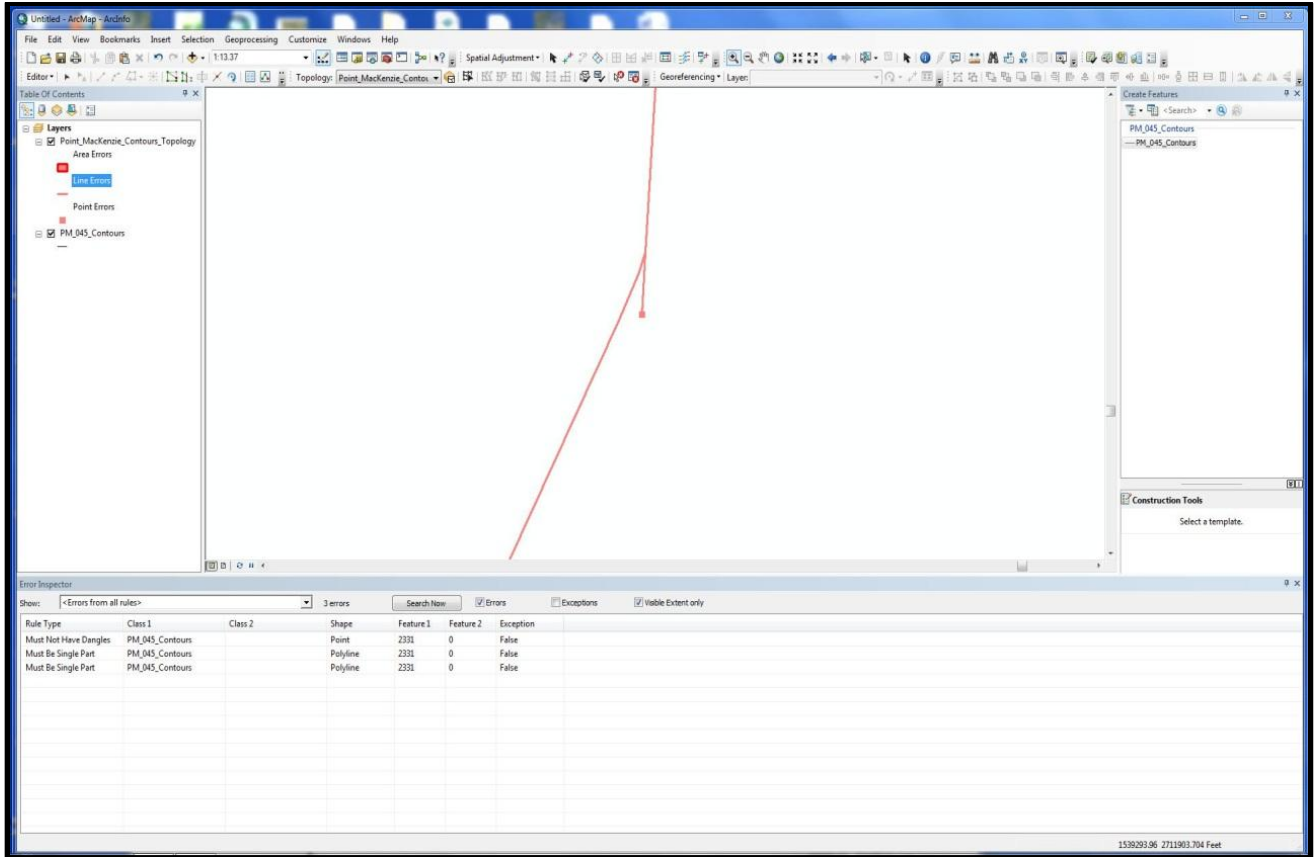
Figure 59, Topology Errors in Contours (PM045).

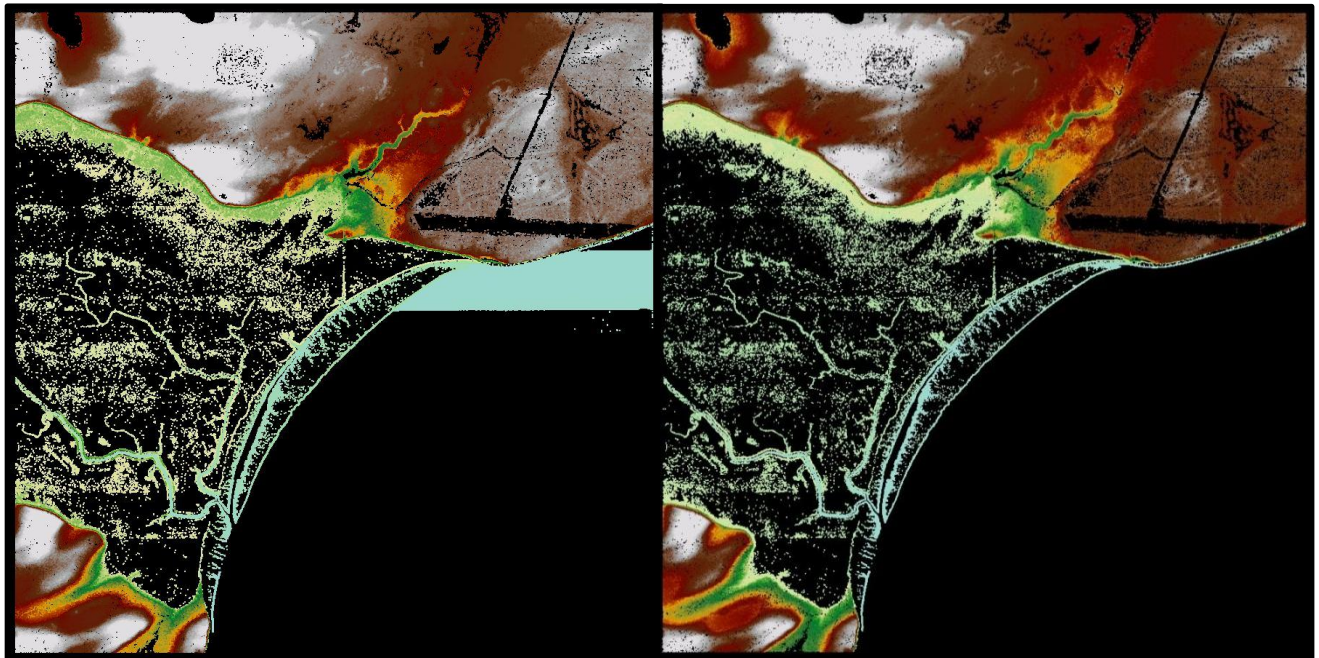
**Low Vegetation errors** – On 03/28/2012, UAF reported additional low vegetation errors that should be fixed (See Figure 60- 62). These include: the northern extent of cook inlet still has low vegetation over water (PM043), a block section of the Susitna River water classified as low vegetation (PM046NE and PM047NW), and a section of Big Lake that is classified as low vegetation (PM070).

Figure 60, Low vegetation (PM043) Left, corrected Right.

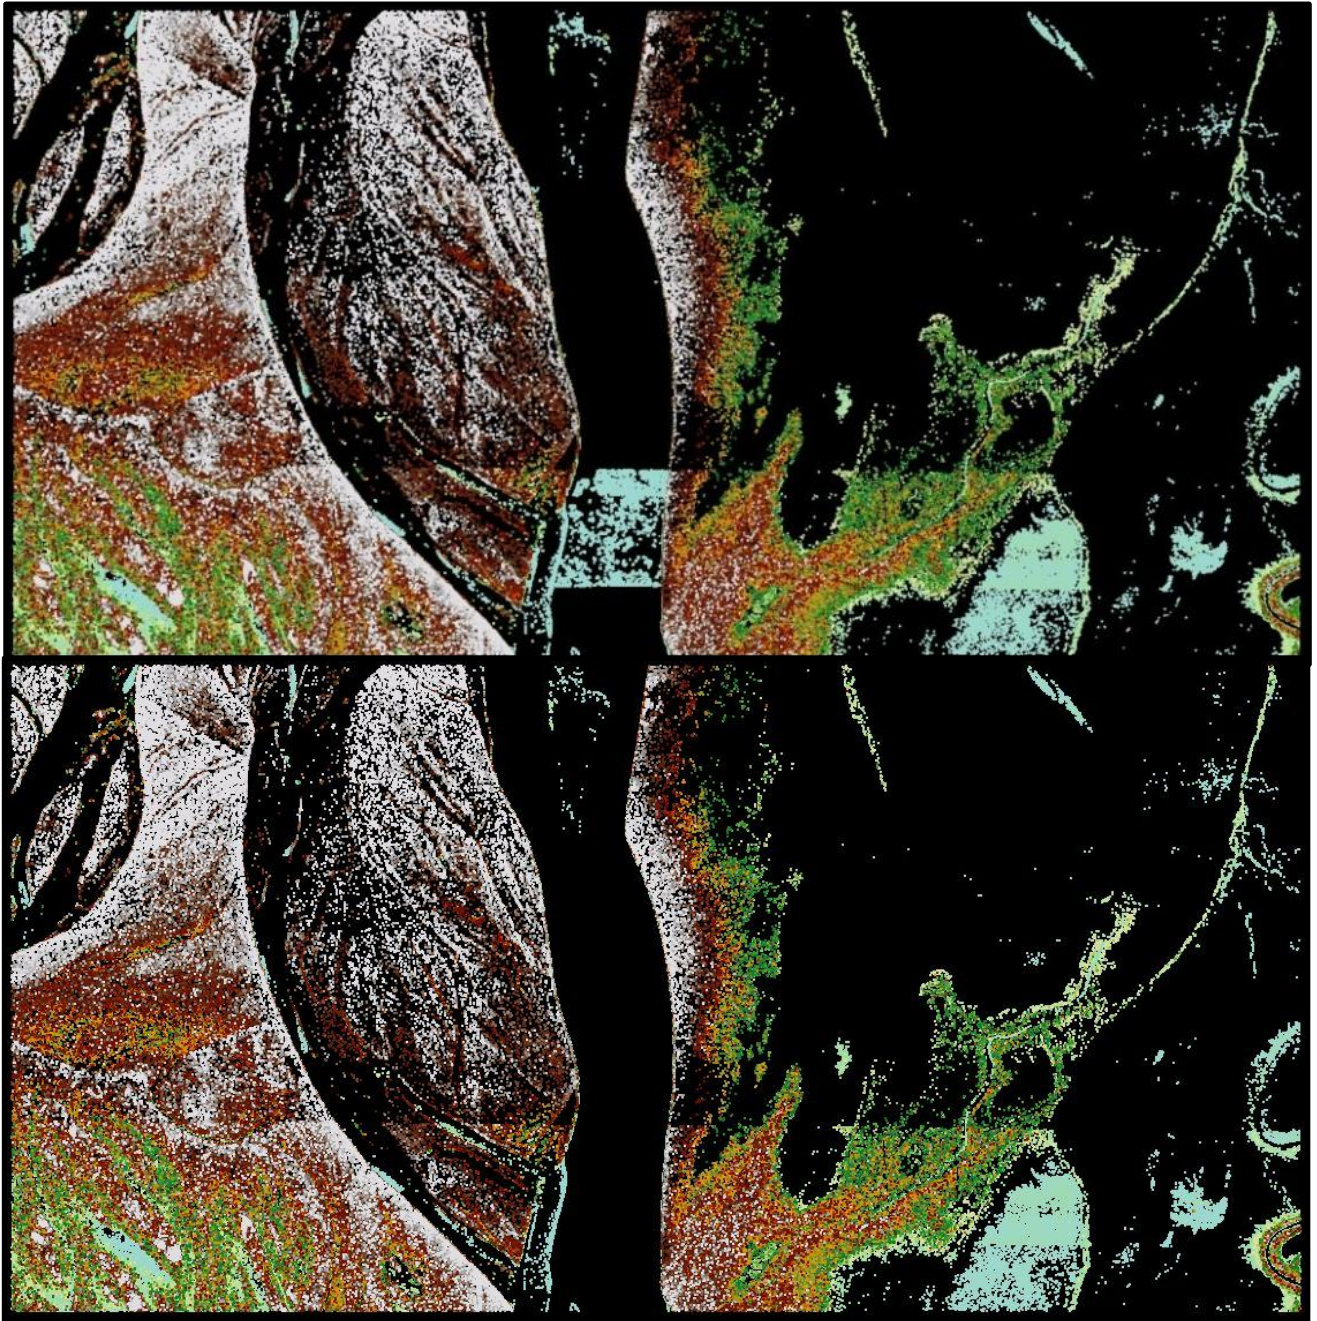
Figure 61, Low Vegetation (PM046-47) Top, corrected Bottom.

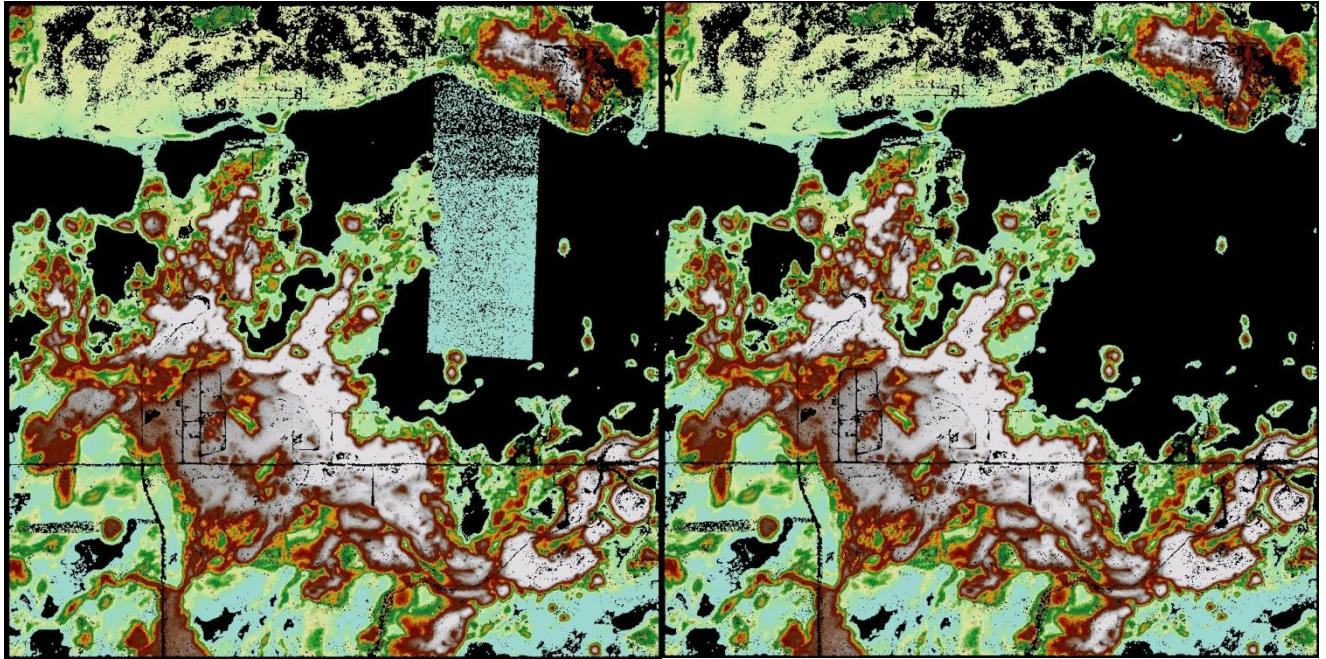
Figure 62, Low Vegetation (PM070) Left, corrected Right.
