**Dewberry's Response to USGS' Review**

**PAgis V13 LiDAR Processing Project**

**G10PC00013**

**Report Date: April 17, 2012**

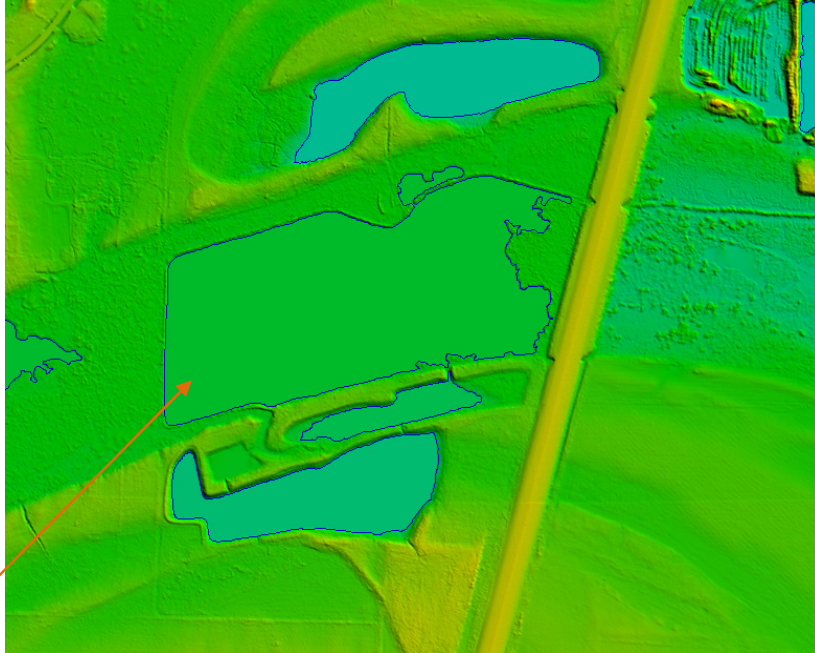
*Figure 2: Tile 15WU2617, Delivery 1. Portions of the identified feature was originally interpreted as a hydro and removed from the ground surface. The LAS and DEM has been corrected by adding portions of this feature back to the ground surface, shown below.*

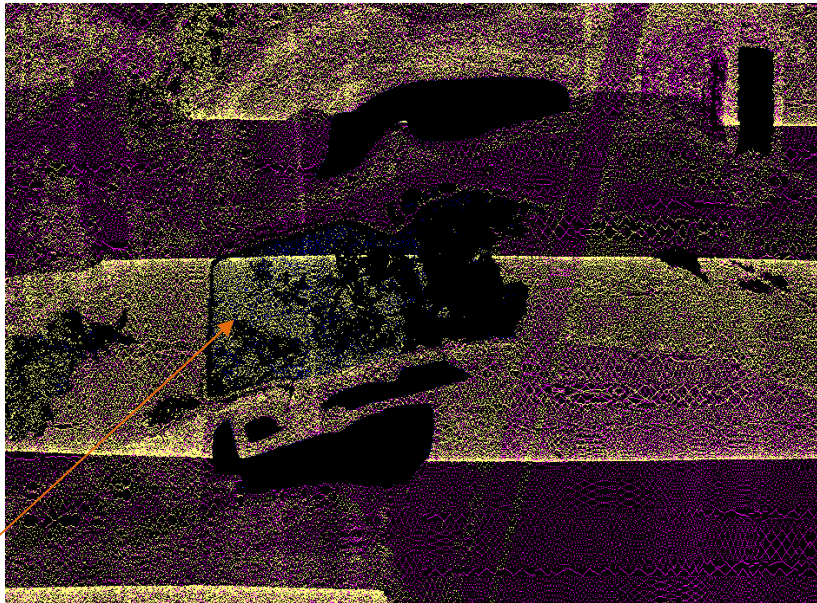
*Figure 3: Tile 15WU2617. The LiDAR points shown above confirm that the breaklines delivered to USGS should be modified to include additional ground data. The black area is where no points were returned due to the presence of water but the yellow points just west of the feature show several points were returned indicating the presence of ground.*

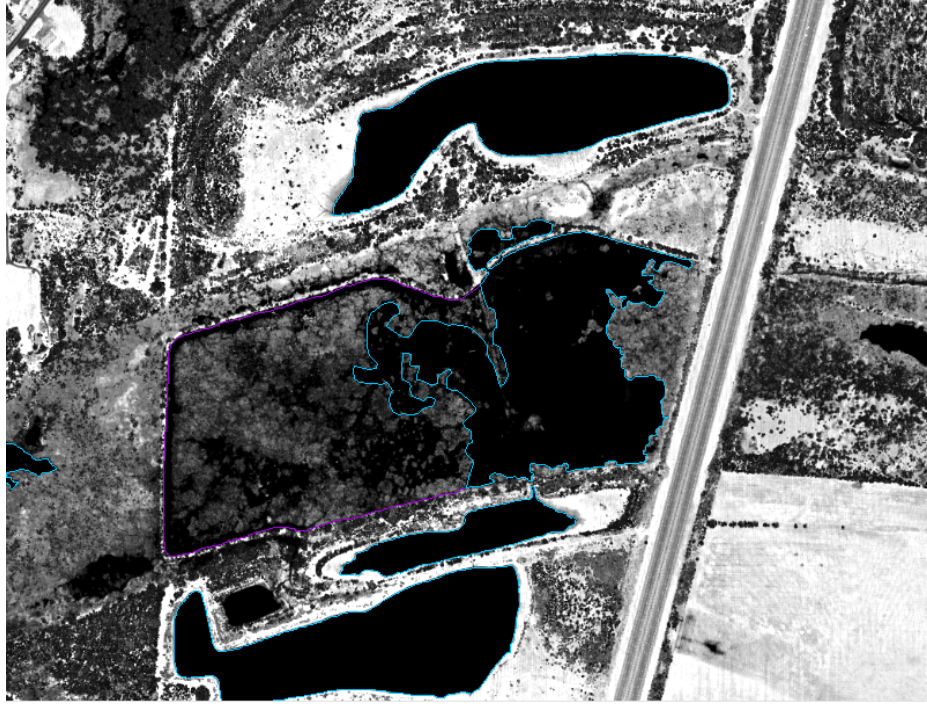
Figure 4: Tile 15WU2617. The intensity image showing the collected breaklines from the first delivery in purple and the modified breaklines from this delivery in blue.

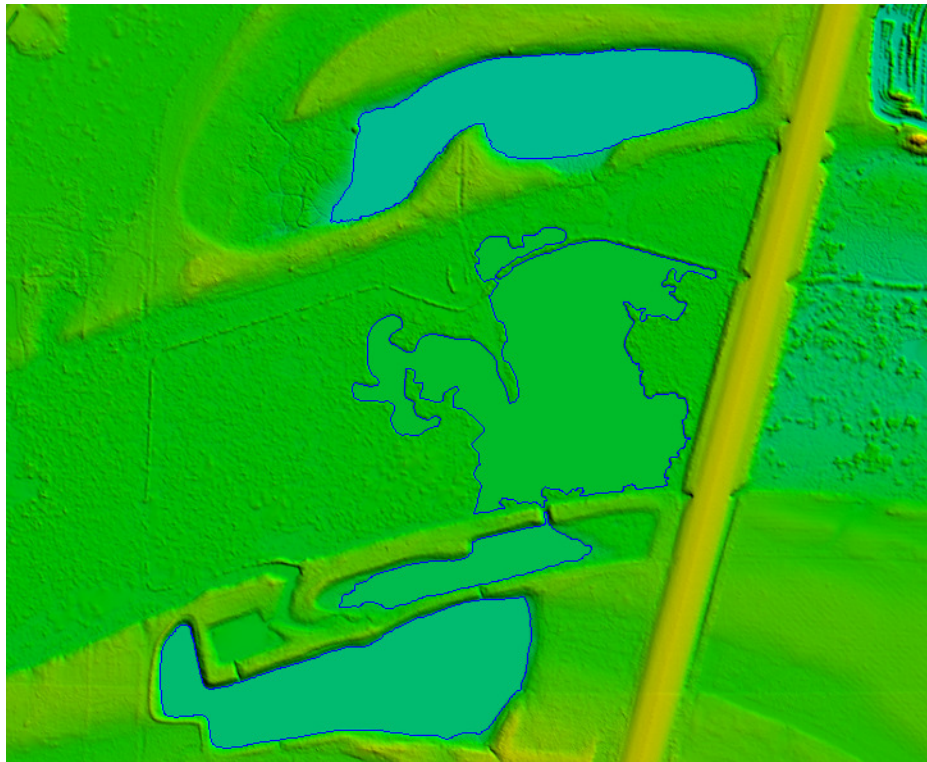
Figure 5: Tile 15WU2617, Delivery 2. Portions of the identified feature was originally interpreted as a hydro and removed from the ground surface. The LAS and DEM has been corrected by adding portions of this feature back to the ground surface.

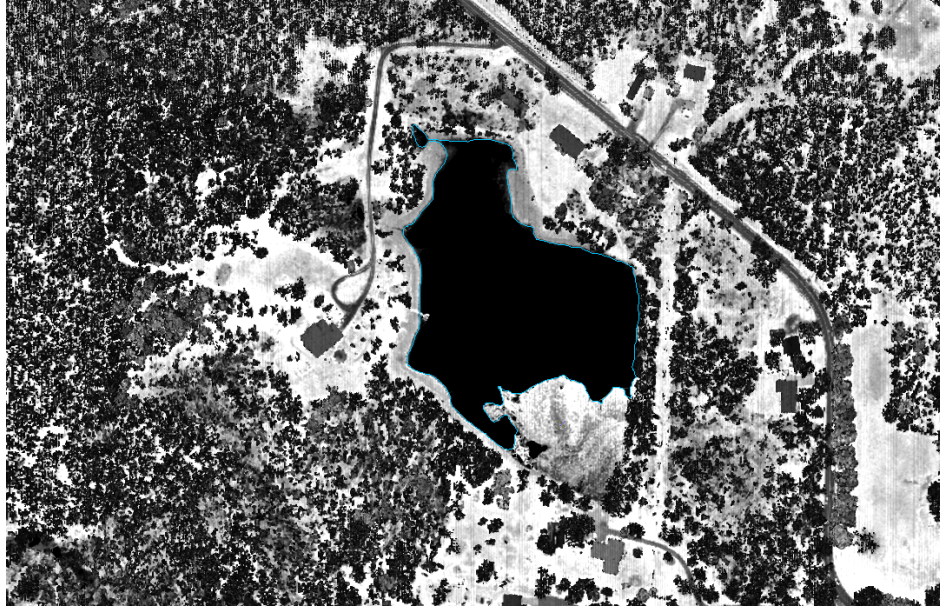
*Figure 6: Tile 15WU2419. As the intensity imagery shows, the breaklines delivered to USGS correctly capture existing waterbodies.*

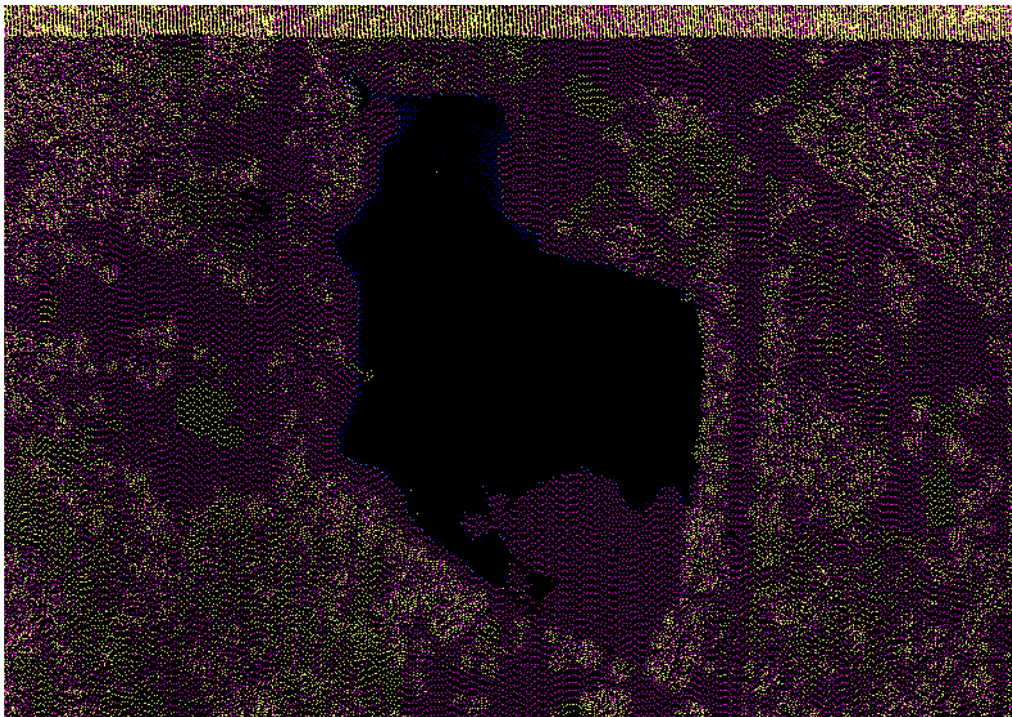
*Figure 7: Tile 15WU2419. The LiDAR points shown above confirm that the breaklines delivered to USGS correctly capture the waterbody. The black area is where no points were returned due to the presence of water but the pink points just south of the feature show several points were returned indicating the presence of ground.*

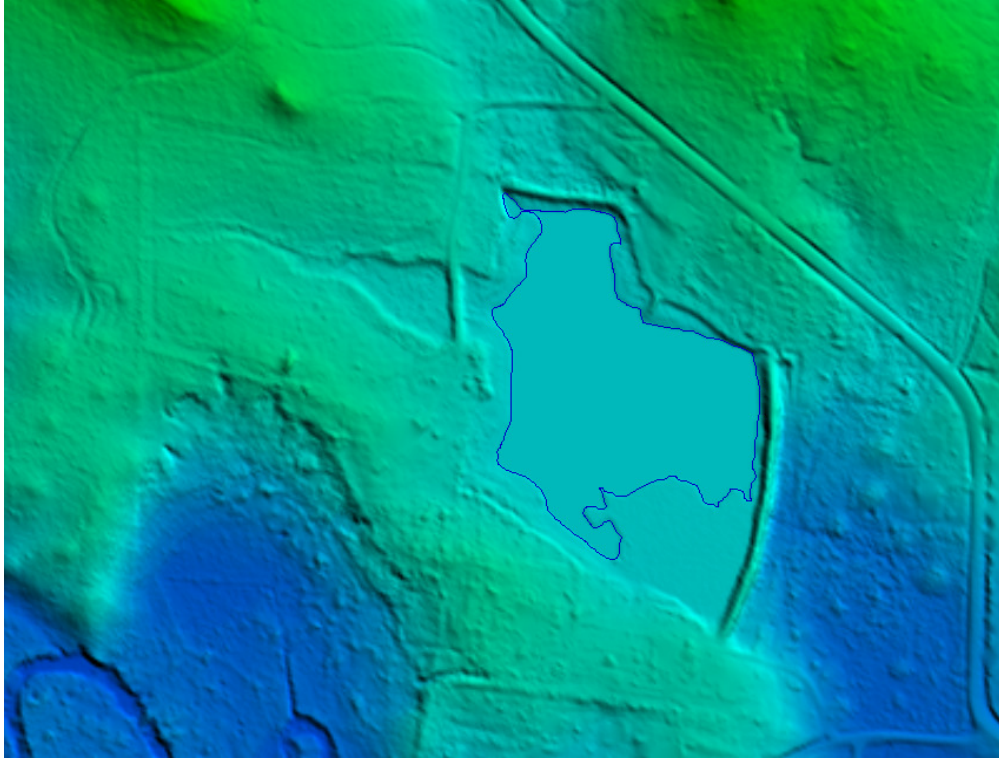
*Figure 8: Tile 15WU2419. The breaklines delivered to USGS correctly capture existing waterbodies. No change was made to the breaklines or DEM surface.*

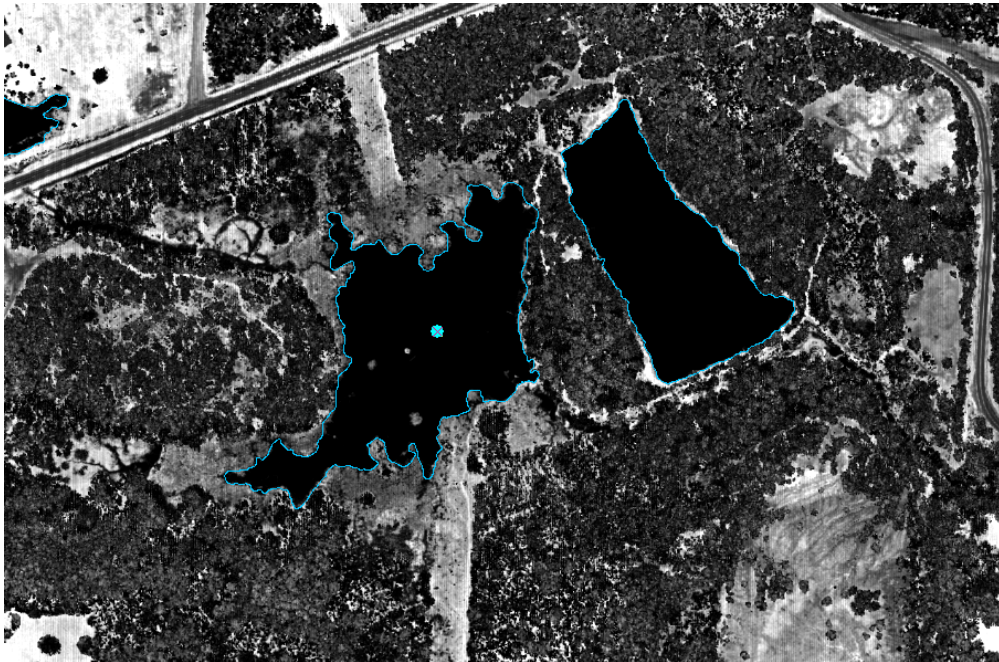
*Figure 9: As the intensity imagery shows, the breaklines delivered to USGS correctly capture existing waterbodies. No change was made to the breaklines or DEM surface.*

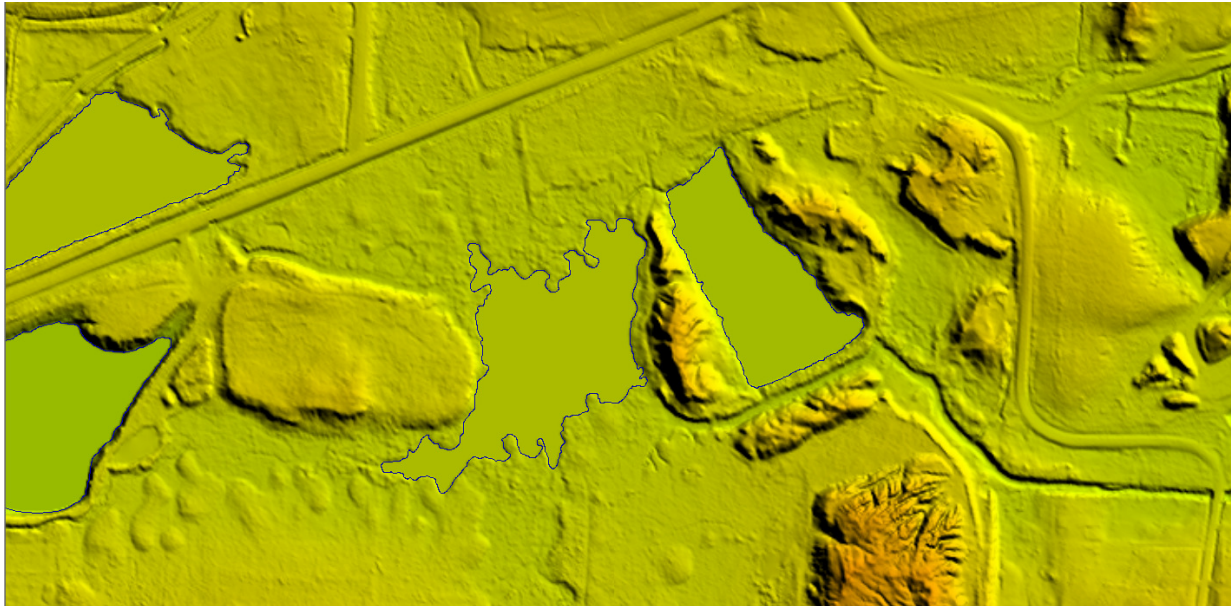
*Figure 10- Tile 15WU221 and 15WU2311. The DEM shows a visual artifact because the surface model is interpolating from the slope leading to the bridge to the hydrographic banks. The surface model must make a continuous model and in order to do so, points are connected through interpolation. This can cause visual artifacts when there are features with large elevation differences.*

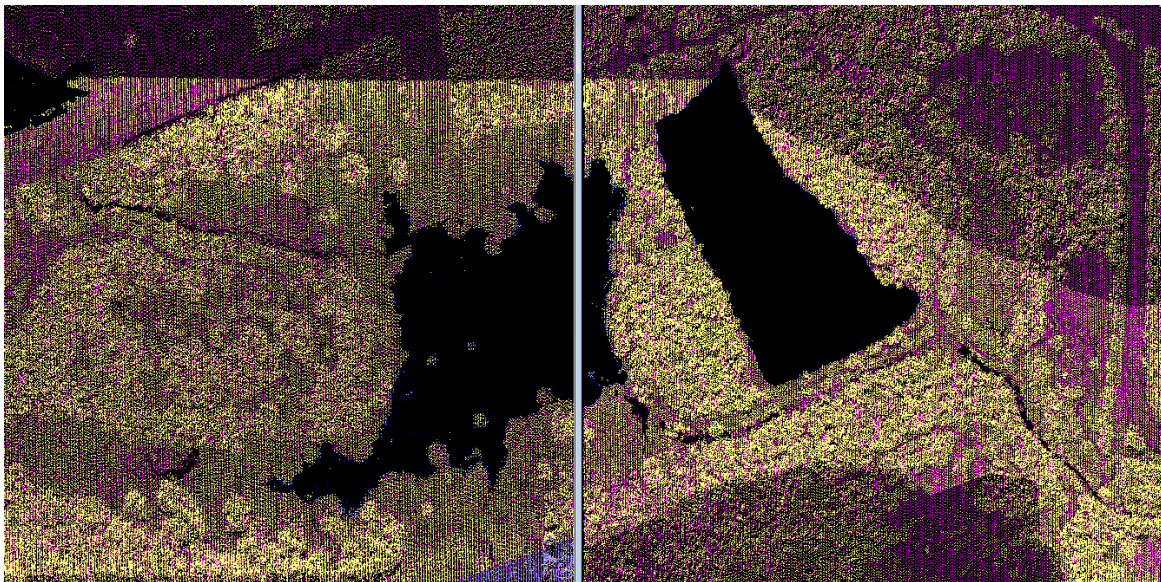
*Figure 11- Tile 15WU221 and 15WU2311. The profile view shows the LiDAR points, colored by class, of this particular feature. All bridge points have been removed from ground (pink) and are unclassified (yellow). There are no ground points that can be modified to correct this visual artifact.*

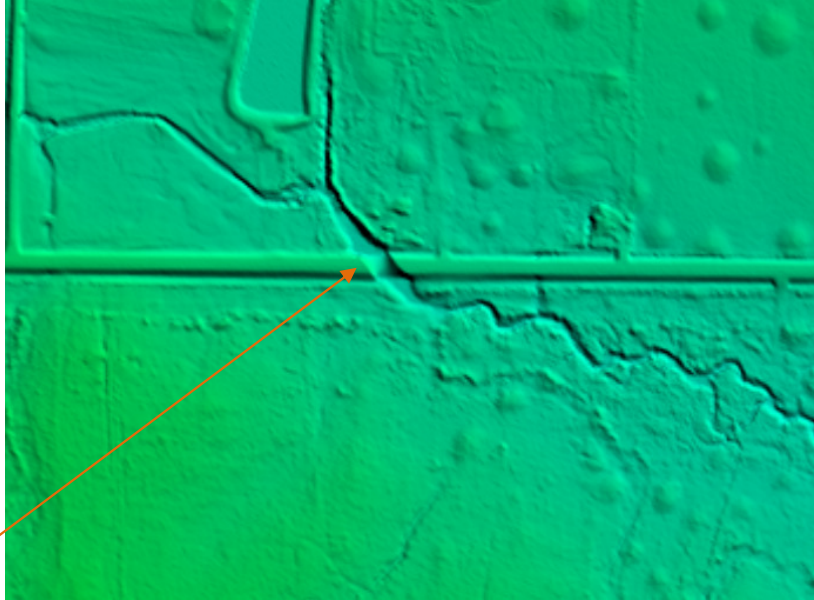
Figure 12- Tile 15WU2322, Delivery 1. The feature identified was originally interpreted as a bridge and removed from the ground surface. USGS identified this feature as a culvert. The LAS and DEM has been corrected by adding this feature back to the ground surface, shown below.

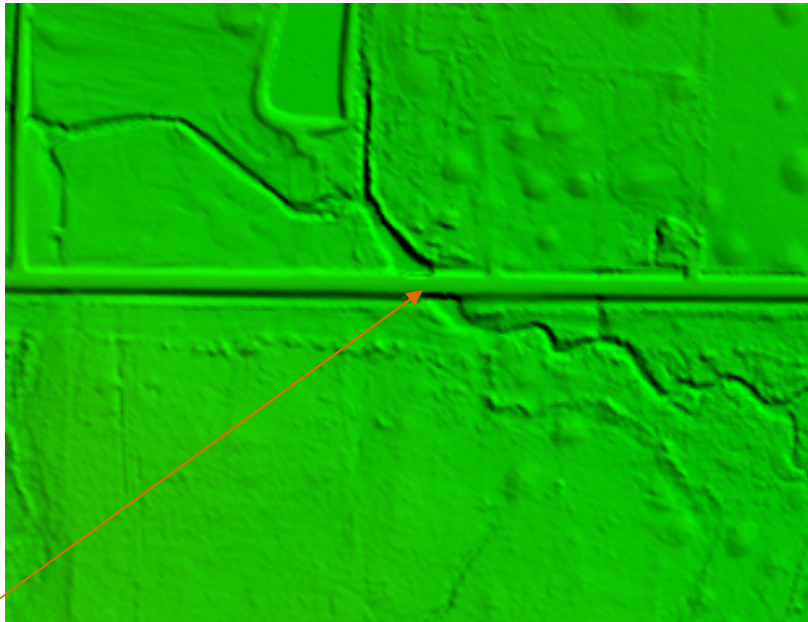
Figure 13- Tile 15WU2322, Delivery 2. The culvert has been added back to the ground surface.

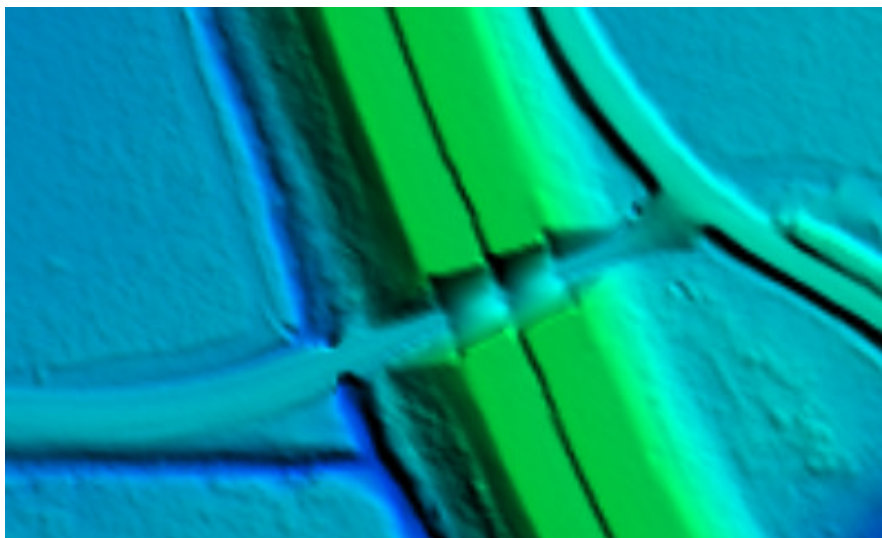
*Figure 14- Tile 15WU1822. The DEM above shows a visual artifact, or “saddle” as labeled in the USGS review report, because the surface model is interpolating across the bridge gap. The surface model must make a continuous model and in order to do so, points are connected through interpolation. This can cause visual artifacts or loss of detail when the surface model must interpolate across removed features, such as bridges, where there are few or no ground LiDAR points.*

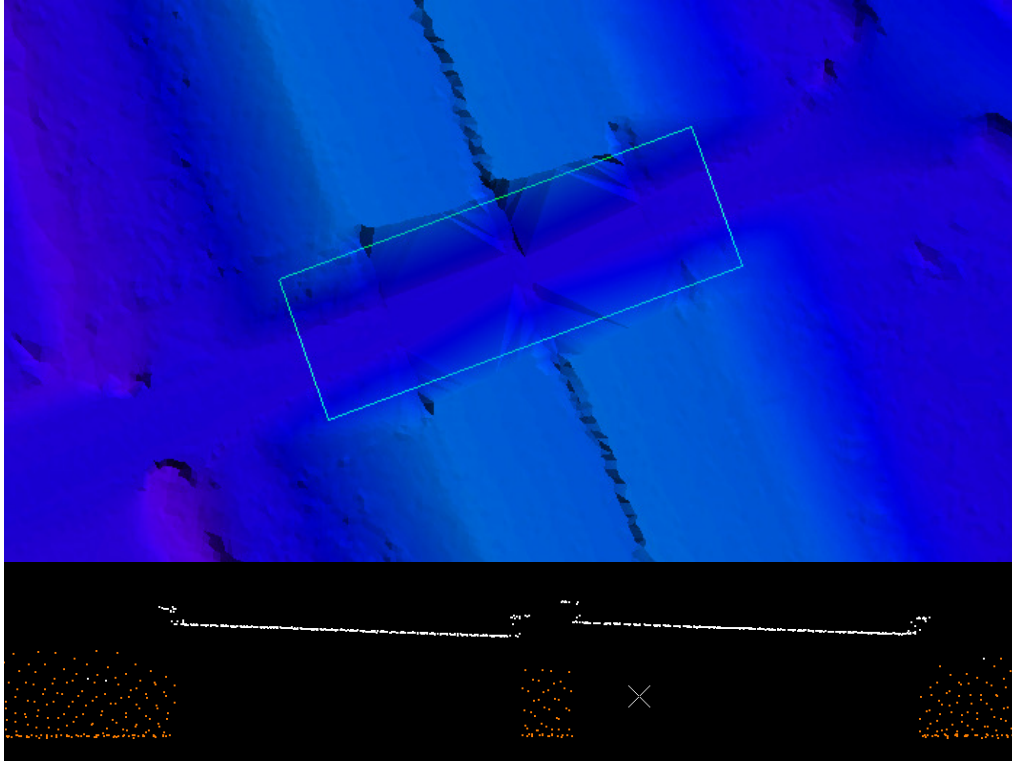
*Figure 15- Tile 15WU1822. The DEM in the top view shows a visual artifact because the surface model is interpolating from the slope leading to the bridge to the hydrographic banks. The surface model must make a continuous model and in order to do so, points are connected through interpolation. This can cause visual artifacts when there are features with large elevation differences. The profile in the bottom view shows the LiDAR points, colored by class, of this particular feature. All bridge points have been removed from ground (orange) and are unclassified (white). There are no ground points that can be modified to correct this visual artifact.*
