Dewberry Response to USGS Review of the FEMA IX - Orange County, CA LiDAR Processing Project

Produced for U.S. Geological Survey

USGS Contract: G10PC00013

Task Order:G12PD00039

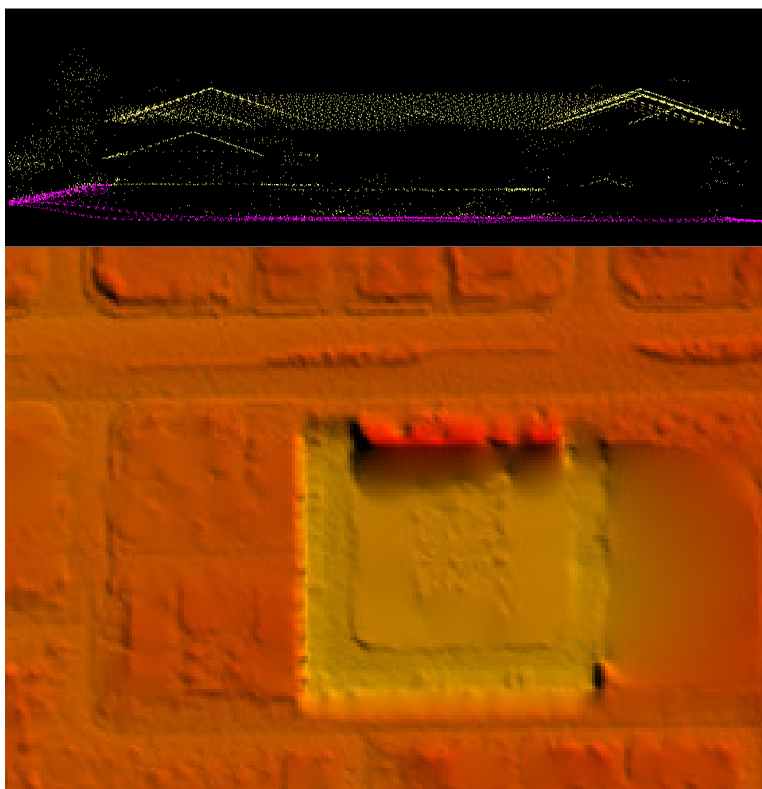
Figure 2 - Tile 11SMT096435. The DEM in the bottom view shows a visual artifact because the surface model is interpolating between the available ground points on either side of the building points that were removed. The profile in the top view shows the LiDAR points of this particular feature colored by class. All building points have been removed from ground (pink) and are unclassified (yellow). There are no ground points that can be modified to correct this visual artifact.

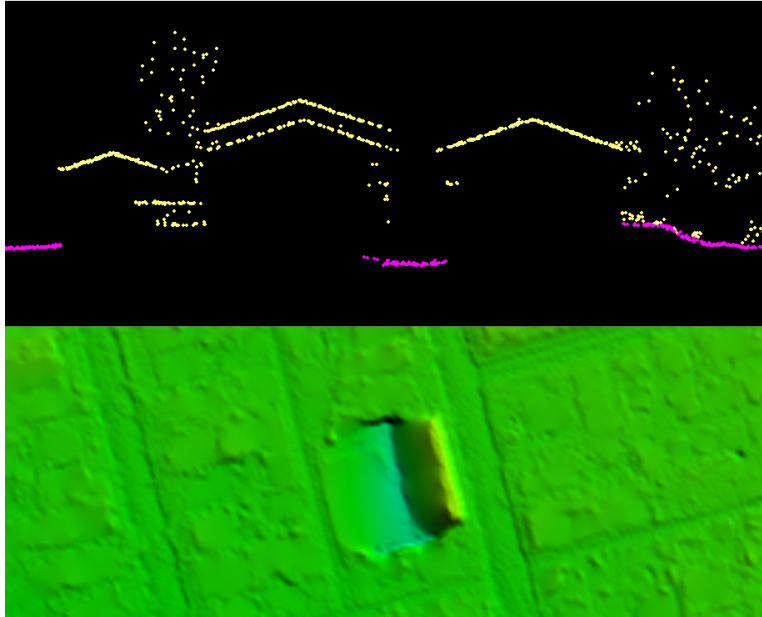
Figure 3 - Tile 11SMT141435. The DEM in the bottom view shows a visual artifact because the surface model is interpolating between the available ground points on either side of the building points that were removed. The profile in the top view shows the LiDAR points of this particular feature colored by class. All building points have been removed from ground (pink) and are unclassified (yellow). There are no ground points that can be modified to correct this visual artifact.

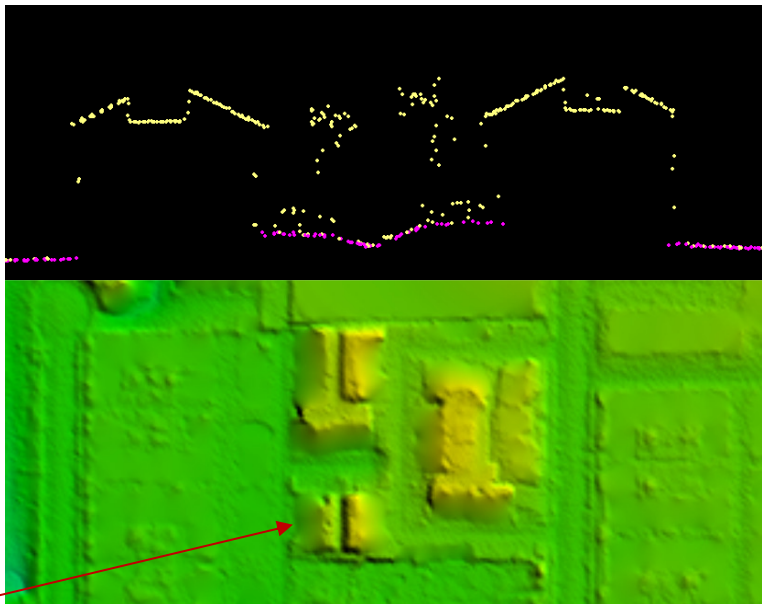
Figure 4 - Tile 11SMT066435. The DEM in the bottom view shows a visual artifact because the surface model is interpolating between the available ground points on either side of two apartment buildings separated by a courtyard. The profile in the top view shows the LiDAR points of this particular feature colored by class. All building points have been removed from ground (pink) and are unclassified (yellow). There are no ground points that can be modified to correct this visual artifact.

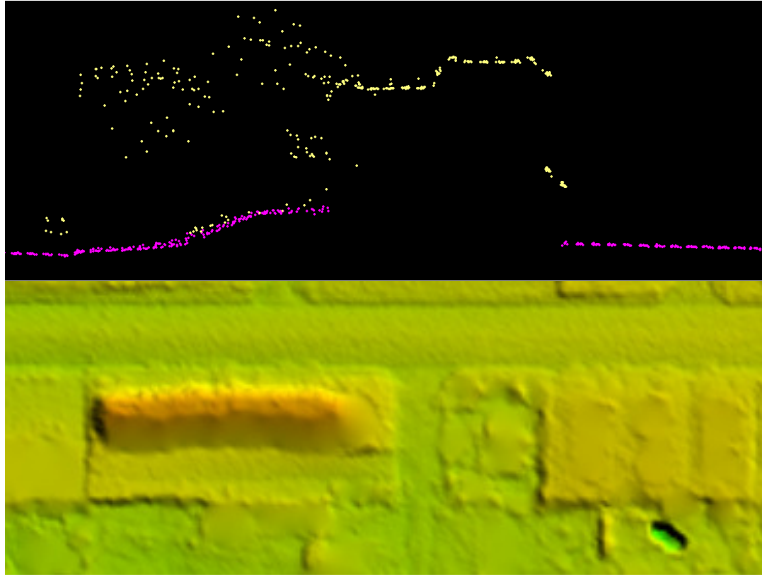
Figure 5 - Tile 11SMT081390. The DEM in the bottom view shows a visual artifact because the surface model is interpolating between the available ground points on either side of the building points that were removed. The profile in the top view shows the LiDAR points of this particular feature colored by class. All building points have been removed from ground (pink) and are unclassified (yellow). There are no ground points that can be modified to correct this visual artifact.

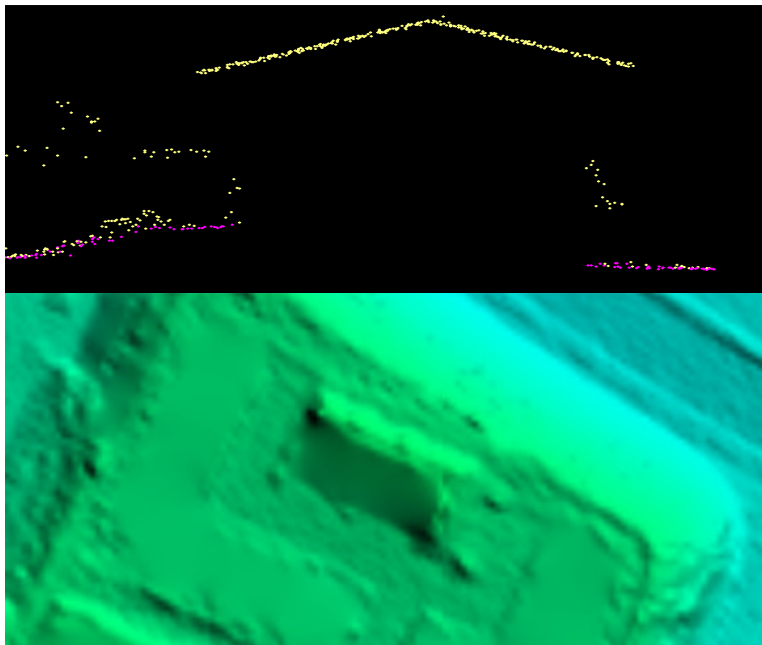
Figure 6 - Tiles 11SMT261225 and 11SMT276225. The DEM in the bottom view shows a visual artifact because the surface model is interpolating between the available ground points on either side of the building points that were removed. The profile in the top view shows the LiDAR points of this particular feature colored by class. All building points have been removed from ground (pink) and are unclassified (yellow). There are no ground points that can be modified to correct this visual artifact.

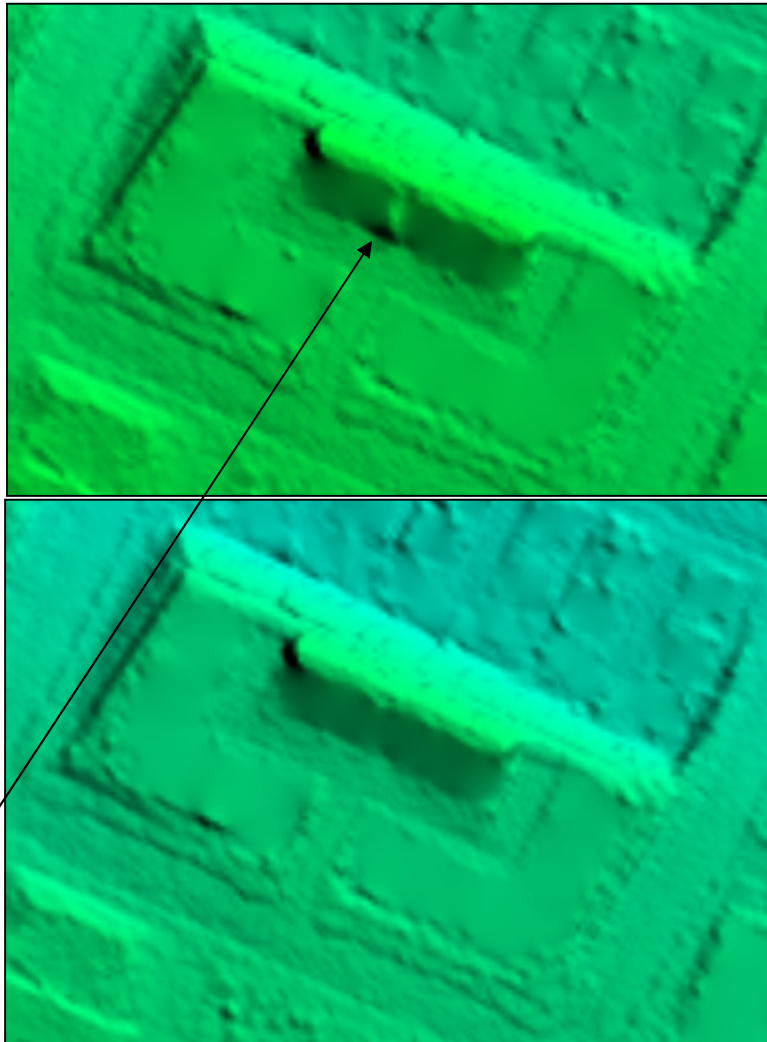
Figure 7 –Tile 11SMT276225. The DEM in the top view is similar to the previous calls but some high points are present that can be modified. These high points were removed from class 2 ground. The impact to the DEM is minor and a visual artifact is still present in the redelivered DEM shown in the bottom view because the surface model is interpolating between the available ground points on either side of the building points that were removed. All building points have been removed from ground.

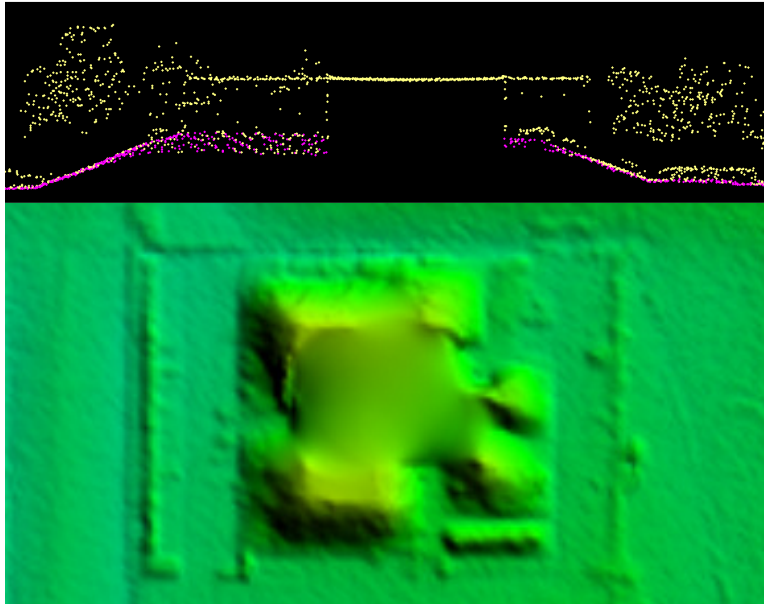
Figure 8 - Tile 11SMT096450. The DEM in the bottom view shows a visual artifact because the surface model is interpolating between the available ground points on either side of the medical center building points that were removed. This looks odd due to the hills included in the landscaping surrounding the building. The profile in the top view shows the LiDAR points of this particular feature colored by class. All building points have been removed from ground (pink) and are unclassified (yellow). There are no ground points that can be modified to correct this visual artifact.

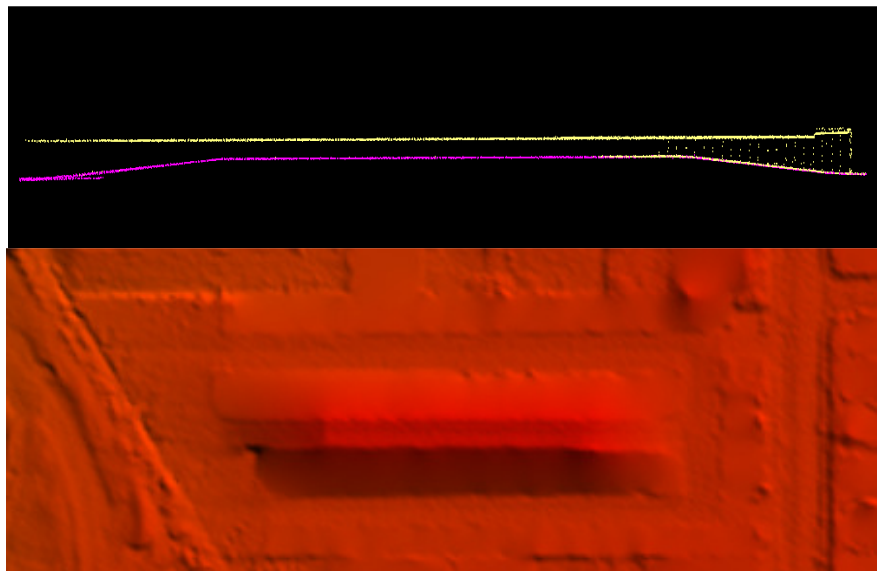
Figure 9 - Tiles 11SMT111210 and 11SMT126210. The DEM in the bottom view shows a visual artifact because the surface model is interpolating between the available ground points on either side of storage facility units that are separated by built up ground forming a raised ramp like feature. The profile in the top view shows the LiDAR points of this particular feature colored by class. All building points have been removed from ground (pink) and are unclassified (yellow). There are no ground points that can be modified to correct this visual artifact.

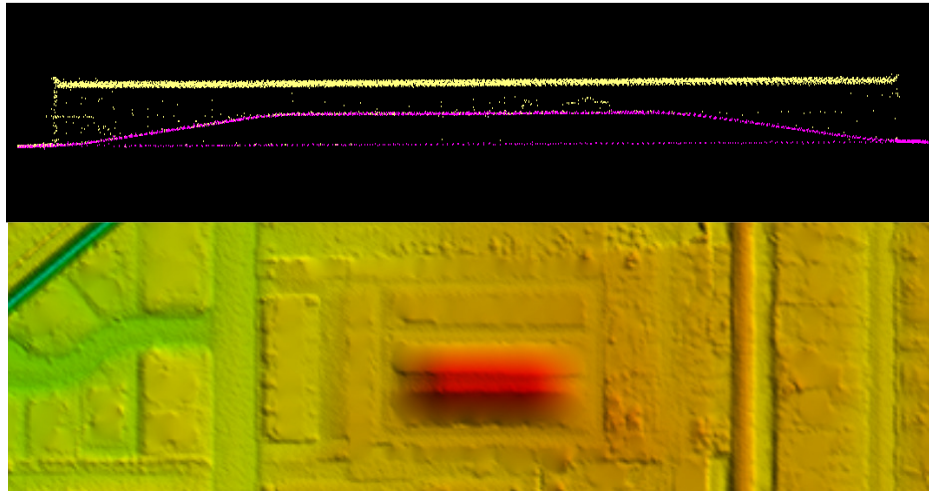
Figure 10 - Tile 11SMT066390. The DEM in the bottom view shows a visual artifact because the surface model is interpolating between the available ground points on either side of more storage facility units that are separated by built up ground forming a raised ramp like feature. The profile in the top view shows the LiDAR points of this particular feature colored by class. All building points have been removed from ground (pink) and are unclassified (yellow). There are no ground points that can be modified to correct this visual artifact.

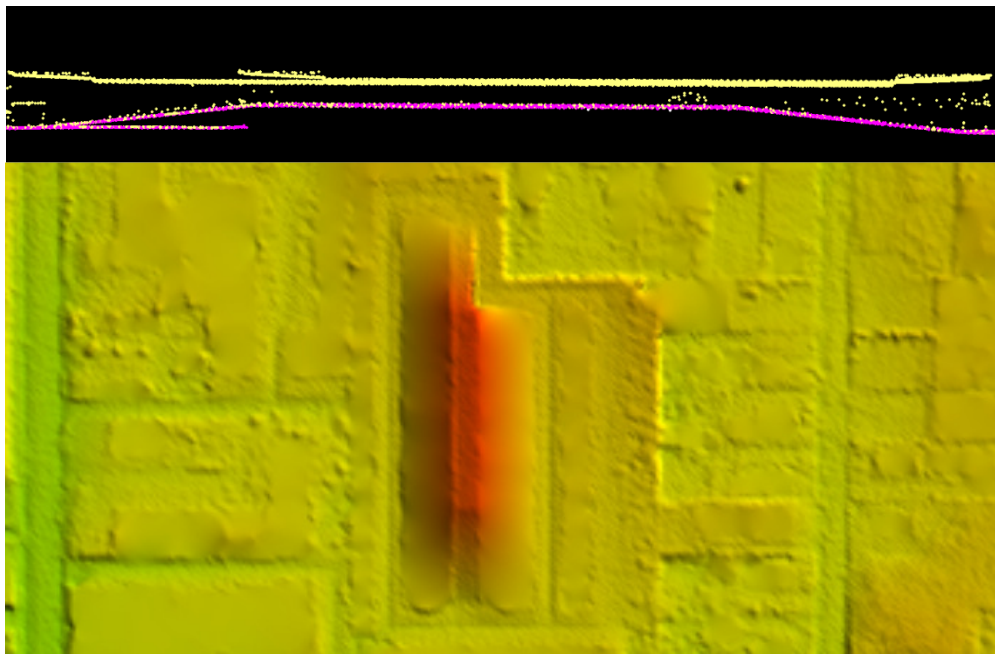
Figure 11 - Tile 11SMT006435. The DEM in the bottom view shows a visual artifact because the surface model is interpolating between the available ground points on either side of more storage facility units that are separated by built up ground forming a raised ramp like feature. The profile in the top view shows the LiDAR points of this particular feature colored by class. All building points have been removed from ground (pink) and are unclassified (yellow). There are no ground points that can be modified to correct this visual artifact.

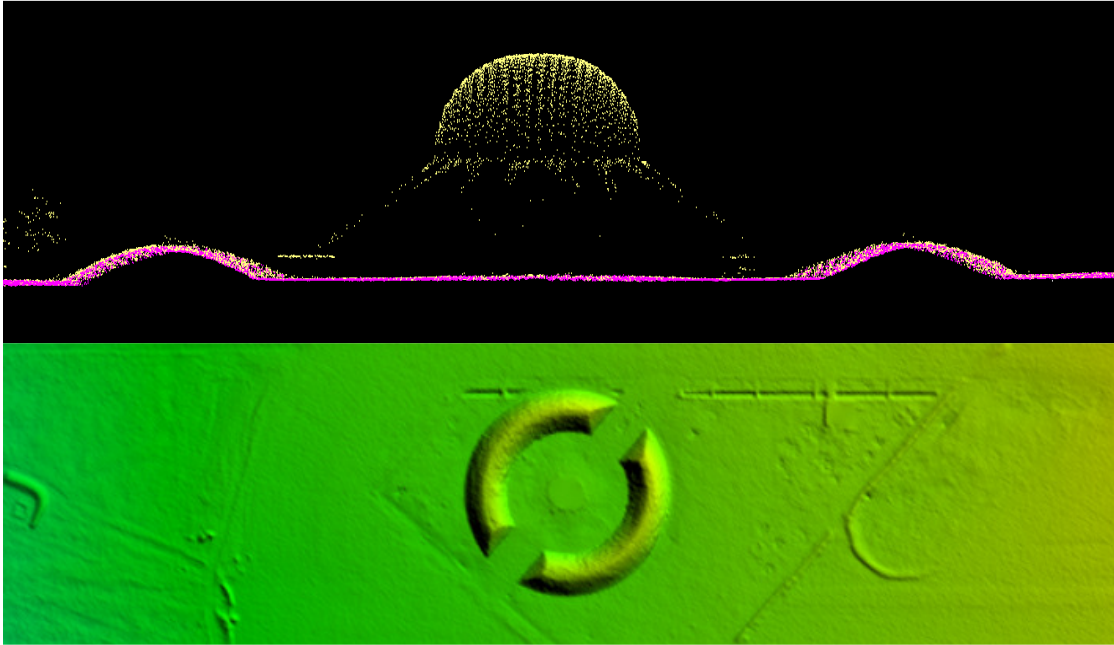
Figure 12 - Tile 11SMT306255. In ground structures exist within the project area. In the example above, earthen mounds have been formed around an area. These features are correctly included in the ground classification.

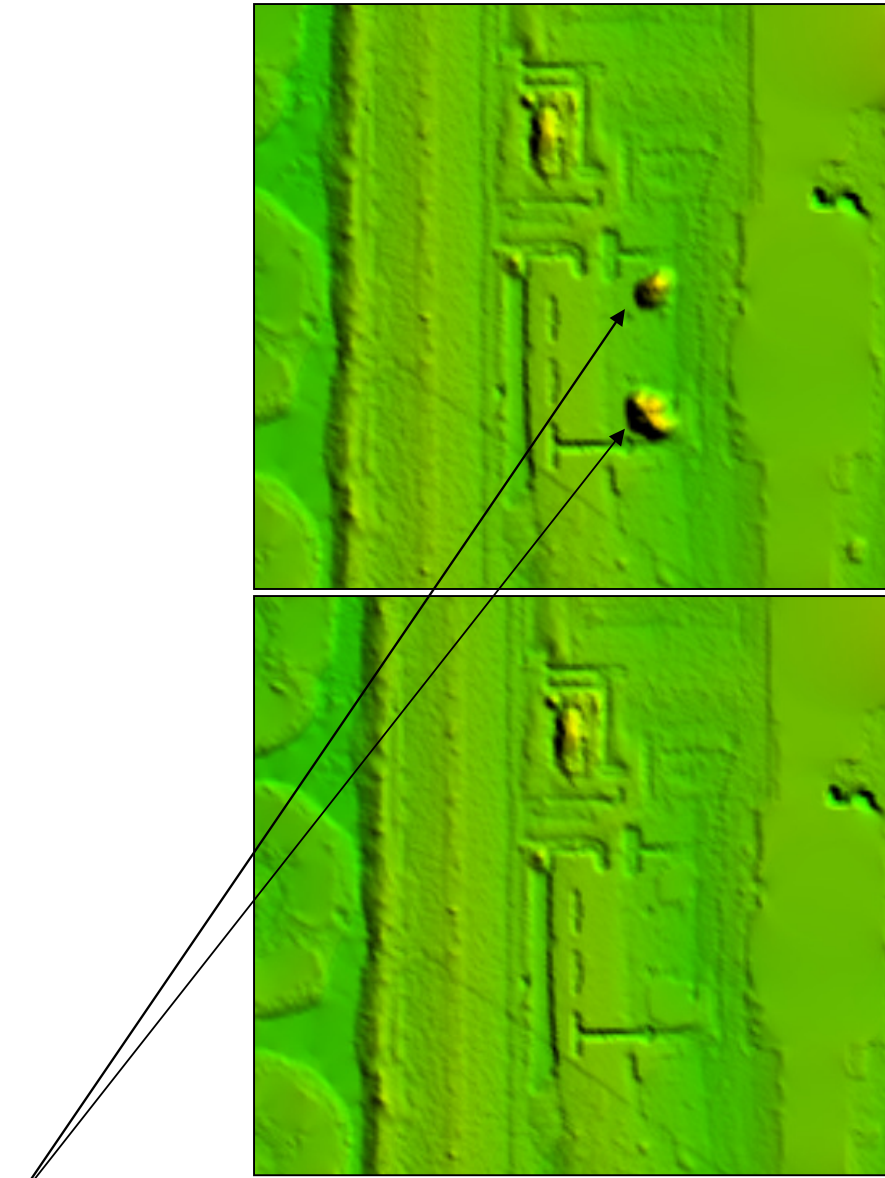
Figure 13 - Tile 11SMT081240. At the time of LiDAR acquisition, this area was under construction and dirt hills were present as shown in the top view. At the request of USGS, these hills have been removed from the ground as shown in the redelivered DEM in the bottom view.

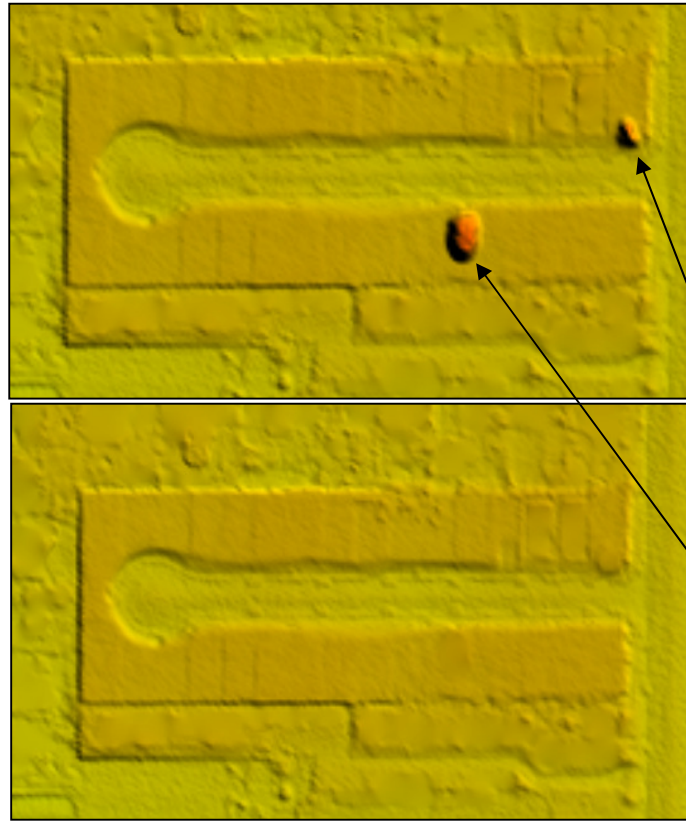
Figure 14 - Tile 11SMT066420. At the time of LiDAR acquisition, this area was under construction and dirt hills were present as shown in the top view. At the request of USGS, these hills have been removed from the ground as shown in the redelivered DEM in the bottom view.

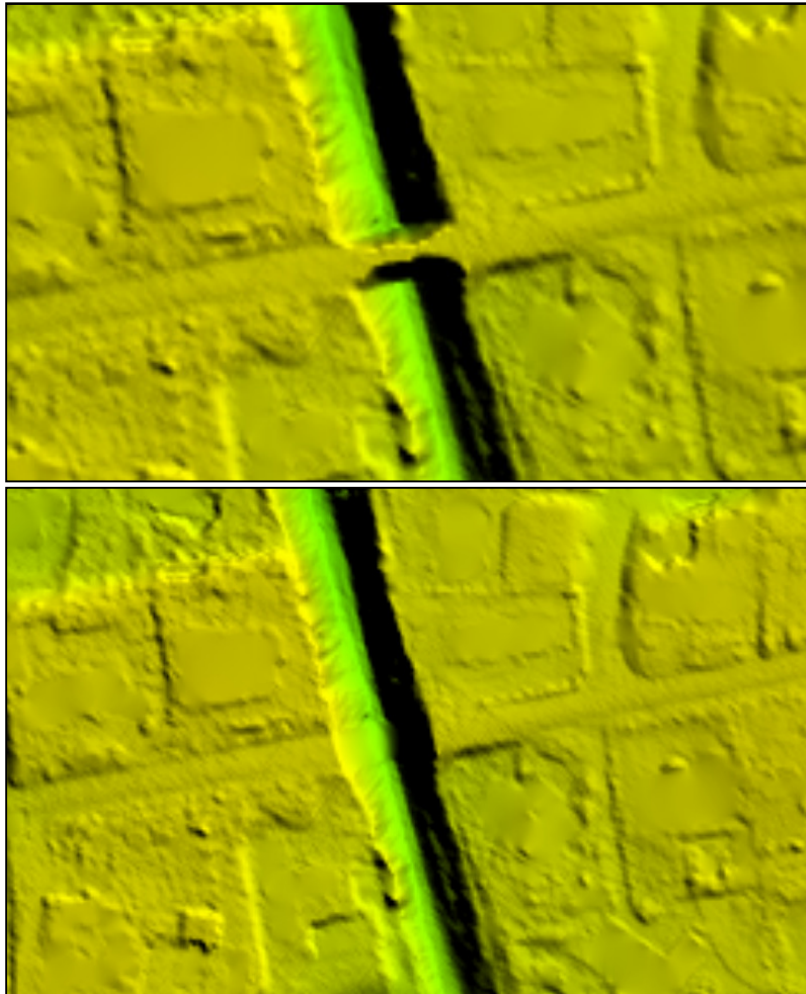
Figure 15 - Tile 11SMT126525. The feature identified was originally interpreted as a culvert and included in the ground surface as shown in the top view. USGS identified this feature as a bridge. The LAS and DEM have been corrected by removing this feature from the ground surface as shown in the bottom view.

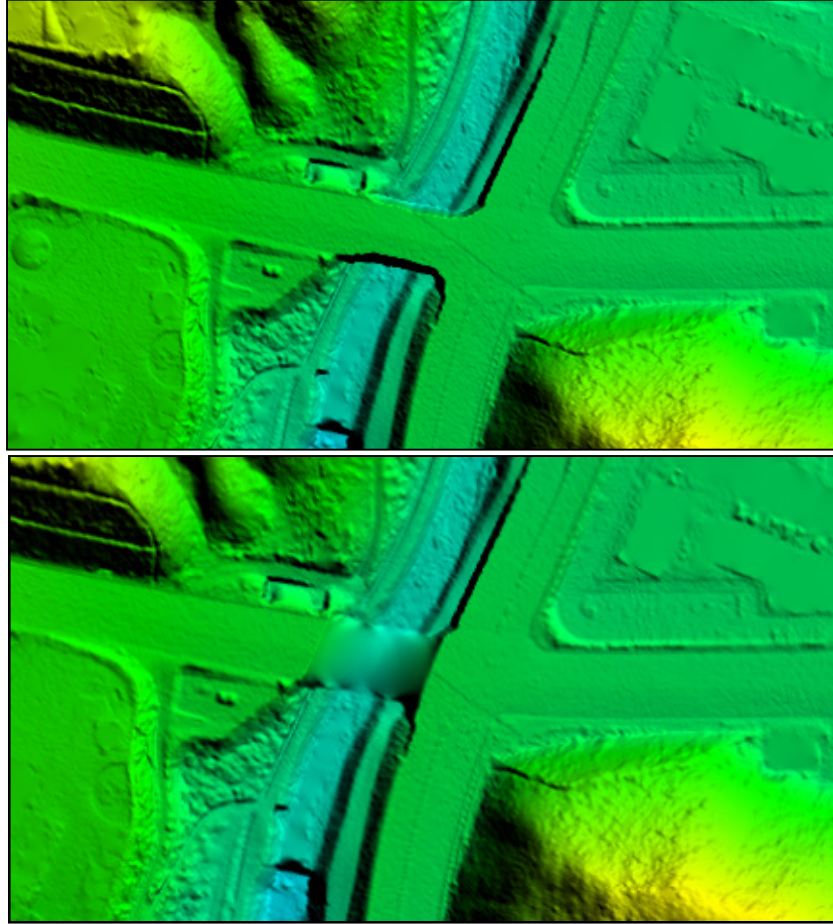
Figure 16 - Tile 11SMT321120. The feature identified was originally interpreted as a culvert and included in the ground surface as shown in the top view. USGS identified this feature as a bridge. The LAS and DEM have been corrected by removing this feature from the ground surface as shown in the bottom view.

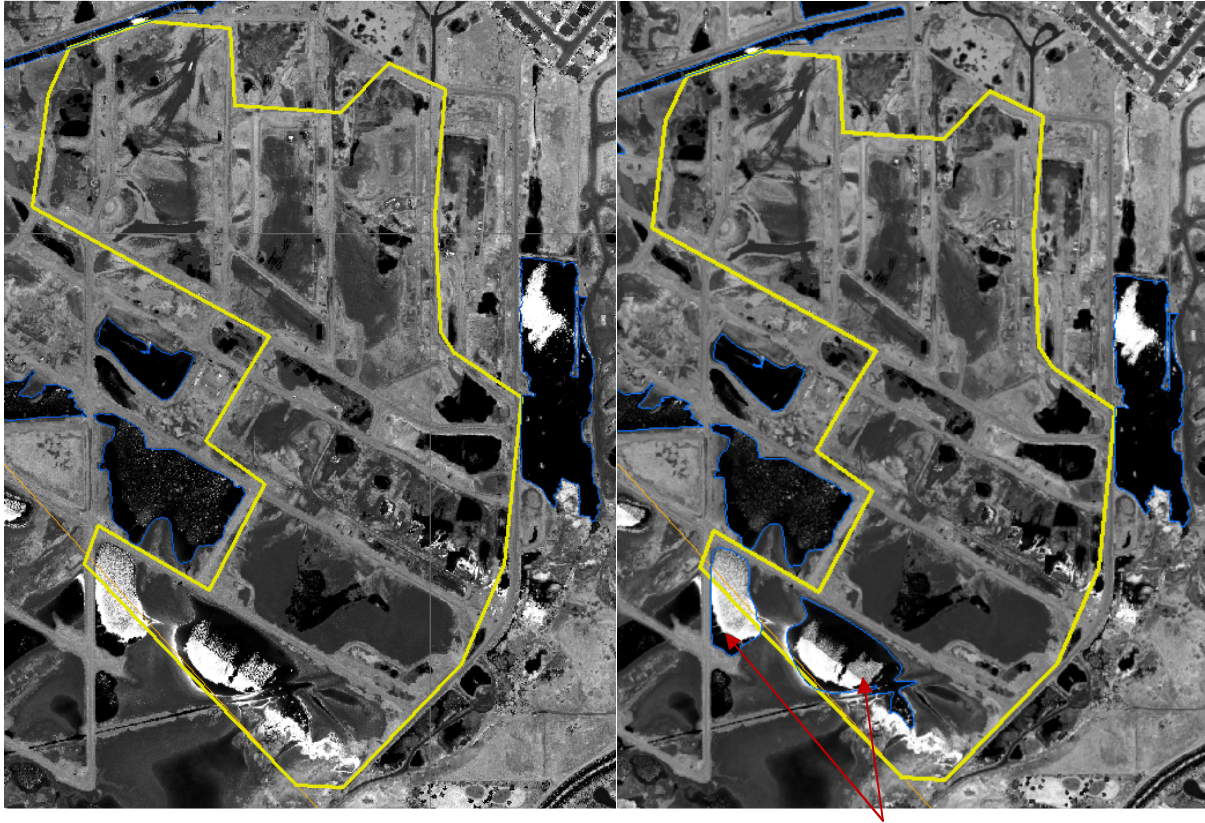
Figure 17 - Tiles 11SMT036270, 11SMT051270, 11SMT036285, and 11SMT051285: The intensity image showing the collected breaklines from the first delivery is on the left. The modified breaklines from this delivery are shown in the intensity image on the right. Dewberry added two ponds to the delivered breaklines. The LAS and DEMs have been corrected to reflect the addition of these features.

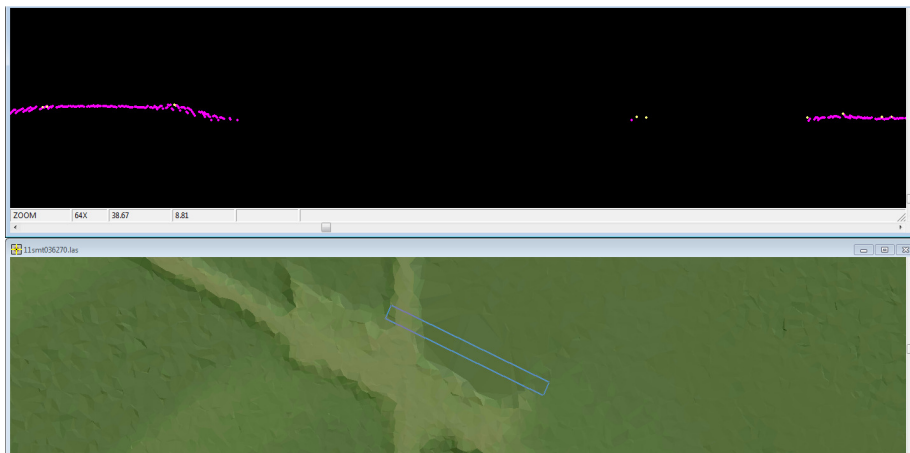
Figure 18 - Tiles 11SMT036270, 11SMT051270, 11SMT036285, and 11SMT051285: The LiDAR points shown above confirm that the breaklines delivered to USGS should be modified to include additional water bodies. The black areas are where no points were returned due to the presence of water. The black areas that are 2 acres or greater and have been confirmed to be water have been added to the breaklines and the LAS and DEMs have been modified to reflect these changes.

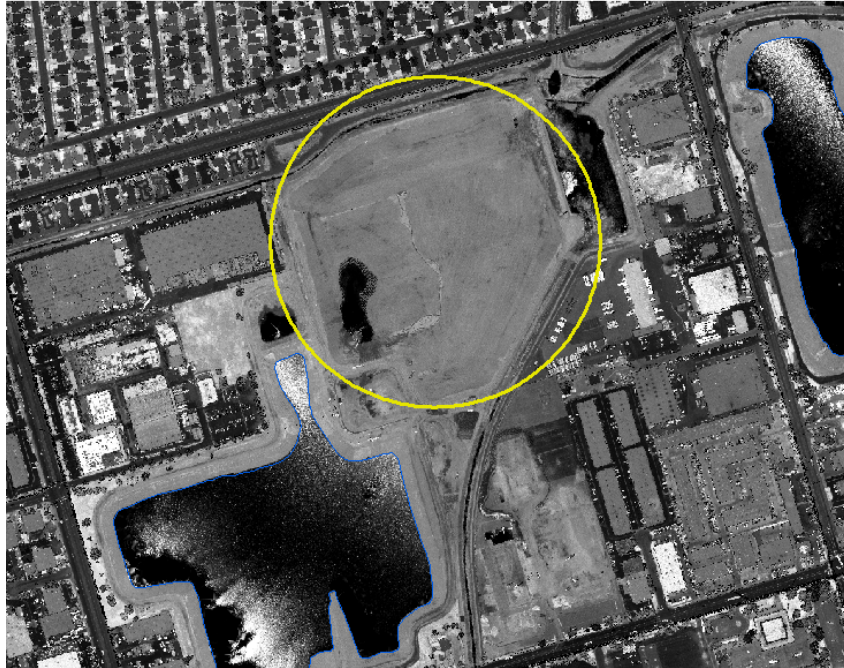
Figure 19 - Tile 11SMT201465. As the intensity imagery shows, the breaklines delivered to USGS correctly capture the water bodies in the area that are 2 acres or greater.

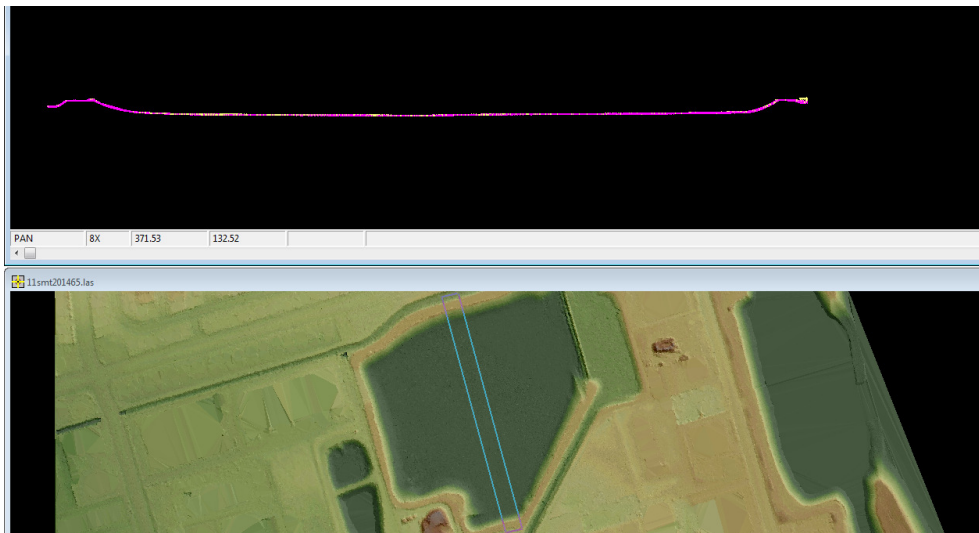
Figure 20 - Tile 11SMT201465. The LiDAR points shown above confirm that the breaklines delivered to USGS correctly capture the water bodies in the area that are greater than 2 acres. Within the identified area, several points were returned indicating the presence of ground. These points have been correctly classified as ground (shown in pink) and the area was not hydro flattened in the delivered DEM. Had there been water present, a black area would show where very few or no points were returned due to the presence of water. It is likely that this area was dry during the time of the mission.

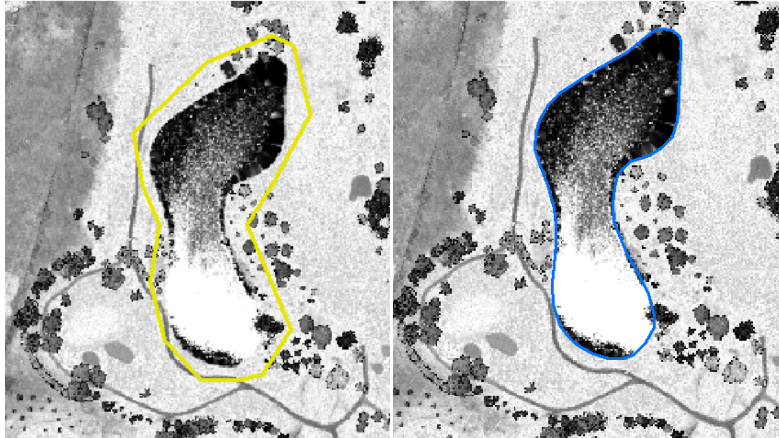
Figure 21 - Tile 11SMT021390. The intensity image showing the collected breaklines from the first delivery is on the left. The modified breaklines from this delivery are shown in the intensity image on the right. Dewberry added one pond to the delivered breaklines. The LAS and DEMs have been corrected to reflect the addition of these features.

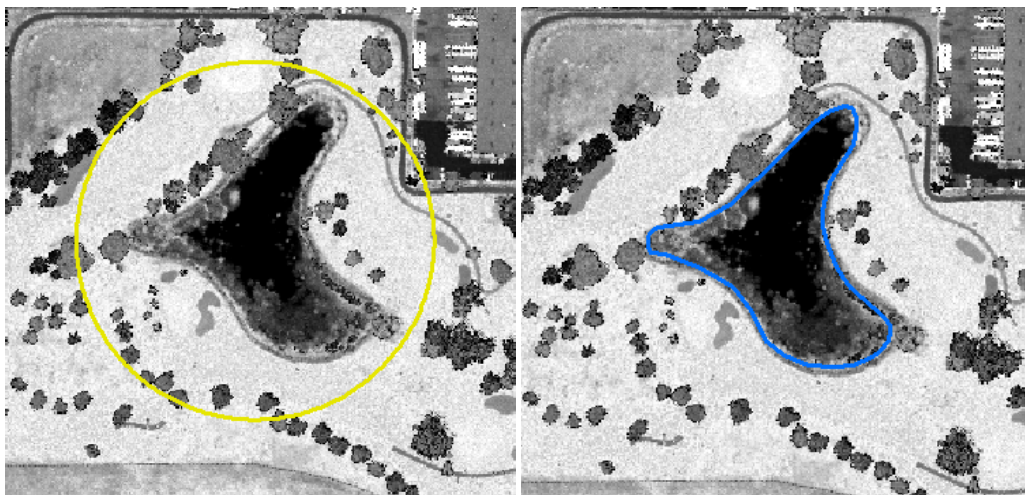
Figure 22 - Tile 11SMT036390. The intensity image showing the collected breaklines from the first delivery is on the left. The modified breaklines from this delivery are shown in the intensity image on the right. Dewberry added one pond to the delivered breaklines. The LAS and DEMs have been corrected to reflect the addition of these features.
