Dewberry Response to USGS Review of the NRCS Maryland LiDAR Processing Project

Produced for U.S. Geological Survey

USGS Contract: G10PC00013

Report Date: 10/16/2012

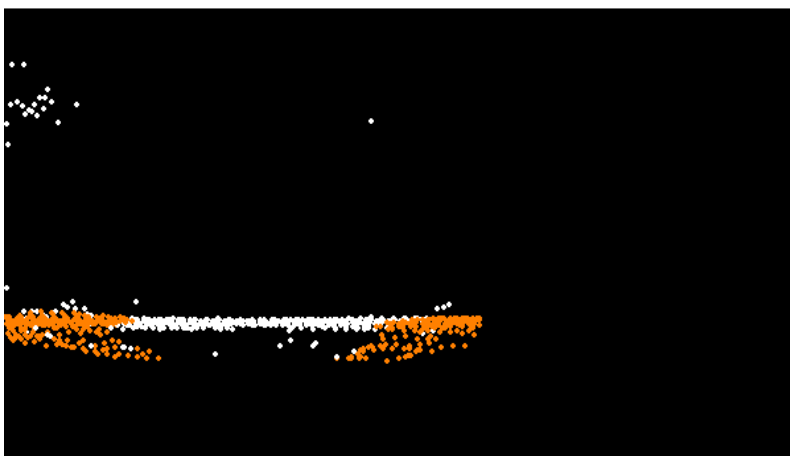
There were three locations where Dewberry interpreted a feature as a culvert and included it in the ground surface. USGS identified these features as bridges, not culverts. Dewberry has modified the points and removed these features from the ground surface.

Figure 2- Tile 18SVH284403. Bridges have been removed from ground (orange) and reclassified to class 1 (white)

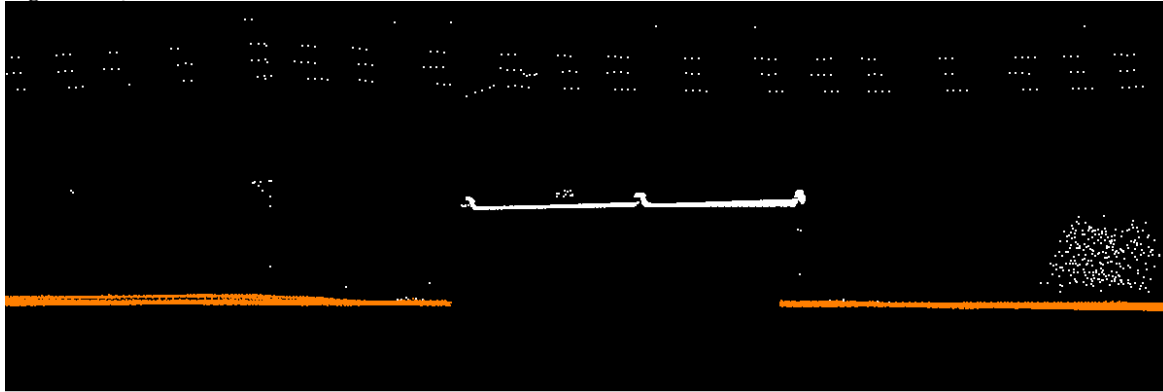
There were three locations where USGS made calls regarding visual artifacts. The DEM surface models are created from TINs or Terrains. TIN and Terrain models create continuous surfaces from the inputs. Because a continuous surface is being created, the TIN or Terrain will use interpolation to triangulate across a bridge opening from legitimate ground points on either side of the actual bridge. This can cause visual artifacts or “saddles.” These “artifacts” are only visual and do not exist in the LiDAR points or breaklines. No points were modified in these locations.

Figure 3-Tile 18SVH479493. No additional points can be removed from ground classification. Bridge “saddles” are a visual artifact resulting from interpolation of a continuous surface.

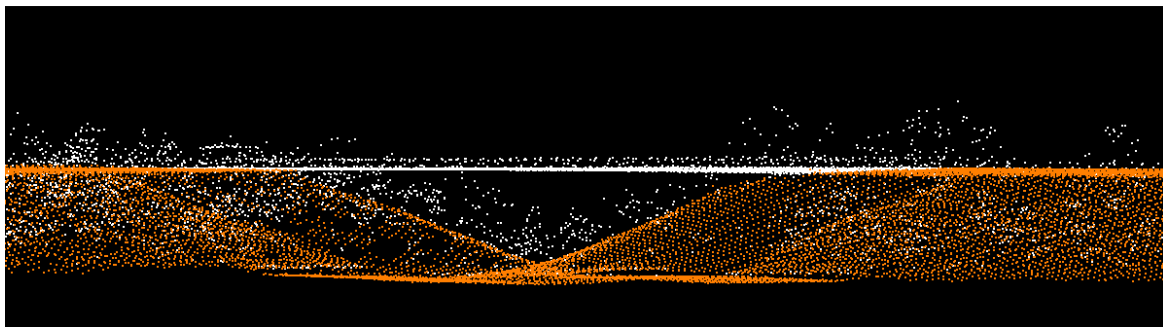
Figure 4-Tile 18SVH494493. No additional points can be removed from ground classification. Bridge “saddles” are a visual artifact resulting from interpolation of a continuous surface.

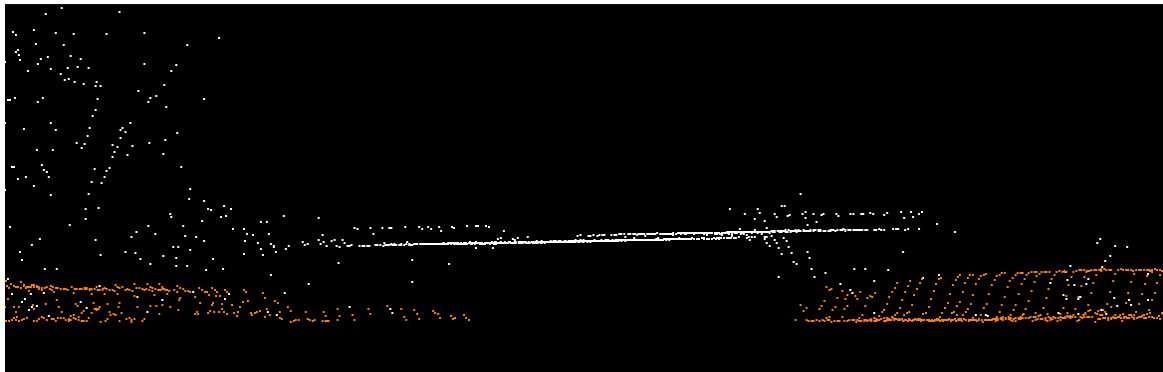
Figure 5-Tile 18SVH389298. No additional points can be removed from ground classification. Bridge “saddles” are a visual artifact resulting from interpolation of a continuous surface.

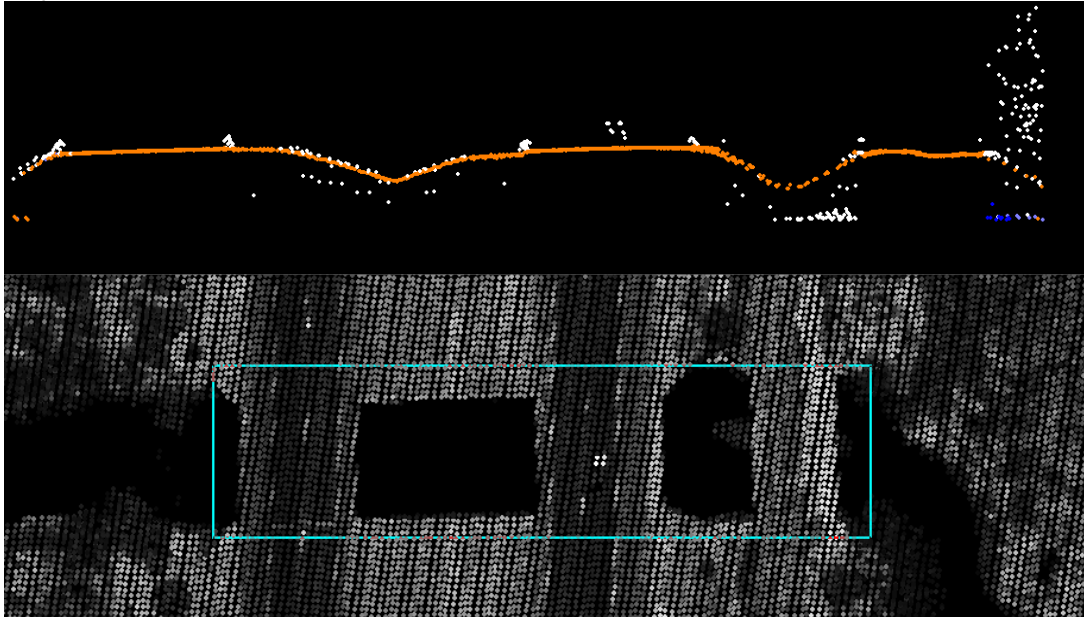
There were three locations where Dewberry interpreted a feature as a bridge and removed it from the ground surface. USGS identified these features as culverts, not bridges. Dewberry has modified the points and added these features to the ground surface. An example is shown below.

Figure 6-Tile 18SVH389238. Culverts have been reclassified from class 1 (white) to ground (orange).

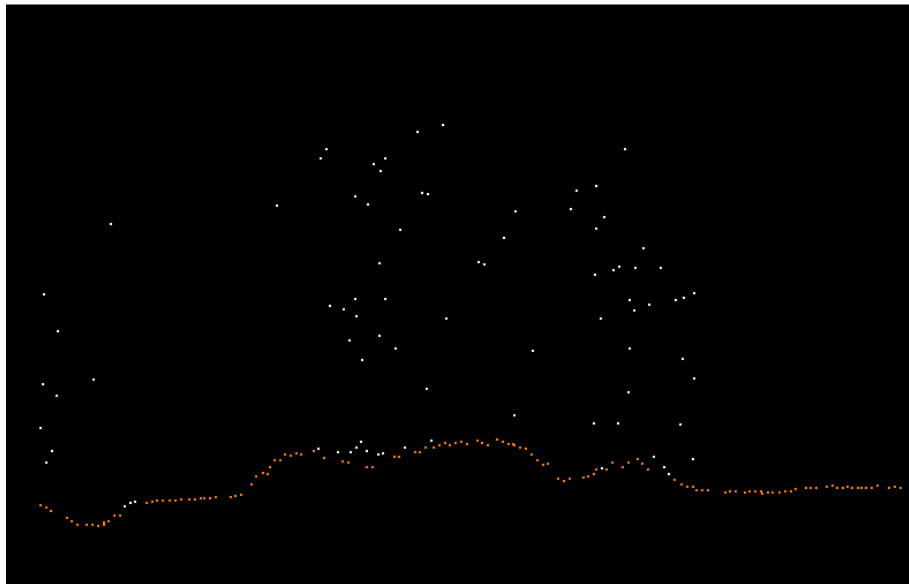
There were two calls to remove features from the ground surface. At first glance these areas may resemble vegetation. However, as the profile shows, the vegetation has been removed and the small mounds are correctly left in the ground. There was one call to add points to ground along a road bank. Points were modified and additional points were added to the ground surface. Examples are shown below.

Figure 7-Tile 18SVH494553. All vegetation points have already been removed from ground (orange). No modification required as mounds are legitimately part of the ground surface.

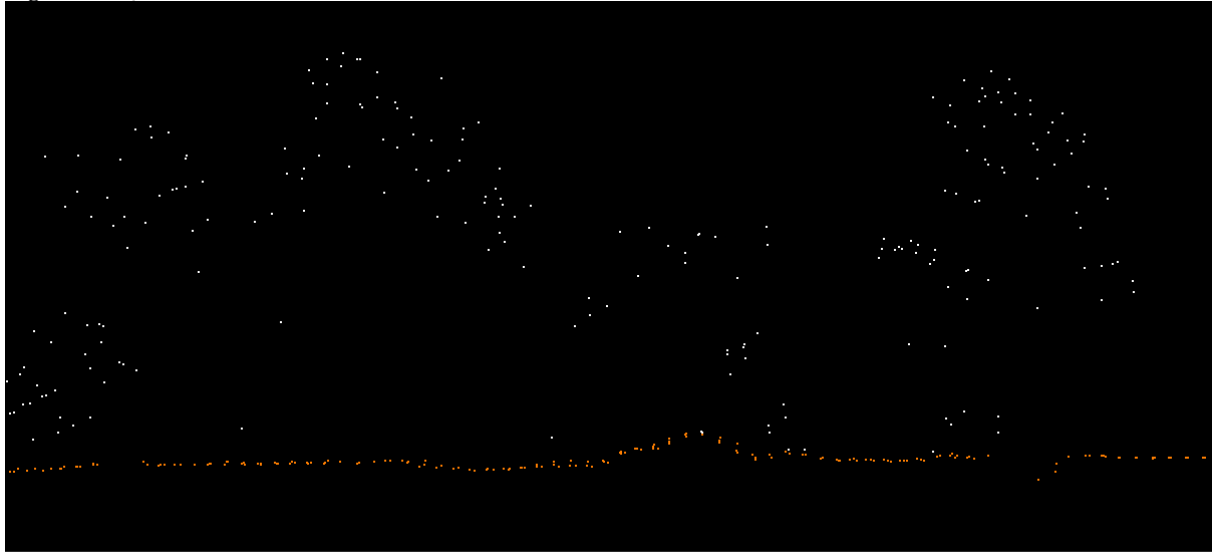
Figure 8-Tile 18SVH374538. All vegetation points have already been removed from ground (orange). No modification required as mounds are legitimately part of the ground surface.

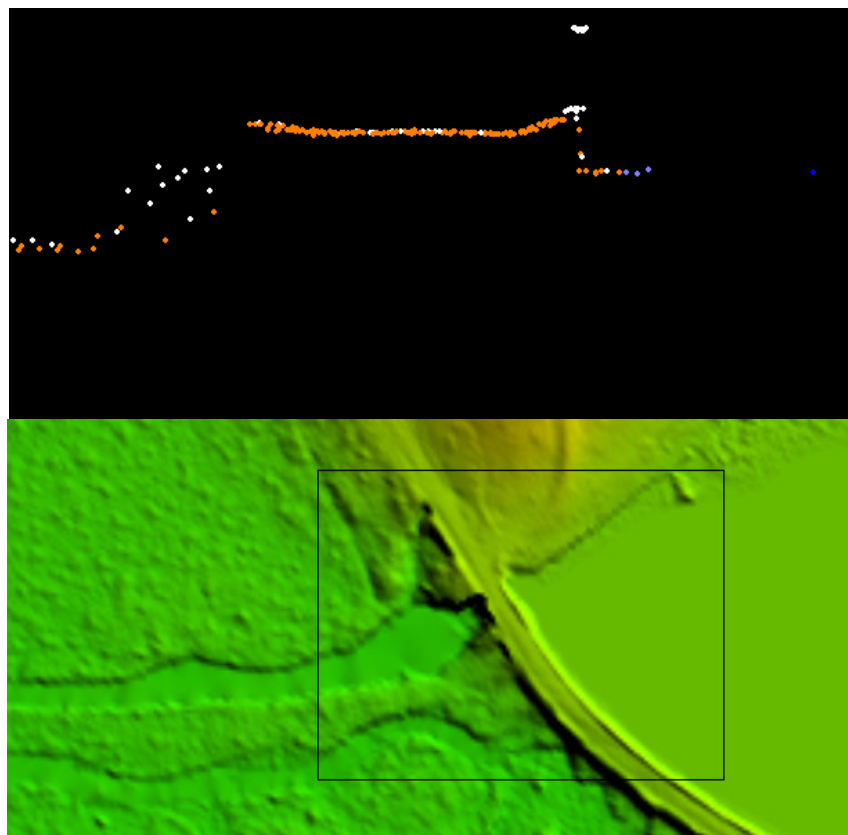
Figure 9-Tile 18SVH344568. Additional points have been added to the ground (orange) to fully model the road feature in the redelivered DEM.

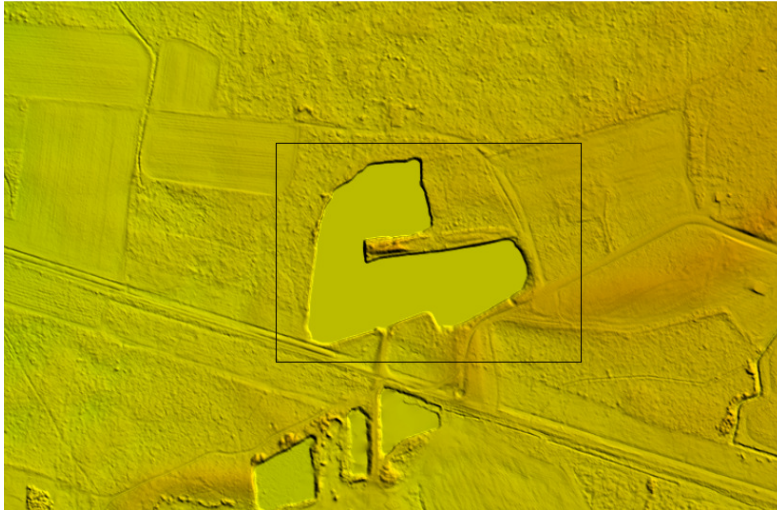
There were four locations where USGS identified areas of water that were not included in the collected breaklines. While the interpretation of the feature may be questionable in the intensity imagery, Dewberry agrees with all four calls after reviewing color imagery and the available LiDAR points. There is one location called out by USGS where the elevation of the breaklines was too low. After reviewing the LiDAR, Dewberry confirmed that the elevation was not accurate and modified the elevation of the breaklines up stream of the structure/ spillway.

Figure 10 - Tiles 18SVH299583, 18SVH314583, 18SVH299568, and 18SVH314568. An additional pond breakline has been collected for this feature and used to flatten the feature in the redelivered DEM. The LAS have been corrected to reflect the addition of this feature.

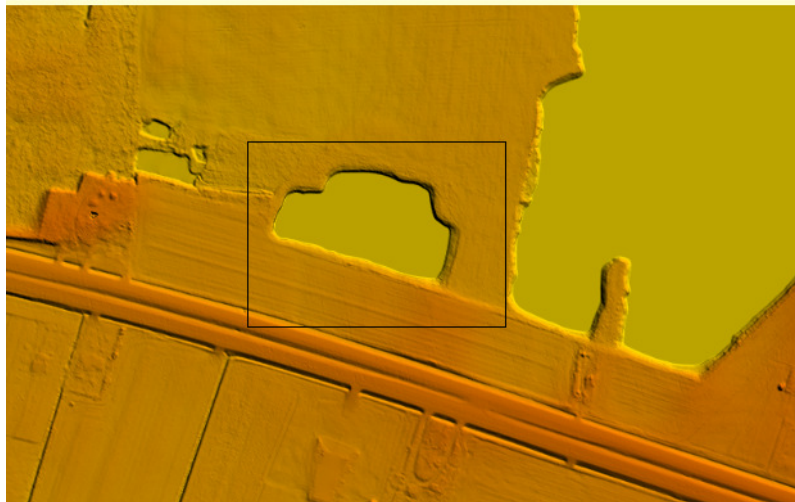
Figure 11 – Tiles 18SVH359553 and 18SVH374553. An additional pond breakline has been collected for this feature and used to flatten the feature in the redelivered DEM. The LAS have been corrected to reflect the addition of this feature.

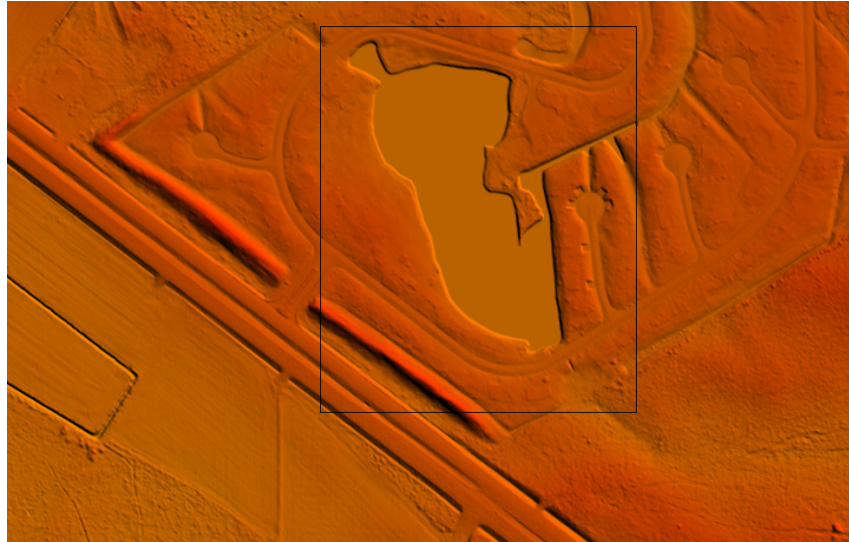
Figure 12 – Tile 18SVH389538. An additional pond breakline has been collected for this feature and used to flatten the feature in the redelivered DEM. The LAS has been corrected to reflect the addition of this feature.

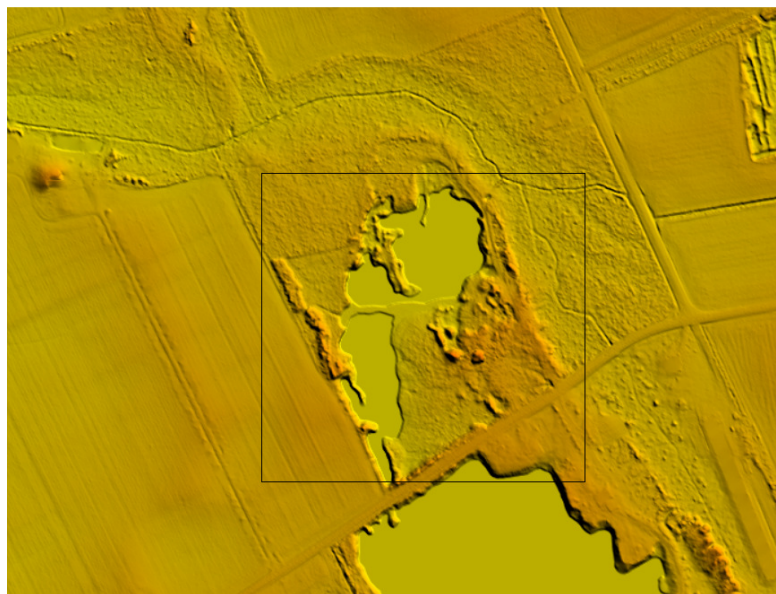
Figure 13 – Tile 18SVH359508. An additional pond breakline has been collected for this feature and used to flatten the feature in the redelivered DEM. The LAS has been corrected to reflect the addition of this feature.

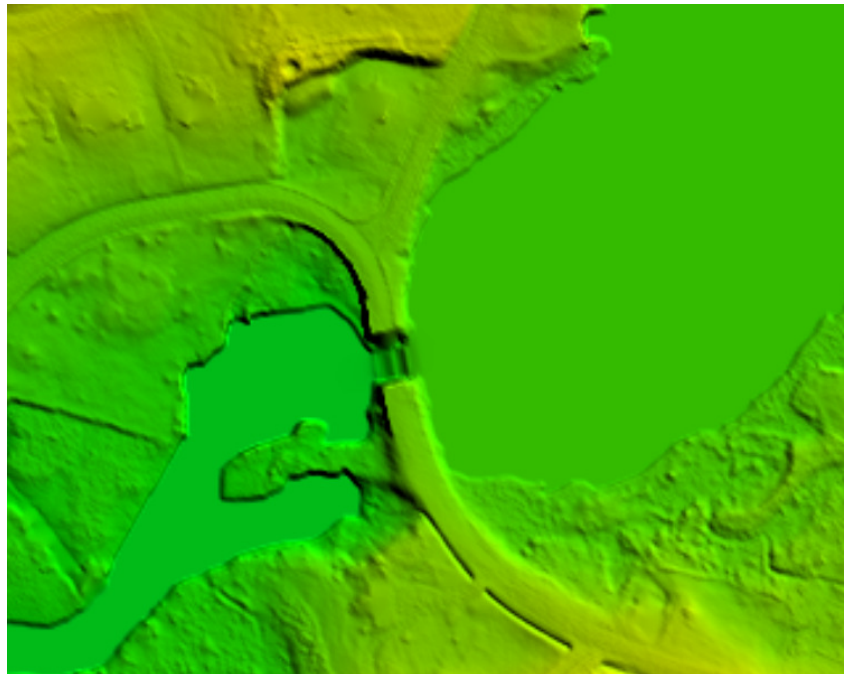
Figure 14 - Tile 18SVH389373. Elevation of breakline has been raised upstream of the spillway and stepped down to the lower tidally influenced area, as shown in the DEM above.

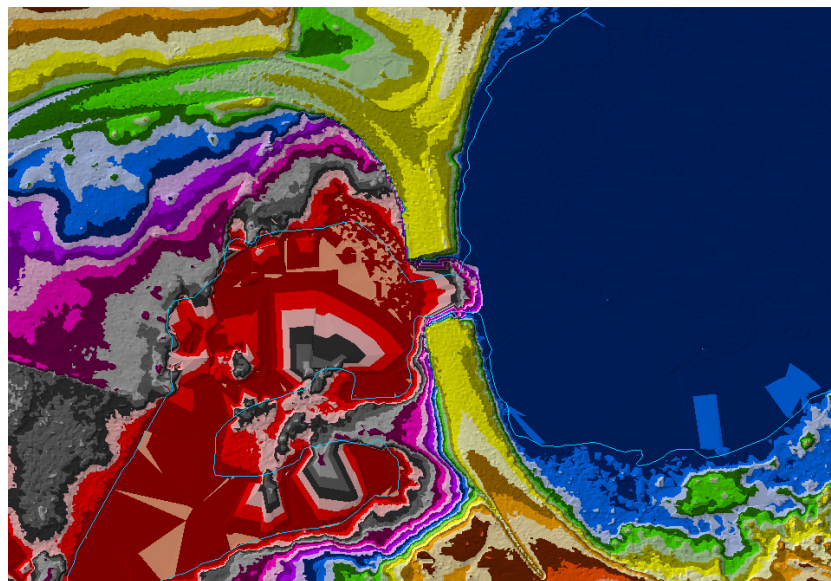
Figure 15 – Tile 18SVH389373. The terrain shows the sudden drop in elevation at the spillway and why Dewberry stepped the elevations to tie the higher elevations upstream of the spillway to the lower elevation downstream of the spillway.
