Dewberry Response to USGS Review Middle Counties Acquisition and Classification for FEMA VA LiDAR

Produced for U.S. Geological Survey

USGS Contract: G11PD00089

Report Date: 10/19/2012

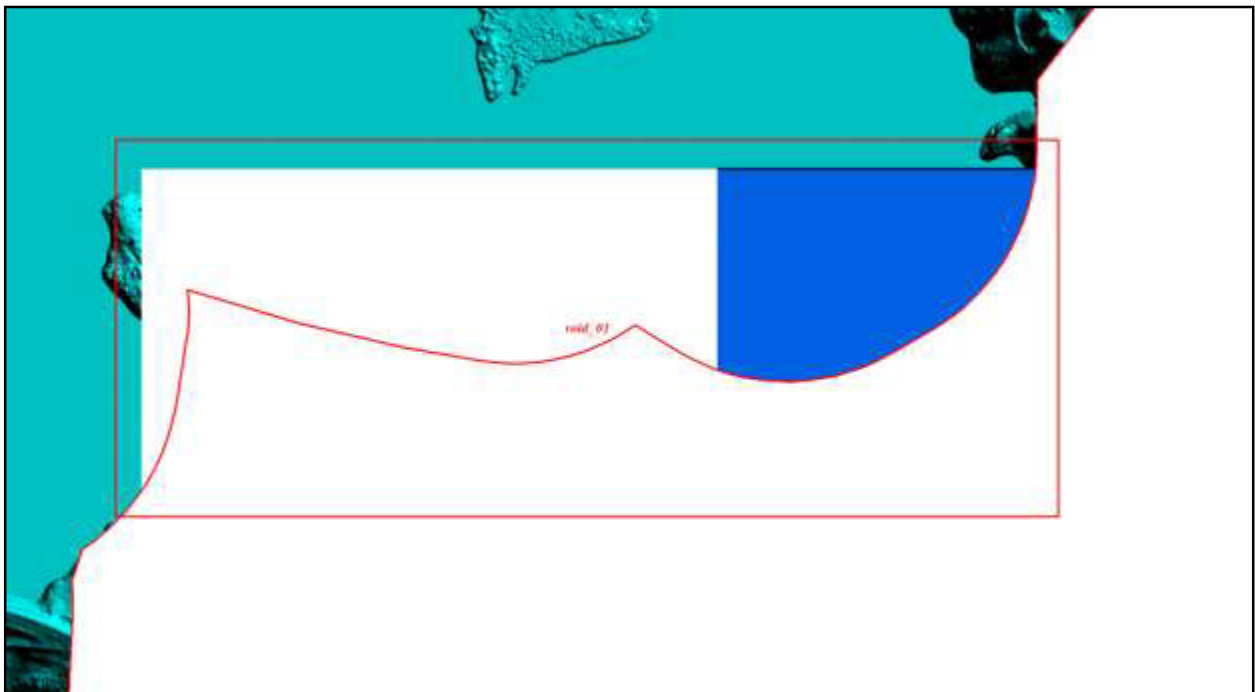
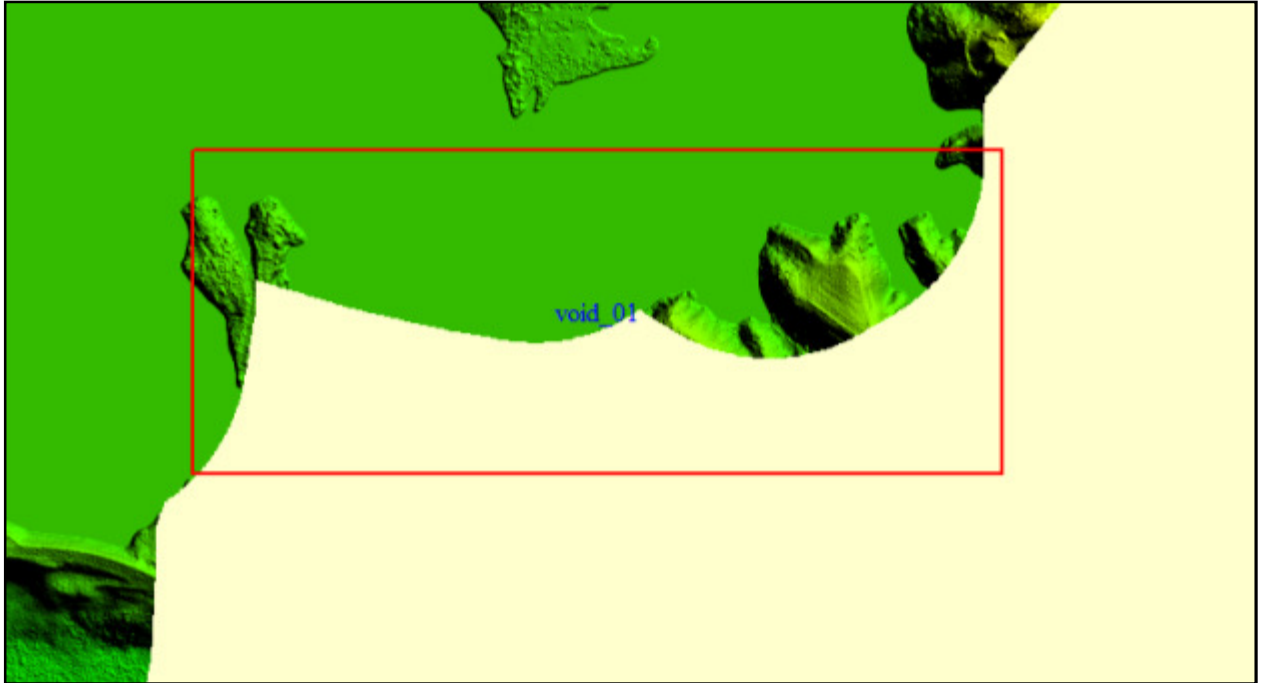
The USGS identified a tile with a void due to a processing error. The DEM was recreated to remove this error from the data.

Figure 1 - Before/After image of DEM_S13_9658_20 showing that the data gap is addressed in the new delivery.

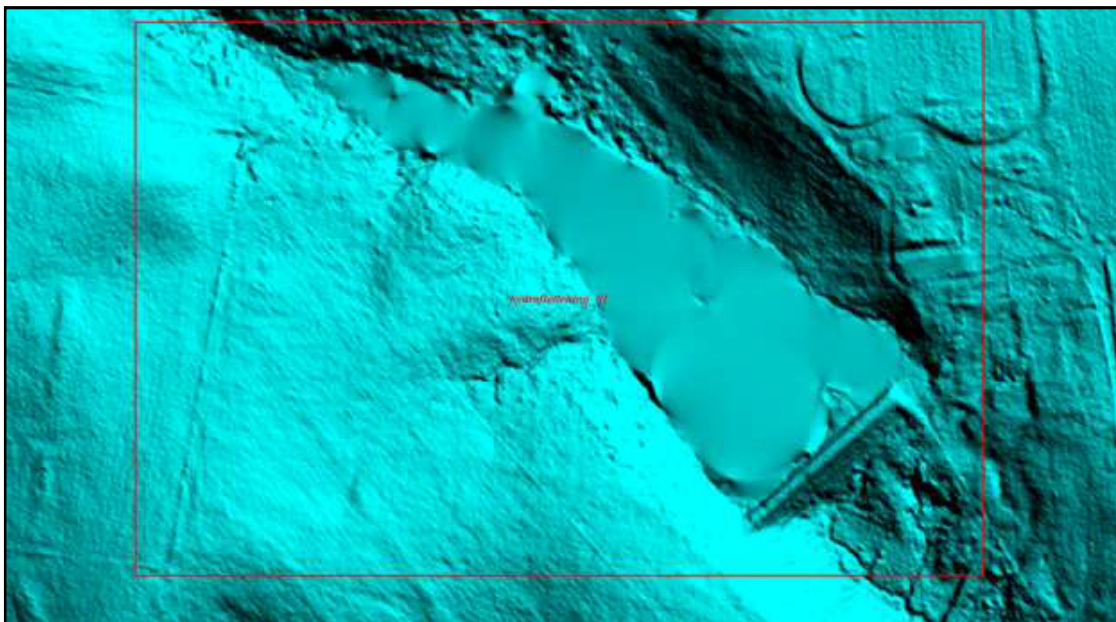
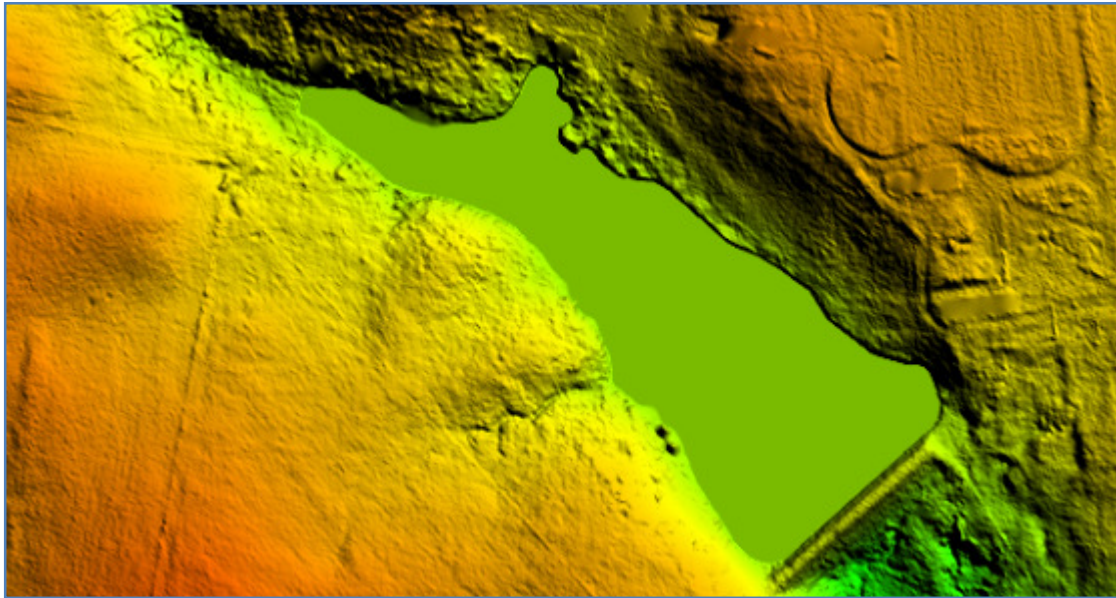
The USGS identified five missing lake/pond features that meet project specifications for collection. The lake/pond features have been added to the breaklines in the 2nd delivery and the LAS and DEMs were reprocessed to address the modifications. An example of the applied corrections can be seen below in Figure 2.

Figure 2 - Before/After of tile DEM_ S13_9626_40 showing that the lake/pond feature is now hydro-flattened in the DEM. The breakline features have been added to the breakline GDB.

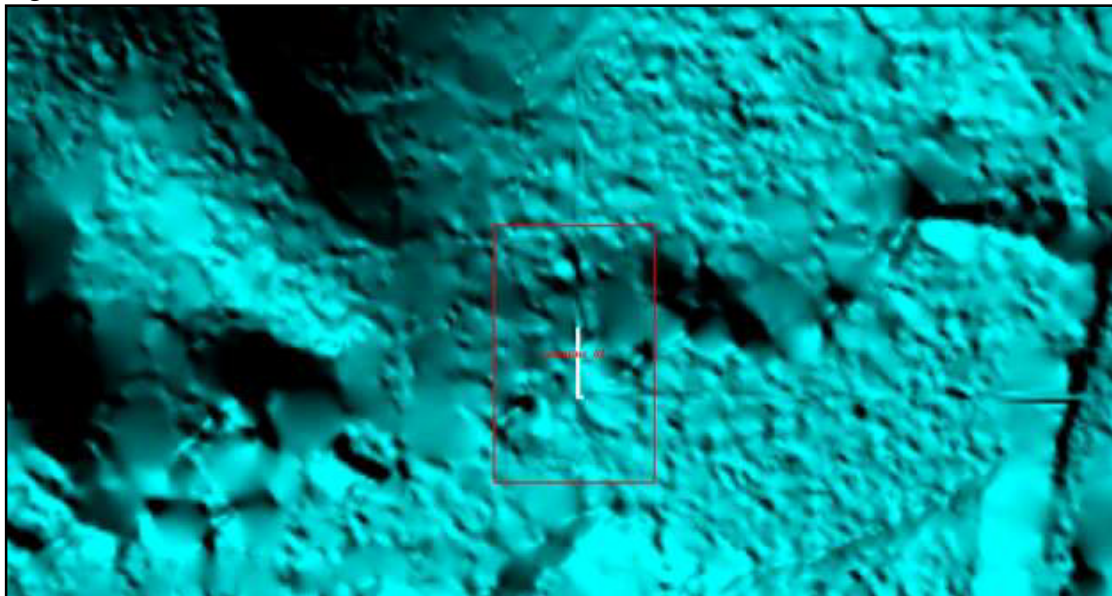
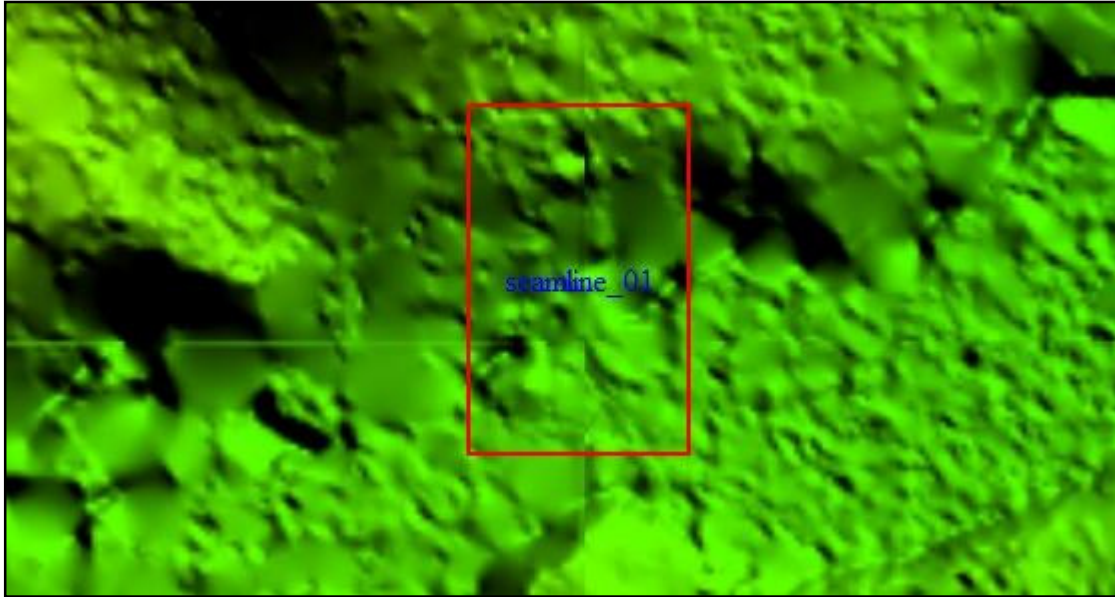
The USGS identified two areas where seam lines between DEM tiles were causing small voids. These two errors occurred at the intersection of 4 DEM tiles each, therefore 8 DEM tiles were reprocessed to remove these errors. An example of the applied corrections can be seen below in Figure 3.

Figure 3 - Before/After of DEM tiles S13_8784_40, S13_8794_10, S13_8783_30, and 8793_20. The void caused by the seam line between the tiles has been removed.

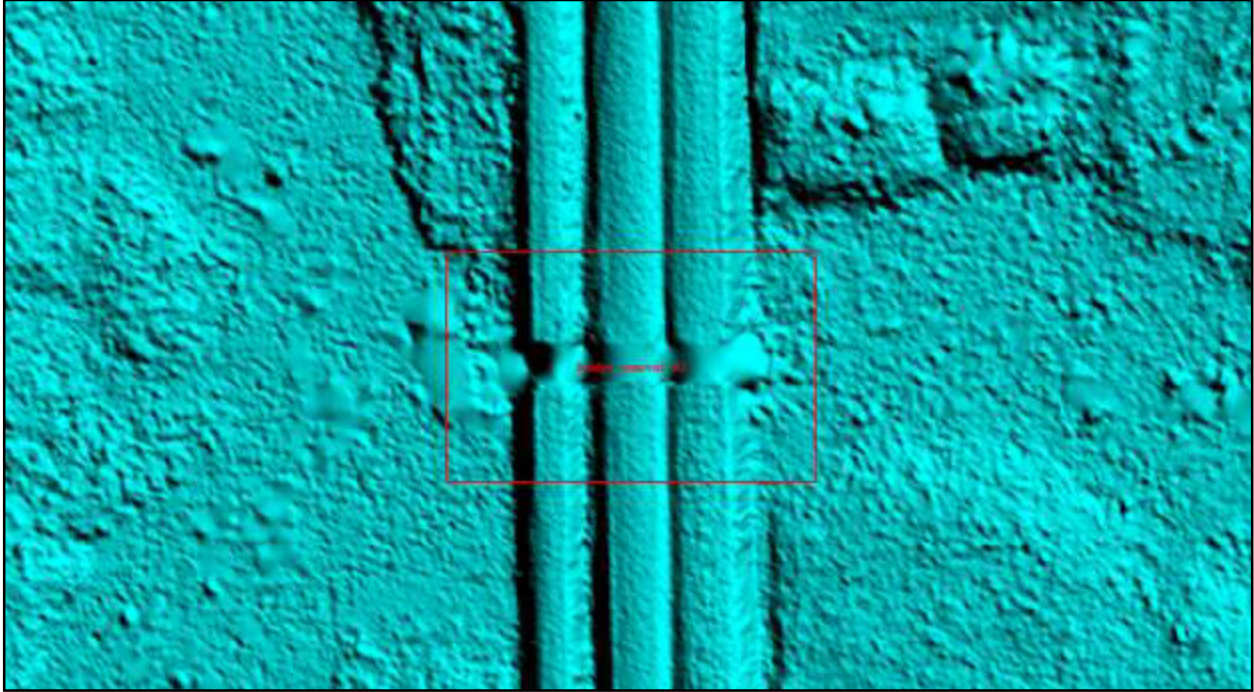
The USGS identified two occurrences where it appeared bridges or portions of bridges were left in the bare-earth surface. Dewberry reviewed these bridges and verified that no bridge points were left in the ground surface. The DEM surface models are created from TINs or Terrains. TIN and Terrain models create continuous surfaces from the inputs. Because a continuous surface is being created, the TIN or Terrain will use interpolation to triangulate across a bridge opening from legitimate ground points on either side of the actual bridge. This can cause visual artifacts or “saddles.” These “artifacts” are only visual and do not exist in the LiDAR points or breaklines. No points were modified at these locations. Figures 4 -6, below, show the bridge features are classified correctly.

Figure 4 - Image provided by USGS of digital elevation model for tile DEM_S13_8516_30.

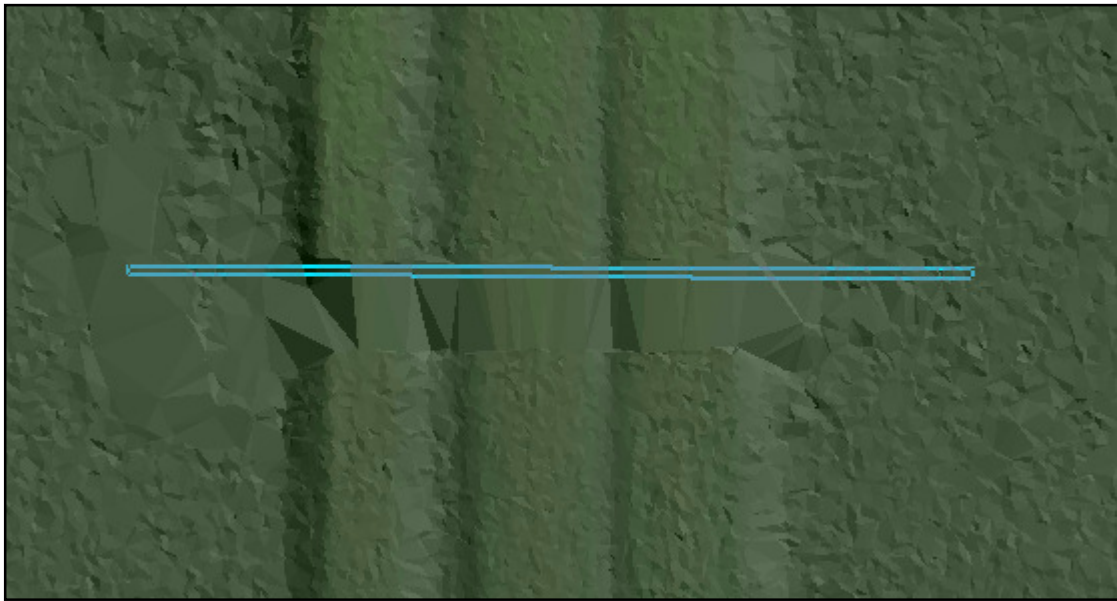
Figure 5 - Ground model of tile LAS_S13_8516_30 showing the same area as image above. The rectangular box shows the location of the cross-section provided below.

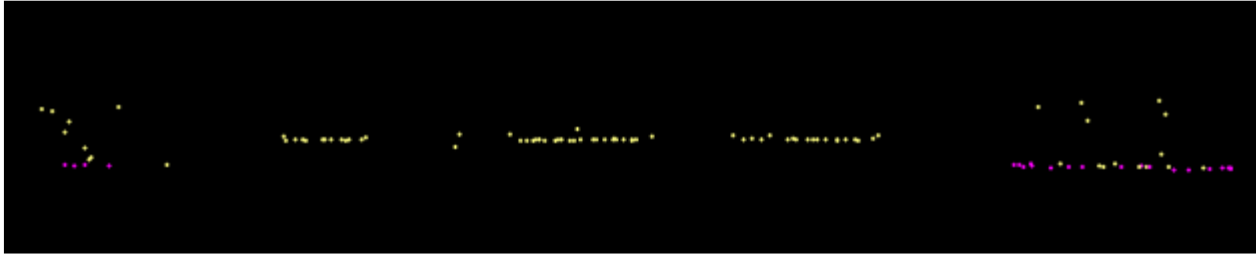
Figure 6 - Profile of LAS from tile LAS_ S13_ 8516_30. The yellow points are Class 1 (unclassified) and purple points are Class 2 (ground). The bridge is completely removed from the ground points.
