Dewberry's Response to USGS' Review

Northern Counties Acquisition and Classification for FEMA VA LiDAR

**USGS Contract:
G11PD00089**

Report Date: March 27, 2012

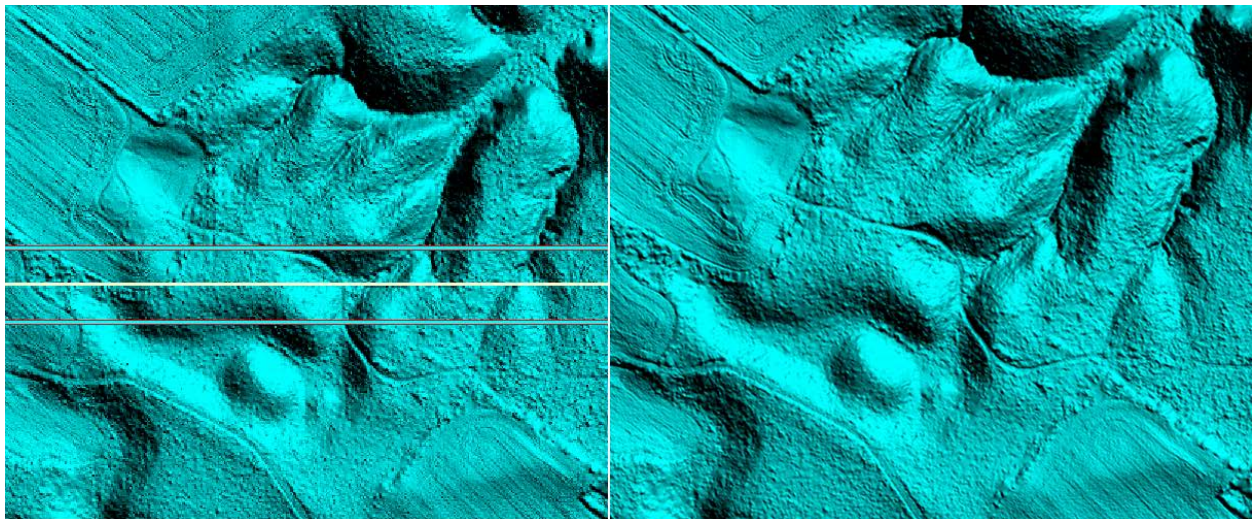
The USGS called out a linear feature where no data appeared in the DEMs. The gap was ~10 feet in width, ran east to west, and occurred between the seams of tiles. Dewberry reprocessed the 31 DEMs and this issue no longer exists. Figure 1 shows an example of new DEMs with no pixel gap.

Figure 1 – Before/After image of DEM_N26_0618_30 and DEM_N26_0619_40 showing that the data gap is addressed in the new delivery (image on the right).

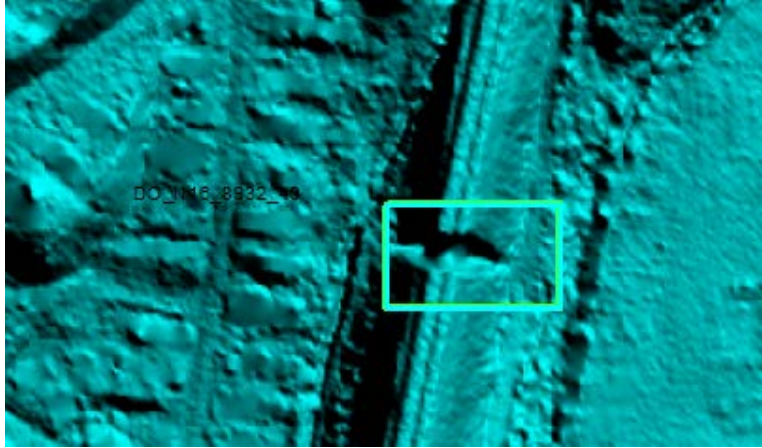
The USGS identified 4 culverts that were removed from the ground model because they were assumed to be bridges. These culverts were added back to the ground model in the LAS tiles and the DEMs were reprocessed to reflect these changes. Figure 2 to Figure 5 show two examples of how the culverts were added back to the ground model.

Figure 2 - Image provided by USGS of digital elevation model of tile DEM_N16_8932_40.

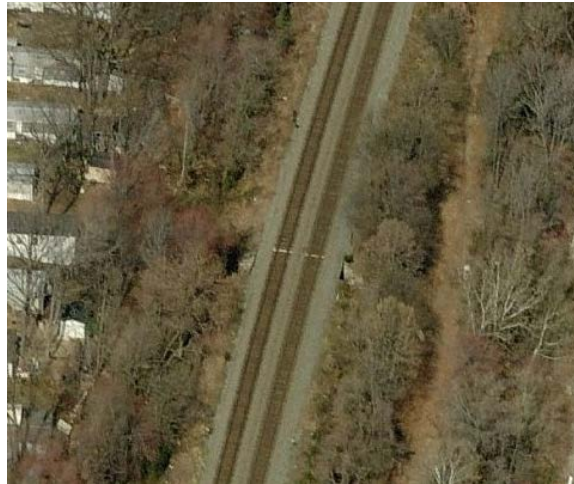
Figure 3 - Bing aerial imagery showing the feature is a culvert.

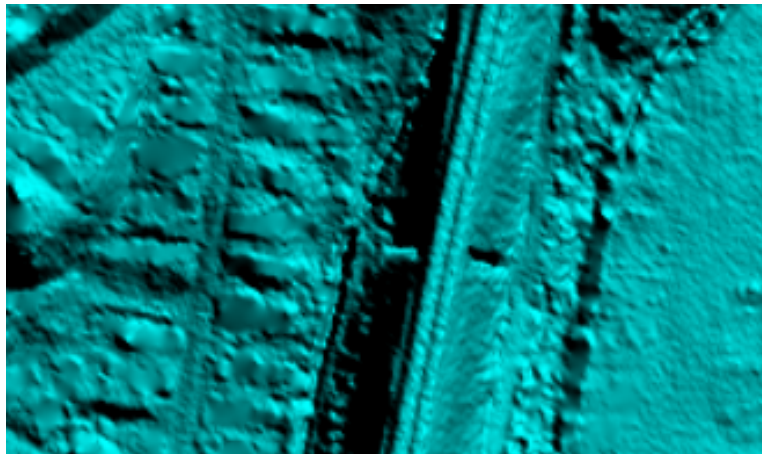
Figure 4 - New digital elevation model of DEM_N16_8932_40 showing the culvert is added back to the ground.

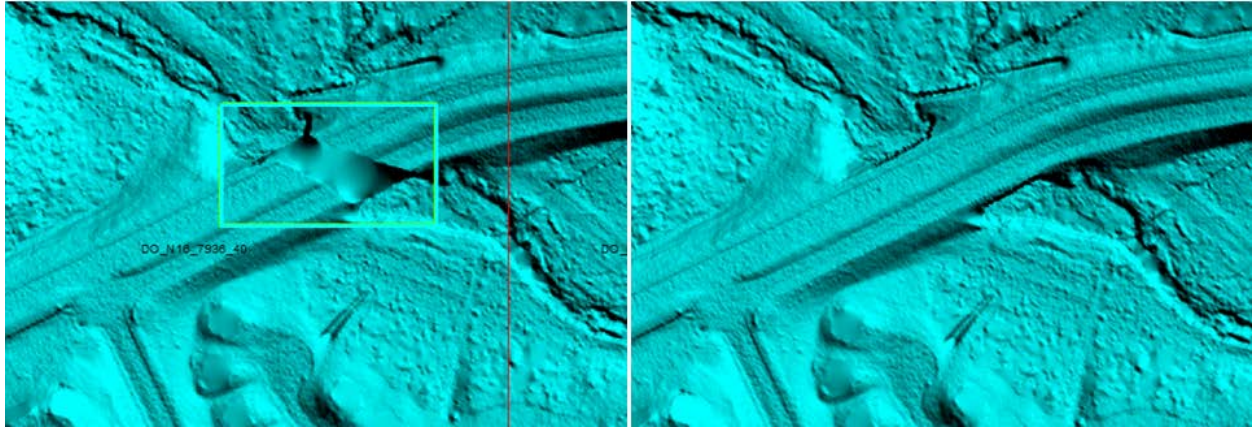
Figure 5 - Before/After image of tile DEM_N16_7936_40. The culvert is added back to the ground model.

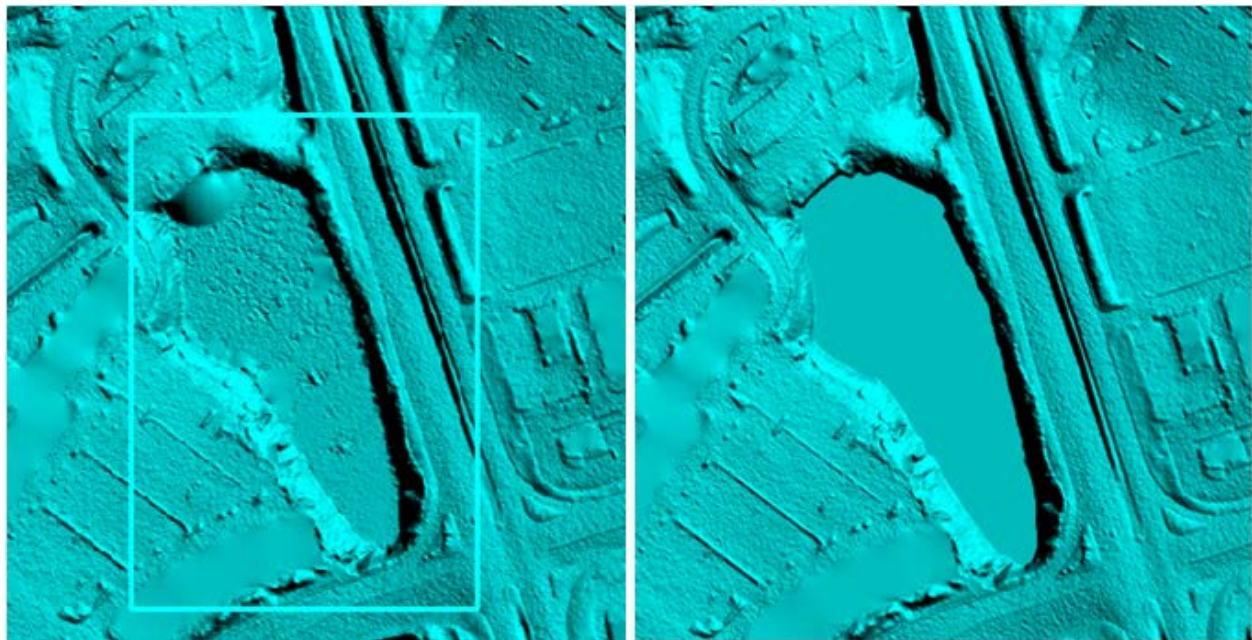
The USGS called out 3 issues with the breaklines. One of these issues was a lake that was not collected in the initial delivery. The lake feature was added to the breaklines in the 2nd delivery and the LAS and DEM was reprocessed to address the change (Figure 6). An additional issue was an edit to the tidal waters breaklines where additional coastline was added to the breaklines. The change to the tidal waters breaklines was addressed in both the LAS and DEM (Figure 7 and Figure 8). The last change was a monotonicity issue where a river drops several feet in elevation over a short length. The area was reprocessed and manually edited to force the stream to flow monotonically (Figure 9 and Figure 10).

Figure 6 – Before/After of tile DEM_N16_7967_10 showing that the lake feature is now hydro-flattened in the DEM. The breakline features are added to the breakline GDB.

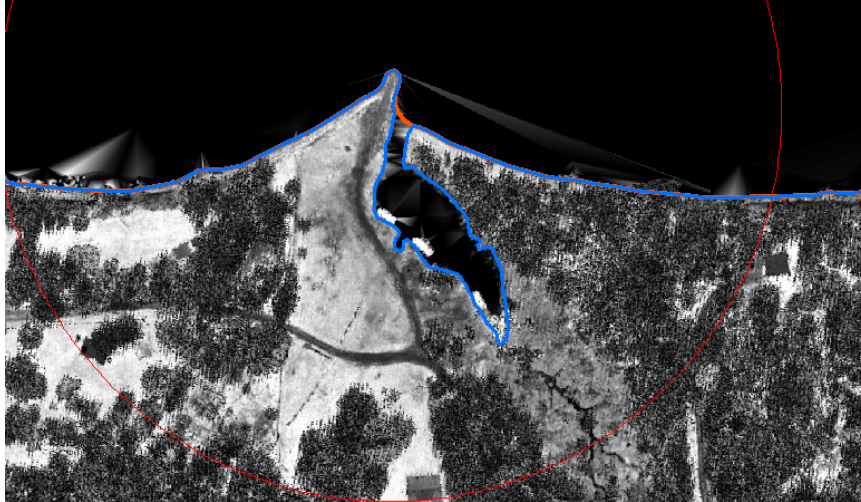
Figure 7 - Full point cloud intensity of LAS_N16_8850_30. The blue line is the new breakline and the orange line is the old breakline. The new breakline incorporates the inlet.

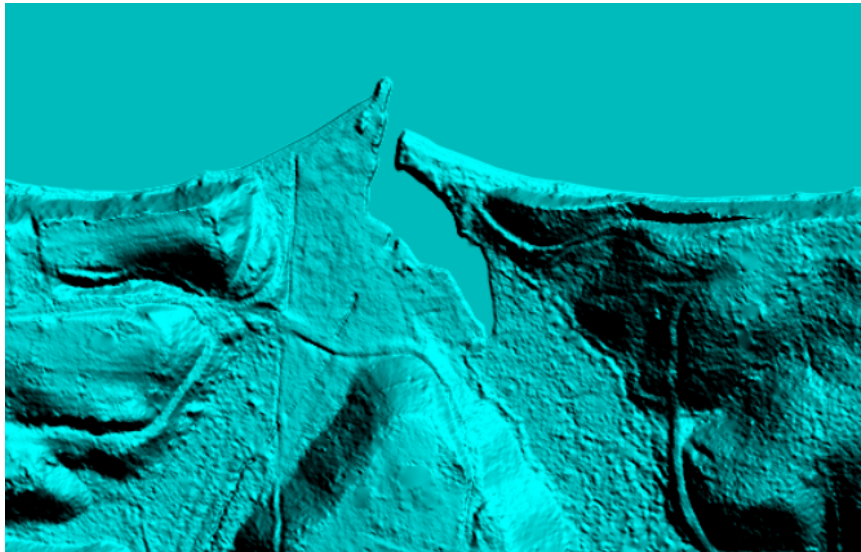
Figure 8 - Digital elevation model of DEM_N16_8850_30 showing the area is hydro-flattened.

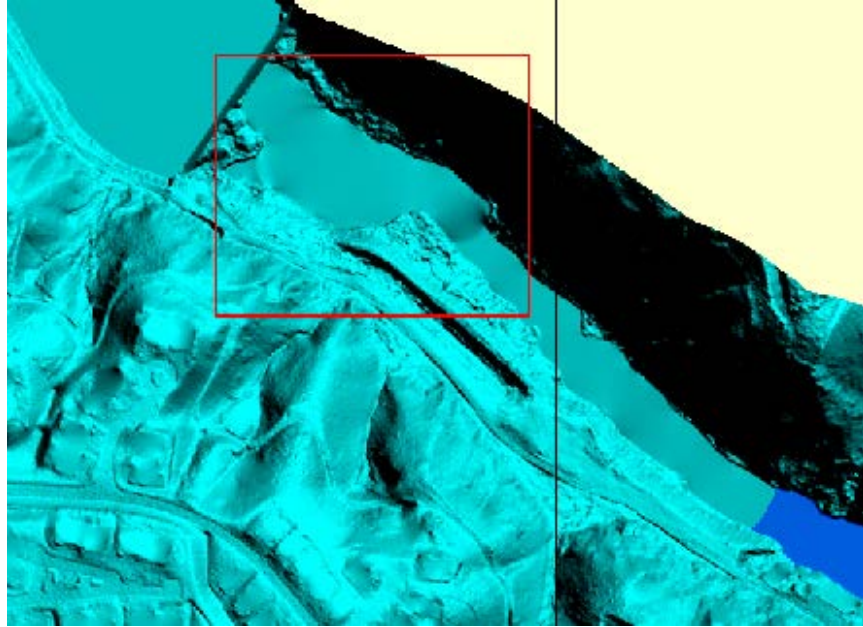
Figure 9 – Digital elevation model of DEM_N16_8933_20 and DEM_N16_8933_30 of initial delivery. There are monotonic issues in this delivery.

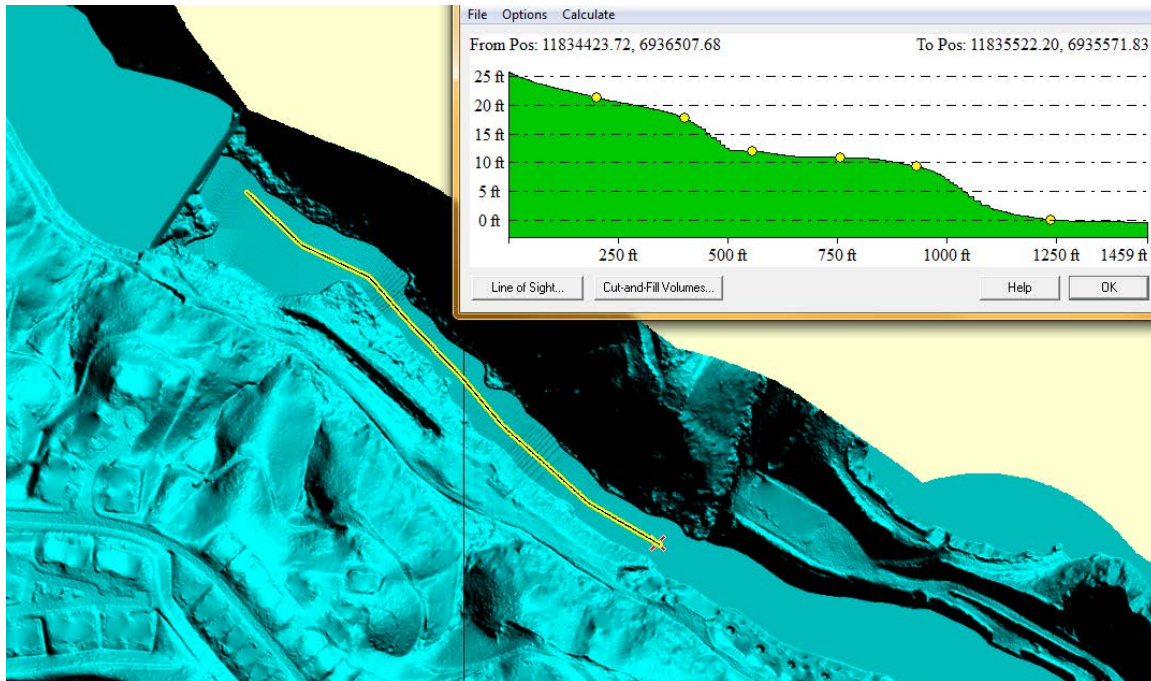
Figure 10 - Digital elevation model of DEM_N16_8933_20 and DEM_N16_8933_30 of second delivery. The monotonic issues are addressed and the stream flows downhill correctly.

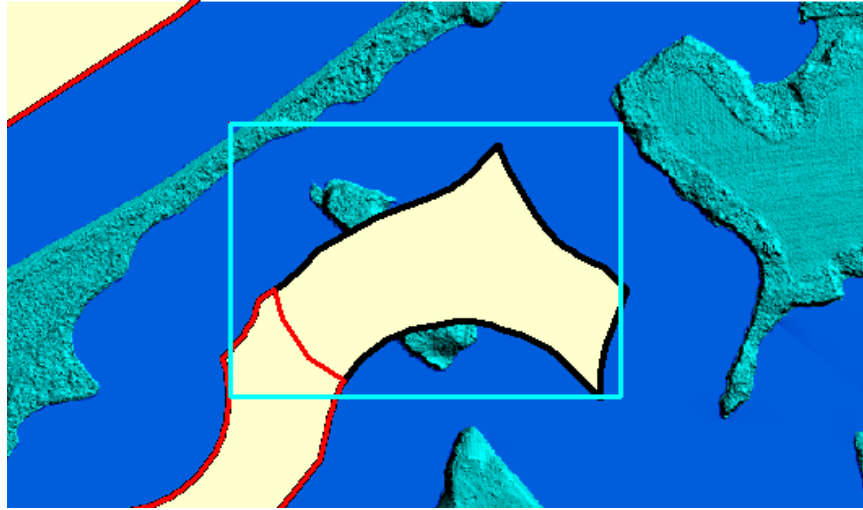
The USGS called out 6 areas of data voids. Upon review, it was determined that these areas fall outside the project boundary and, with the exception of one call, occur in water. Therefore, no edits were made to the majority of the calls. One change was made to the project boundary to add an island to the

Figure 11 - Image provided by USGS of digital elevation model of tiles DEM_N26_0618_30 and DEM_N26_0619_40. The red line is the new project boundary and the black line is the old project boundary. The new line incorporates the island into the ground model.

ground model. The LAS, breaklines, and DEMs were all reprocessed to reflect this addition (Figure 11 and Figure 12).

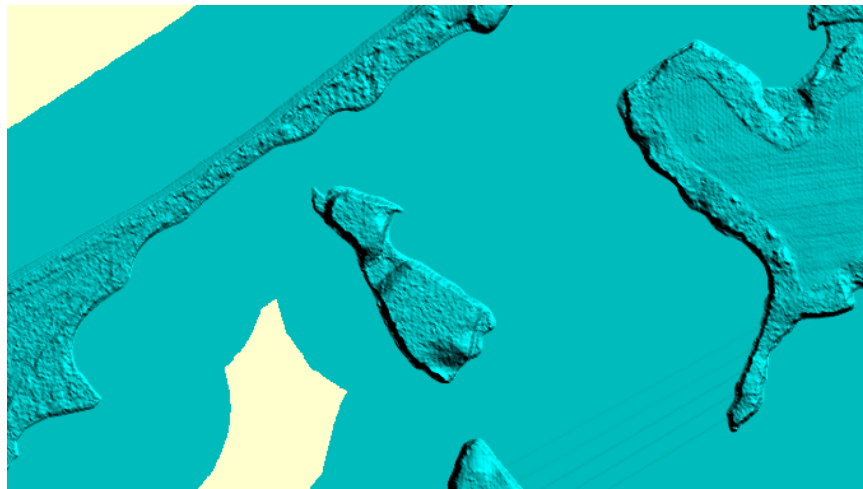
Figure 12 – Digital elevation model of tiles DEM_N26_0618_30 and DEM_N26_0619_40 showing the island is incorporated into the ground model in the 2nd delivery.

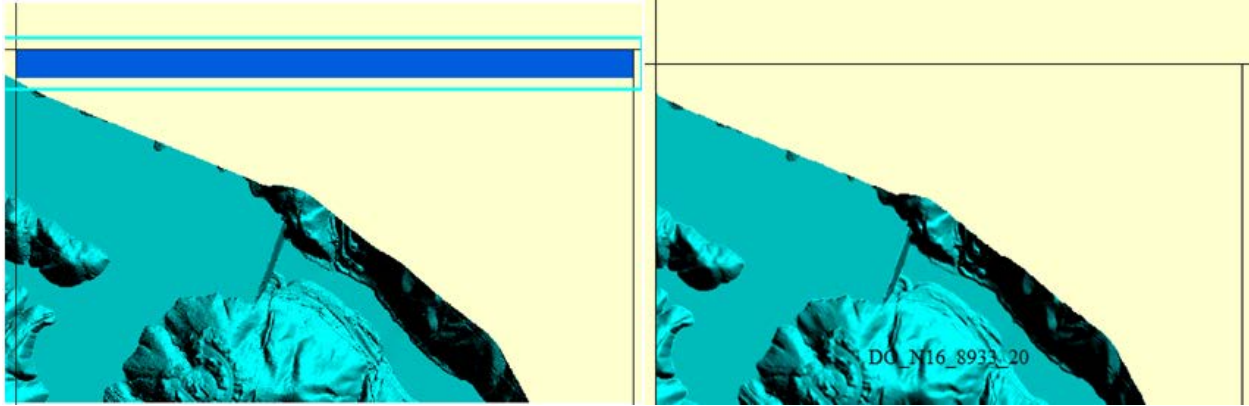
The USGS identified an artifact from clipping a DEM that was left in the original dataset. The DEM was reprocessed and does not exist in the 2nd delivery (Figure 13).

Figure 13 - Before/After of tile DEM_N16_8933_20 showing that the artifact is removed in the 2nd delivery (image to the right).

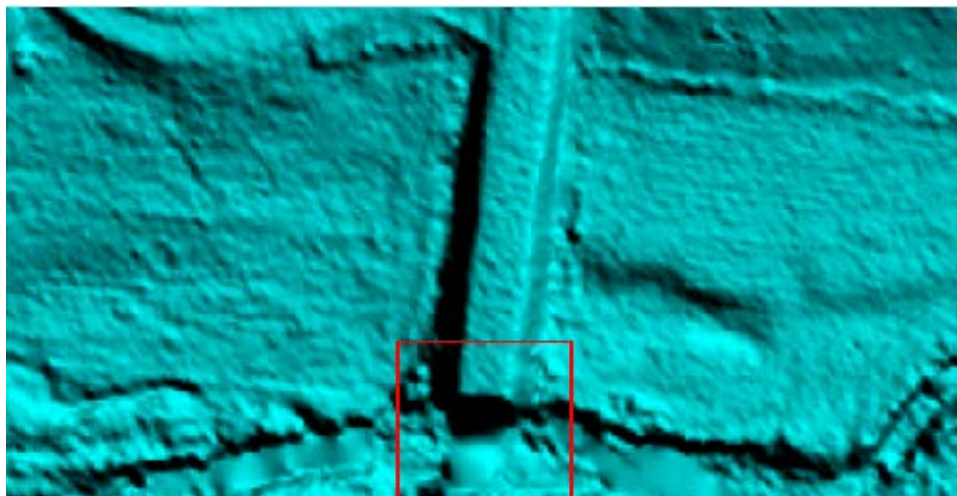
The USGS called out 19 occurrences where the appearance of a bridge was left in the digital elevation model. The DEM surface models are created from Terrains. Terrain models create continuous surfaces from the inputs, in this instance LiDAR ground points and breaklines. Because a continuous surface is being created, the Terrain will interpolate and triangulate across a bridge opening from legitimate ground points on either side of the actual bridge. This makes the model appear to contain a bridge feature when in fact the points on the bridge have been removed from the ground. Therefore, 18 of the 19 edit calls resulted in no change. Figure 1 through Figure 4, below, show examples of how a bridge appears to be left in the surface model due to interpolation, but is in fact removed from the ground surface. Figure 5 below shows the one change to the LAS where a bridge was fully removed from the ground model.

Figure 14 - Image provided by USGS of digital elevation model of tile DEM_N17_7020_30.

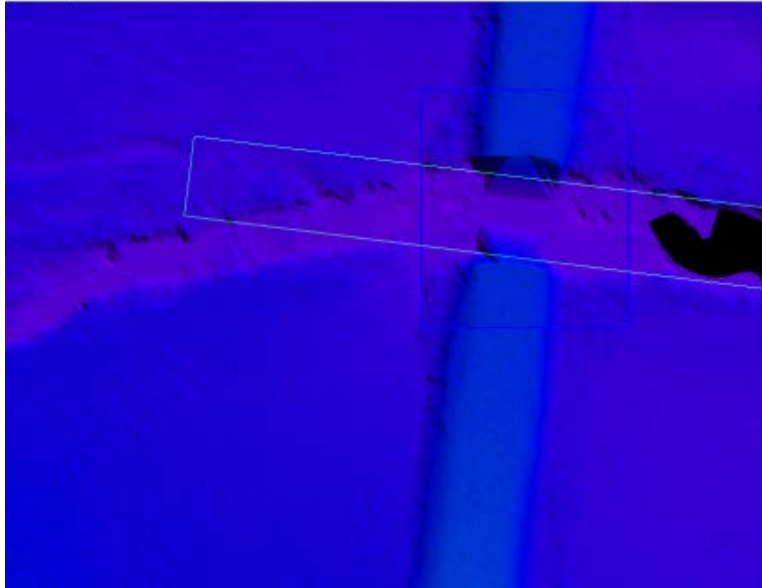
Figure 15 - Ground model of tile LAS_N17_7020_30 showing the same area as image above. The rectangular box shows the location of the two cross-sections provided below.

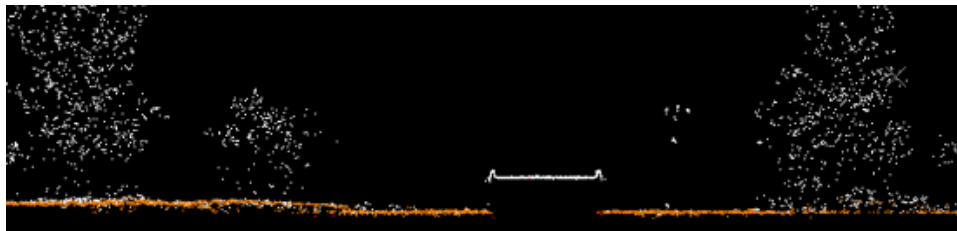
Figure 16 - Profile of LAS from tile LAS_N17_7020_30. The white points are Class 1 (unclassified) and orange points are Class 2 (ground). The bridge is completely removed from the ground points.

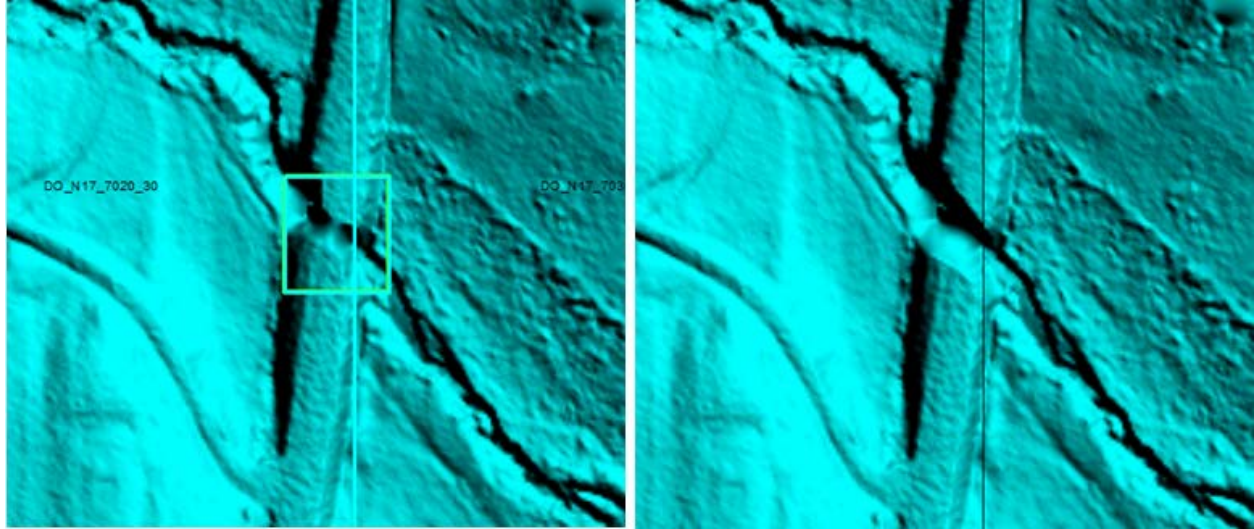
Figure 18 – Before/After image of tile DEM_N17_7020_30. The bridge is fully removed in the ground.

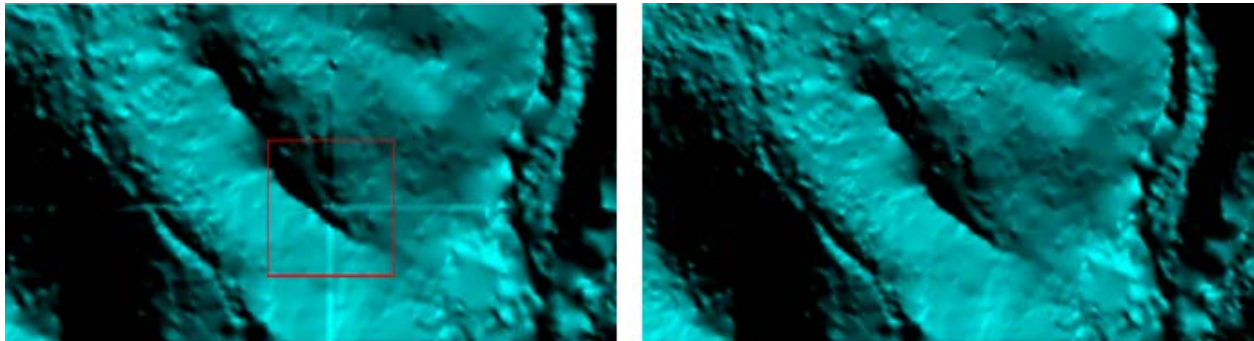
The USGS identified 2 areas where a visible seam appeared between 2 tiles. This seam is a product of the way Global Mapper visually represents the data and is not an artifact that requires fixing in the DEMs. No changes were made to the DEMs. DEMs were mosaicked at these seams to show that no visible difference in elevation or shift in pixels is present in the final data (Figure 19 and Figure 20).

Figure 19 – Image to the left is how Global Mapper represents the data and image on the right are the DEMs mosaicked together showing no visible seam exists. The 4 DEMs shown here are DEM_S13_9932_20, DEM_S13_9932_30, DEM_S13_9932_10, and DEM_S13_9932_40.

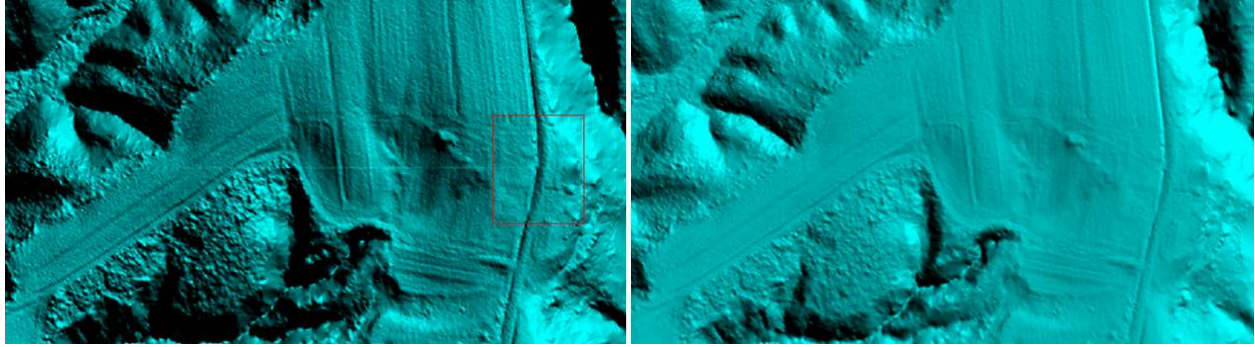
Figure 20 - Image to the left is how Global Mapper represents the data and image on the right are the DEMs mosaicked together showing no visible seam exists. The 4 DEMs shown here are DEM_S13_9940_20, DEM_S13_9940_30, DEM_S13_9940_10, and DEM_S13_9940_40.

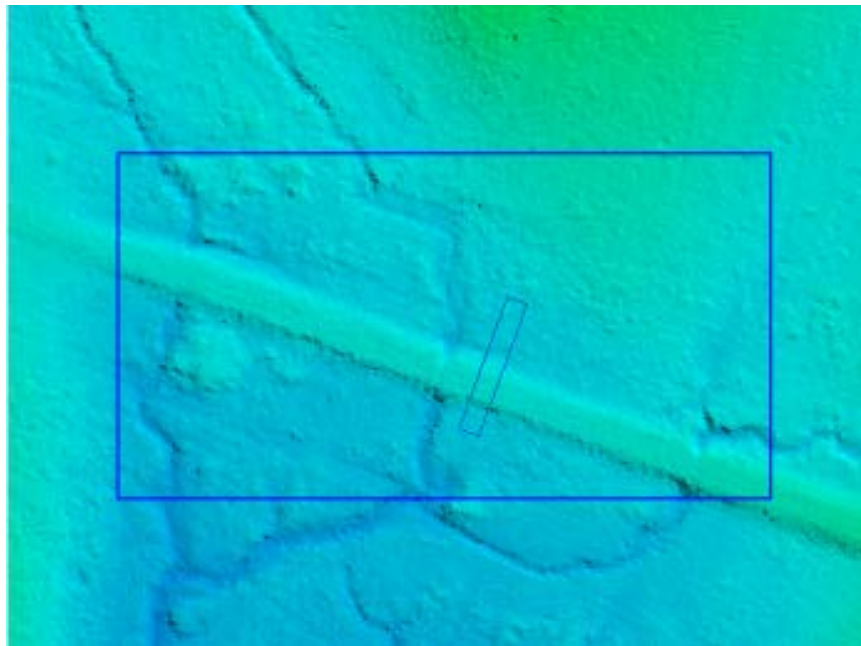
The USGS identified one ground anomaly. This area was investigated and it was determined that the model represents the current ground conditions so no changes were made.

Figure 21 - Digital ground elevation model of tile LAS_N16_7981_10. The larger boxed area was called by the USGS. The smaller box shows the profile of the next image.

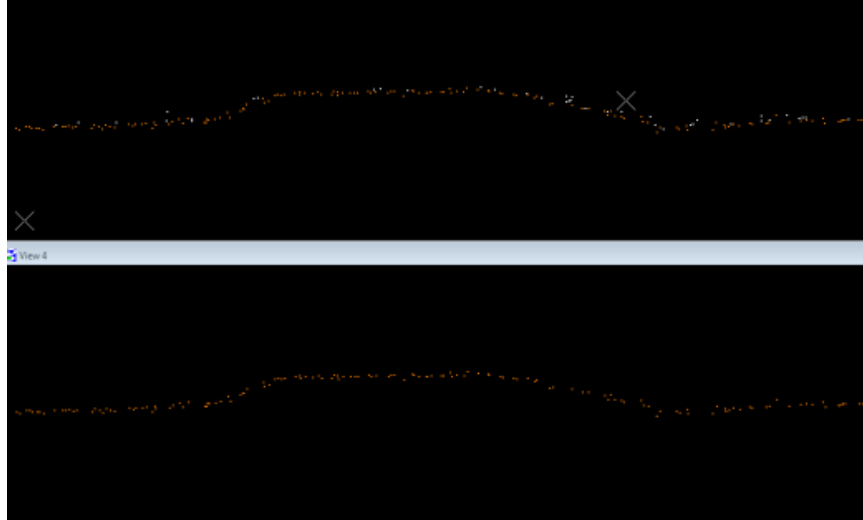
Figure 22 - Profile of LAS from tile LAS_N16_7981_10. The white points are Class 1 (unclassified) and orange points are Class 2 (ground). The ground is accurately depicted in this area.
