# **Dewberry Response to USGS/FEMA Region 2 Review of the NY Great Lakes Area QL2 LiDAR - Orleans County Processing Project**

Produced for U.S. Geological Survey

USGS Contract: G10PC00013

Task Order:G14PD00043

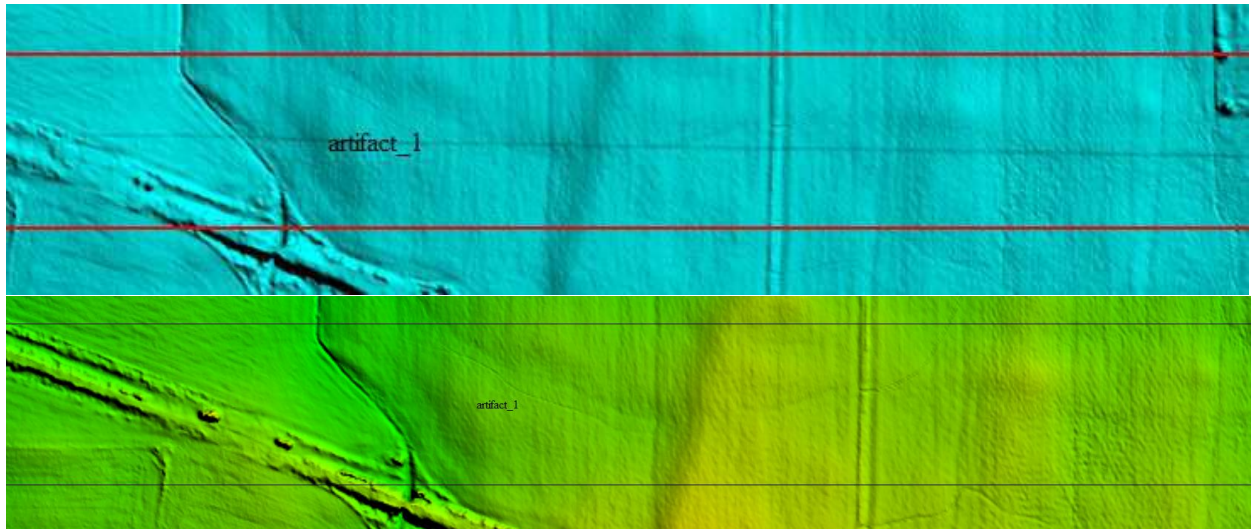
There were two locations where the USGS identified places that had what appeared to be artifacts and not represent the true ground surface.

Figure 3- Tile 17TQJ555005. Artifacts have been removed from the DEM surface. Top is before bottom is after.

- There was two calls to address anomalies with the DEM surface
  - Both issues have been corrected.

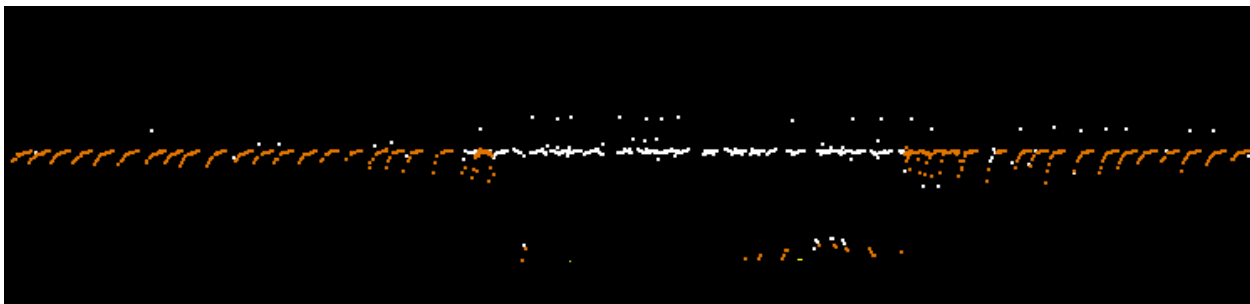
There were seven locations where USGS made calls regarding visual artifacts. The DEM surface models are created from TINs or Terrains. TIN and Terrain models create continuous surfaces from the inputs. Because a continuous surface is being created, the TIN or Terrain will use interpolation to triangulate across a bridge opening from legitimate ground points on either side of the actual bridge. This can cause visual artifacts or “saddles.” These “artifacts” are only visual and do not exist in the LiDAR points or breaklines. No points were modified in these locations. Breaklines were placed to remove the “saddles” in the DEM.

Figure 4-Tile 17TQJ450020. No additional points can be removed from ground classification. Bridge “saddles” are a visual artifact resulting from interpolation of a continuous surface. Breaklines are placed to remove “saddles” in the DEM.

- There were seven calls to remove bridges or bridge related artifacts.
  - All calls have been fixed.

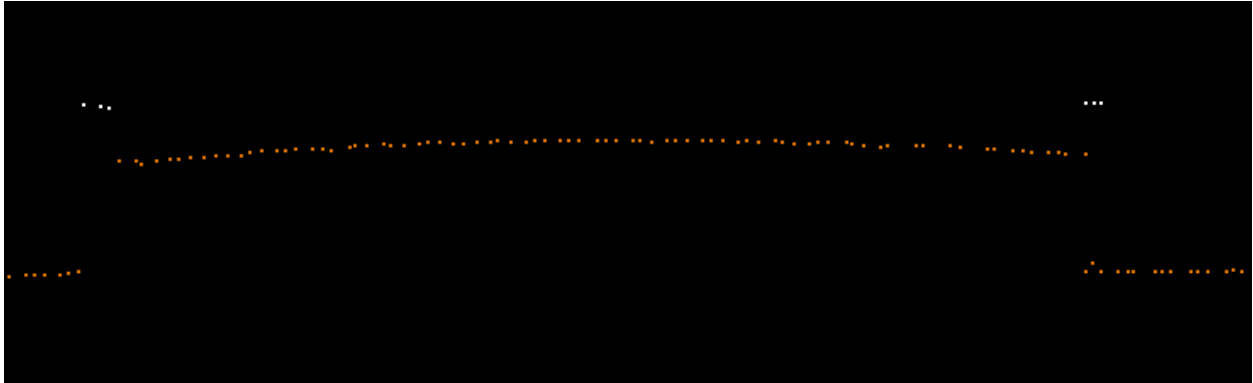
There was one locations where Dewberry interpreted a feature as a bridge and removed it from the ground surface. USGS identified these features as culverts, not bridges. Dewberry has modified the points and added these features to the ground surface. An example is shown below.

Figure 5-Tile 17TQH210885. Culverts have been reclassified from class 1 (white) to ground (orange).

- There was one call to replace culverts.
  - All available points have been added back to ground at this locations.

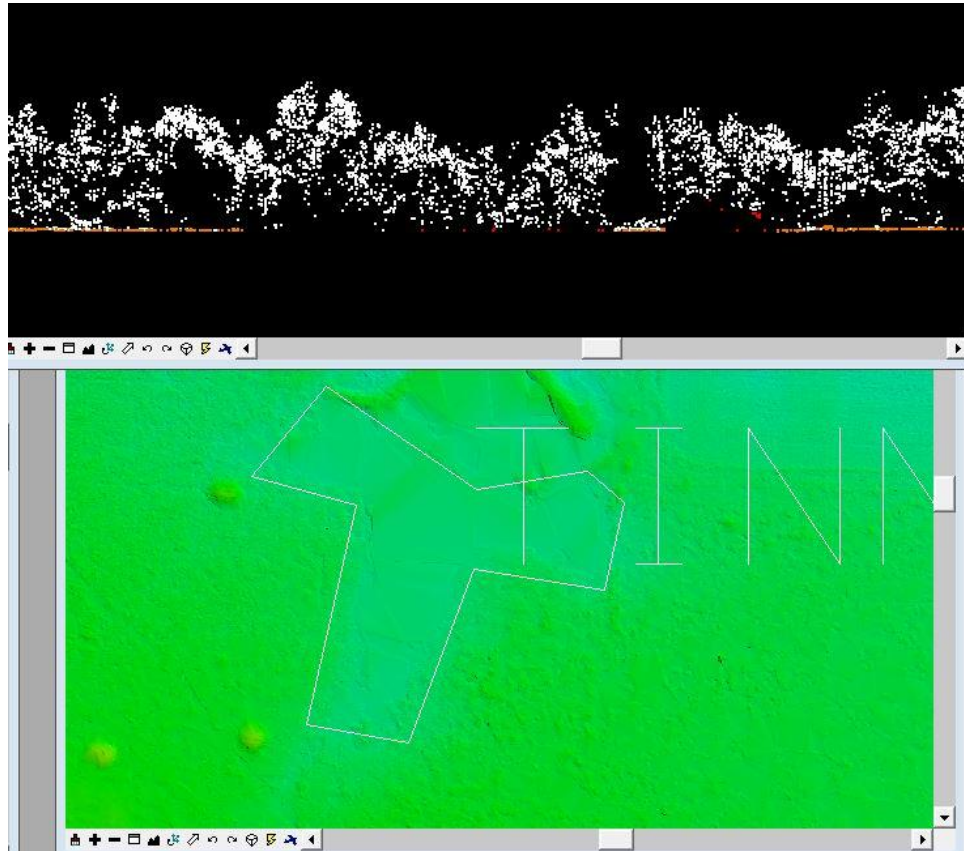
There were twenty five calls to bring back more ground in vegetated areas. In most areas there were no extra ground point to add back to the surface. Attempts were made to add points if possible, but DEM surfaces still look very similar. Examples are shown below.

Figure 6-Tile 17TQH345975. All possible points have already been moved to ground (orange). No modification required as no new points to add to the ground surface.

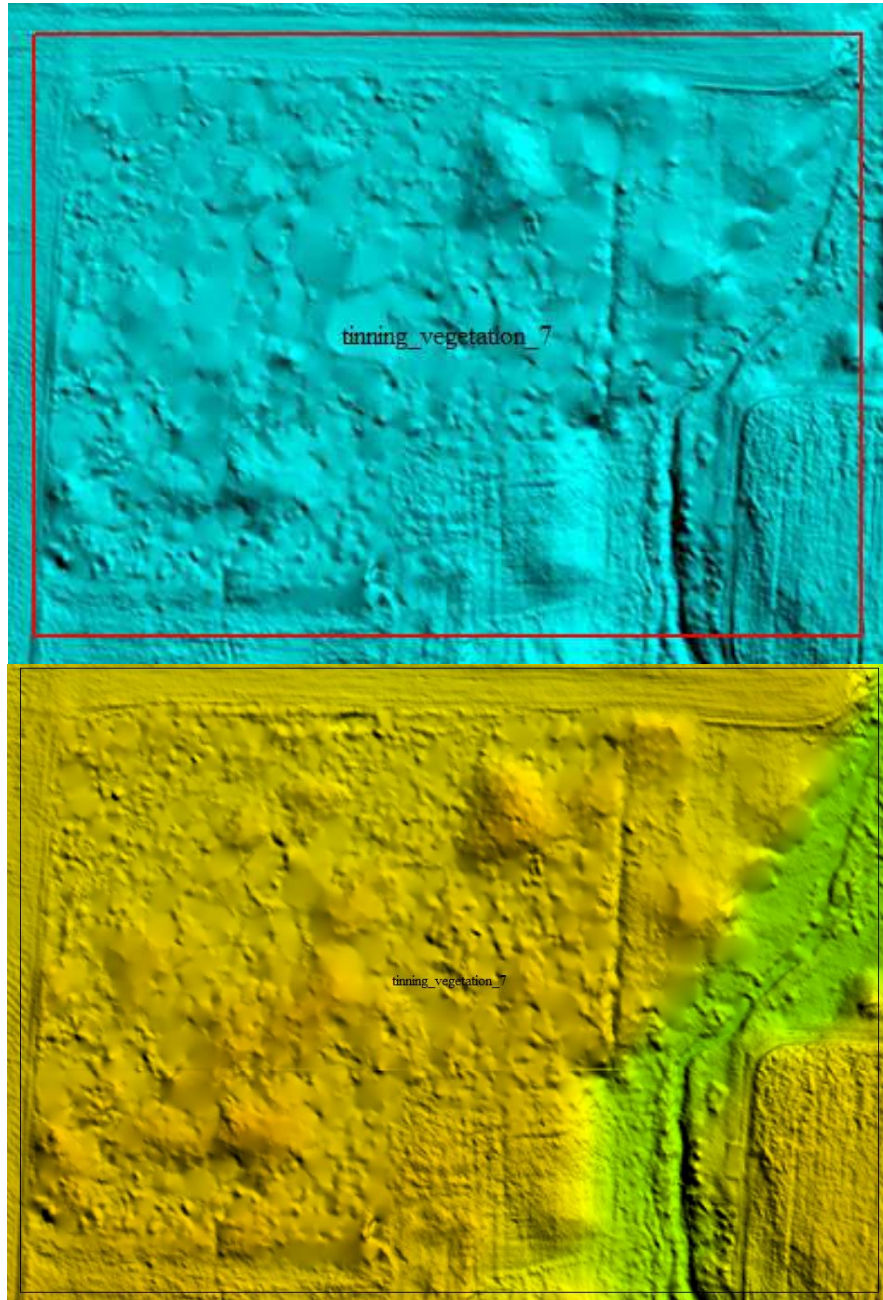
Figure 7-Tile 17TQH255055. Comparing the before (top) to after (bottom) showing no real change when adding points back to the ground surface.

- There were 25 calls about tinning in vegetated areas.
  - Efforts were made to correct these places, but it seemed to have little effect on the final DEM.

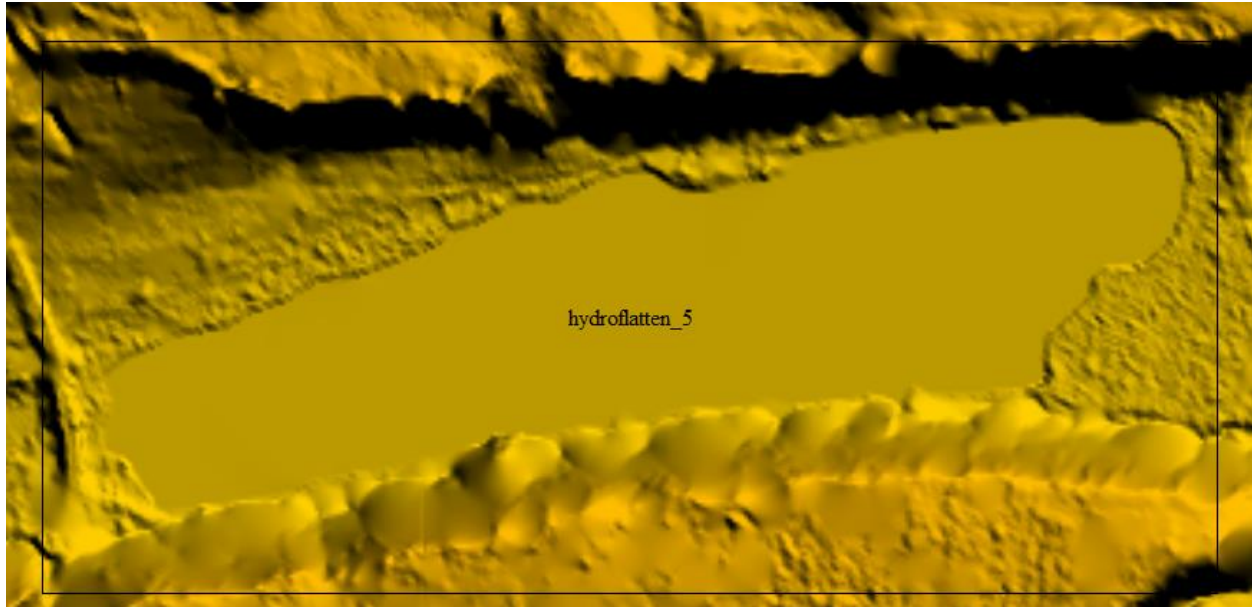
There were 7 locations where USGS identified areas of water that were not included in the collected breaklines. While the interpretation of the feature may be questionable in the intensity imagery, Dewberry agrees with all seven calls after reviewing color imagery and the available LiDAR points.

Figure 8 – Tile 17TQH300960. An additional pond breakline has been collected for this feature and used to flatten the feature in the redelivered DEM. The LAS has been corrected to reflect the addition of this feature.

- There were seven calls to modify breaklines.
  - All seven of these issues have been corrected.

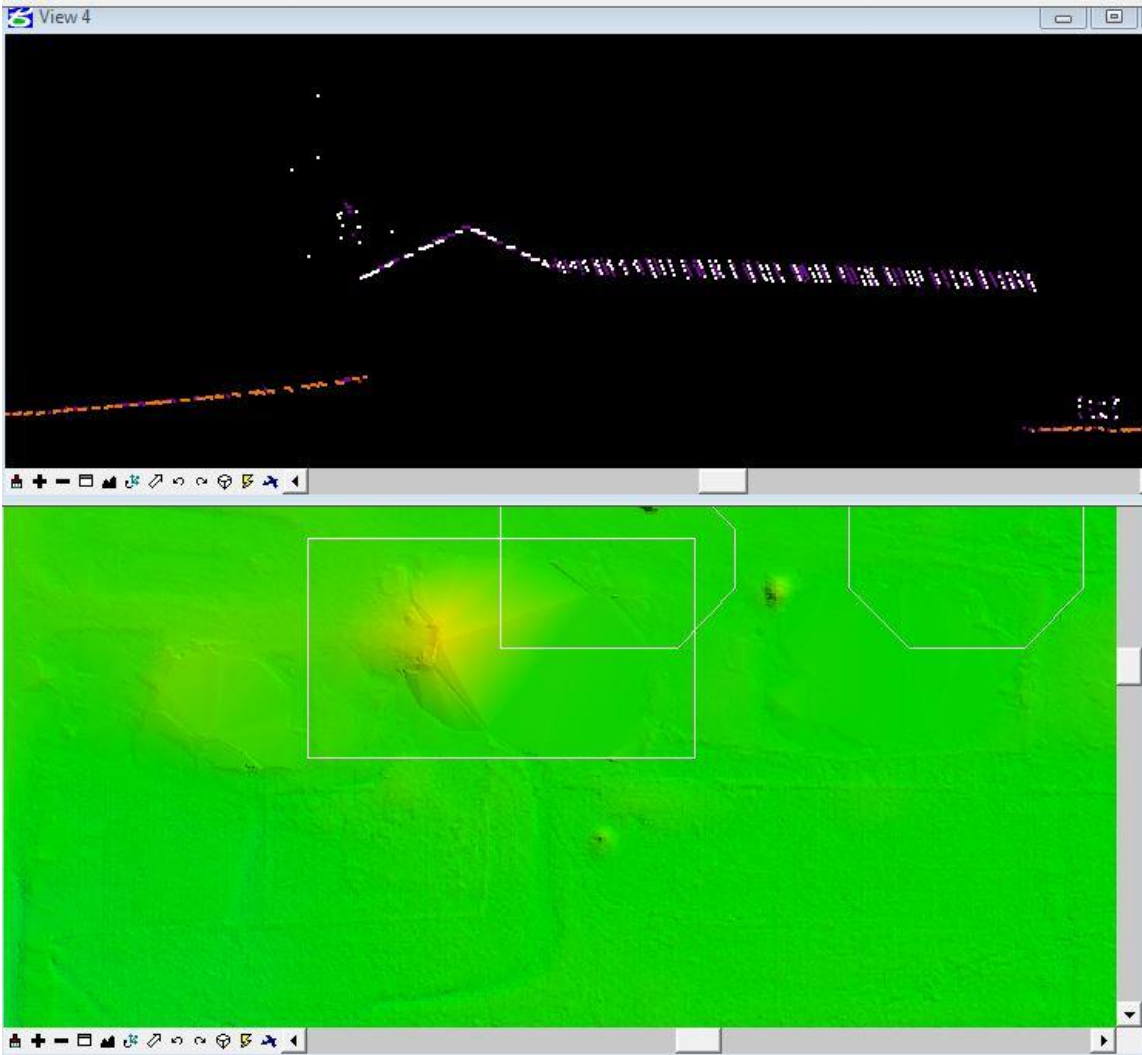
There were three locations where the USGS identified places that had what appeared to be buildings left in the ground surface and not represent the true ground surface. Two of the calls had the point adjusted and one was not changed because the points are part of a ground feature see screen shot below.

Figure 9 – Tile 17TQH210930. The area called out as part of a building being left in the ground (orange) is part of a berm built up behind the structure.

- There were three calls to remove buildings or part of buildings left in the ground surface
  - Two of the calls where fixed.
  - One of the calls was not fixed since it was a legitimate ground feature.
