# Dewberry Response to USGS Review of the Texas West Central Project Block 12 LiDAR Project

Produced for U.S. Geological Survey

USGS Contract: G10PC00020

Task Order:140G0218F0072

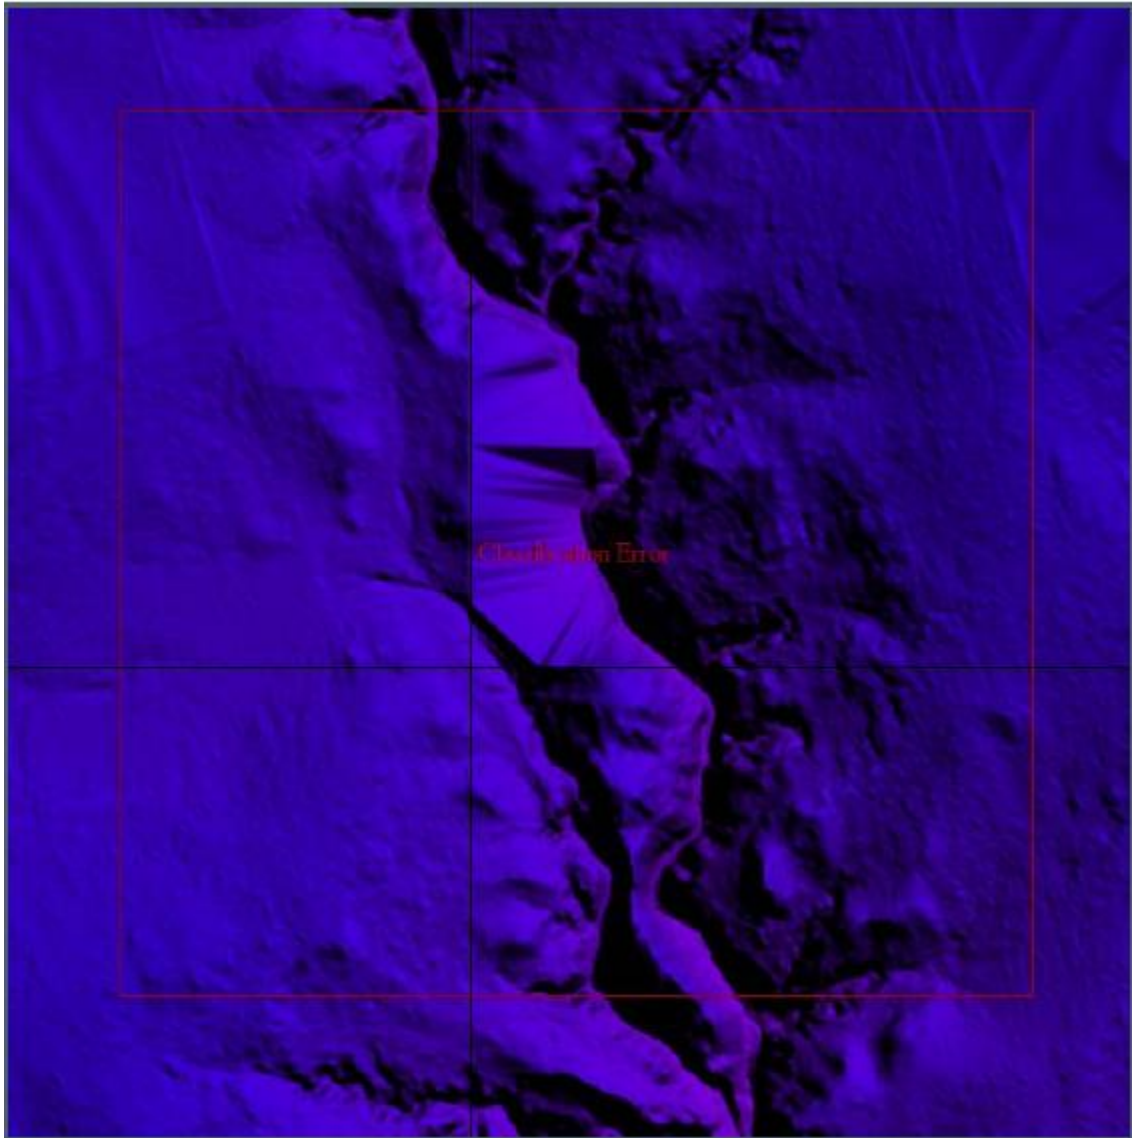
Figure 4 – Tile 14SLB705510 – USGS screenshot.

USGS made one data void call where data was missing in Tile 14SLB705510. Dewberry reviewed the tile and added ground where necessary.

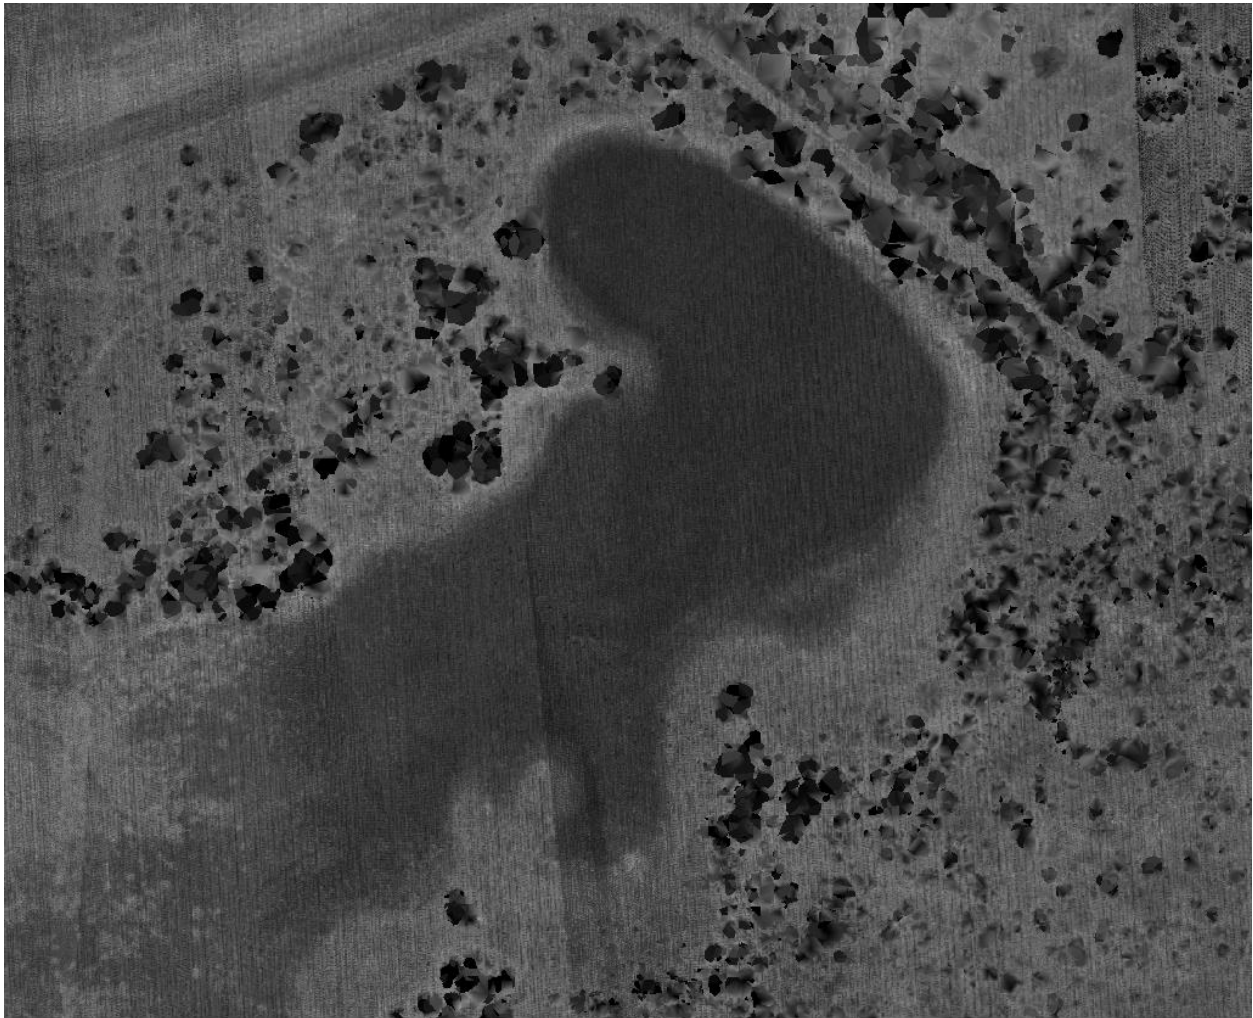
Figure 11 - Tile 14SLC750185 – Screenshot of intensity imagery shows waterbody is dry at the time of collection.

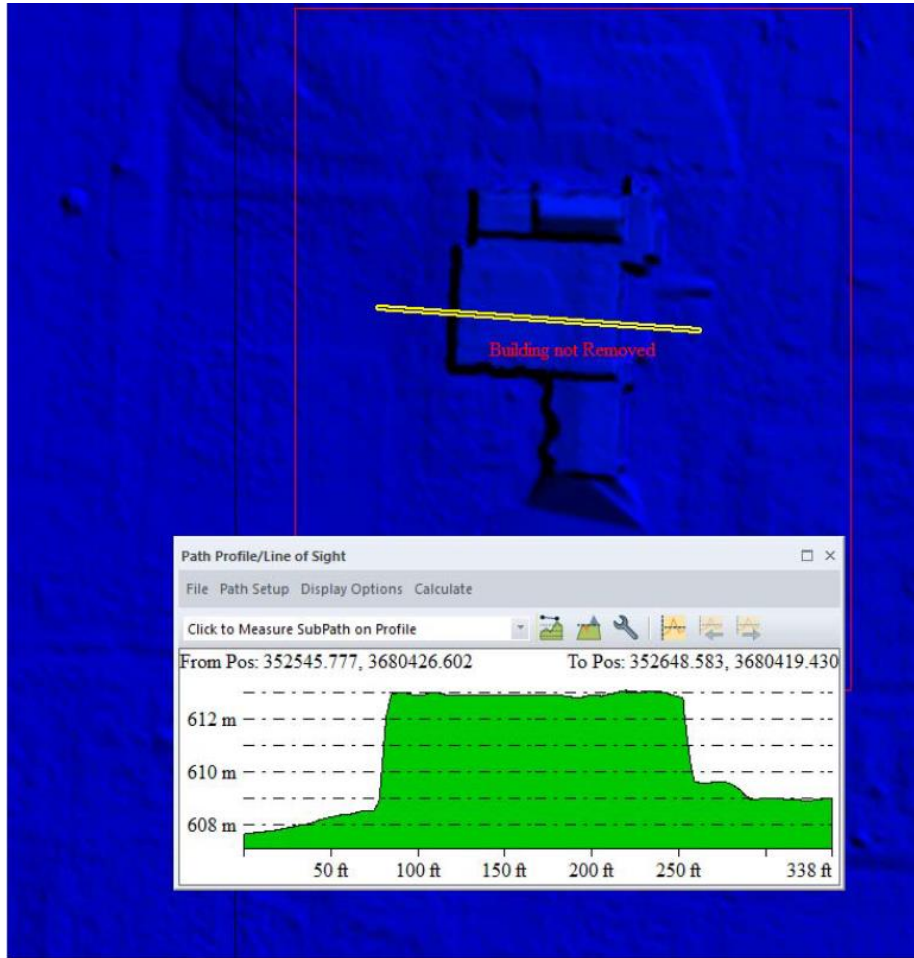
Figure 12 – Tile 14SLB525795 – USGS screenshot.

USGS made one call to remove a manmade structure. Dewberry reviewed the tile and removed the structure.
