QA Review Response

FY15 TOPO-BATHY LIDAR, ELWHA RIVER, WA

TASK ORDER NUMBER: G15PD01145
USGS CONTRACT: G10PC00057

This report explains issues noted in the USGS Quality Assessment Report dated 2016-01-21 and how these have been addressed.

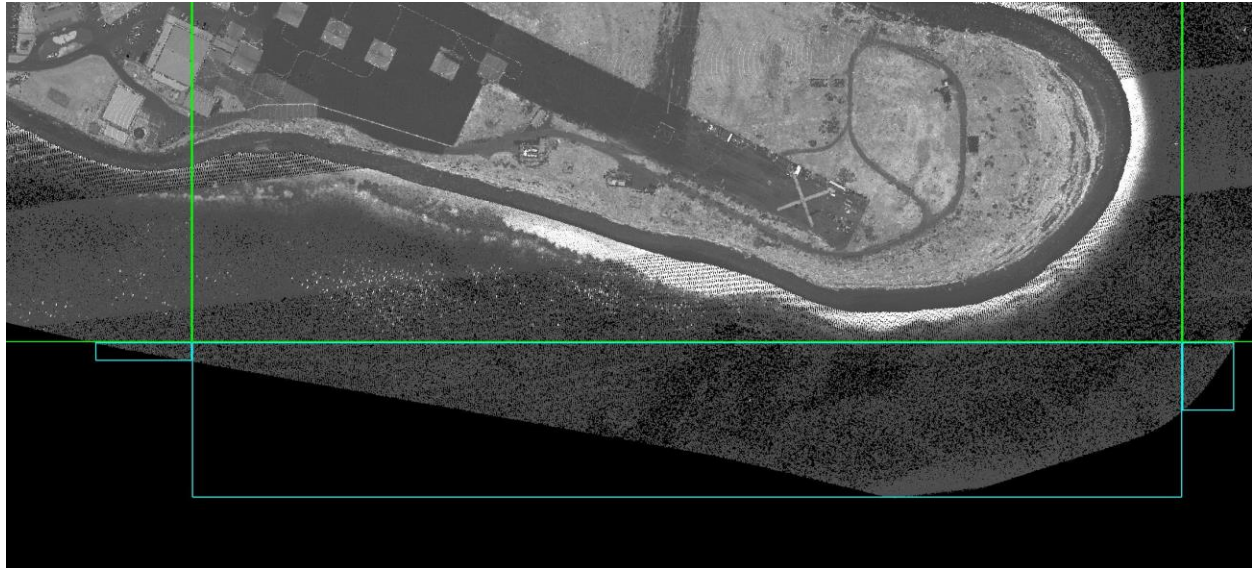
Issue: tiles 10UDU702310, 10UDU687310 & 10UDU695310: do not appear to be normalized to 16 bit.

Response: All data is collected by the sensor at 16-bit. Therefore no normalization was necessary. These blocks contain mostly bathy noise classes (lower three cyan colored blocks), therefore values do not stretch from 0 to 65535. However values do range from 0 to greater than 3000, which is much more than an 8-bit value. No action necessary; data is 16-bit.

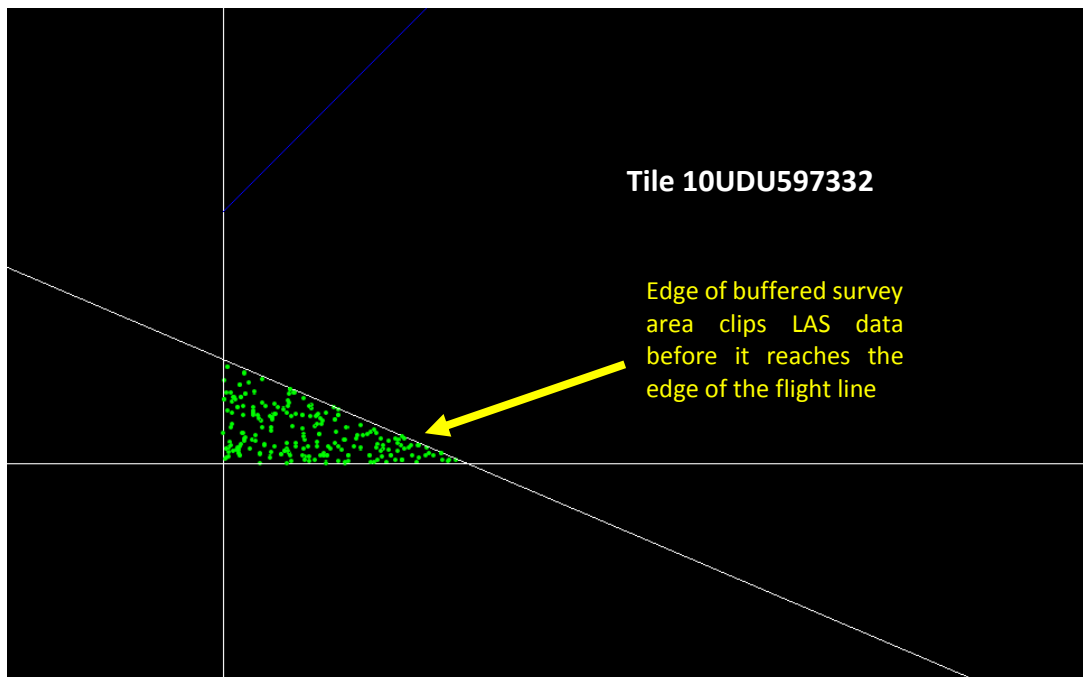
Issue: 10UDU597332, 10UDU605325, 10UDU702310: Edge of flight line bits do not appear to be populated correctly.

Response: there is no edge of flight line in these tiles. No action to be taken.
