# Leica Geosystems Leica TerrainMapper-L Calibration Certificate

<b>Product</b>	Leica TerrainMapper-L
<b>Serial Number</b>	90515
<b>Date</b>	12 December 2018
<b>Inspector</b>	Robert Bosch

# Leica Geosystems Leica TerrainMapper-LN Calibration Certificate

<b>Product</b>	Leica TerrainMapper-LN
<b>Serial Number</b>	91513
<b>Date</b>	25 February 2019
<b>Inspector</b>	Xu Wang

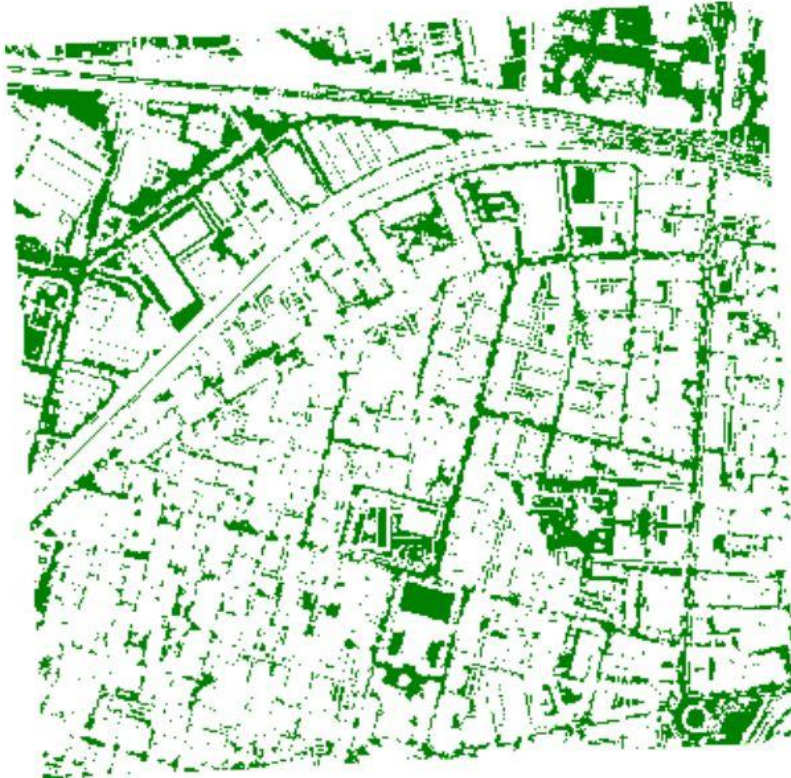
M003\_1000C\_091330\_vs\_M010\_1000C\_091927

29588 valid patches with size of 2 m found. Only patches with standard deviation < 0.05 m and minimum of 5 points are included.

Color	Limits [m]	Number of patches	Proportion of total number of patches [%]
Blue	<=0.04	29546	99.86
Orange	0.04-0.07	38	0.13
Green	0.07-0.1	1	0.00
Red	>0.1	3	0.01

Figure 3 Vertical difference between two perpendicular lines at 1000 m AGL.
