## LiDAR Quality Assessment Report

**IL\_District4-mcdonough\_2014**

NGTOC  
2015-05-18  
Brent Marz

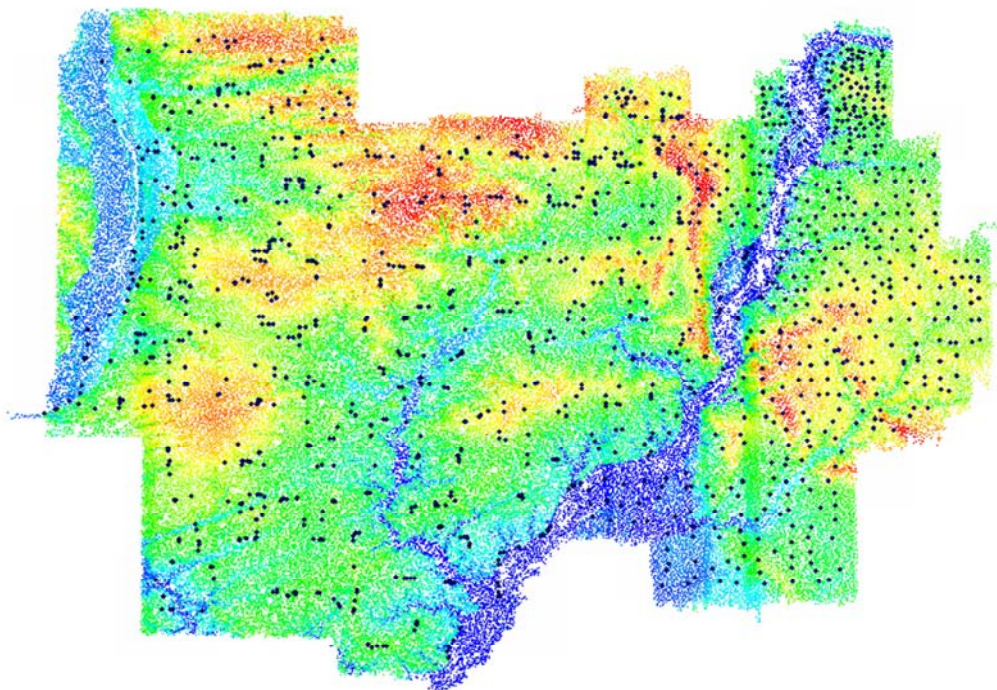
Checkpoint Distribution Image

above results for DEM accuracies are for Fulton county, listed below are the vertical accuracies for each of the 12 counties (as it was not possible to process vertical accuracy across the whole project at once). Swath Vertical Accuracy was able to run for full project.

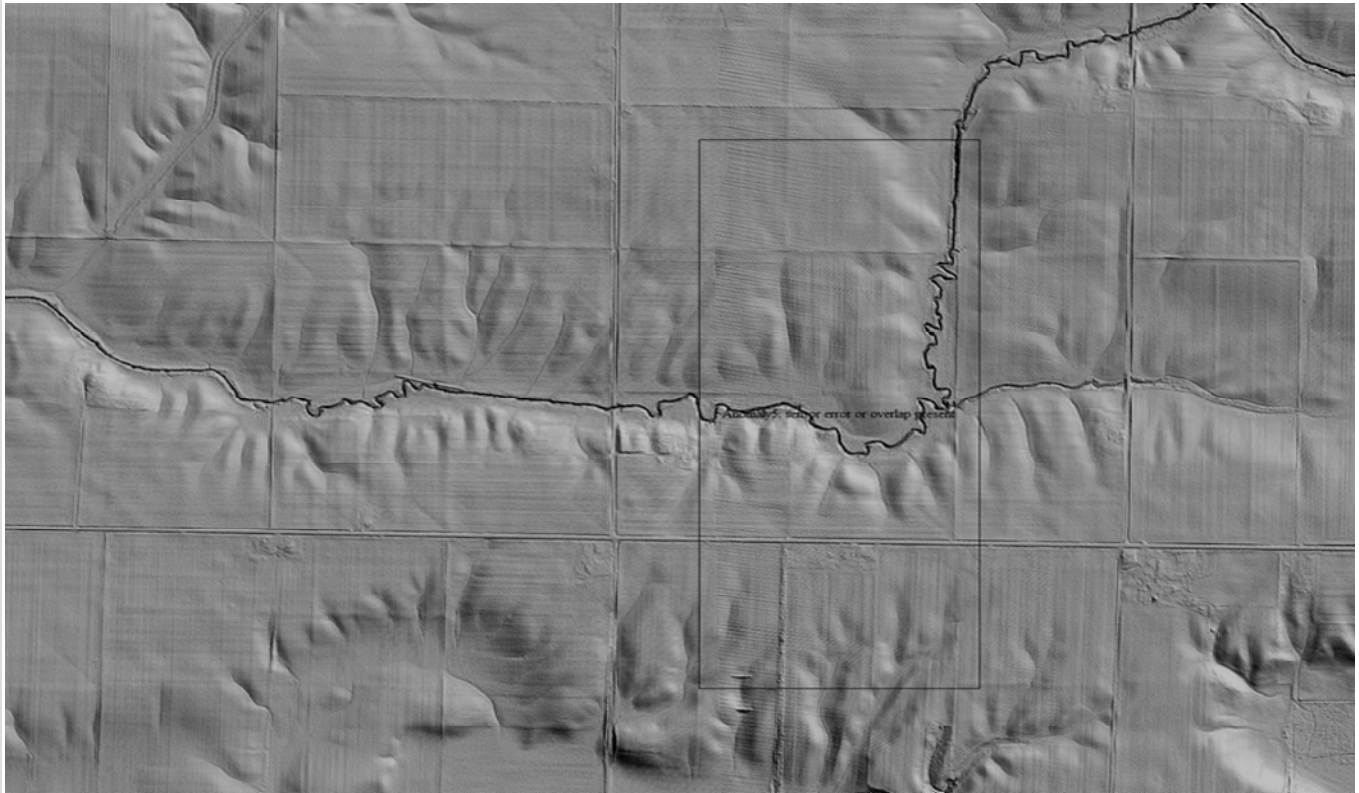
Anomaly5: sensor error or overlap present

DEM errors are representative of errors in District 4 dataset.

Most DEM errors represented above have caused minimal elevation change and are not issues, except in: McDonough County, Stark County, and Warren County.

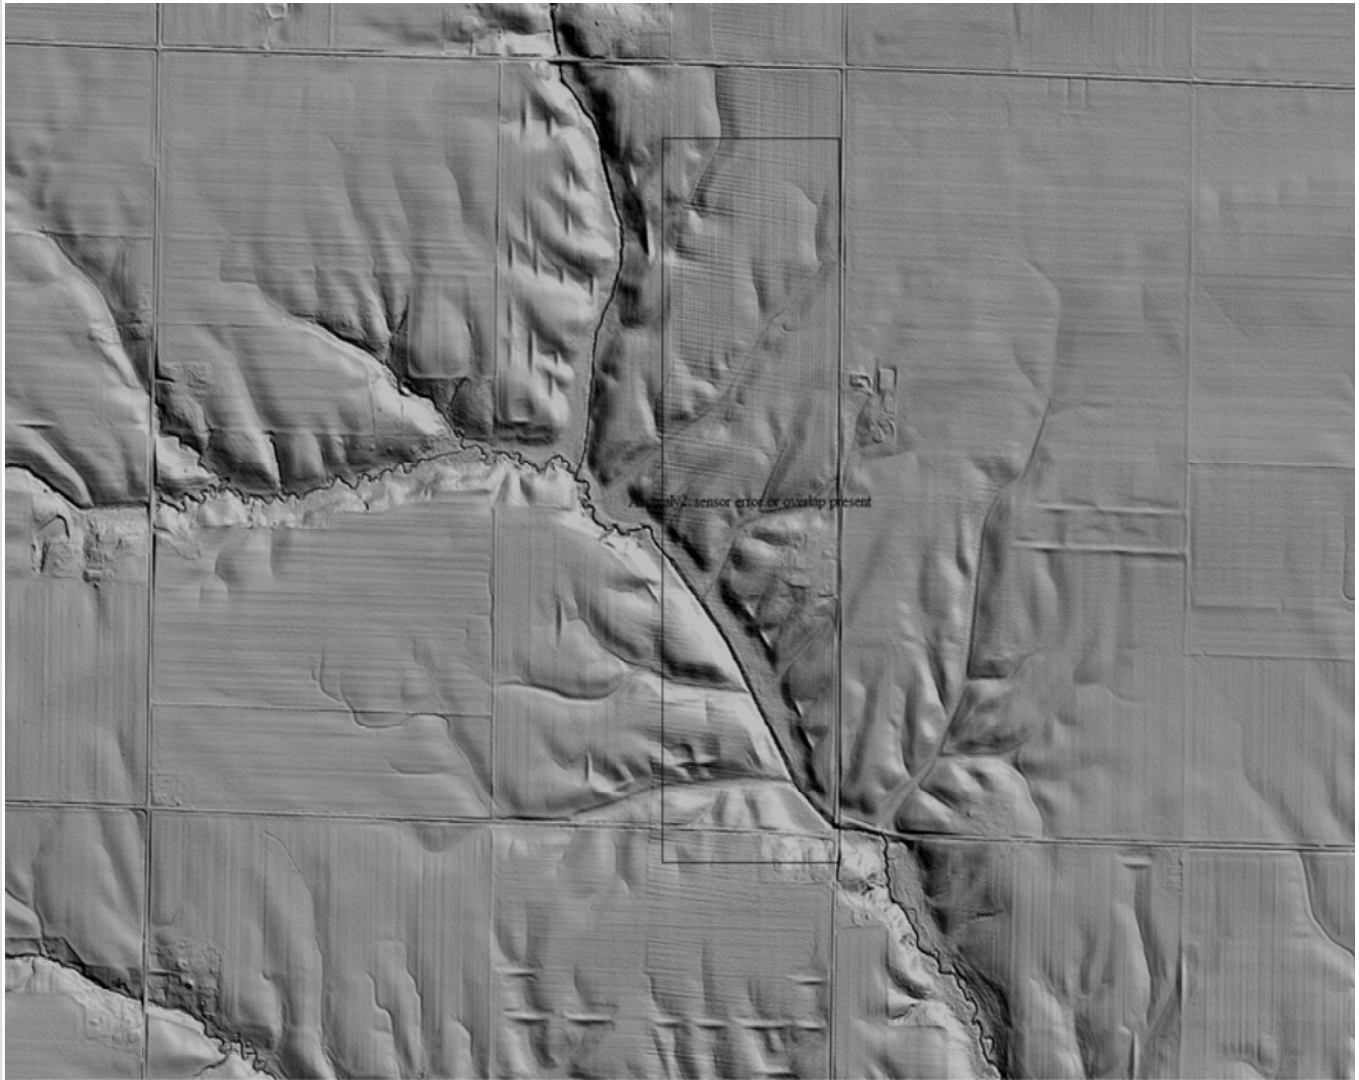
Anomaly2: Sensor error or overlap present, representative of errors in dataset  
DEM errors are representative of errors in District 4 dataset.

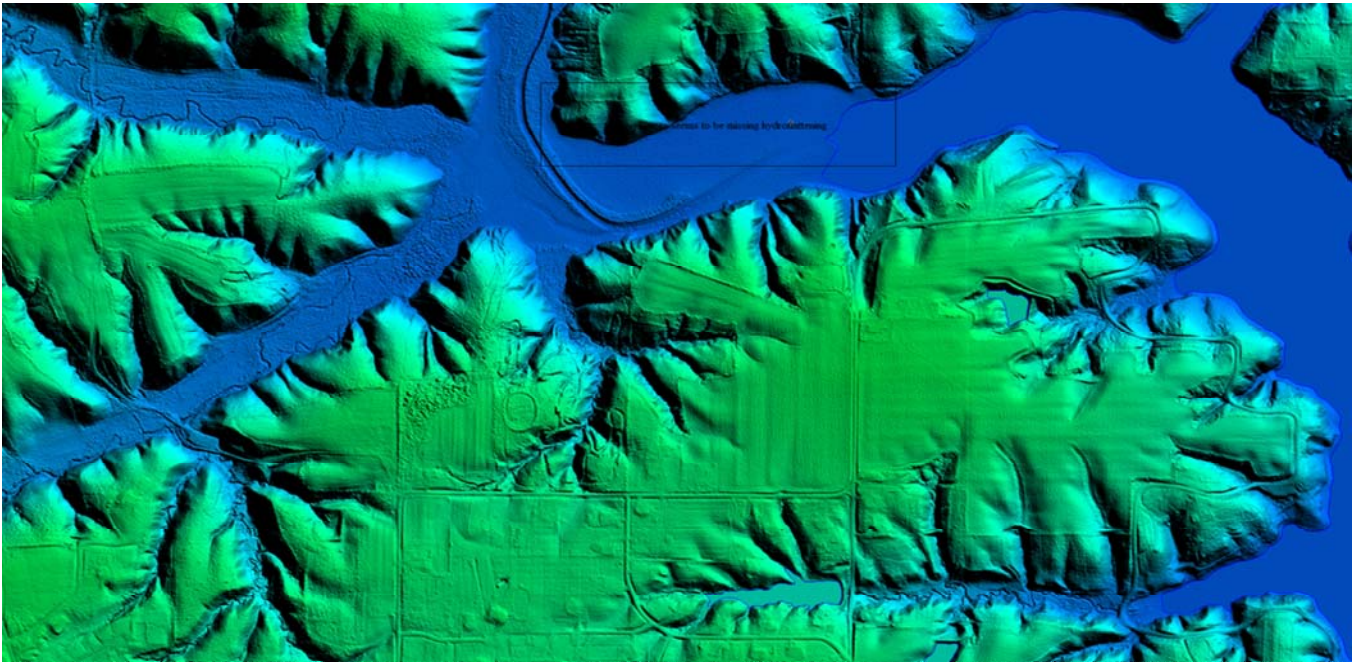
water1: area seems to be missing hydroflattening; representative of errors found in dataset  
DEM errors are representative of errors in District 4 dataset.

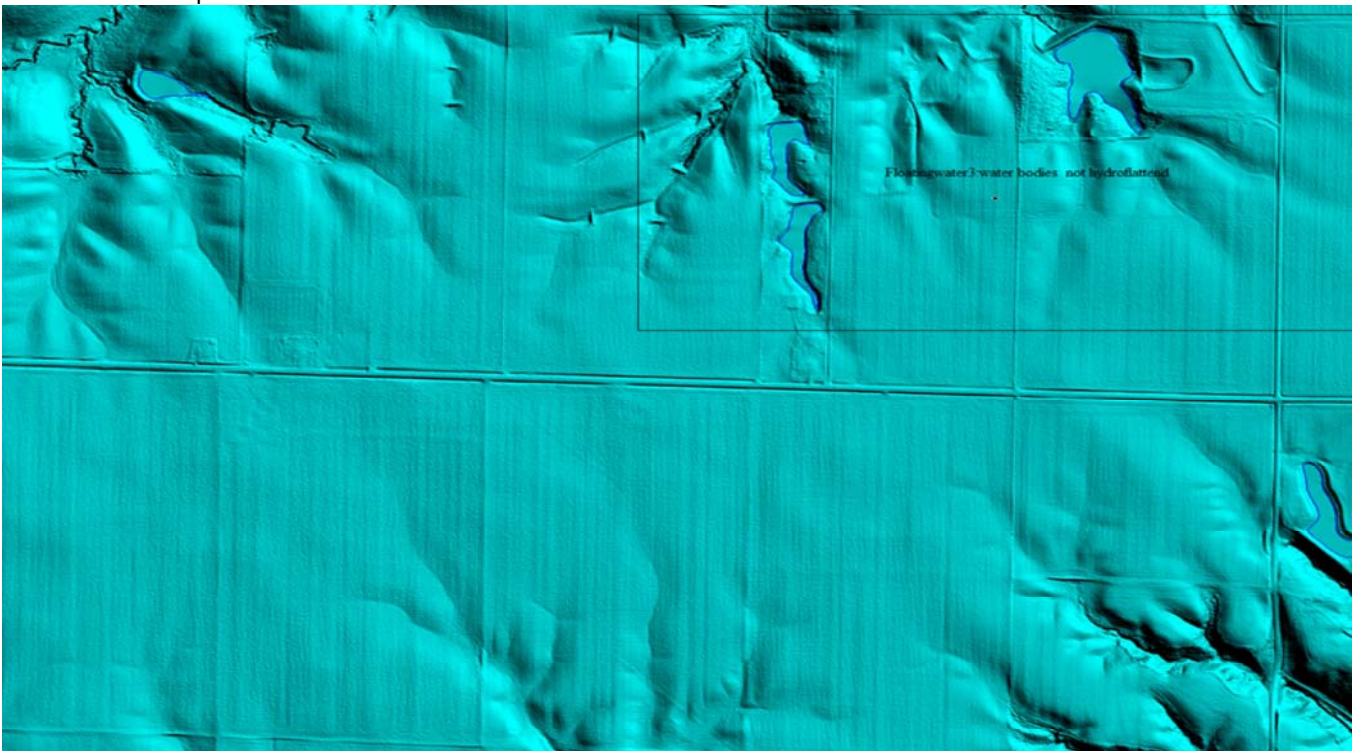
Floatingwater3: water bodies not hydroflattened, representative of errors in dataset  
DEM errors are representative of errors in District 4 dataset.

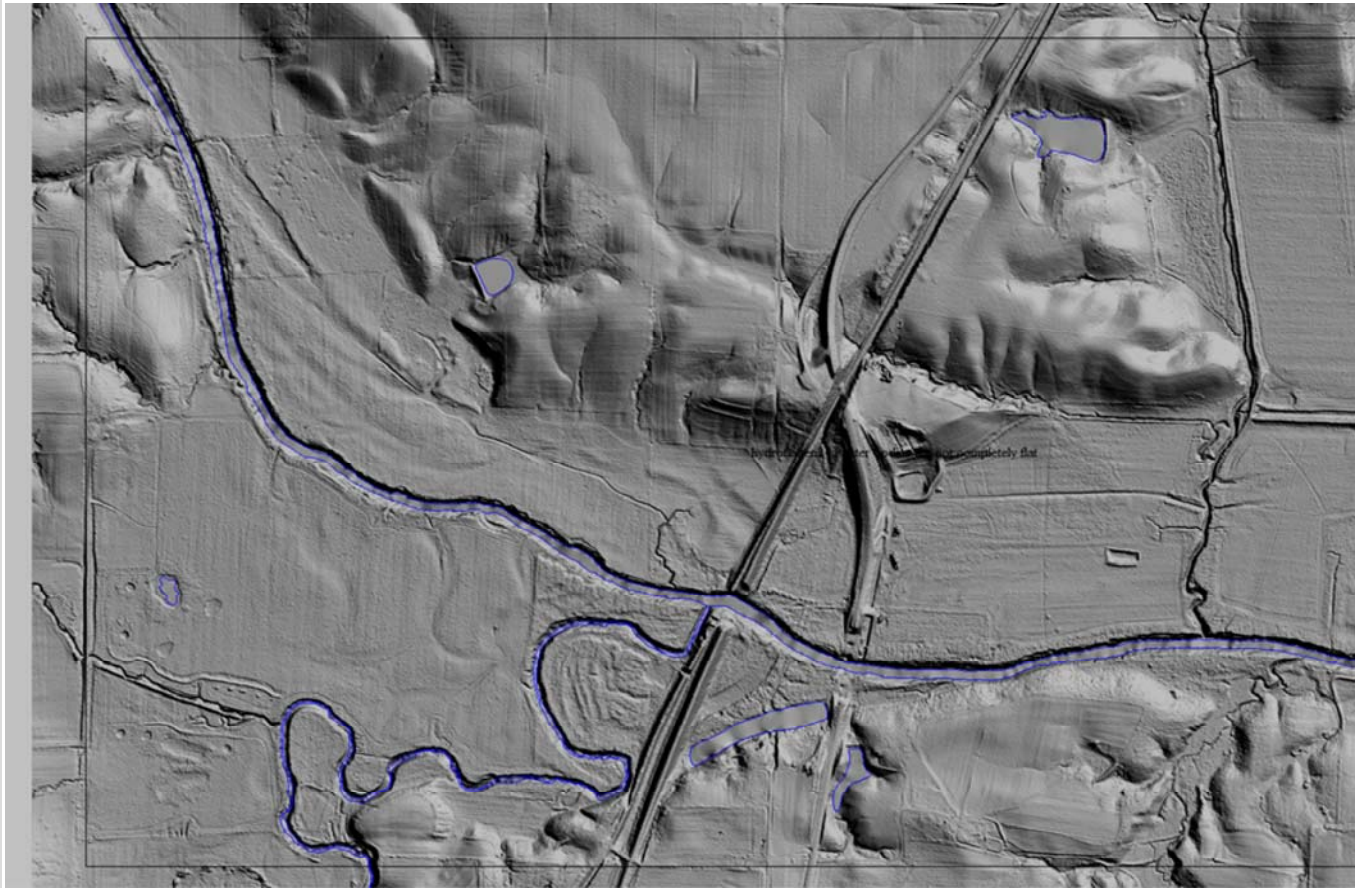
hydroflatten24: waterbodies not flattened, in McDonough county there are many rivers lakes that have not been hydroflattened. Additionally, there is many of the hydroflattened streams in this data have been inconsistently hydroflattened in comparison to the other counties (due to river/stream sizes)  
Error representative of issues in McDonough county only

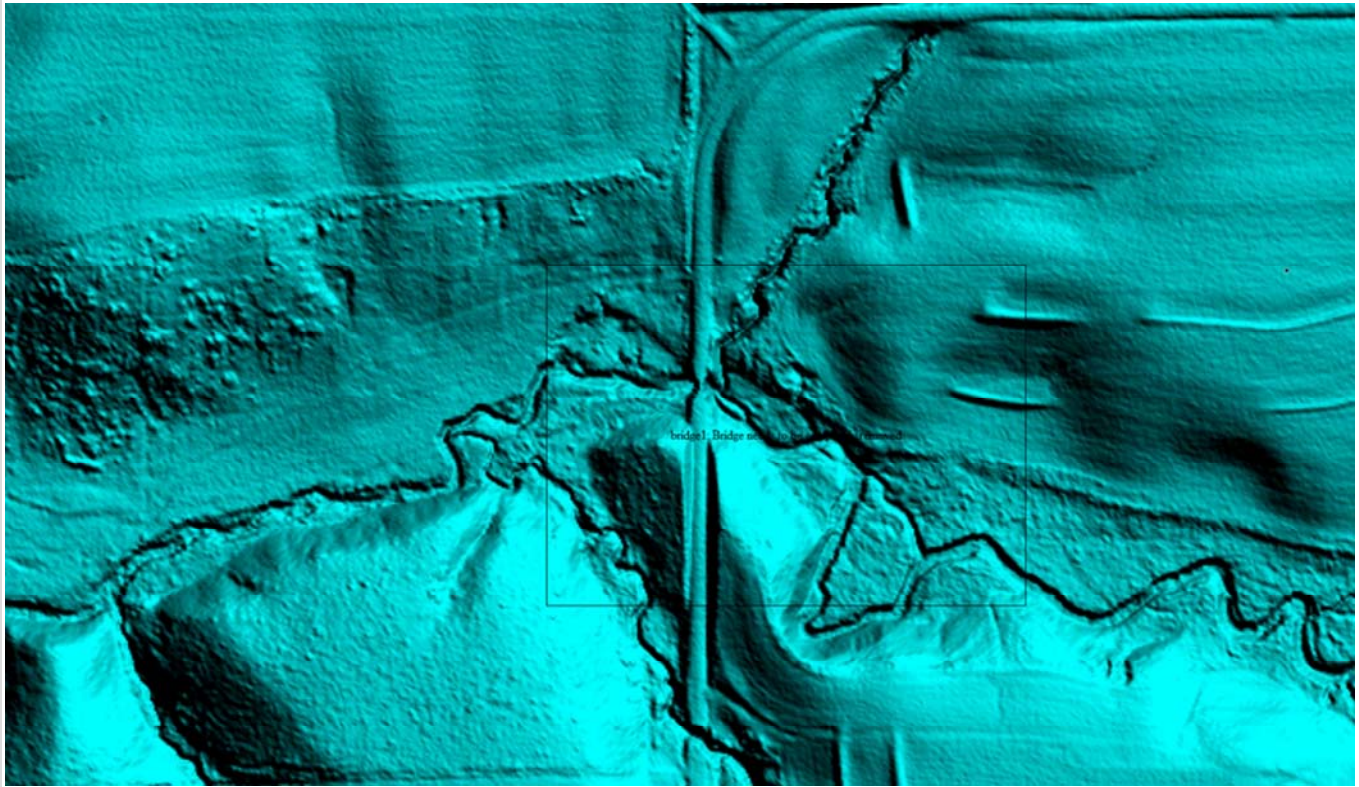
bridge1: Bridge needs to be completely removed, representative of errors in dataset  
DEM errors are representative of errors in District 4 dataset.

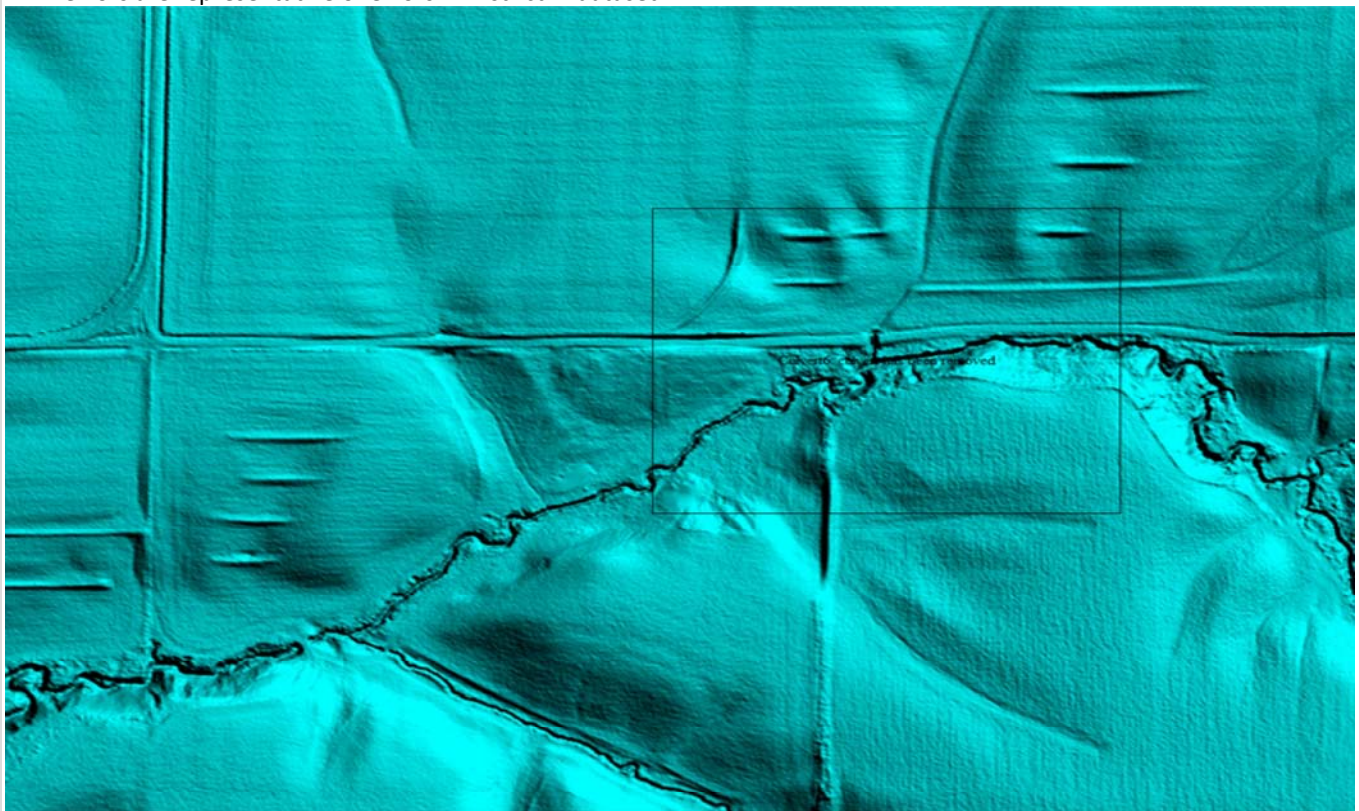
Culvert6: culvert has been removed; representative of errors within dataset  
DEM errors are representative of errors in District 4 dataset.

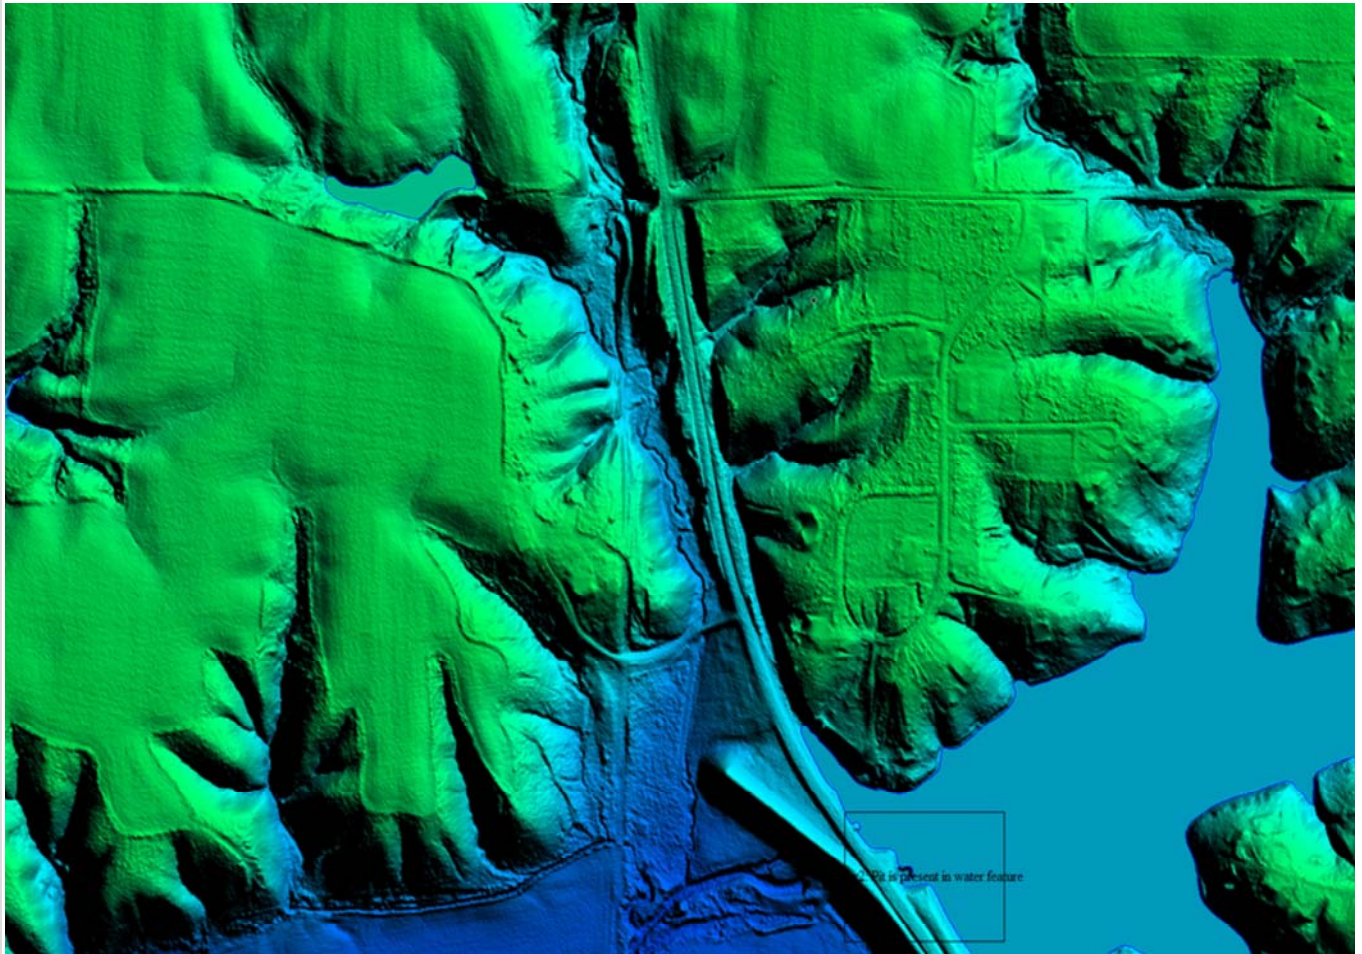
Water2: Pit is present in water.  
DEM errors are representative of errors in District 4 dataset.

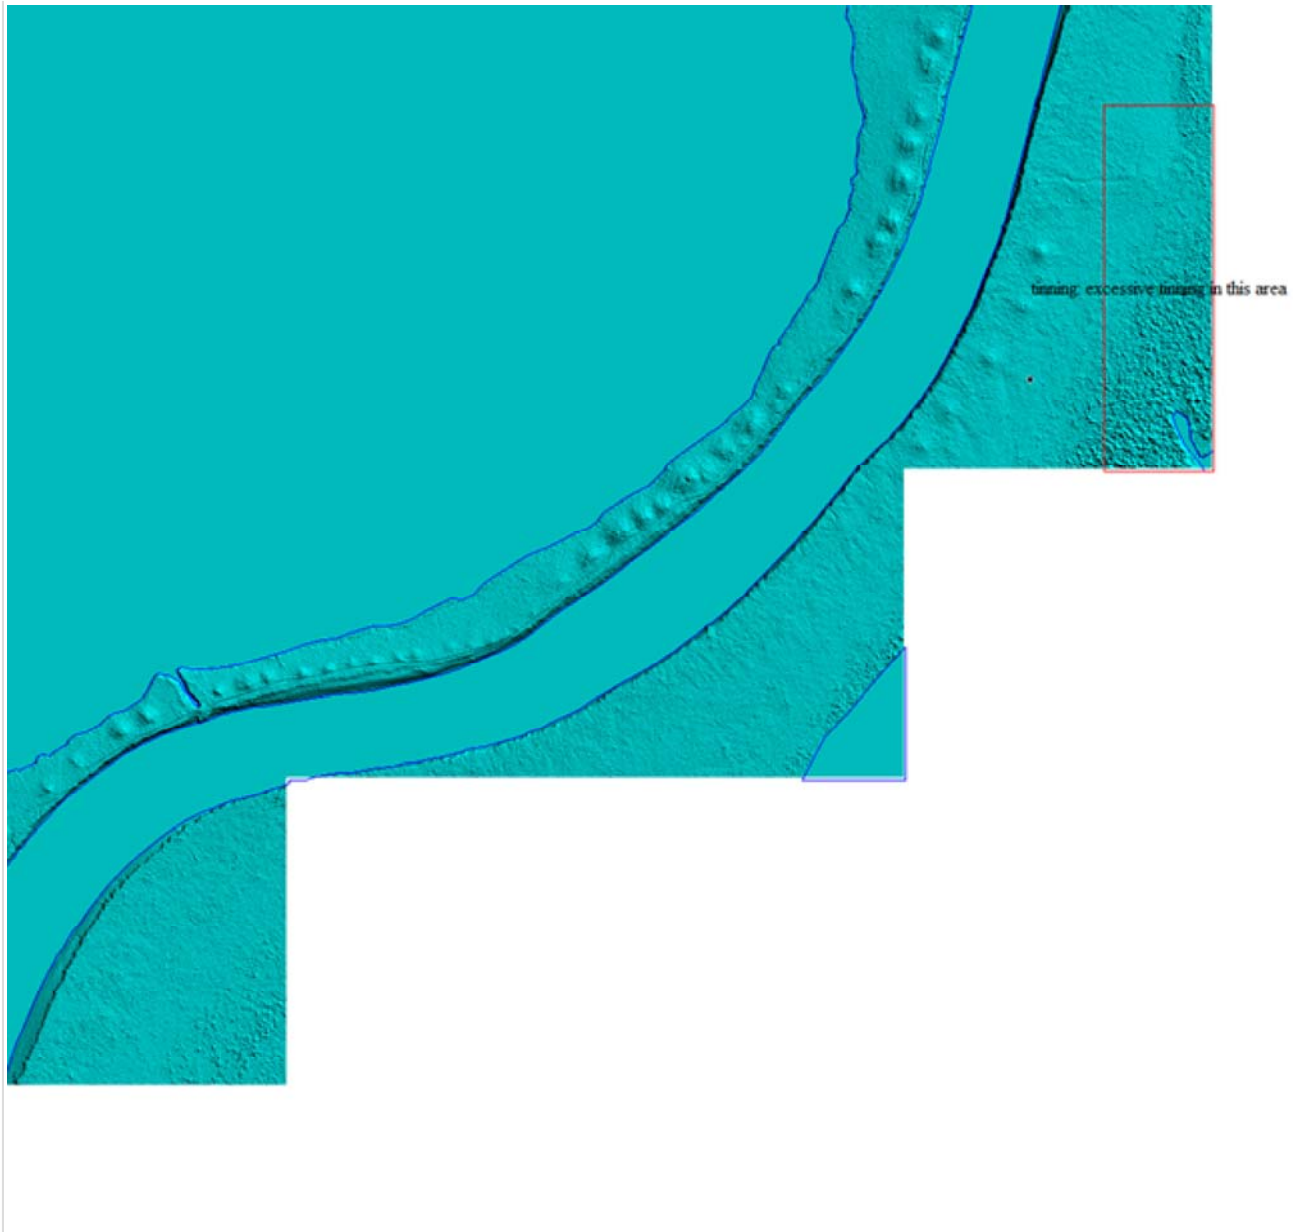
tinny: excessive tinning in this area; error is representative  
DEM errors are representative of errors in District 4 dataset.
