USGS FL Hurricane Michael Work Package: 188518

Work Unit: 229801 & 229804

Report Produced for U.S. Geological Survey

Report Date: June 1, 2022

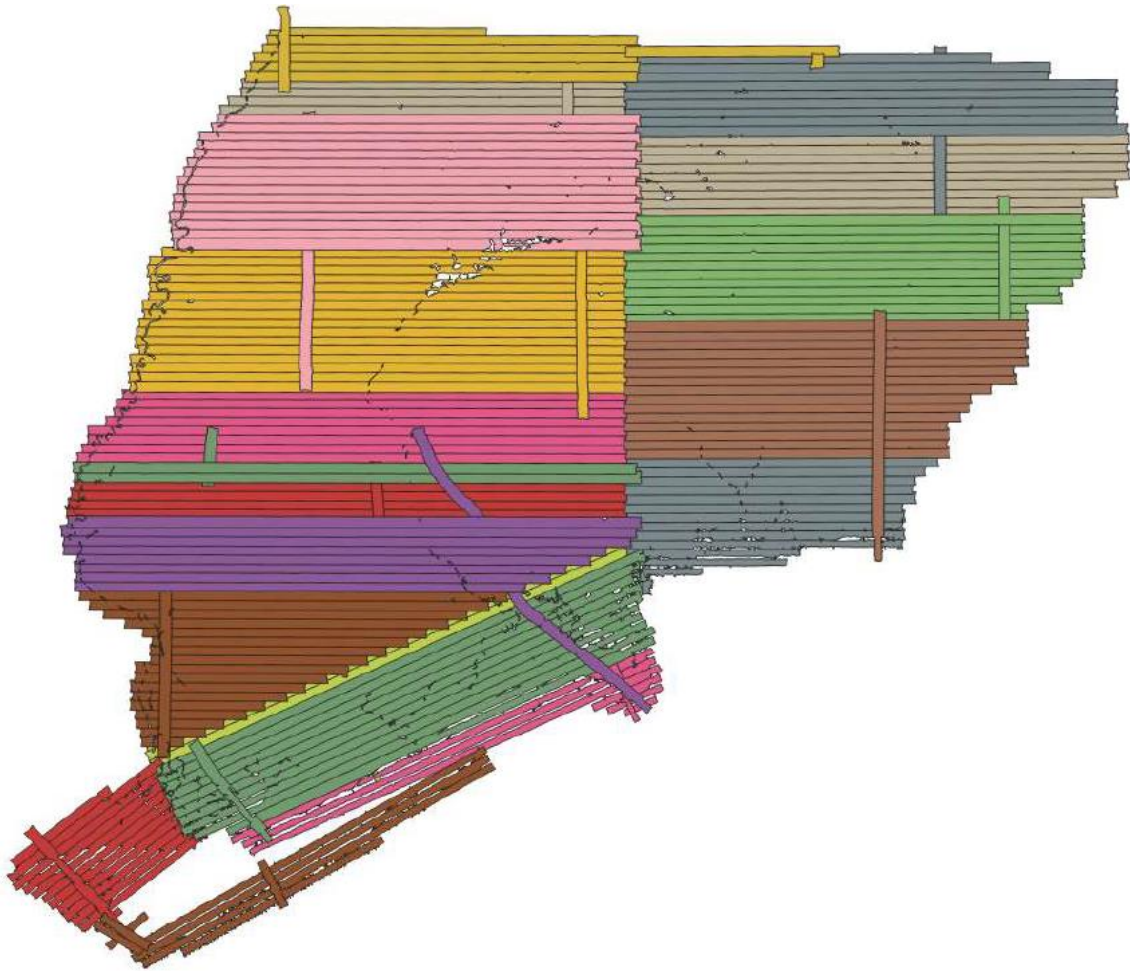
Figure 8 - Lidar swath output showing complete coverage.

Data collected by the lidar unit was reviewed for completeness, acceptable density, and to make sure all data were captured without errors or corrupted values. All GPS, aircraft trajectory, mission information, and ground control files were reviewed and logged. A supplementary coverage check was carried out (figure 8) to ensure that there were no unreported gaps in data coverage.
