FL Peninsular 2018 Lidar Project - Hernando County

Report Produced for U.S. Geological Survey

USGS Contract: G16PC00020

Report Date: March 18, 2021

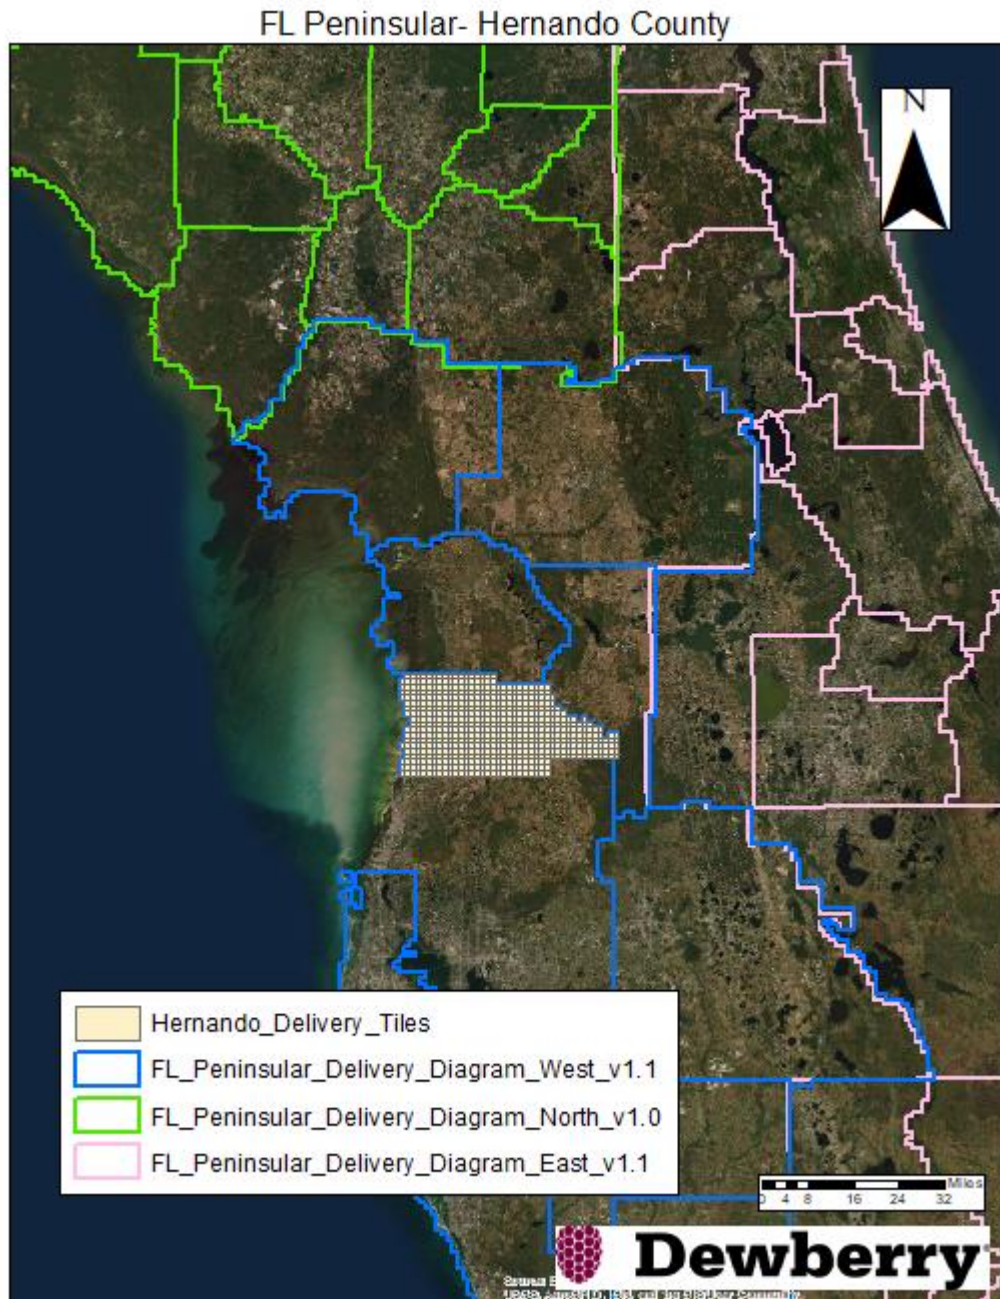
The block area is shown in figure 1. Hernando County contains 594 5,000 ft by 5,000 ft tiles. The project tile grid contains 39,217 5,000 ft by 5,000 ft tiles.

Figure 1 - Project map and tile grid.

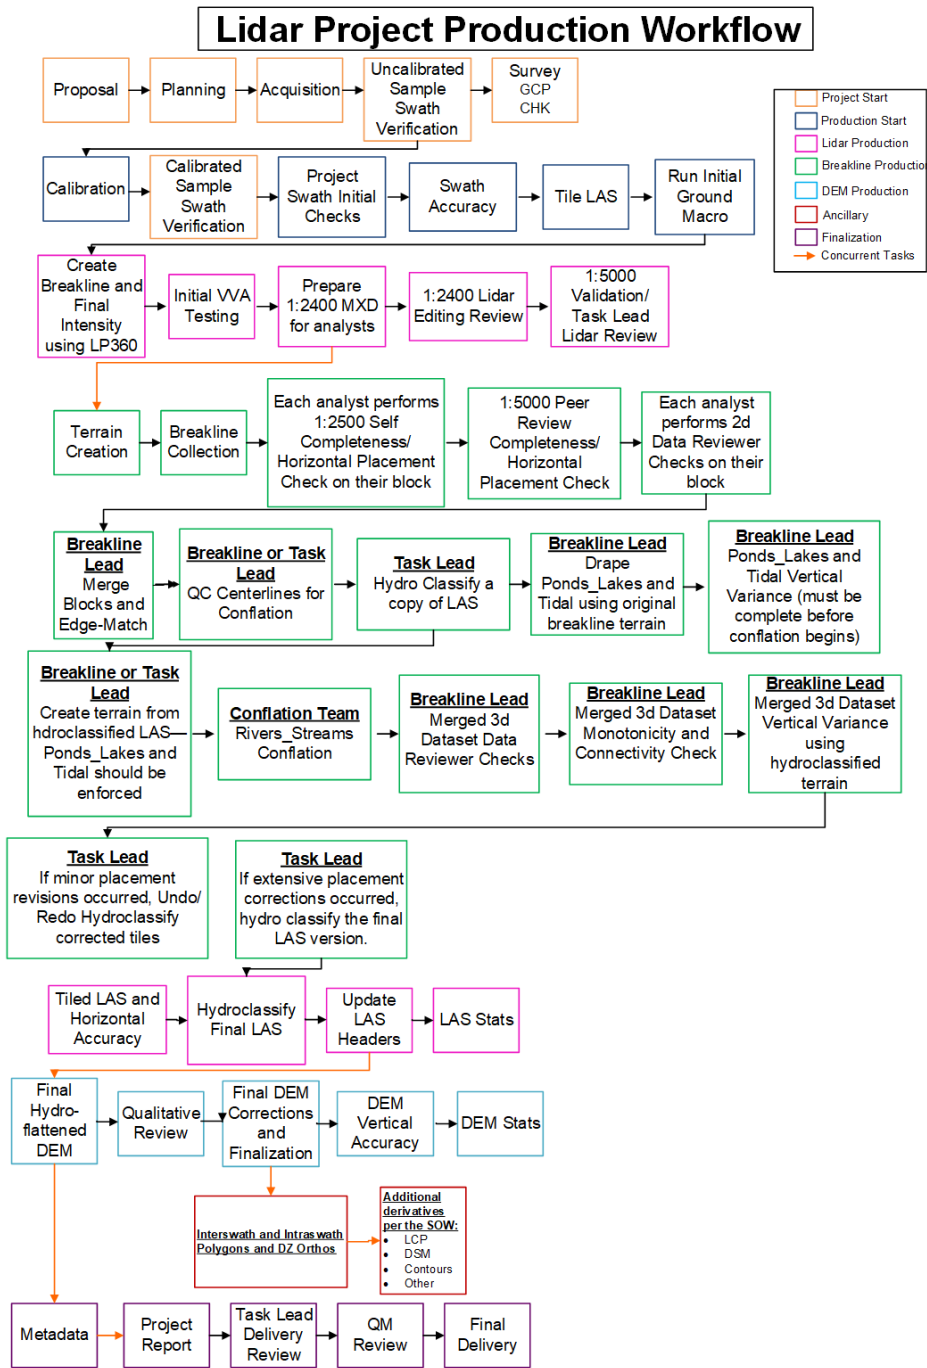
The diagram below outlines Dewberry's standard lidar production workflow.

Figure 2- Dewberry’s Lidar Production Workflow Diagram

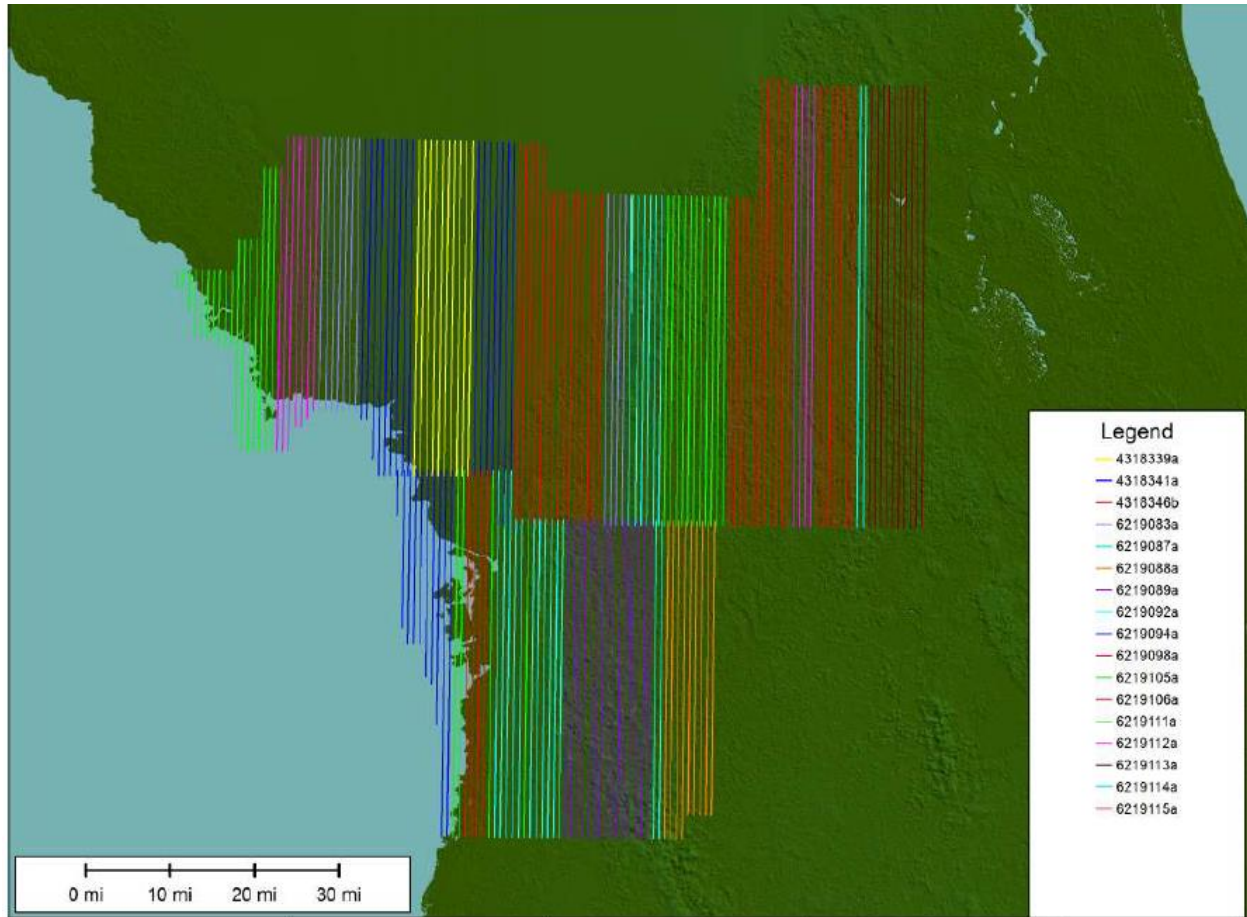
Figure 3. Trajectories of flight lines flown by Airborne Imaging.

Upon notification to proceed, the flight crew loaded the flight plans and validated the flight parameters. The acquisition manager contacted air traffic control and coordinated flight pattern requirements. Lidar acquisition began immediately upon notification that control base stations were in place. During flight operations, the flight crew monitored weather and atmospheric conditions. Lidar missions were flown only when no condition existed below the sensor that would affect the collection of data. The pilot constantly monitored the course, position, pitch, roll, and yaw of the aircraft. The sensor operator monitored the lidar sensor, the position dilution of precision (PDOP), and performed the first quality control review during acquisition. The flight crew reviewed weather and cloud locations. Any flight lines impacted by unfavorable conditions were marked as invalid and re-flown immediately or at an optimal time.

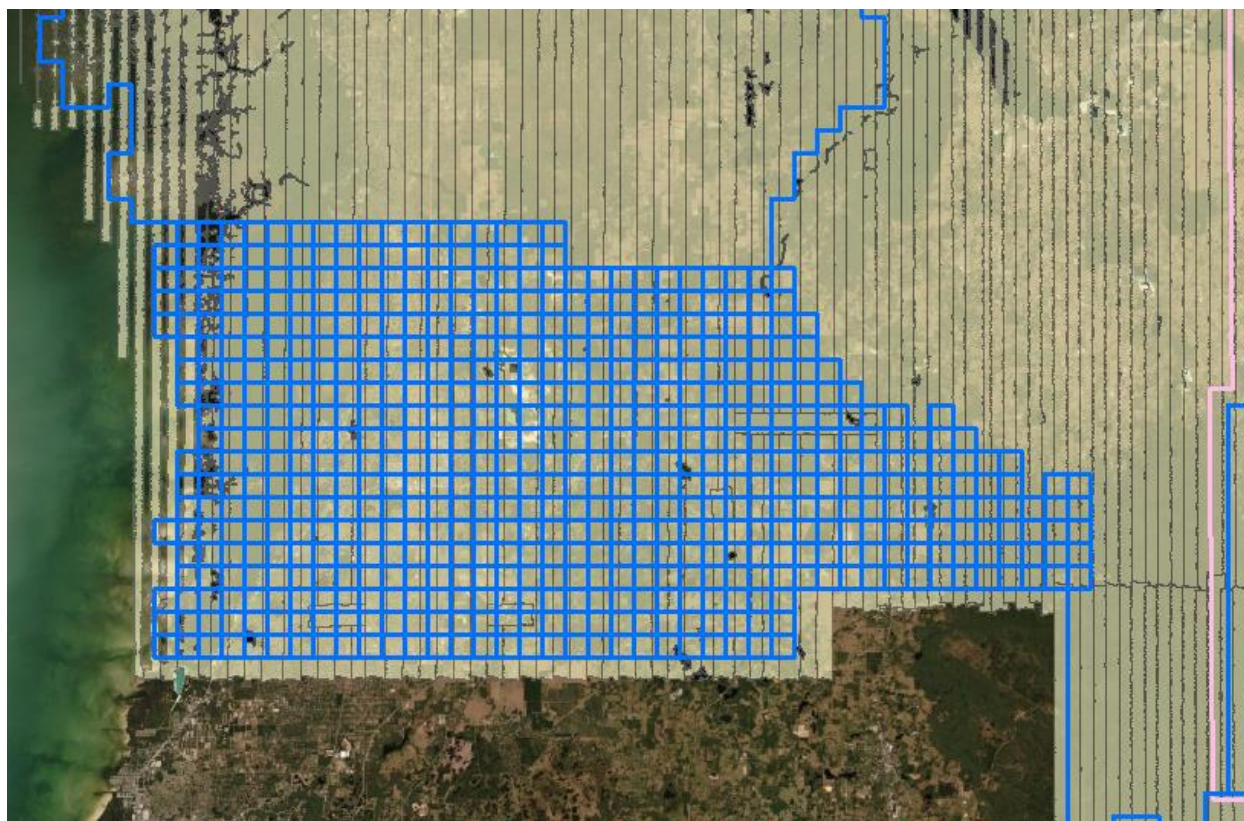
Data collected by the lidar unit was reviewed for completeness, acceptable density, and to make sure all data were captured without errors or corrupted values. All GPS, aircraft trajectory, mission information, and ground control files were reviewed and logged. A supplementary coverage check was carried out (Figure 4) to ensure that there were no unreported gaps in data coverage.

Figure 4 - Lidar swath output showing complete coverage.

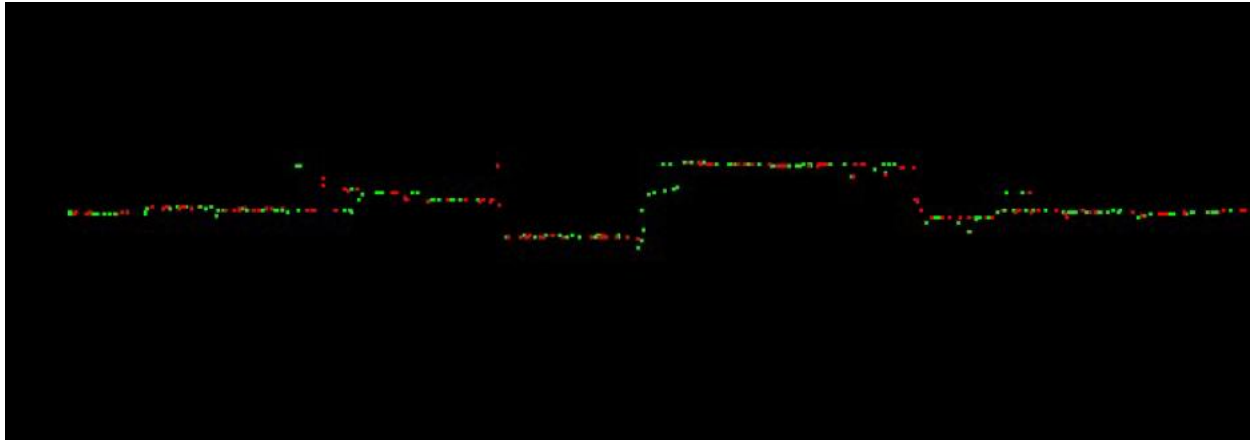
The initial points for each mission calibration were inspected for flight line errors, flight line overlap, slivers or gaps in the data, point data minimums, or issues with the lidar unit or GPS. Roll, pitch and scanner scale were optimized during the calibration process until relative accuracy requirements were met (Figure 5).

Figure 5 - Profile views showing results of roll and pitch adjustments.

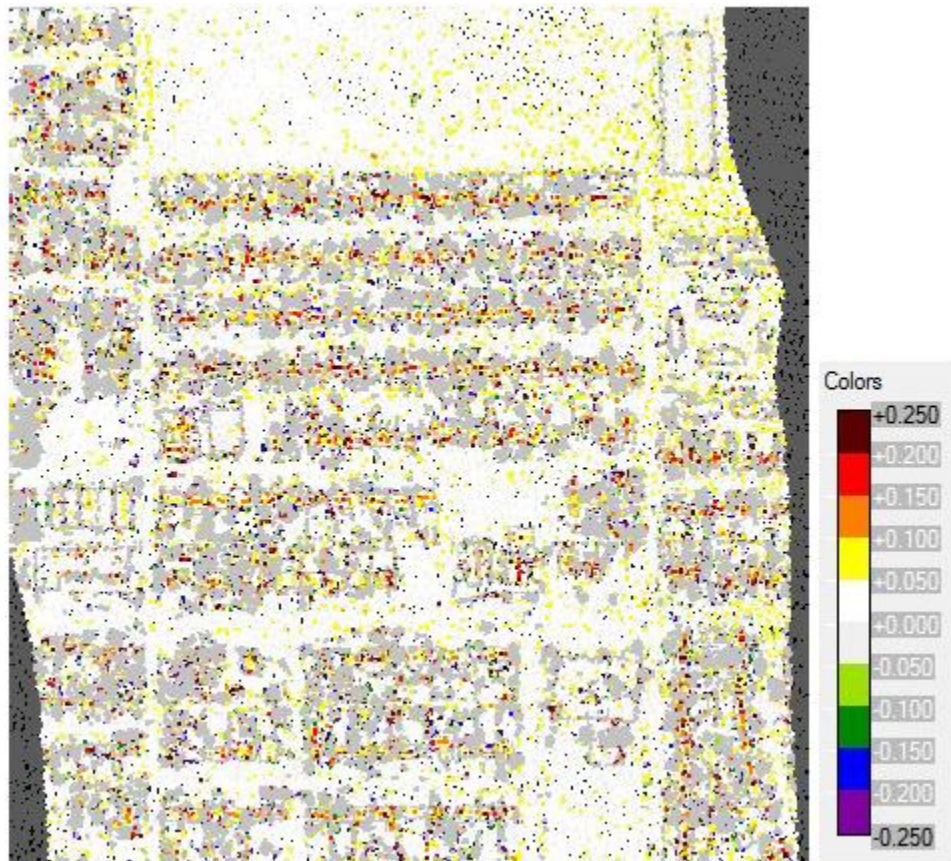
Relative accuracy and internal quality were checked using at least 3 regularly spaced QC blocks in which points from all lines were loaded and inspected. Vertical differences between ground surfaces of each line were displayed. Color scale was adjusted to flag errors that were not within project specifications (Figure 6). Cross sections were visually inspected across each block to validate point to point, flight line to flight line, and mission to mission agreement.

- ≤ 6 cm maximum difference within individual swaths (intra-swath); and
- ≤ 8 cm RMSDz between adjacent and overlapping swaths (inter-swath).

Figure 6 - QC block colored by vertical difference between swaths to check accuracy at swath edges.

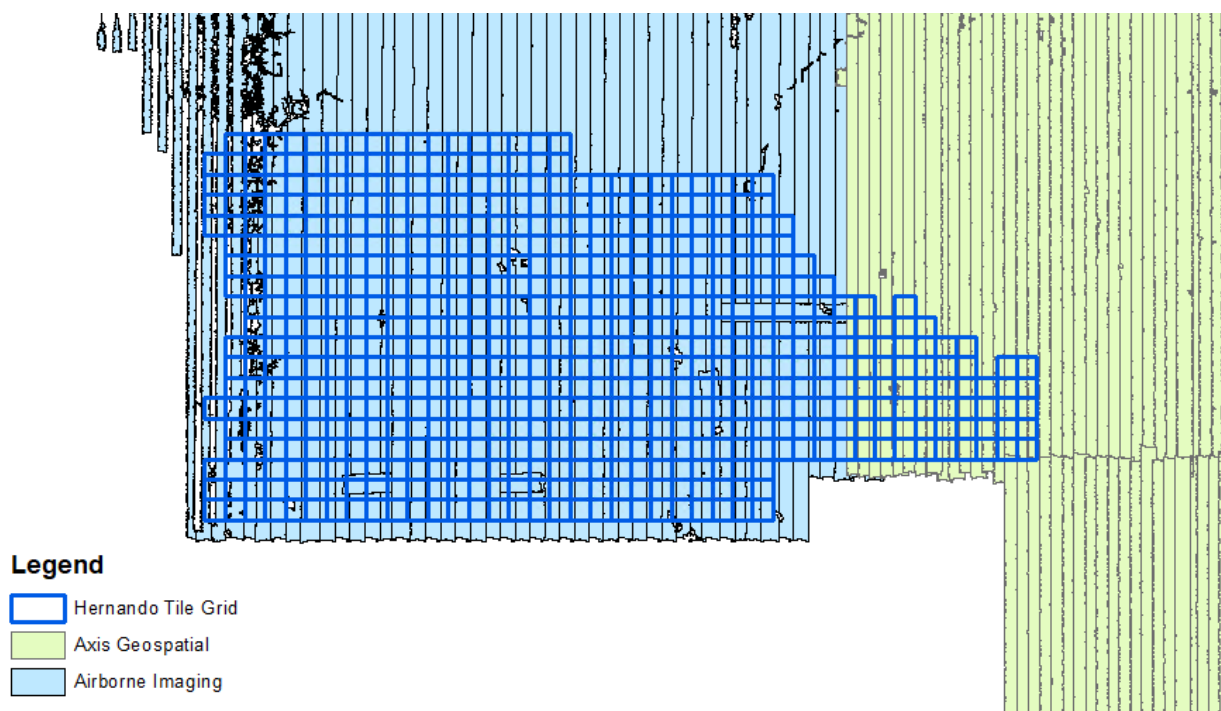
Figure 7- Flight lines flown by Axis Geospatial (green) and Airborne Imaging flight lines flown (light blue) overlaid with the Hernando delivery tile grid (blue), showing complete coverage.

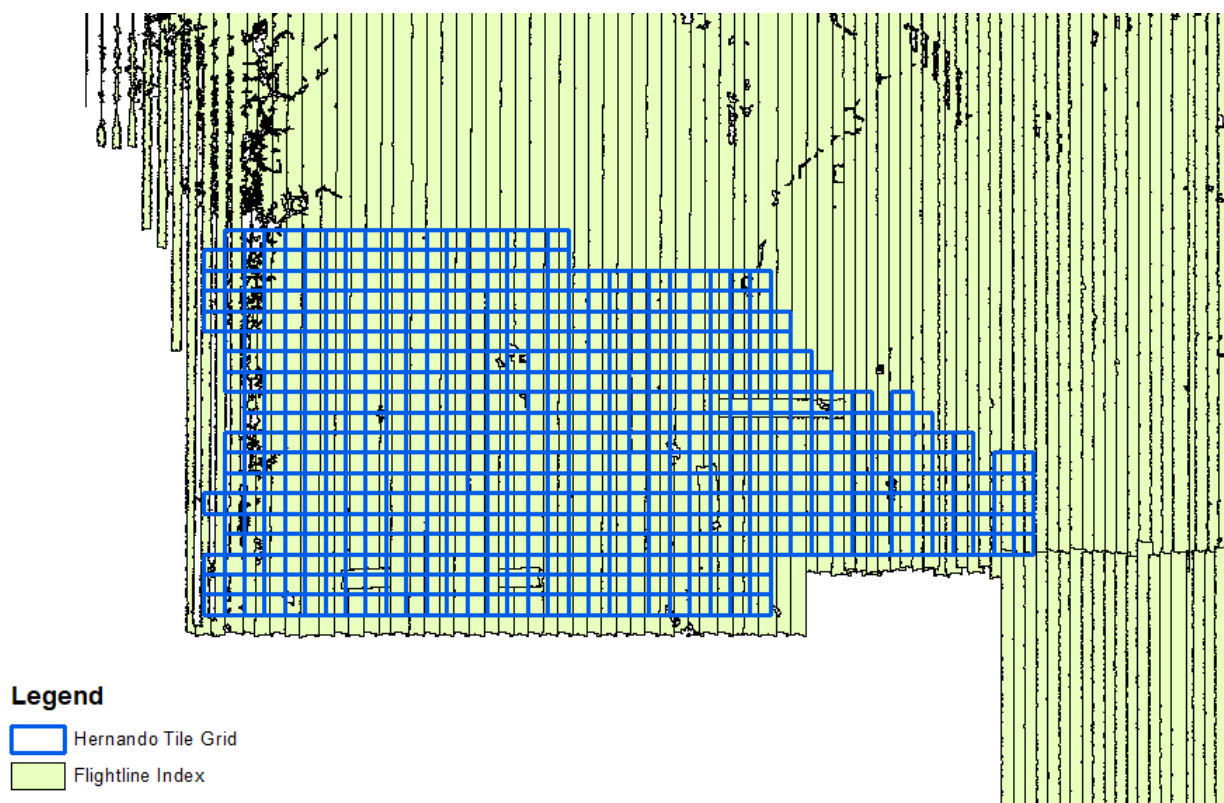
Data collected by the lidar unit was reviewed for completeness, acceptable density, and to make sure all data were captured without errors or corrupted values. All GPS, aircraft trajectory, mission information, and ground control files were reviewed and logged. A supplementary coverage check was carried out to ensure that there were no unreported gaps in data coverage.

Figure 8- Lidar swath output showing complete data coverage.

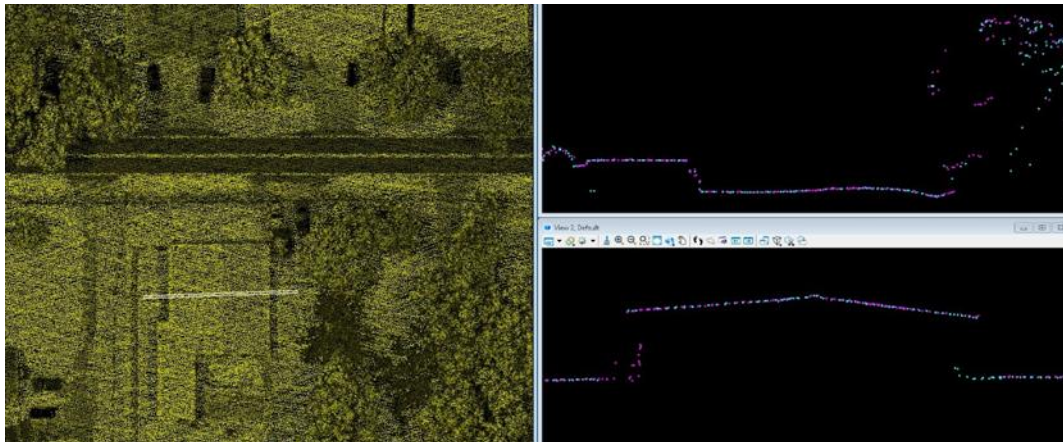
Figure 9 - Profile views showing results of roll and pitch adjustments by Axis Geospatial.

The initial points for each mission calibration were inspected for flight line errors, flight line overlap, slivers or gaps in the data, point data minimums, or issues with the lidar unit or GPS. Roll, pitch and scanner scale were optimized during the calibration process until relative accuracy requirements were met.

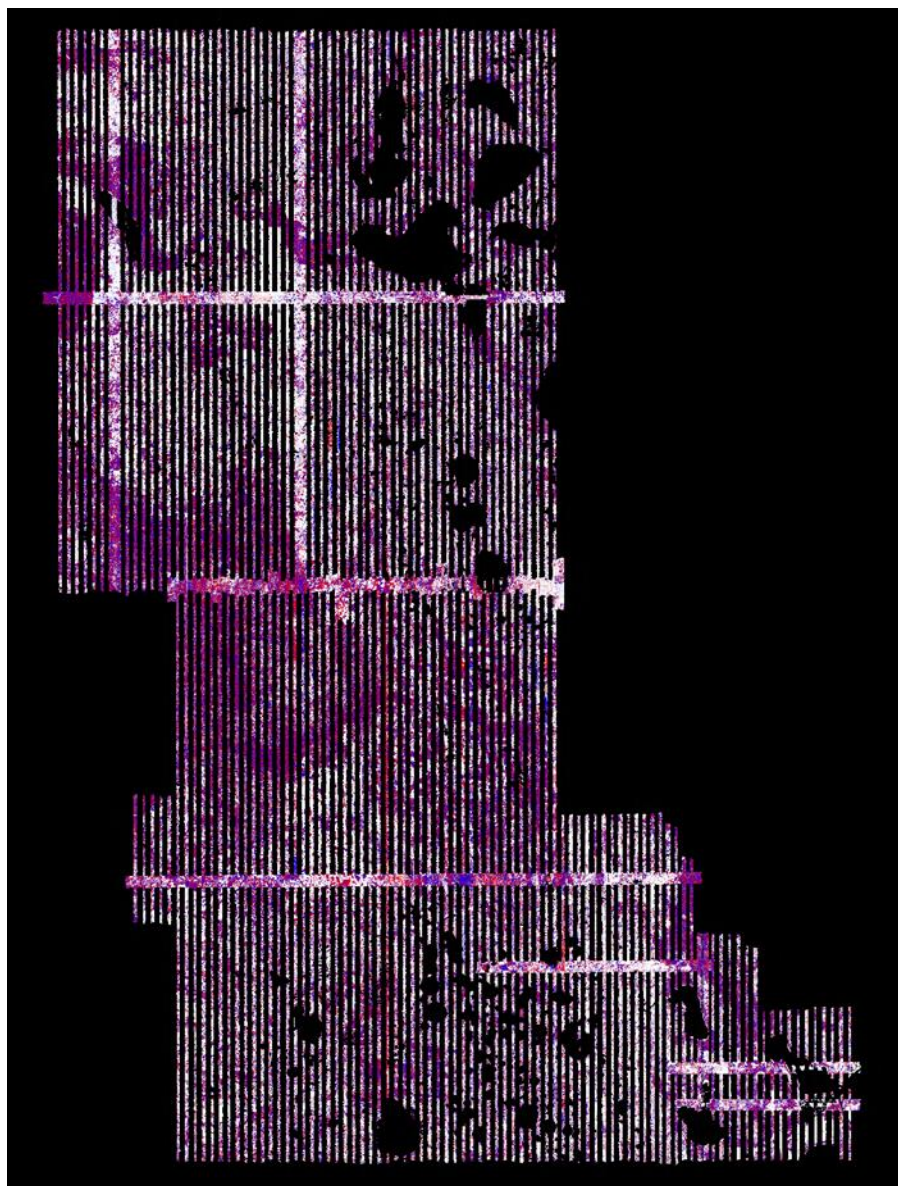
Relative accuracy and internal quality were checked using at least three regularly spaced QC blocks in which points from all lines were loaded and inspected. Vertical differences between ground surfaces of each line were displayed. Color scale was adjusted to flag errors that were not within project specifications. Cross sections were visually inspected across each block to validate point to point, flight line to flight line, and mission to mission agreement.

- ≤ 6 cm maximum difference within individual swaths (intra-swath); and
- ≤ 8 cm RMSDz between adjacent and overlapping swaths (inter-swath).

Figure 10 - QC block colored by vertical difference between swaths to check accuracy at swath edges by Axis Geospatial.

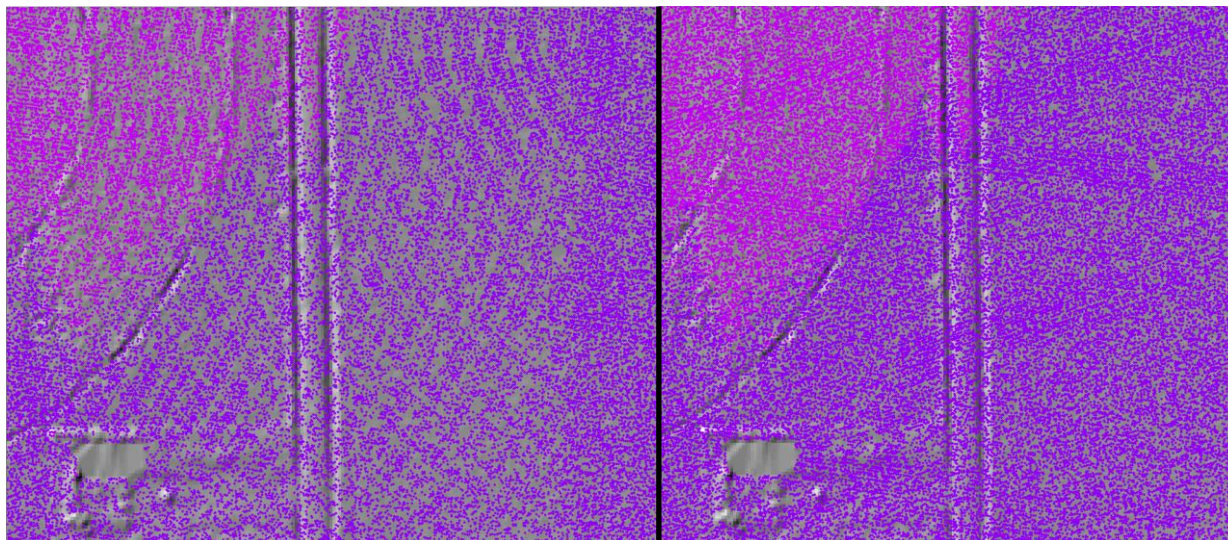
During post-processing of the lidar data, Riegl software interpolates coordinates within the blind zones between last returns on each side of the gap. These are flagged as “synthetic” points and are assigned a valid time stamp, though they do not have any waveform data or pulse width information. Amplitude and reflectance are averaged from surrounding points. The assignment of synthetic points does not change the original raw point cloud data.

This dataset contains flagged synthetic points. The images below show an example from a different dataset of synthetic points applied to the ground class of the lidar point cloud.

Figure 11 – The left image shows ground classified without synthetic points. The right image shows ground classified with synthetic points. Both images are overlaid on a hillshade of the example area.
