FL Peninsular Hernando County/ Pasco County 2018 Tie Analysis

Report Produced for the United States Geological Survey

Dewberry

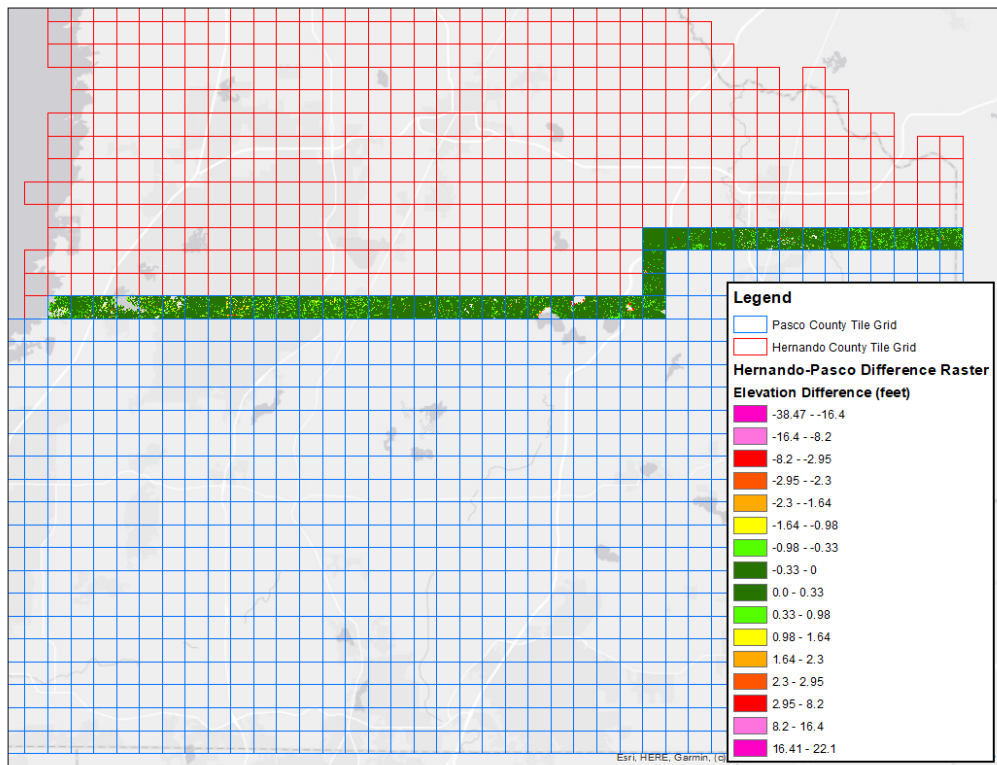
Figure 1 - A total of 43 tiles overlap between the Hernando County AOI and previously collected Pasco County AOI.

There are 43 Hernando County tiles which overlap with the Pasco County lidar data, shown in Figure 1 below. A difference raster was produced to analyze elevation differences between the two datasets in areas of overlap. Each pixel in the difference raster represents a value of elevation change between the two overlapping datasets. Profiles and visual reviews were used to compare the two datasets where the datasets are adjacent, but do not overlap. This review of the adjacent, non-overlapping areas was to ensure no obvious feature discontinuities exist between the datasets. Dewberry has determined that no gross feature discontinuities were identified.

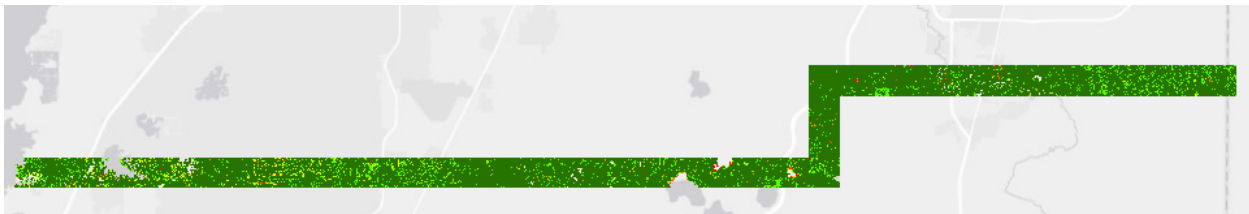
Figure 3 - Difference raster, binned using the symbology key outlined above, created for the Hernando County-Pasco County overlap.

Figure 3 shows the full difference raster symbolized with the key outlined above.
