FL Peninsular 2018 Lidar Project- St. Lucie County

Report Produced for U.S. Geological Survey

USGS Contract: G16PC00020

Report Date: March 3, 2021

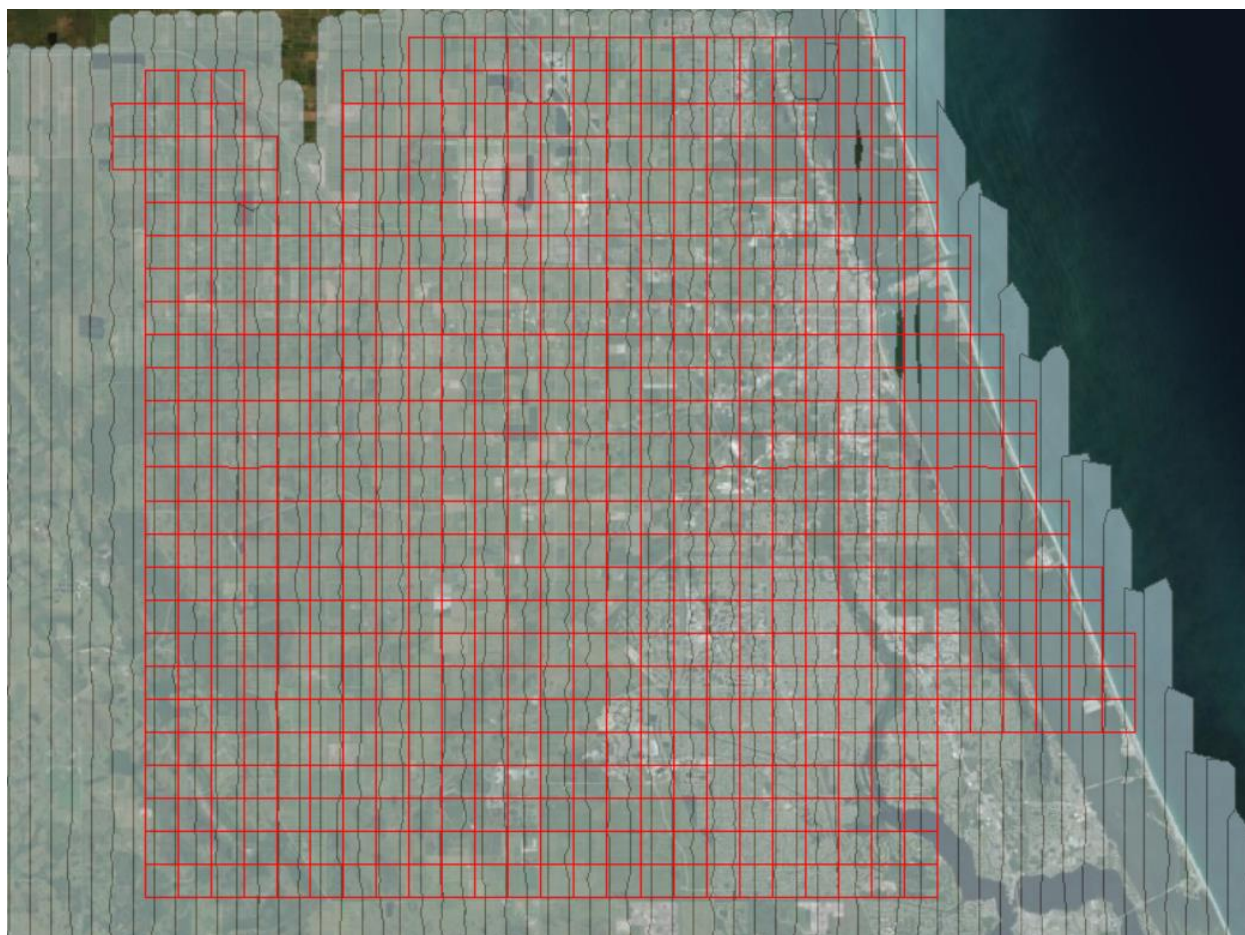
Data collected by the lidar unit was reviewed for completeness, acceptable density, and to make sure all data were captured without errors or corrupted values. All GPS, aircraft trajectory, mission information, and ground control files were reviewed and logged. A supplementary coverage check was carried out (Figure 3) to ensure that there were no unreported gaps in data coverage.

Figure 3. Lidar swath output showing complete coverage.
