CHECK POINT DOCUMENTATION REPORT

Re-Check Point ID:

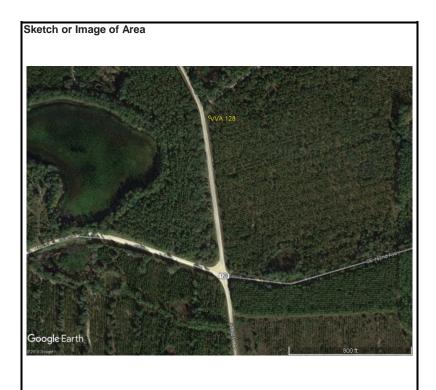
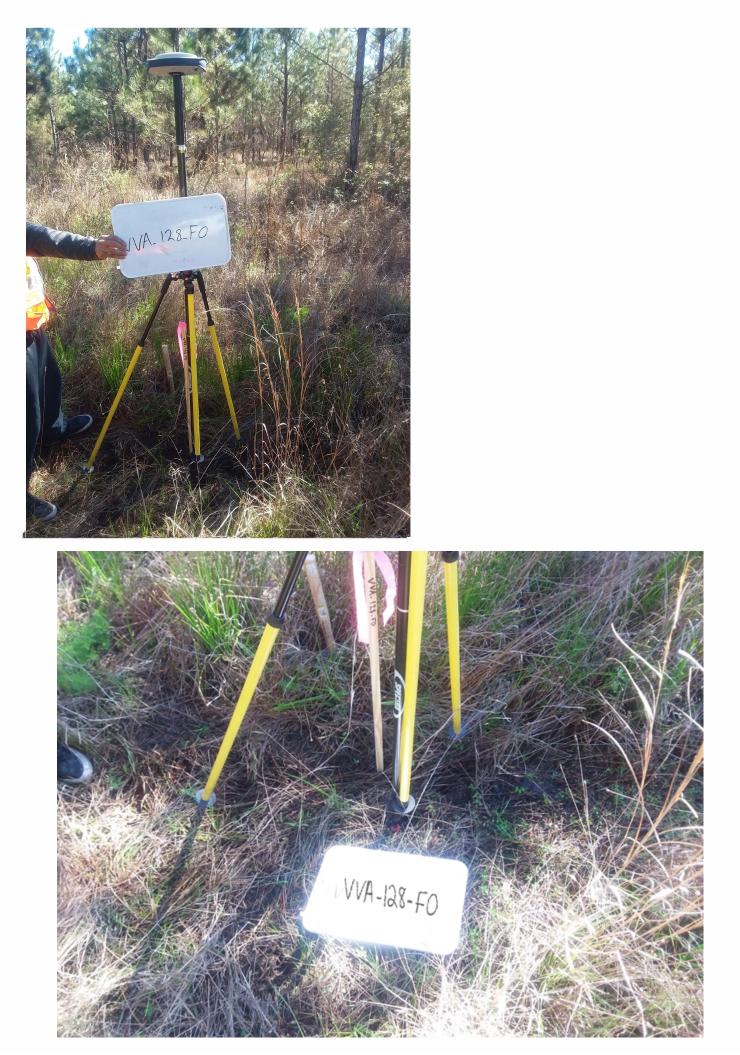
PICTURES

Date: 03/06/19	Time: <u>10:13</u> ⊠ a.m. □ p	o.m. Employee Name	: Micheal Tadros	
Job Name: <u>Florida Peninsula</u>	r LiDAR	Point ID:	16055 VVA 128 FO	
State: FL Latitud	le: <u>29°30′25.16318″N</u>	⊠ + 🗆 – Longi	itude: <u>82°04'34.24089"W</u> [□+⊠-
