Dewberry Ground control point documentation report

Date: <u>12/21/18</u>	Time: <u>08:45</u>	a.m. 🛛 p.m. Employee Name: <u>Alberto Martinez</u>				
Job Name: <u>Florida P</u>	eninsular LiDAR	Point ID: <u>15001 (GCP QSI 139)</u>				
State: FL	Latitude: 28°45′13.55687″ N	<u></u> ∠ ∠ ∠ ∠ ∠ ∠ ∠ ∠ ∠ ∠	_□+⊠-

Address and/or Intersection: Lake Terry Drive & Lake Jem Road

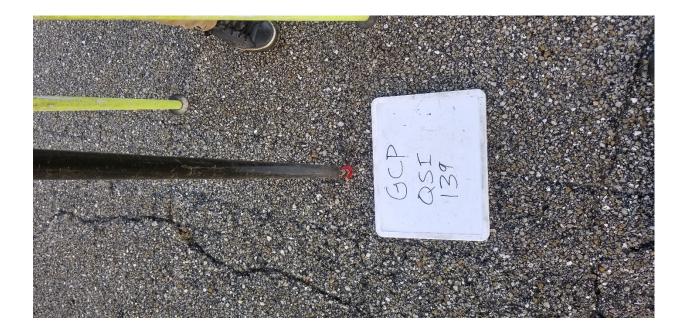
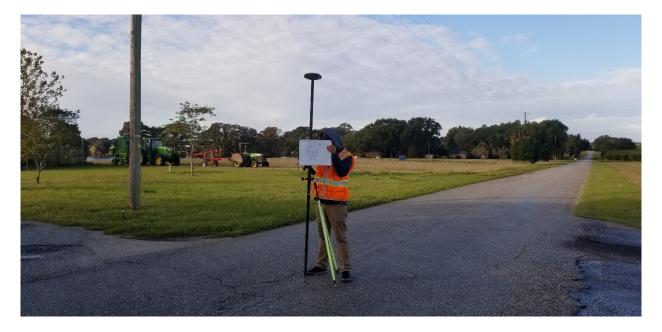
Picture(s) of Area & Setup

SET MND "TRAV PT LB 8011"
