Dewberry GROUND CONTROL POINT DOCUMENTATION REPORT

Date: <u>12/28/18</u>	Time: <u>10:58</u>	a.m. D p.m. Employee Name: <u>Andrew Strickland</u>	
Job Name: <u>Florida Penir</u>	nsular LiDAR	Point ID: (GCP QSI 42) 60036	
State: <u>FL</u> La	atitude: <u>30°18'09.55531"N</u>	⊠ + □ – Longitude: <u>81°23'33.30018"</u> W	+ 🛛 –

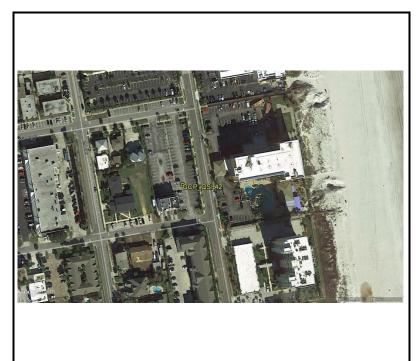
Description of Point:

SET LG Mag N&D "TRAV PT LB 8011" in PI of White Striping Sketch or Image of Area

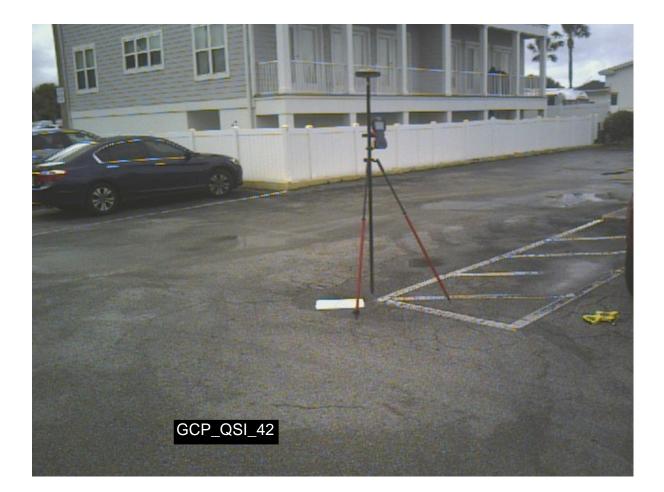
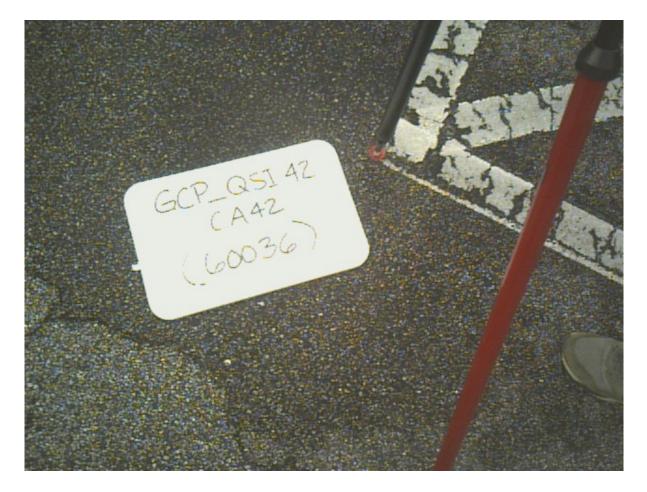
Picture(s) of Area & Setup

Address and/or Intersection: Additional Overflow Parking for Address # 1515 (Hampton Inn) West Side of 1st N

- PAVEMENT
- □ MOWED GRASS
- □ BARE SOIL
- □ NGS Control
