Dewberry Ground control point documentation report

Date: 02/01/19	Time: <u>12:30</u>] a.m. 🛛 p.m. Employ	ee Name: Andrew Strickland	
Job Name: Florida Peninsular LiDAR			Point ID: (GCP QSI 84) 60175	
State: FL Latitude	e:	_⊠ + □	– Longitude: <u>81°32'04.45065"W</u>	+ 🛛 –

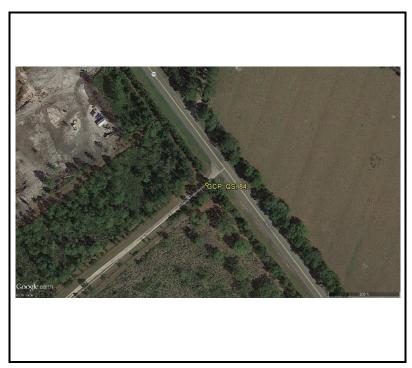
Sketch or Image of Area

SET 5/8" IRC Stamped "TRAV PT LB 8011"

GCP QSI 84 CA 84 84 0175 60175 à
