Florida Southeast Lidar

Report Produced for U.S. Geological Survey

USGS Contract: G16PC00020

Task Order: 140G0218F0178

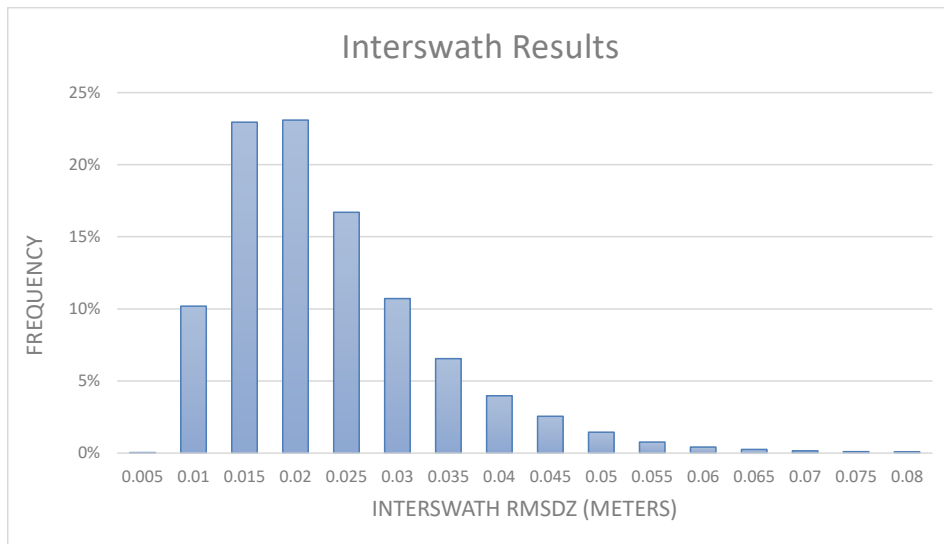
Figure 9—Frequency distribution of interswath RMSDz results

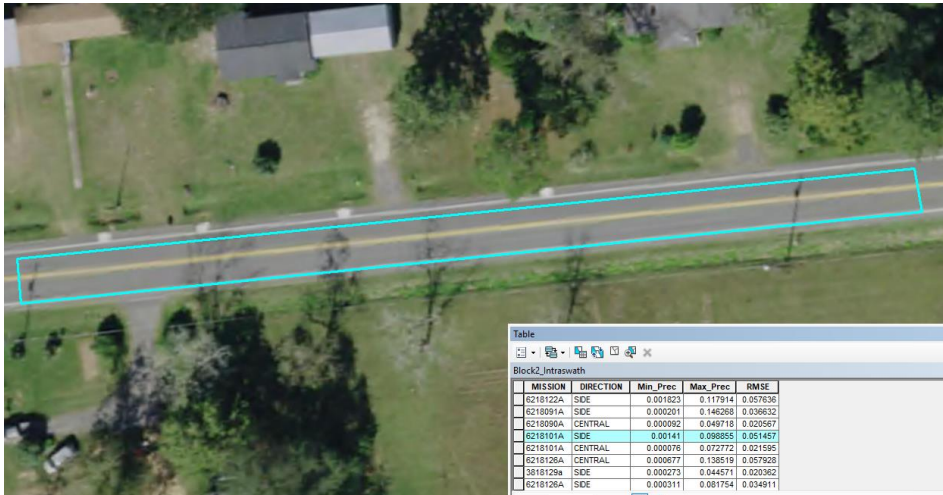
Figure 12—Example test polygon for intraswath testing, and its results

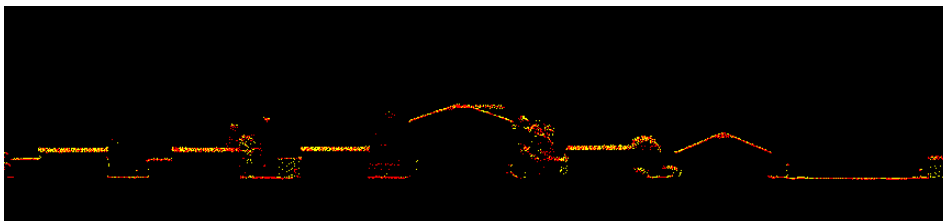
To ensure horizontal alignment between adjacent or overlapping flight lines, Dewberry uses QTM scripting and visual reviews. QTM scripting is used to create files similar to DZ orthos for each swath but this process highlights planar surfaces, such as roof tops. In particular, horizontal shifts or misalignments between swaths on roof tops and other elevated planar surfaces are highlighted. Visual reviews of these features, including additional profile verifications, are used to confirm the results of this process. The image below shows an example of the horizontal alignment between swaths for Florida Southeast Lidar Project; no horizontal alignment issues were identified.

Figure 14—Horizontal Alignment. Two separate flight lines differentiated by color (Yellow/Red) are shown in this profile. There is no visible offset between these two flight lines. No horizontal alignment issues were identified.

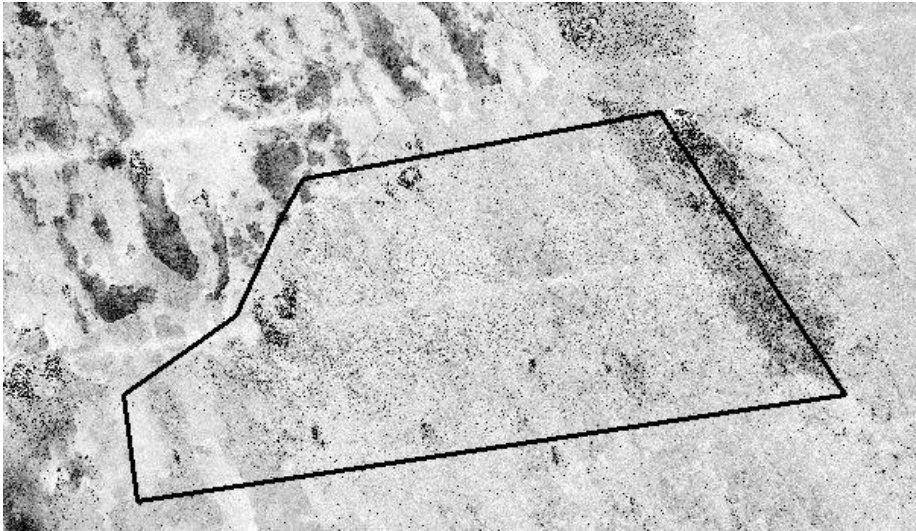
Figure 30— Tiles e1531n0469, e1532n0469, e1533n0469, e1531n0470, e1532n0470, e1533n0470, e1534n0470, e1535n0470, e1532n0471, e1533n0471, e1534n0471, e1535n0471. Lack of vegetation following a brush fire is causing the temporal differences depicted in the intensity imagery.

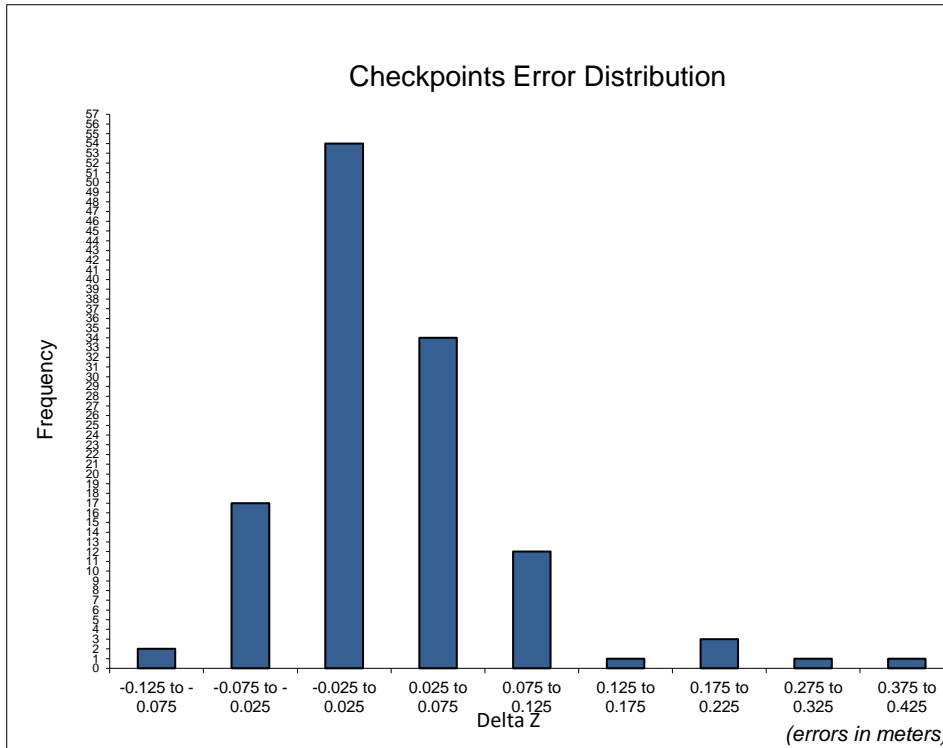
Figure 35—Histogram of Elevation Discrepancies with errors in meters

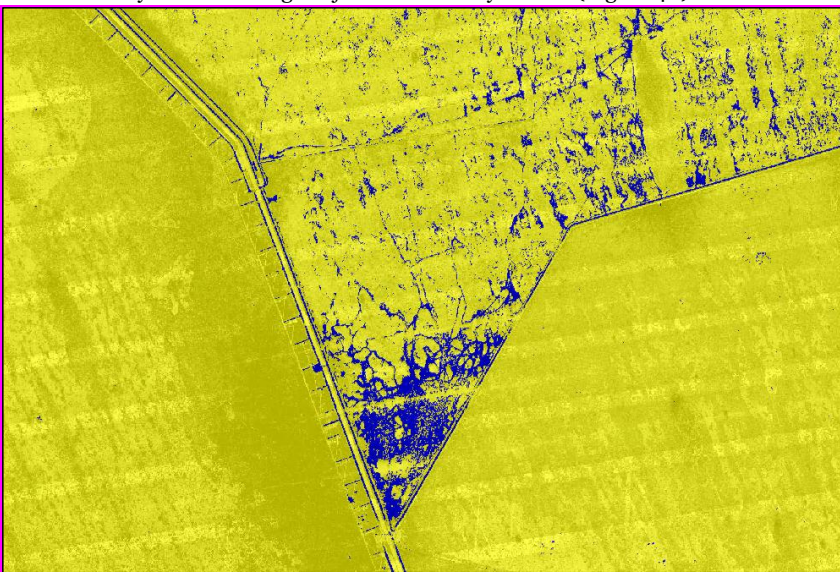
Figure 40—Image objects classified as Water (blue) and Ground (yellow).

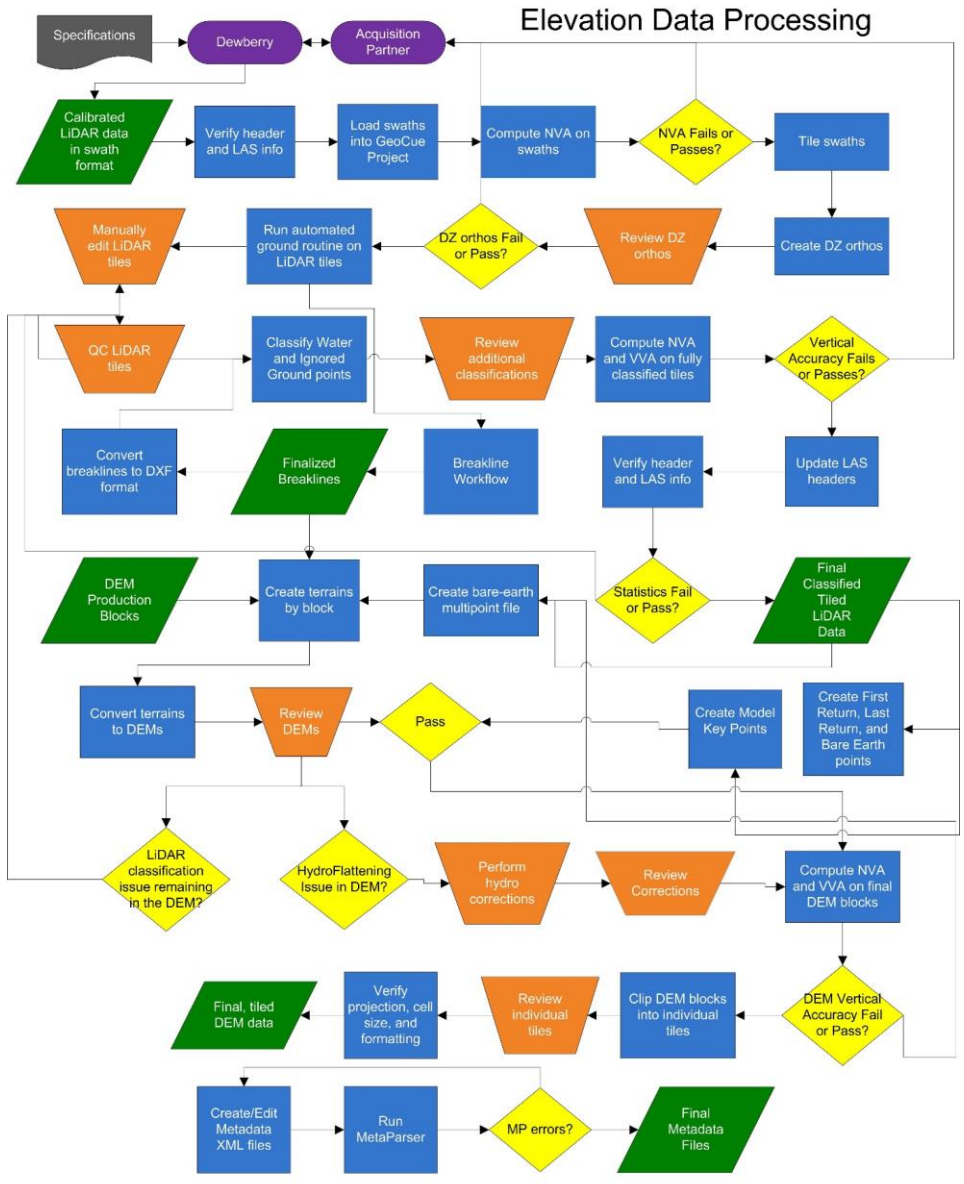
Figure 42—DEM Production Workflow

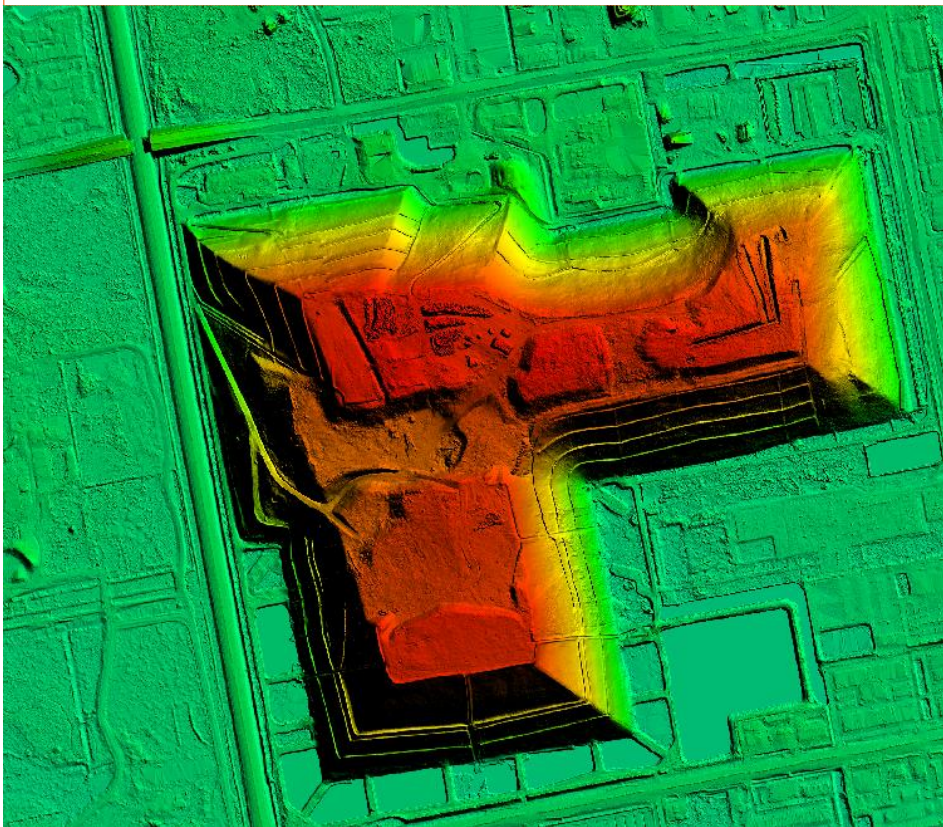
The image below shows an example of a bare earth DEM.

Figure 43—Tile e1587n0491. The bare earth DEM is shown in the image above.

Dewberry performed a comprehensive qualitative assessment of the bare earth DEM deliverables to ensure that all tiled DEM products were delivered with the proper extents, were free of processing artifacts, and contained the proper referencing information. This process was performed in ArcGIS software with the use of a tool set Dewberry has developed to verify that the raster extents match those of the tile grid and contain the correct projection information. The DEM data was reviewed at a scale of 1:5000 to review for artifacts caused by the DEM generation process and to review the hydro-flattened features. To perform this review Dewberry creates HillShade models and overlays a partially transparent colorized elevation model to review for these issues. All corrections are completed using Dewberry's proprietary correction workflow. Upon completion of the corrections, the DEM data is loaded into Global Mapper for its second review and to verify corrections. Once the DEMs are tiled out, the final tiles are again loaded into Global Mapper to ensure coverage, extents, and that the final tiles are seamless.

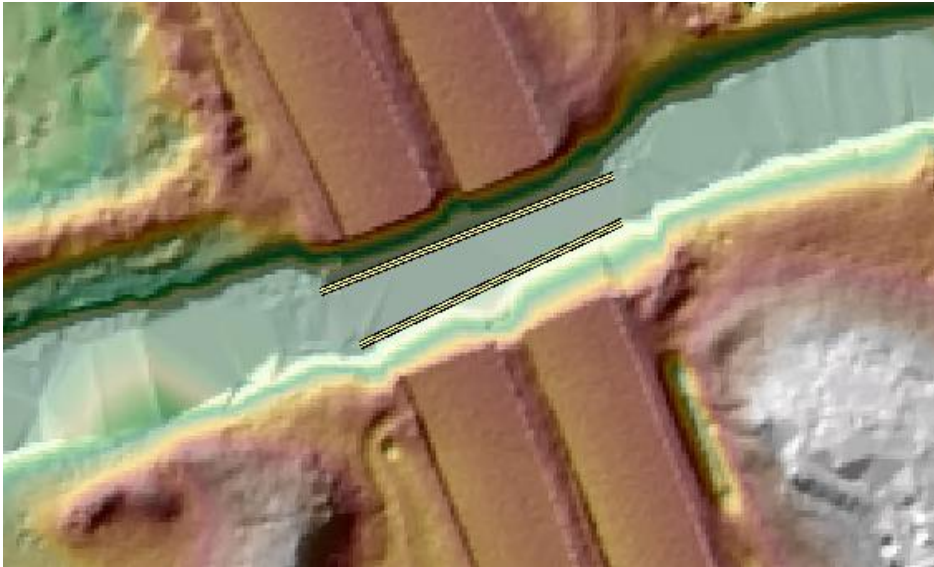
Figure 45—Tile e1579n0484. The DEM on the top shows a bridge saddle artifact, while the DEM on the bottom shows the same location after bridge saddle breaklines have been enforced.
