# **ID Southern ID\_2018\_D19**

**Work Package: 183648**

**Work Units: 230906, and 230909**

**Report Produced for U.S. Geological Survey**

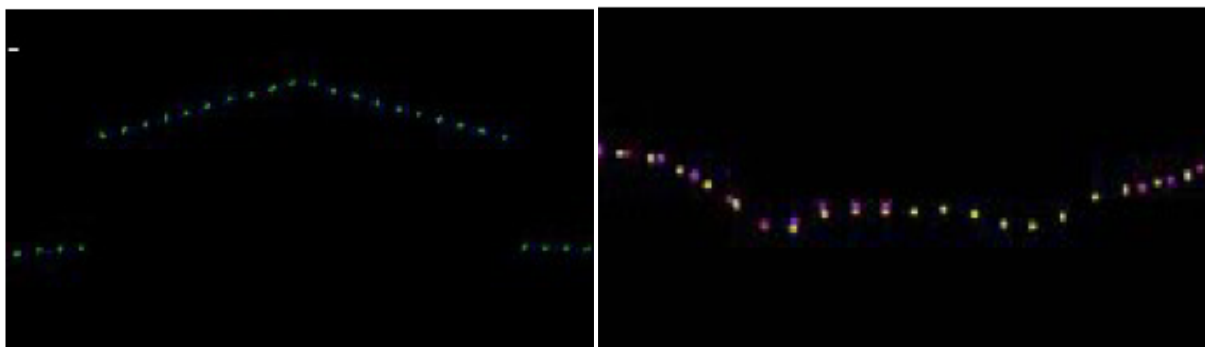
Figure 5. Profile views showing results of roll and pitch adjustments.

The initial points for each mission calibration were inspected for flight line errors, flight line overlap, slivers or gaps in the data, point data minimums, or issues with the lidar unit or GPS. Roll, pitch and scanner scale were optimized during the calibration process until relative accuracy requirements were met.

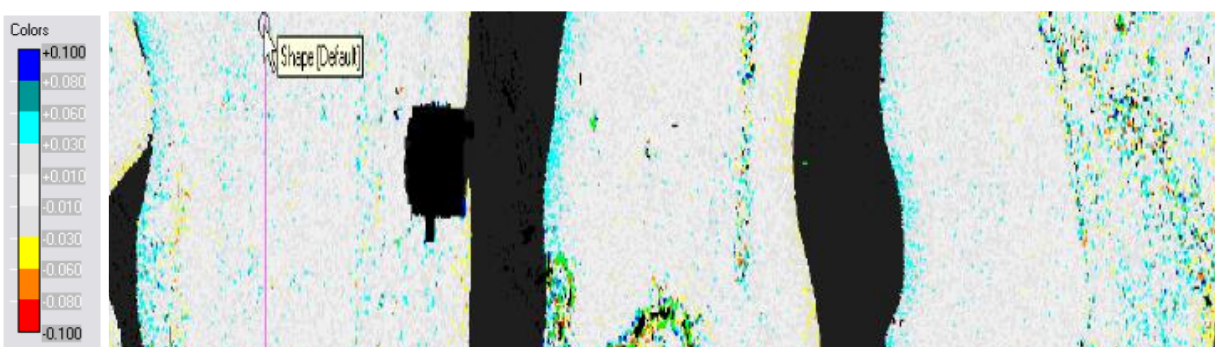
Figure 6. QC block colored by vertical difference between swaths to check accuracy at swath edges.

Relative accuracy and internal quality were checked using at least 3 regularly spaced QC blocks in which points from all lines were loaded and inspected. Vertical differences between ground surfaces of each line were displayed. Color scale was adjusted to flag errors that were not within project specifications. Cross sections were visually inspected across each block to validate point to point, flight line to flight line, and mission to mission agreement.

- $\leq 6$  cm maximum difference within individual swaths (intra-swath); and
- $\leq 8$  cm RMSDz between adjacent and overlapping swaths (inter-swath).
