LiDAR Quality Assessment Report

KS_Area1-Eastern_2013

NGTOC
2014-06-30

The project Area 1 Kansas includes Anderson, Allen, Neosho, and Labette counties. Areas were defined and supplied by Kansas Department of Administration and includes approximately 2250 square miles for analysis.

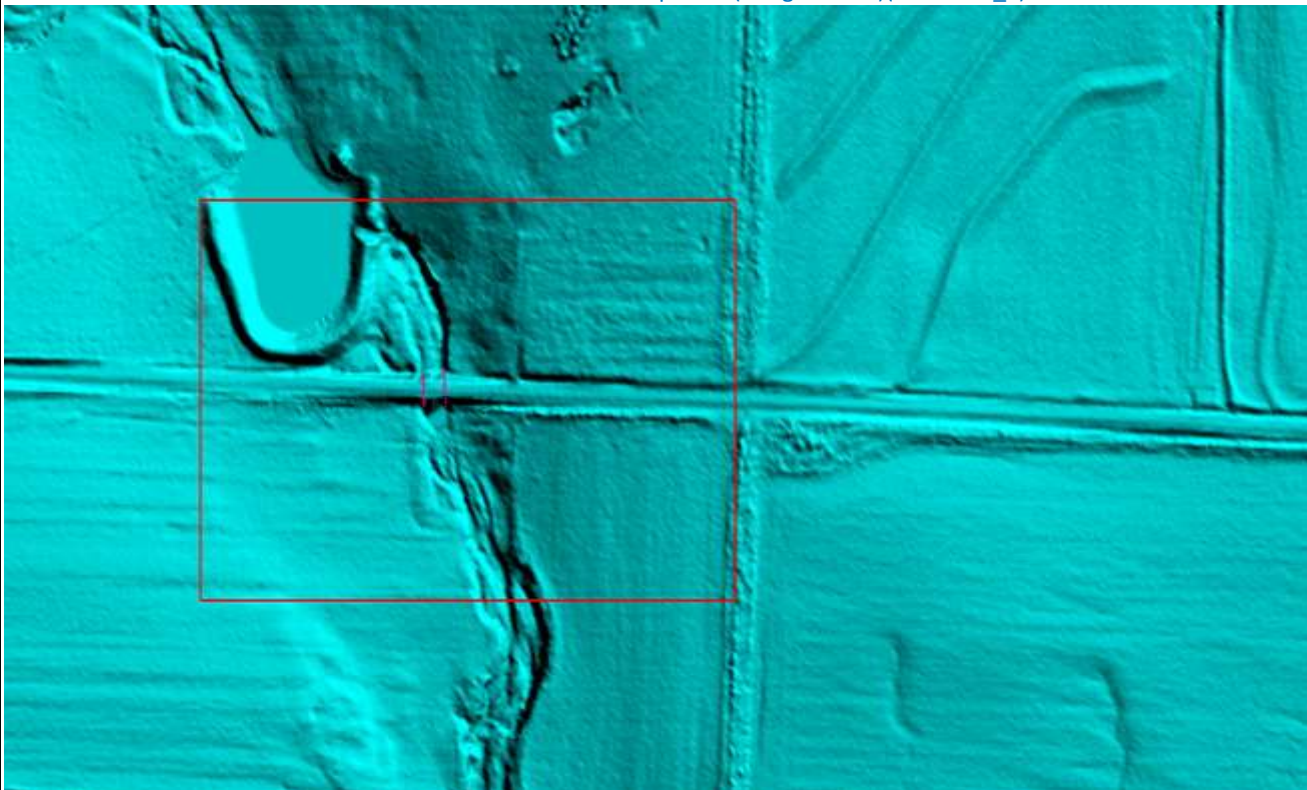
*****some breaklines still exist where culverts have been replaced (image below)(Breakline_1)

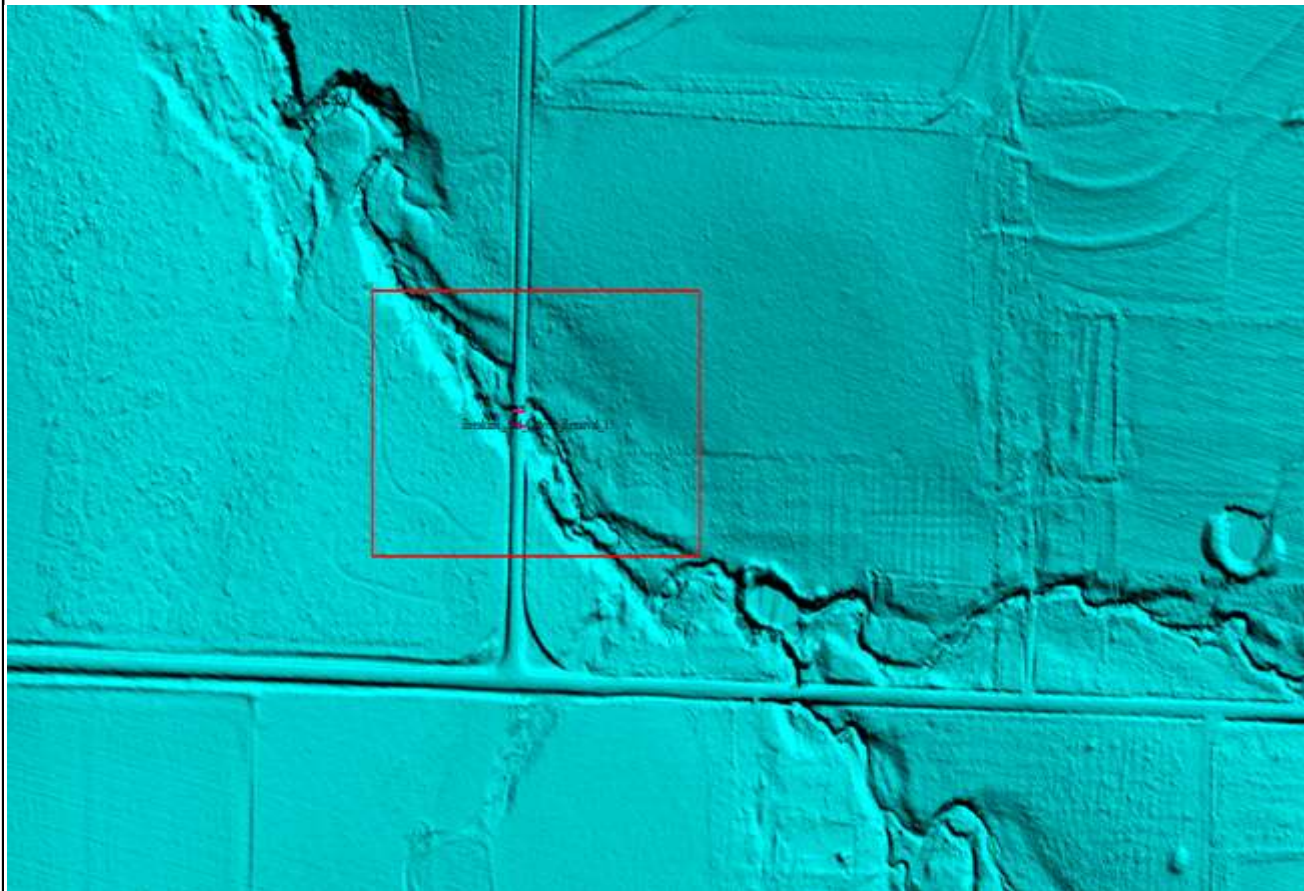
*****some culverts have been partially removed and breaklines remain. (image below) (Breakline_and_Culvert_1)

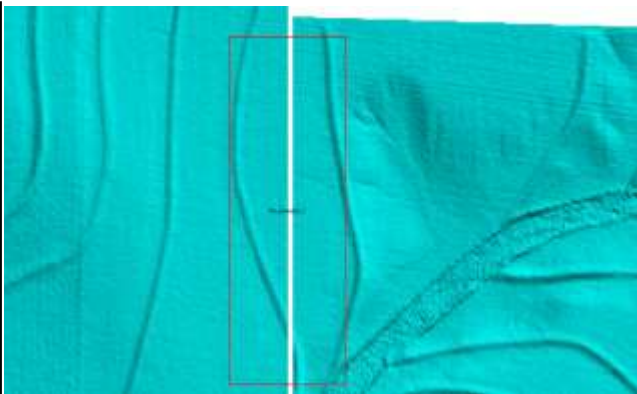
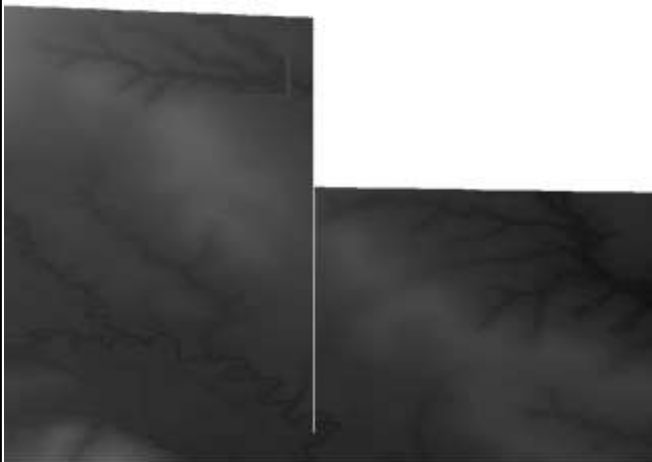
Image from Global Mapper showing tile mismatch (above) and ArcMap (below). [Corrected by vendor.](#)

Tile mismatch between DEM tiles BE_15STC8550 and BE_15STC9050. [Corrected by vendor.](#)

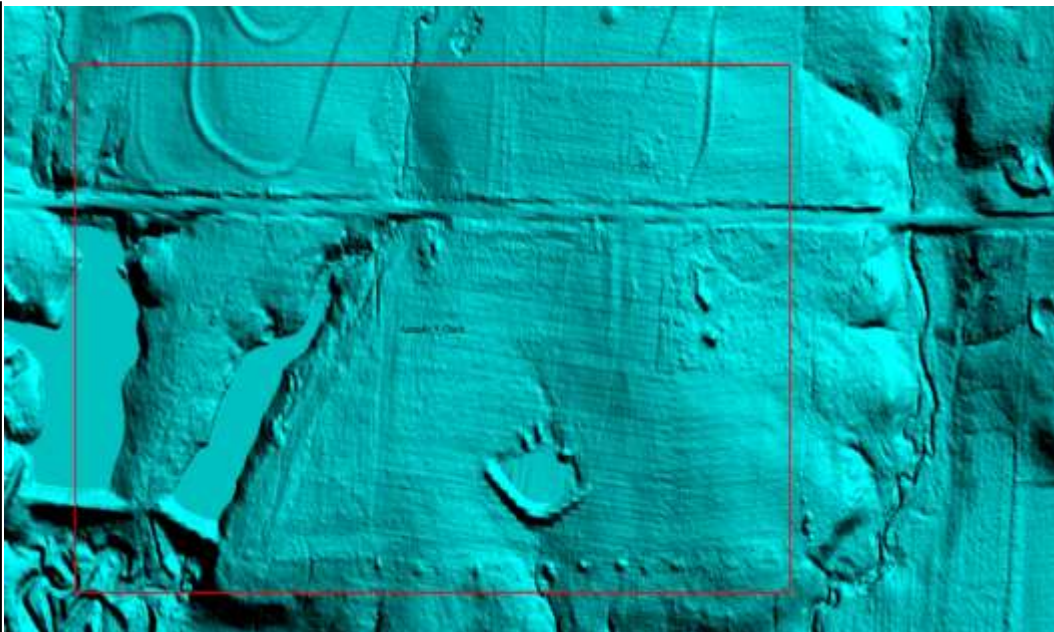
Anomalous error (Anomaly_9) showing different data resolution. Location: 37° 34' 18.9748" N, 95° 06' 11.3445" W
*****Not corrected, but accepted

"In the UTM15 geodatabase a shape has been added with the description of *Kansas_2012_Data_Limit*. In order to provide full tile DEMs between Kansas 2013 and Kansas 2012 project areas, Kansas 2012 data was included. The inclusion of Kansas 2012 data introduced a visible seam between the two data sets due to seasonal changes, differences between missions, and sensors. The only way to alleviate the appearance of the anomalous error would be by the removal of the Kansas 2012 data, and by providing partial tiles along the eastern boundary of Kansas 2013."

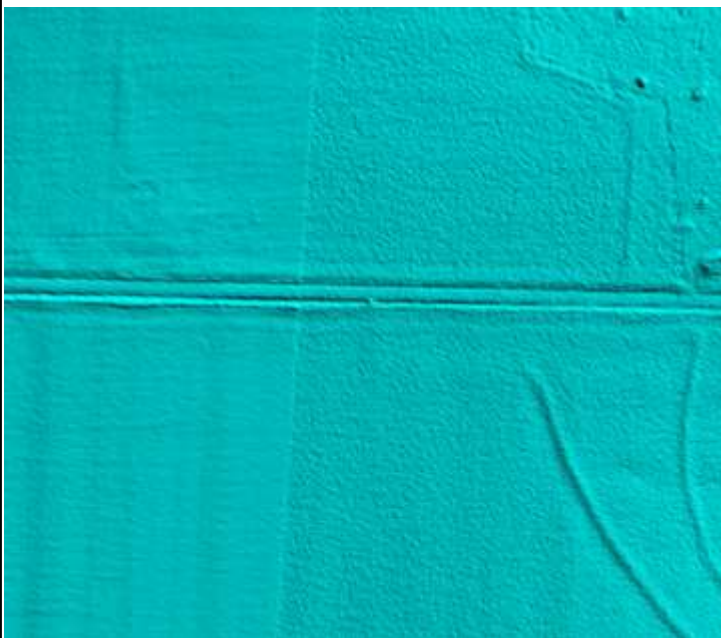
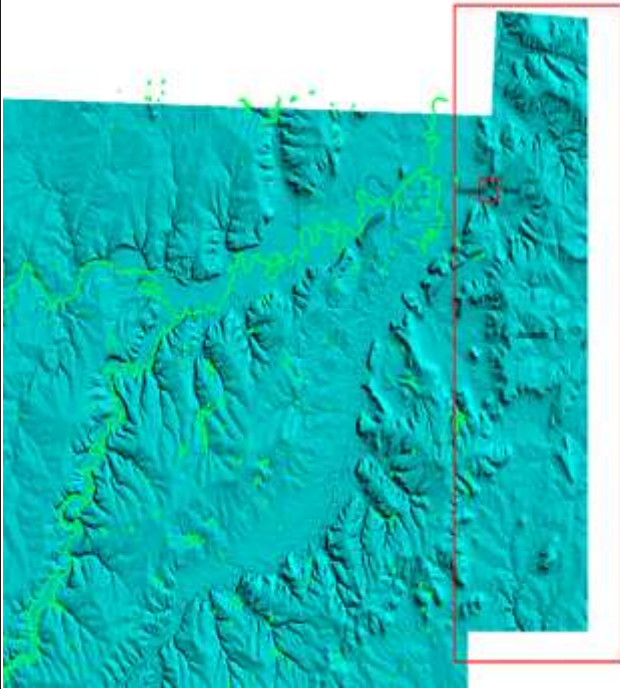
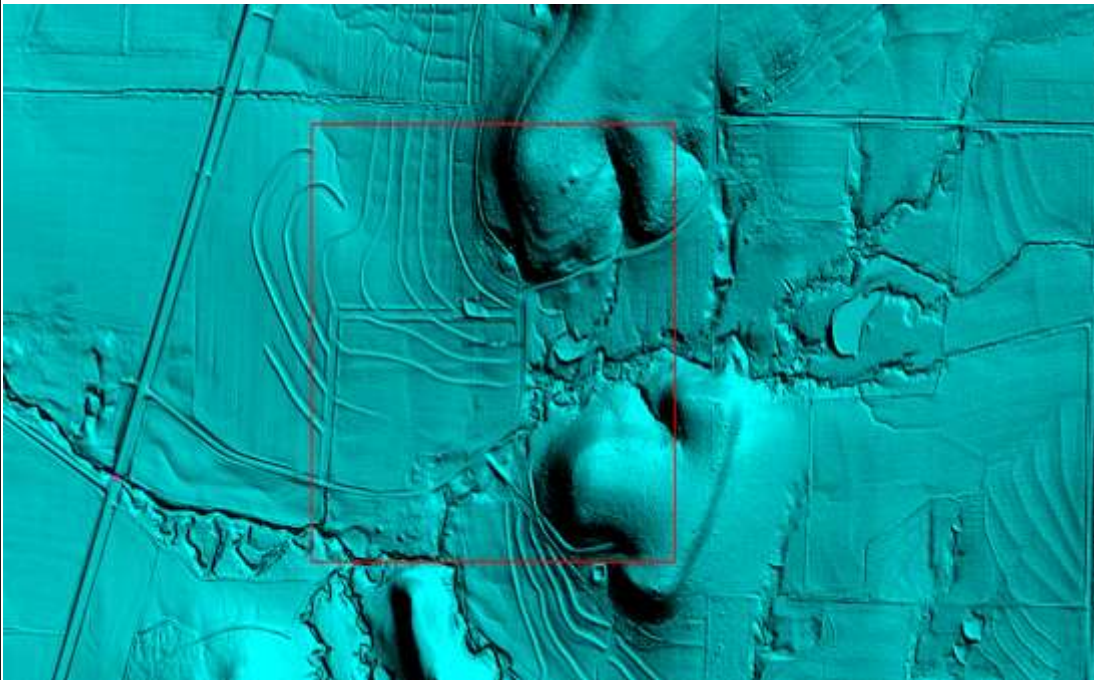
Global Mapper error image (above) ArcMap image
*****This errors still exist. It seems to be endemic throughout the north-eastern corner of the dataset. Please
recheck (see new error images below and in error shapefile). Accepted, See explanation from vendor below.

Error identified along entire eastern edge of DEM. Location: 37° 57' 1.2367" N, 95° 07' 50.7476" W *****Not corrected

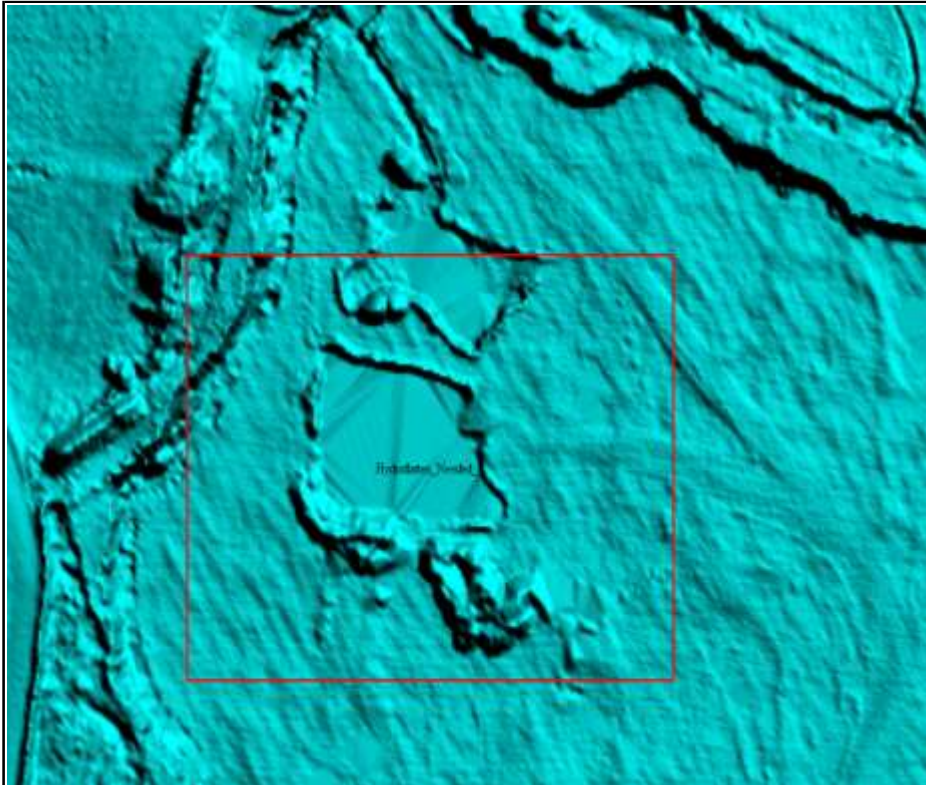
Hydro-flattening error (Hydroflatten_Needed_5). Location: 37° 45' 54.2384" N, 95° 26' 20.3021" W. Three similar errors exist. *****Corrected by vendor

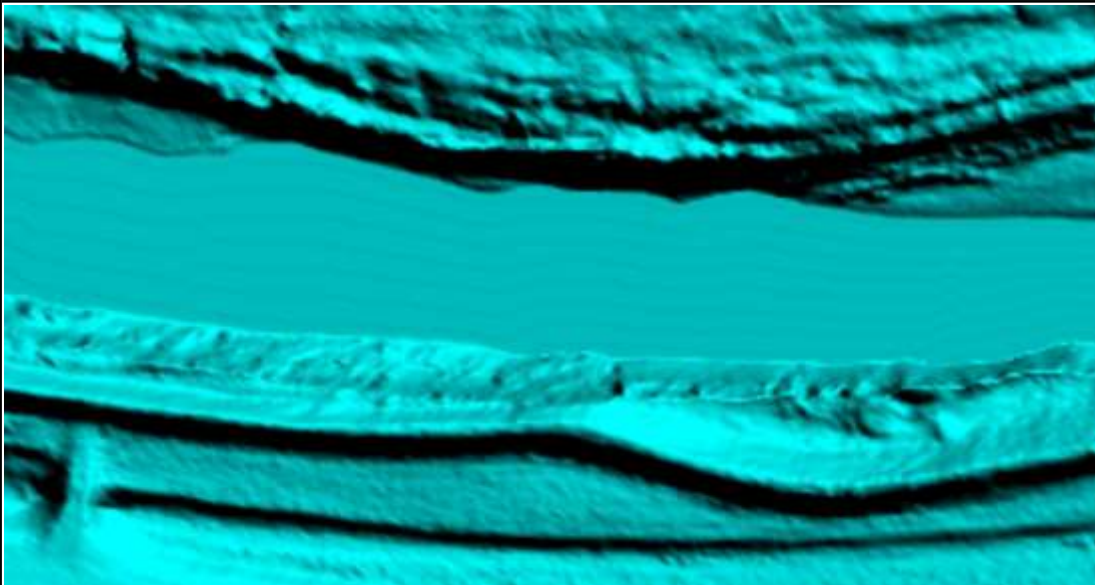
Several hydro-flattening errors exist within the streams. Image above is representative (Water_Issue_11). 15 of these error types exist; please review river system where errors exist.

***River errors corrected by vendor

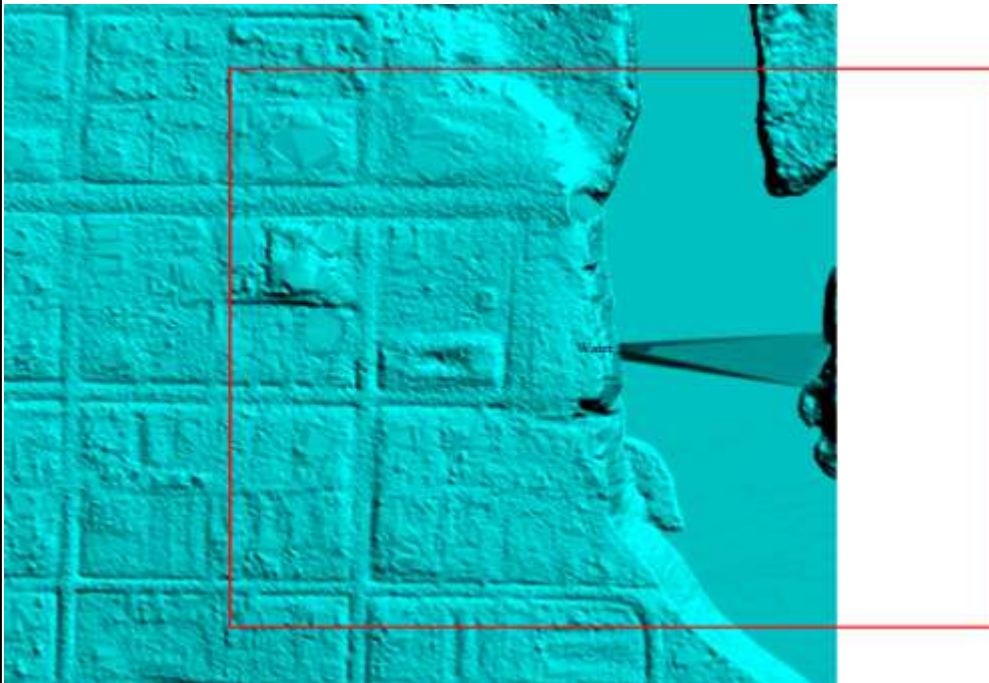
***Water issue beneath bridge. Corrected by vendor.

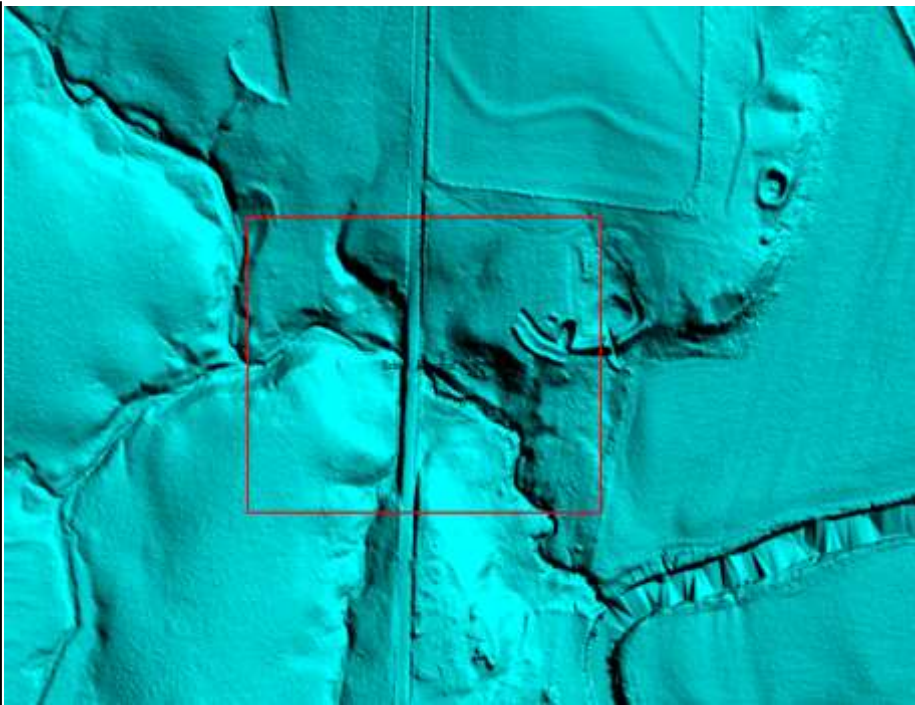
Several errors exist where bridges were not removed from DEM. Above image is representative (Bridge_Removal_6). Location: 37° 34' 39.3071" N, 95° 08' 34.2986" W***Corrected by vendor

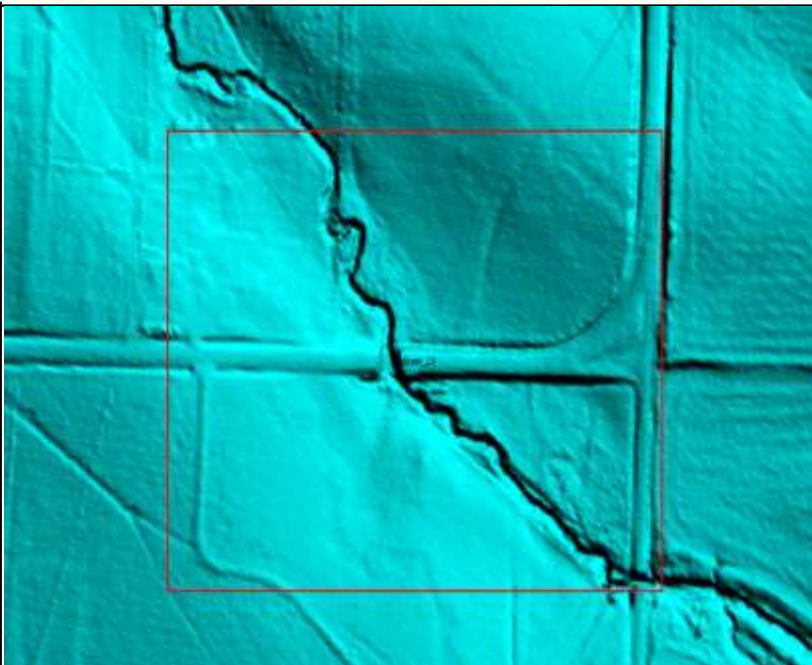
Culvert errors in which culverts were removed from DEM and need to be added back in. Above image is representative (Culvert_29) Location: 37° 52' 41.9722" N, 95° 25' 45.0572" W. 97 of this error type exist. ***Corrected by vendor

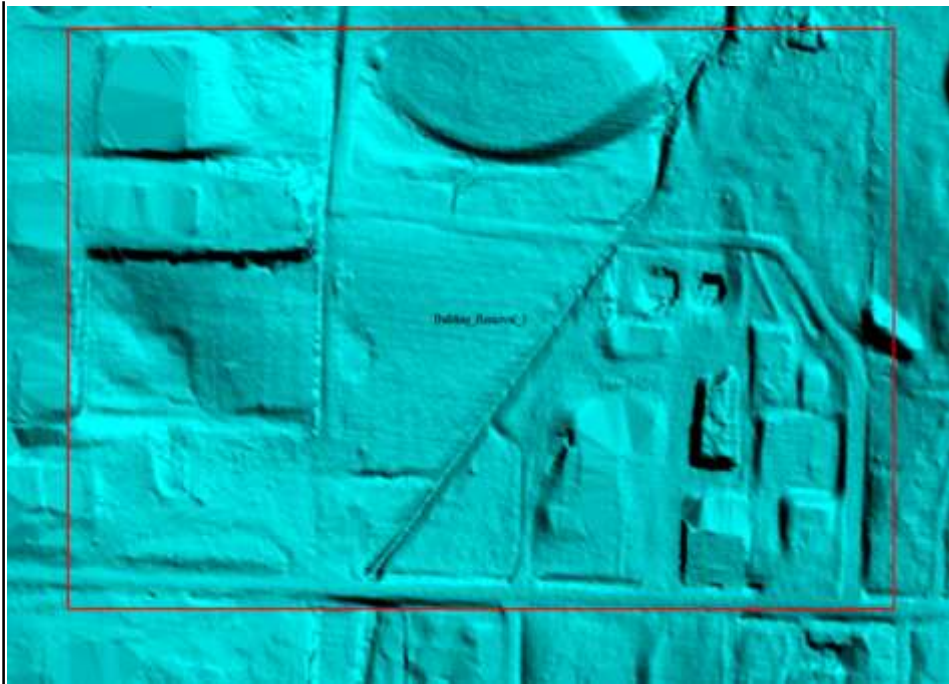
Buildings not removed from DEM. The above image is representative of this error type (Building_Removal_1). Location: 38° 17' 21.8901" N, 95° 14' 43.5772" W. 4 of this error type exist. [****OK, thanks for info.](#)
