Potomac Topobathy

Report Produced for U.S. Geological Survey

USGS Contract: 140G0221F0226

Task Order: MD_PotomacP2_Topobathy_2021_D21

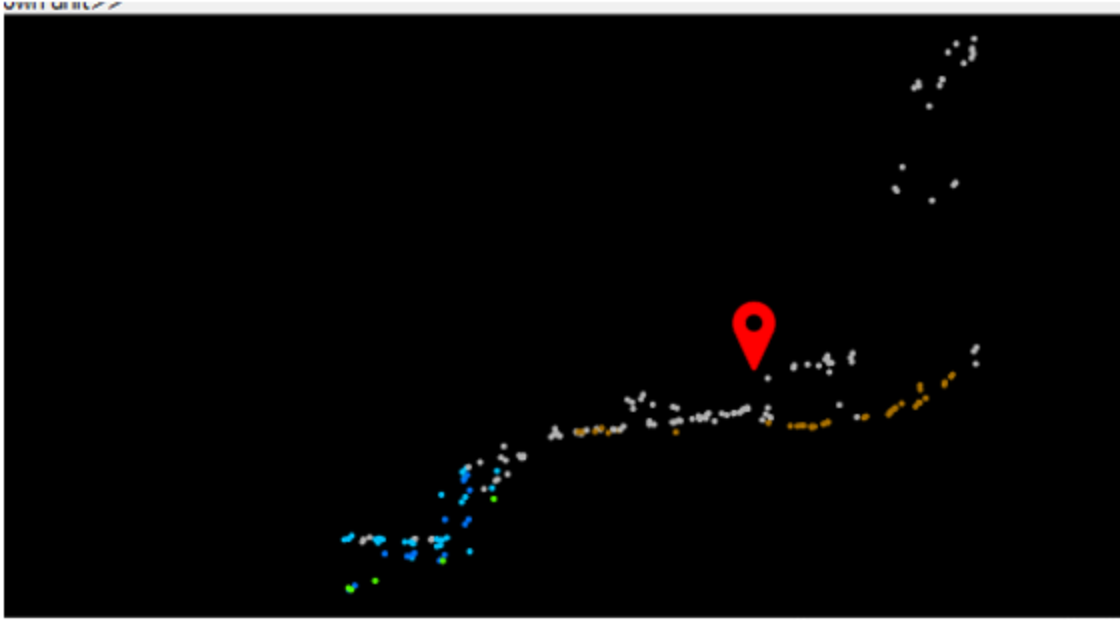
Figure 4. NVA-17 shown with the large pin. This point was removed from raw swath vertical accuracy testing because the overlying rock pile.

Checkpoint NVA-17 was removed from the raw swath vertical accuracy testing due to its location next to a rock pile. Though NVA-17 was located in open terrain, the rock pile was modeled by the lidar point cloud. Because the point cloud was not yet classified to remove vegetation, structures, and other above-ground features from the ground model, these high points produced erroneous elevation values during the swath vertical accuracy testing. Therefore, this point was removed from the final calculations. Once the data underwent classification, the rock piles were removed from the final ground classification and NVA-17 was usable in the final vertical accuracy testing, the results of which are reported in Section 4 of this report.

Table 6 illustrates the effect of the rock pile on the apparent positional accuracy of the lidar data by comparing the surveyed elevation of NVA-17 with the elevation of the surface generated from the raw swath data (which includes the power line). Table 7 demonstrates that the effect of the rock pile is removed following classification of the lidar data. Figure 6 shows a 3D model of the lidar point cloud colored by elevation, with the location of the checkpoint beneath the power line marked by a pin.

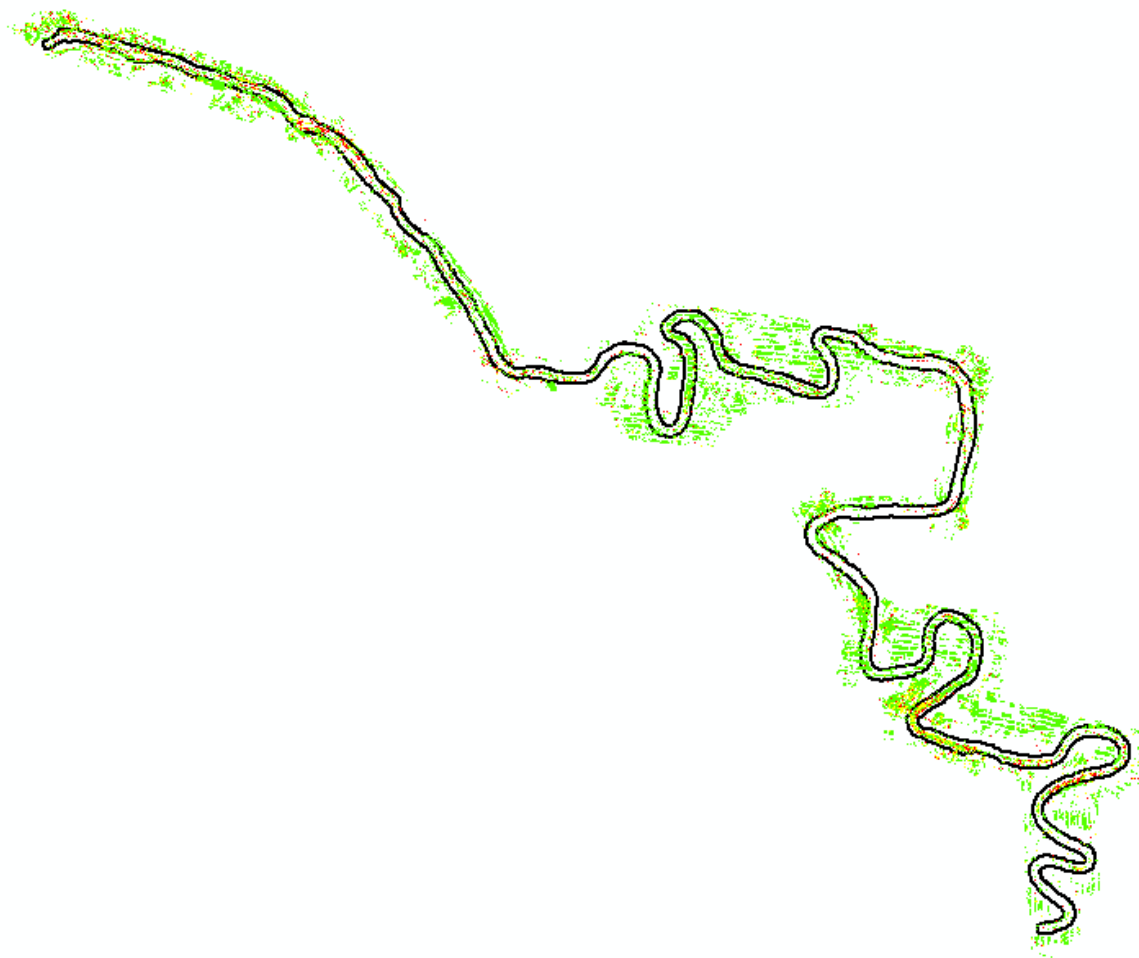
Figure 5. Single return interswath DZ rasters for the Potomac Topobathy Project.

Prior to classification, Dewberry validated the precision of the lidar calibration by creating delta-Z (DZ) rasters to visualize interswath accuracy. These rasters were generated with 1 m cell resolution based on the maximum difference in elevation between undifferentiated only returns in non-vegetated areas of overlap between flight lines. Each pixel of the raster was colorized according to the resulting value. Cells where overlapping flight lines were within 8 cm of each other were colored green, cells where overlapping flight lines had elevation differences between 8 cm and 16 cm were colored yellow, and cells where overlapping flight lines had elevation differences greater than 16 cm were colored red. Pixels that did not contain points from overlapping flight lines were designated as NoData and left empty.

Areas of vegetation and steep slopes (slopes with 16 cm or more of valid elevation change across 1 linear meter) are expected to appear yellow or red in the DZ rasters. Bathymetric areas can also appear yellow or red due to factors like different tidal stages between missions. Large or continuous sections of yellow or red pixels following terrain features or land cover zones are typically reflective of variable or unfavorable (e.g., vegetated) conditions for DZ measurements, whereas large or continued sections of yellow or red pixels following flight line patterns can indicate acquisition or calibration issues. The interswath DZ rasters for Potomac Topobathy are shown in Figure 5. Based on visual inspection, no issues with swath-to-swath calibration were noted.

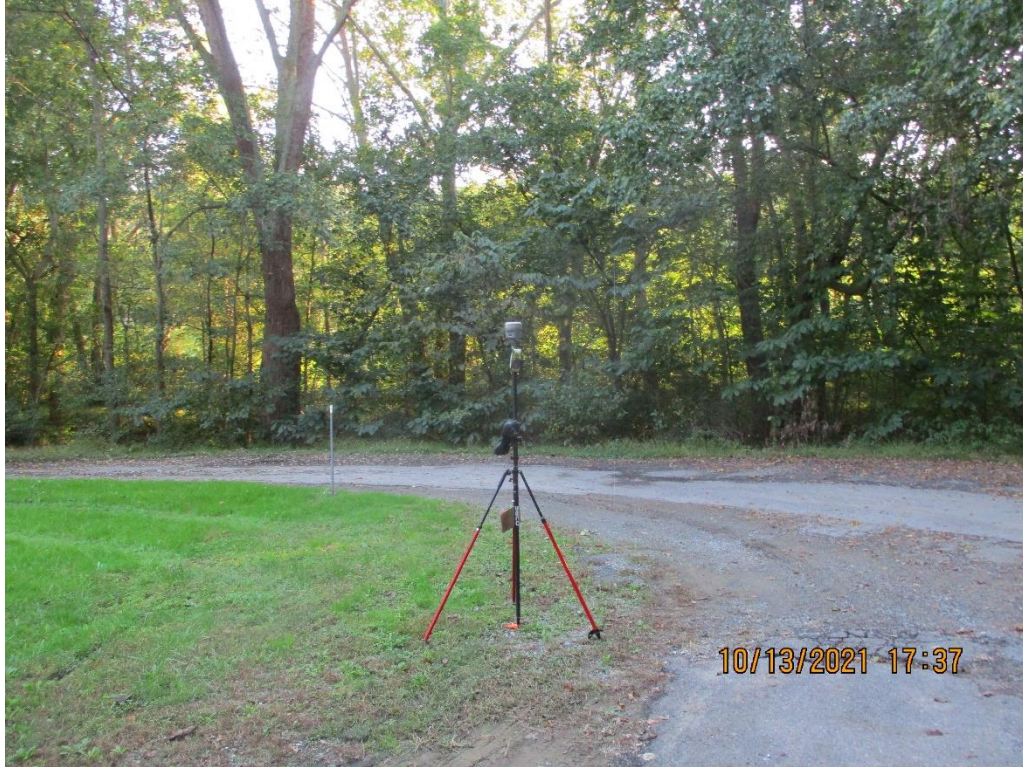
Figure 9. The surveyed elevation of checkpoint VVA_9 is over 4 meters above the ground surface in the lidar data. Review by the surveyor deemed this survey checkpoint erroneous and unsuitable to use in the final vertical accuracy testing.

Three checkpoints were removed from the classified lidar vertical accuracy testing. VVA_9 (Figure 9) showed a 4-meter difference between the surveyed elevation and the lidar elevation, with no issues in the lidar data to support the discrepancy. The surveyor reviewed and recalculated this checkpoint but could not account for the issue. The checkpoint was therefore considered low confidence and removed from the final vertical accuracy testing. Even without this checkpoint, there were enough total checkpoints and enough checkpoints per land cover category to satisfy project requirements.

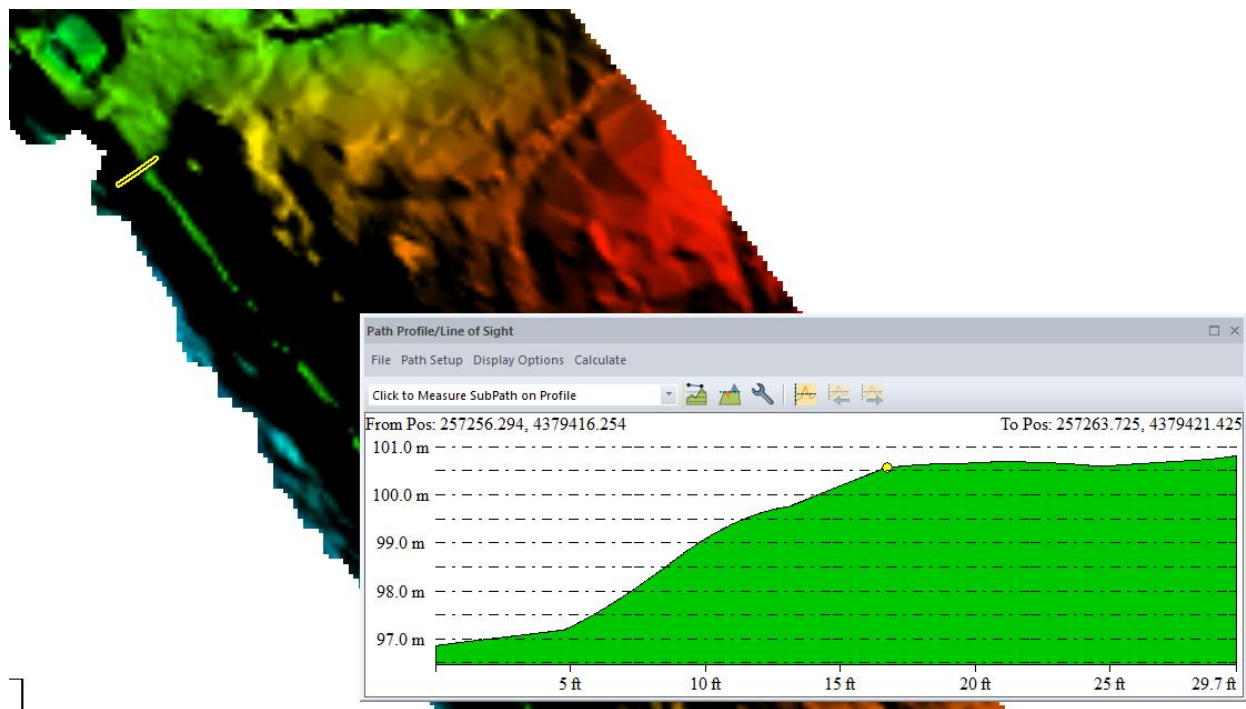
Figure 8. Checkpoint NVA_17, shown as the yellow circle in the profile, is located near a pile or rock. This checkpoint was removed from final classified vertical accuracy testing due to its location on a slope.

One checkpoint (NVA_17) was removed from the classified lidar vertical accuracy testing due to its proximity to breaks in the terrain. Per the task order, checkpoints should not be located within 5 meters of a significant change in slope. Breaks in the terrain may cause erroneous vertical accuracy results due to interpolation of the surface. Points on such terrain do not adequately test how well a sensor or a vegetation filtering technique performed. The coordinates of this checkpoint are provided in Table 11, and a profile showing the checkpoint located near breaks in the terrain are shown in Figure 8.
