# USGS Maryland Potomac River Topobathymetric Lidar Project

Report Produced for U.S. Geological Survey

USGS Contract: G16PC00020

Report Date: 04/20/2020

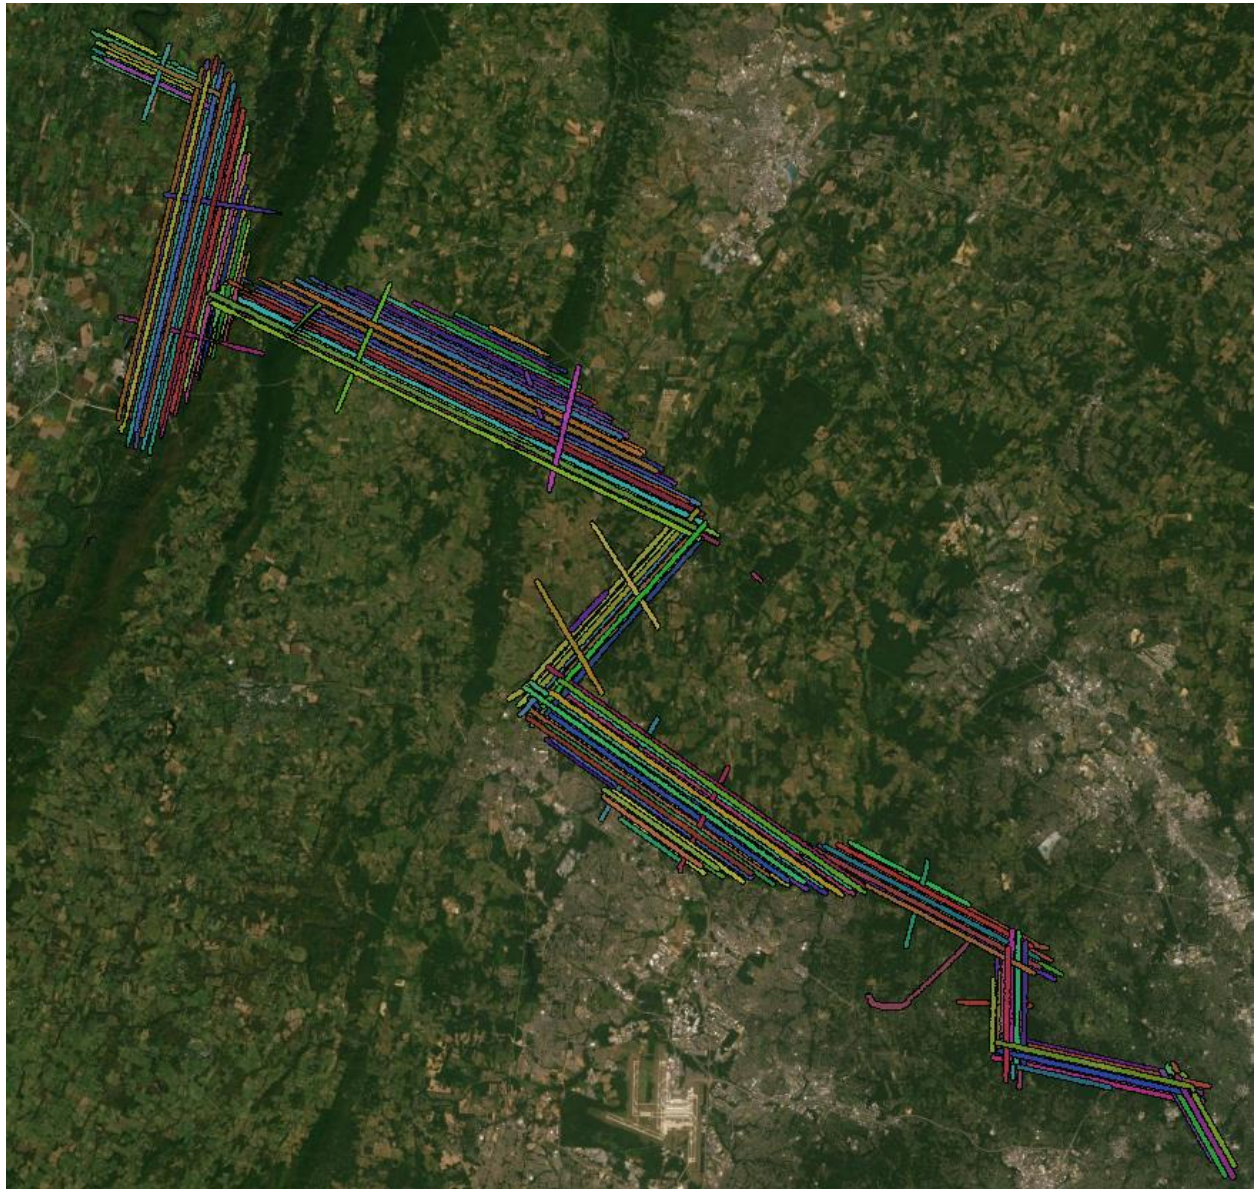
Figure 4 – Lidar swath output showing complete coverage.

Dewberry reviewed data collected by the lidar unit for completeness, acceptable density and to make sure all data was captured without errors or corrupted values. In addition, all GPS, aircraft trajectory, mission information, and ground control files were reviewed. Dewberry noted two data gaps, each near the edge of the AOI and outside of the bathymetry areas. IIC made an effort to re-fly these areas but was unable to complete the reflights due to the flight restrictions discussed above.

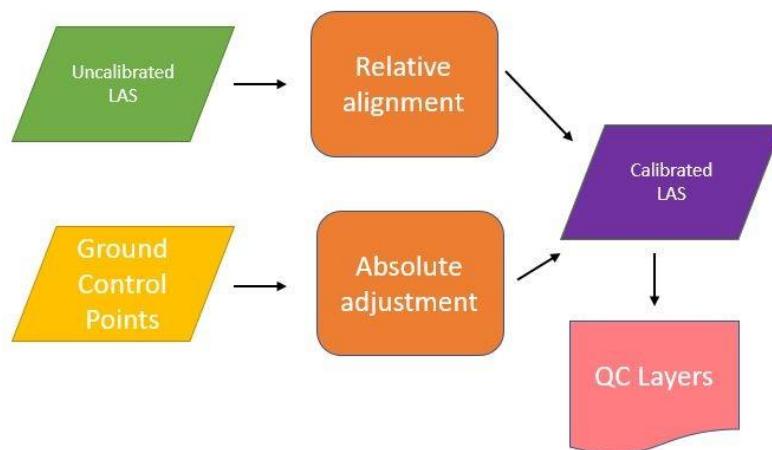
Figure 5: Alignment / Calibration workflow

Many quality control measures were utilized for this process, including generation of difference rasters (DZ orthos), review of adjustment parameters, and review of registration/match regions. After this process was completed the data were compared to independently collected checkpoints to ensure that absolute accuracy met RMSEz specification.

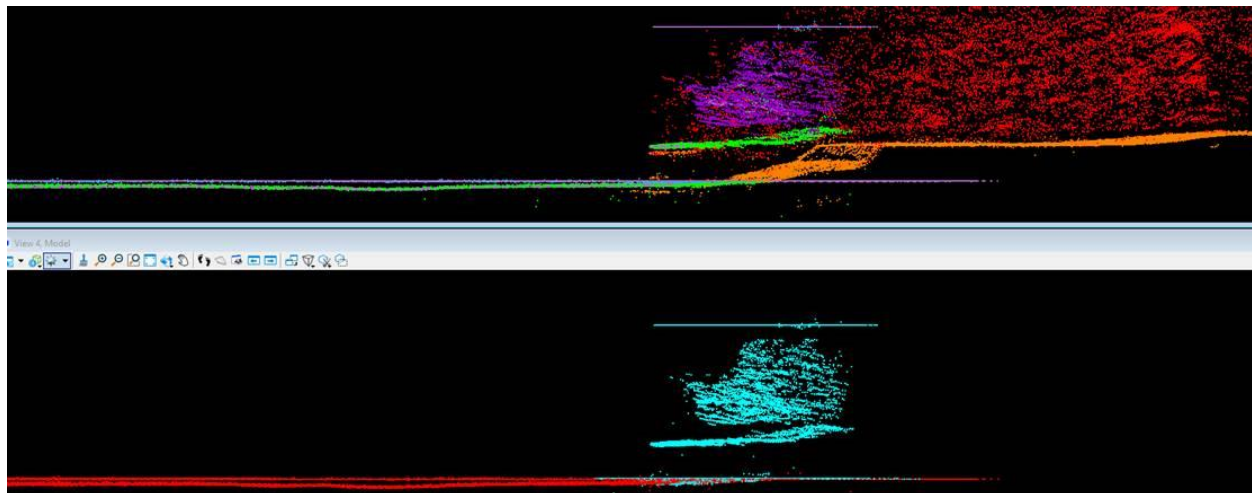
**Figure 6: Refraction offsets caused by erroneous synthetic water surface points. The upper profile shows points colored by class. Bathy bottom (green), default (red), ground (orange), noise (purple), and synthetic water surface (light purple) classes are shown. The lower profile shows the points colored by flightline.**

The Leica Survey Studio software automated refraction correction adds synthetic water surface points (class 42) to the data to represent a planar surface at the approximate water surface elevation for each flightline. These points are differentiated from real data with a return number of 0. In some cases, typically along the edges of flightlines that coincide with steep elevation changes such as the riverbanks, the sensor added erroneous water surface points. Erroneous synthetic water surface placement resulted in incorrect refraction correction and geometrically incorrect ground point locations. Therefore, before manual lidar classification was performed, these erroneous areas—all points associated with green sensor channels, including synthetic and real lidar points—were manually reclassified to withheld default to prevent incorrect surfaces being grounded. As these artifacts were located along the edge of flight lines, no data voids were created during this process. Following final classification, return number was used as a filter to return the synthetic water surface points to class 42.

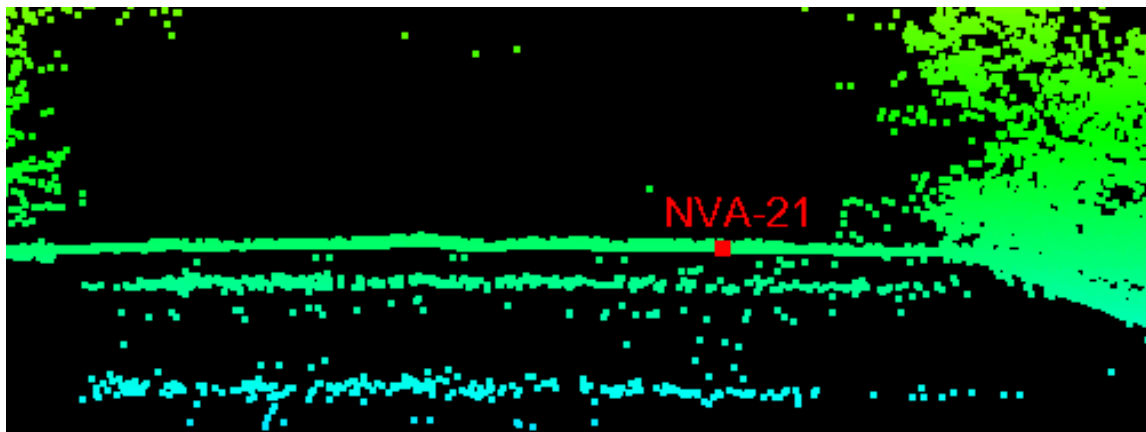
Figure 12 – Lidar profile showing NVA-21 with abundant low noise.

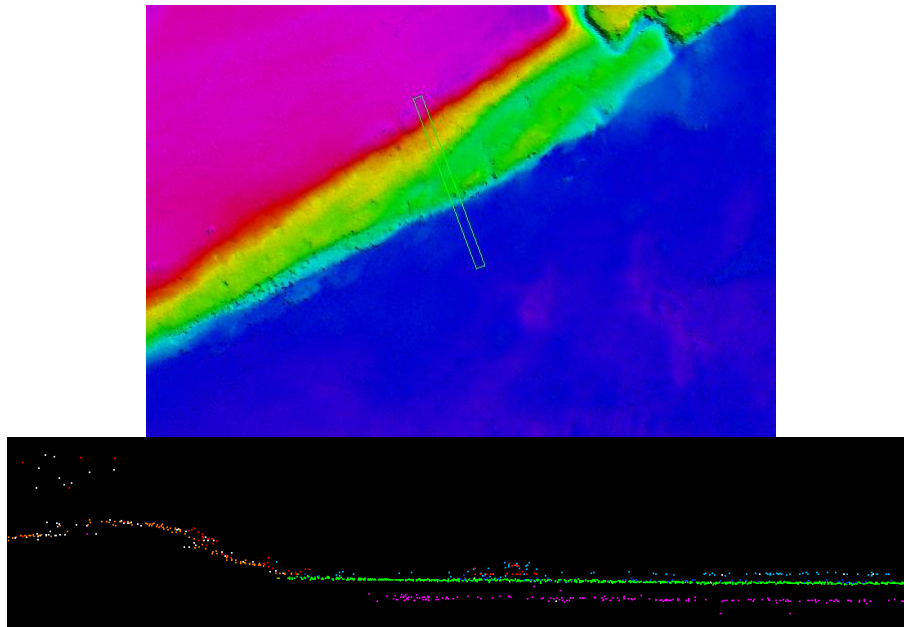
**Figure 20 – The land-water interface should be seamless with no hard edges or seamlines. The topobathy surface model is shown above with a profile location overlaid. The profile is shown in the bottom image where bathy bottom points are green, ground points are orange, water column points are blue, and unclassified points are red.**

Special attention was given along shorelines or the land/water interface as no hard edges or seams should exist between ground and bathy bottom.

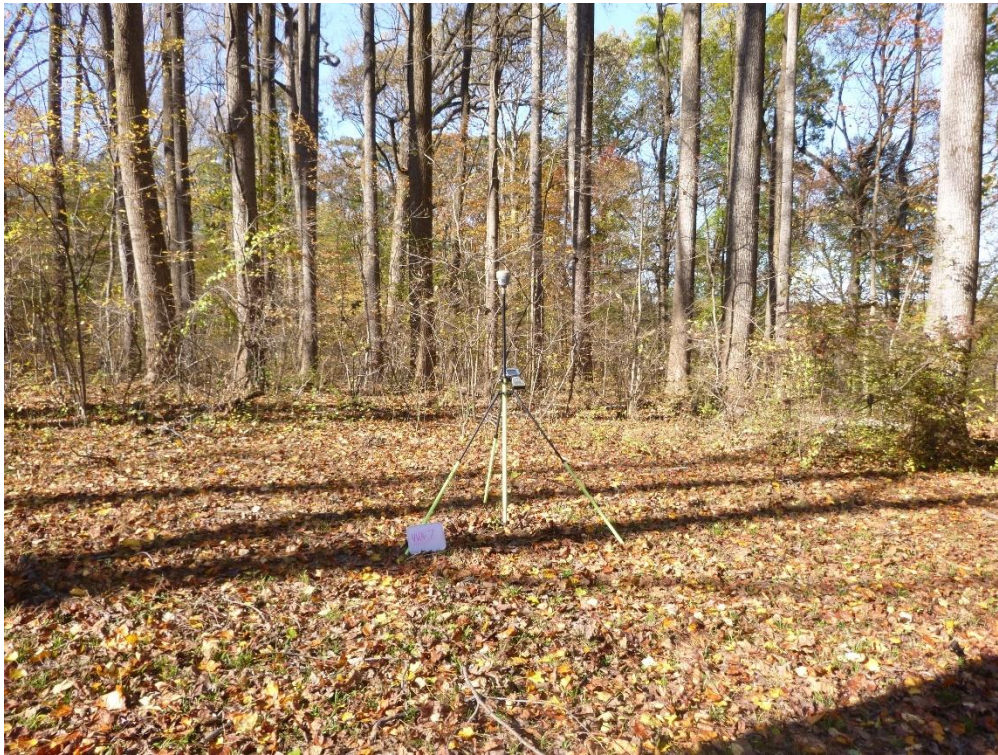
**Figure 26 – Checkpoint VVA-7. The surveyed elevation of this forest checkpoint is over 3 meters above the ground surface in the lidar data. Review by the surveyor deemed this survey checkpoint erroneous and unsuitable to use in the final vertical accuracy testing.**

One checkpoint was reviewed by the surveyor for issues. Dewberry requested checkpoint VVA-7 be reviewed by the surveyor because the delta Z between the lidar and survey was over 3 meters and there was no issue in the lidar data to support this discrepancy. Other survey points within the same flight line tested within anticipated thresholds. Upon review, it was determined that the checkpoint was collected according to specifications, but that tall trees within twenty feet of the checkpoint may have introduced multipath error (figure 23). VVA-7 was therefore excluded from accuracy testing.

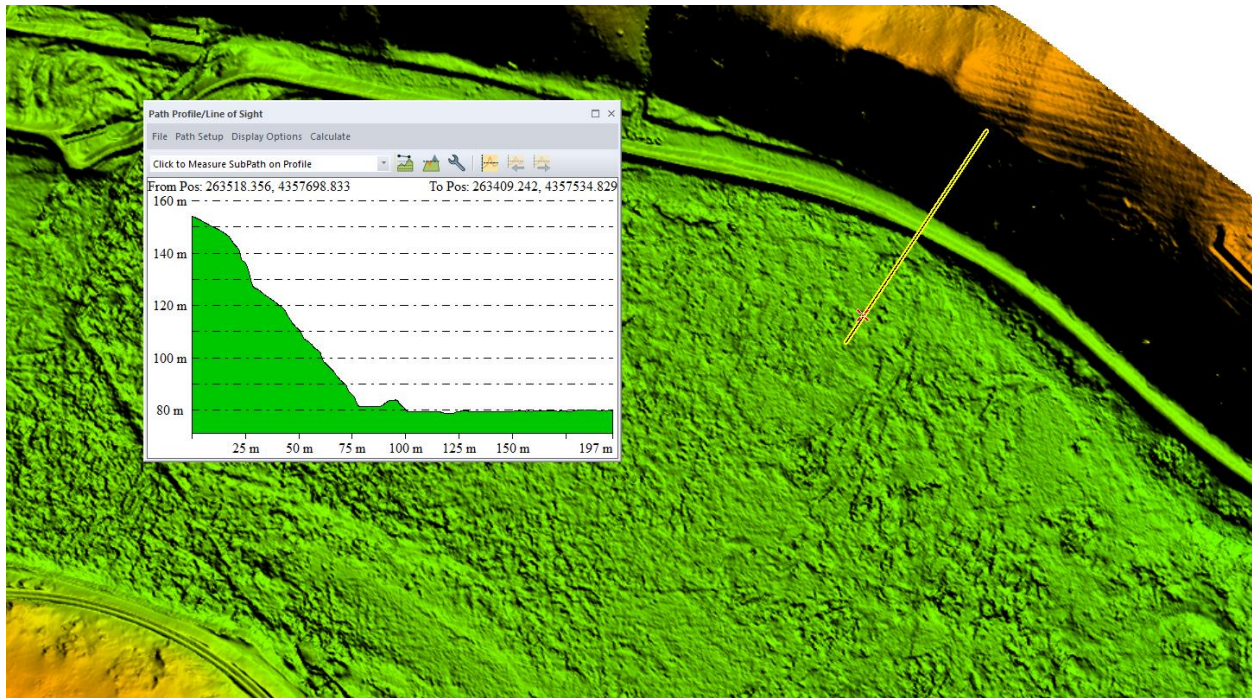
Figure 29 – DEM tile 18STJ630570. An example of the land-water interface is shown. No hard edges along the interface were identified during DEM QA/QC.

The final topobathy DEMs were then reviewed in ArcMap at a 1:5000 scale. A review with the void polygons visible and another review without the void polygons visible was performed in order to ensure voids were enforced properly and there were no issues along the boundaries of the void layer. Special attention was given along the land/water interface to ensure there were no hard edges along the interface (figure 26). Any remaining lidar issues and DEM artifacts were flagged by the reviewer and corrected by the editing team as necessary.
