Leica Geosystems Leica TerrainMapper-LN Calibration Certificate

Product	Leica TerrainMapper-LN
Serial Number	91511
Date	03 July 2019
Inspector	Mark O'Neal

Product	Leica TerrainMapper-LN
Serial Number	91513
Date	25 February 2019
Inspector	Xu Wang

Product	Leica TerrainMapper-L
Serial Number	90515
Date	12 December 2018
Inspector	Robert Bosch

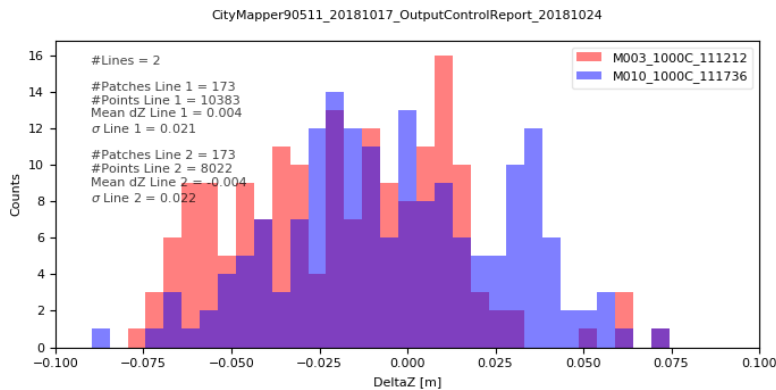
Figure 1 Vertical distance to ground control points at 1000 m AGL.

5.2.1 Multi-line accuracy of two perpendicular lines to ground control points

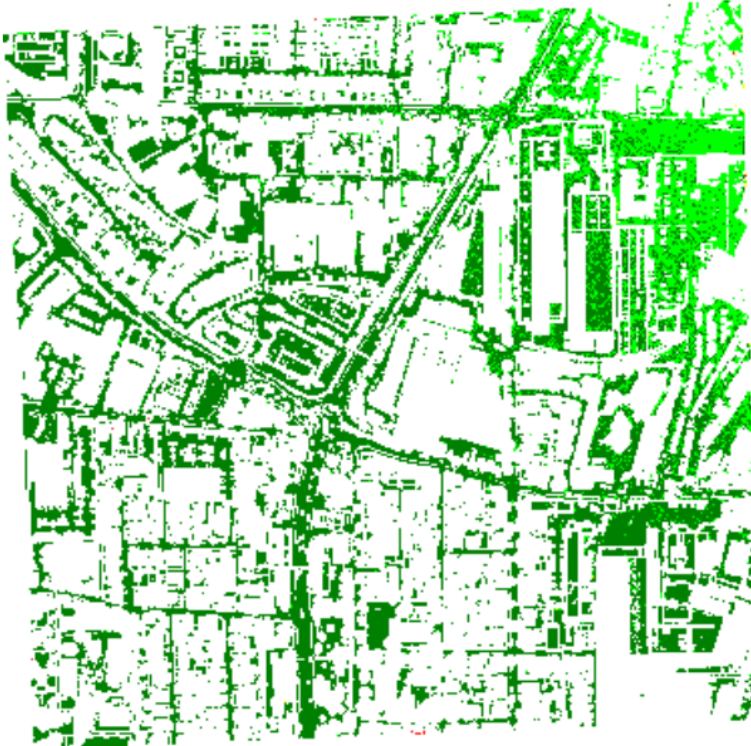
Figure 3 Vertical difference between two perpendicular lines at 1000 m AGL.

5.2.3 Multi-line accuracy between two perpendicular lines

M003_1000C_111212_vs_M010_1000C_111736

39940 valid patches with size of 2 m found. Only patches with standard deviation < 0.05 m and minimum of 5 points are included.

Color	Limits [m]	Number of patches	Proportion of total number of patches [%]
Dark Green	<=0.04	32066	80.29
Light Green	0.04-0.07	7841	19.63
Yellow	0.07-0.1	21	0.05
Red	>0.1	12	0.03

Vertical difference

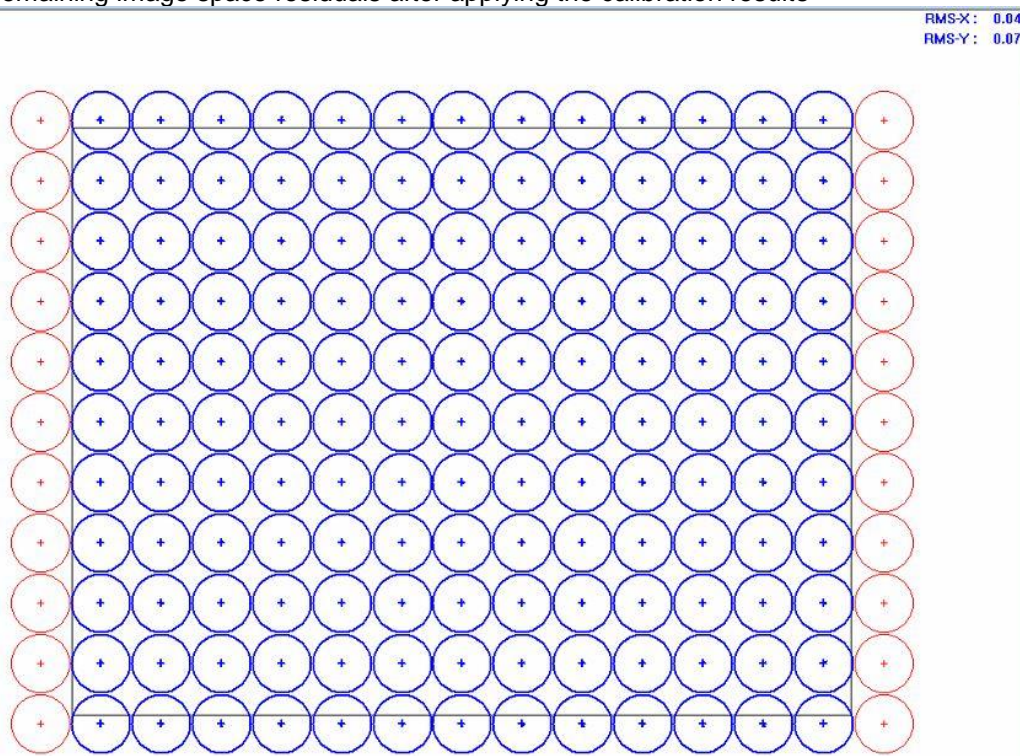
Remaining image space residuals after applying the calibration results

Radius of circles is 0.0007 mm

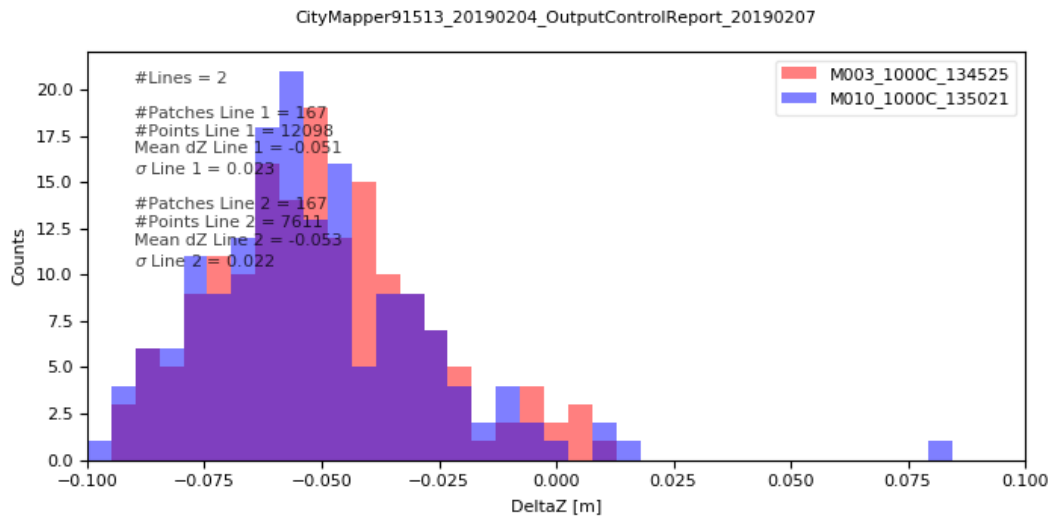
Figure 1 Vertical distance to ground control points at 1000 m AGL.

5.2.1 Multi-line accuracy of two perpendicular lines to ground control points

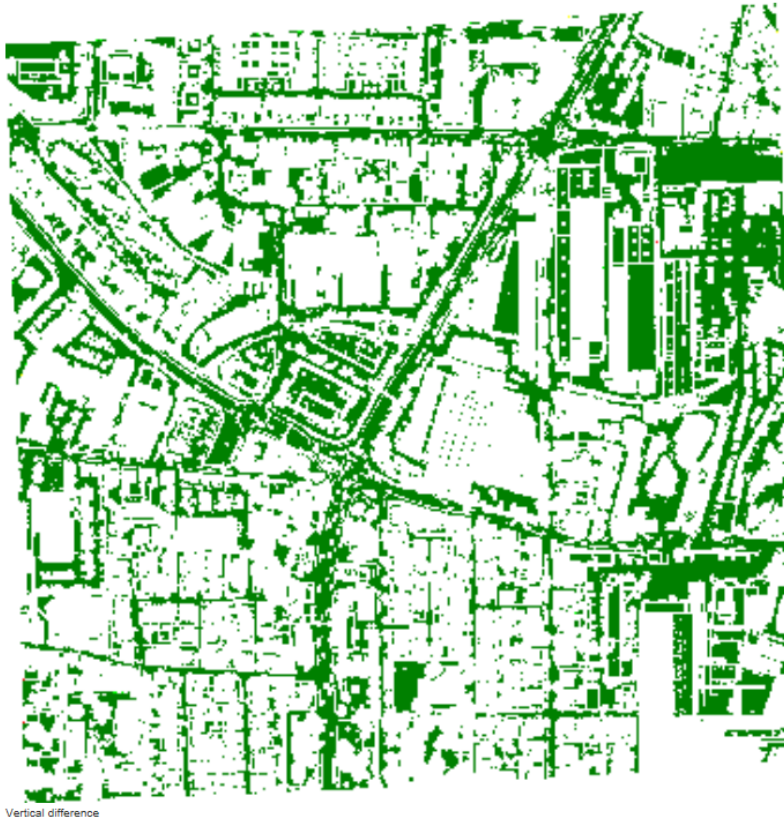
Figure 3 Vertical difference between two perpendicular lines at 1000 m AGL.

5.2.3 Multi-line accuracy between two perpendicular lines

M003_1000C_134525_vs_M010_1000C_135021

41041 valid patches with size of 2 m found. Only patches with standard deviation < 0.05 m and minimum of 5 points are included.

Color	Limits [m]	Number of patches	Proportion of total number of patches [%]
Dark Green	<=0.04	41014	99.93
Light Green	0.04-0.07	20	0.05
Yellow	0.07-0.1	4	0.01
Red	>0.1	3	0.01

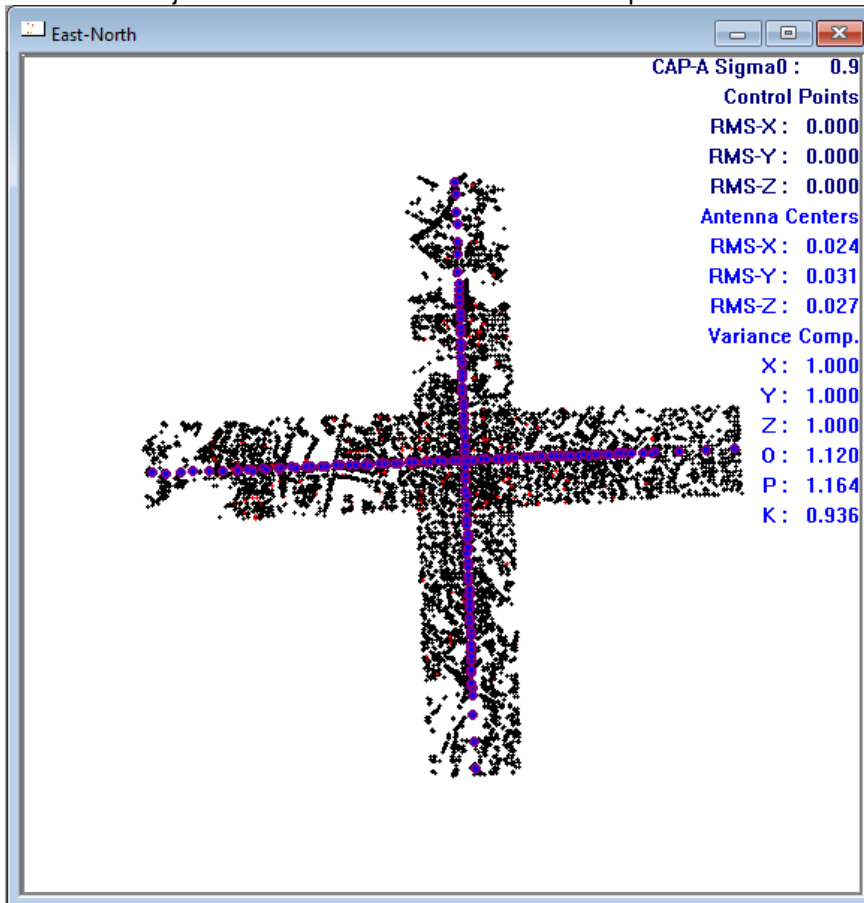
Resulting sigma naught of bundle adjustment:

0.0010

Final bundle adjustment results after elimination of tie point blunders:

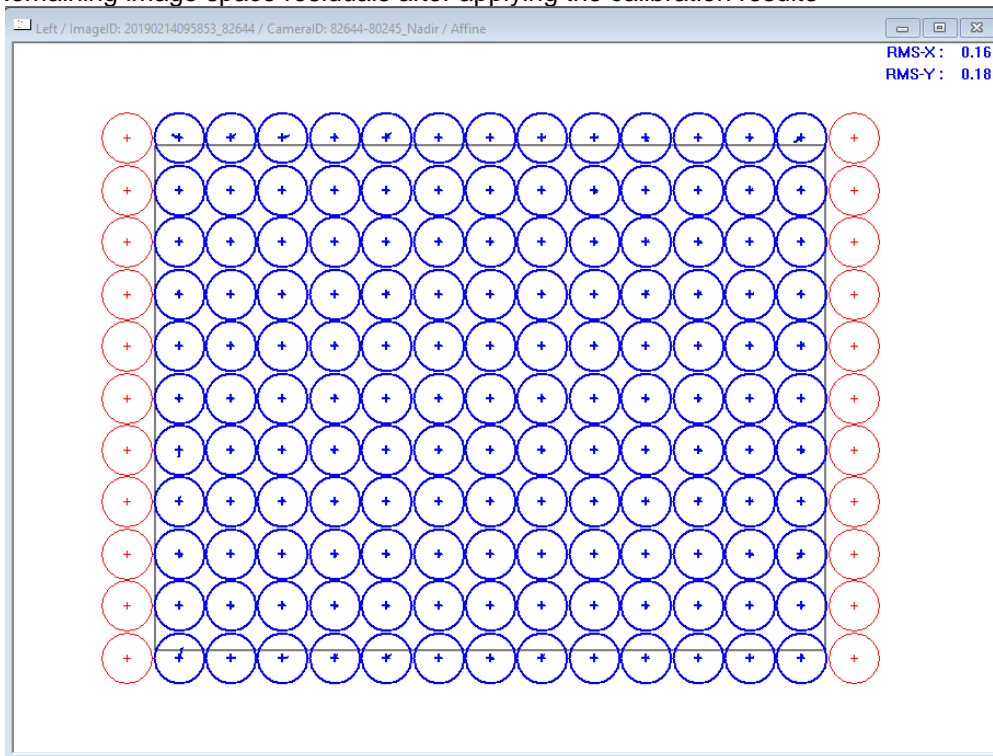
Remaining image space residuals after applying the calibration results

Radius of circles is 0.0010 mm

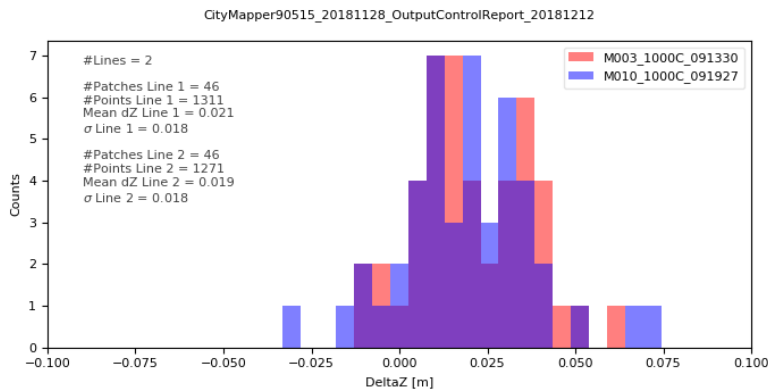
Figure 1 Vertical distance to ground control points at 1000 m AGL.

5.2.1 Multi-line accuracy of two perpendicular lines to ground control points

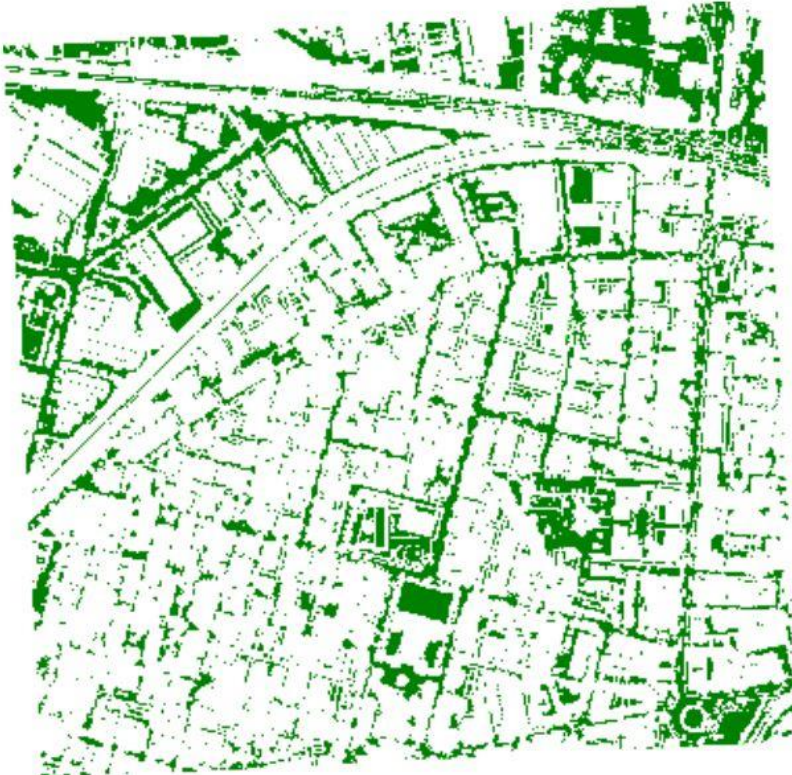
Figure 3 Vertical difference between two perpendicular lines at 1000 m AGL.

5.2.3 Multi-line accuracy between two perpendicular lines

M003_1000C_091330_vs_M010_1000C_091927

29588 valid patches with size of 2 m found. Only patches with standard deviation < 0.05 m and minimum of 5 points are included.

Color	Limits [m]	Number of patches	Proportion of total number of patches [%]
Dark Green	<=0.04	29546	99.86
Light Green	0.04-0.07	38	0.13
Yellow	0.07-0.1	1	0.00
Red	>0.1	3	0.01

Vertical difference
