LiDAR Quality Assessment Report

MO_Atchison-Holt-Andrew_2013

NGTOC 2016-02-16 Stephanie Fulk

Project: MO_Atchison-Holt-Andrew_2013

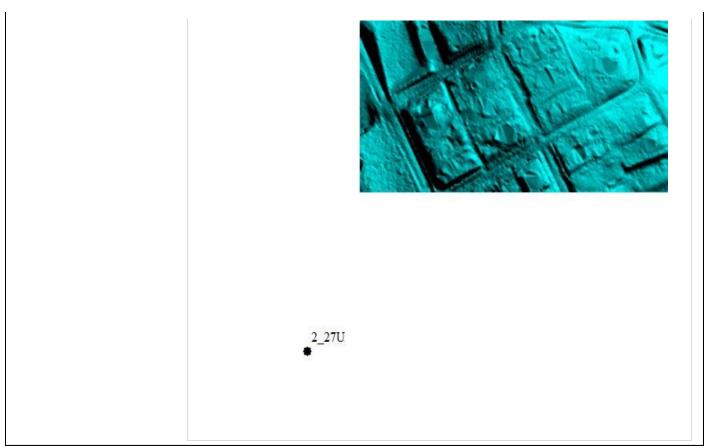
Point 2_27U was removed from Urban class. Point did not lie within the DEM area. See image.

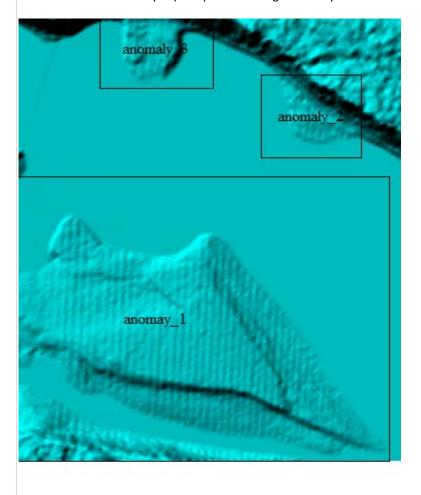
- ✓ DEM tiles do not overlap
- ✓ DEM tiles conform to Project Tiling Scheme
- ✓ Quantity of DEM files conforms to Project Tiling Scheme
- ✓ DEM tiles are uniform in size
- ✓ DEM tiles properly edge match and free of edge artifacts
- ✓ Tiles are free from Spikes and Pits
- ✓ Tiles are free from Data Holidays (voids due to processing or collection errors)
- ☐ Tiles do not exhibit systematic sensor error or cornrowing

Possible sensor error may explain pattern change anomaly. Please correct.

2/18/2015 vendor corrected
