# LiDAR Quality Assessment Report

ME\_SouthernAreas\_2012

This lidar project, ME\_SouthernAreas\_2012, is part of three, non-contiguous areas as part of the Maine Statewide Lidar and Orthoimagery project. This report reflects the lower two areas, also known as Mid-Coastal Cleanup. The third area is ME\_ARoostook\_2012 and has its own separate report.

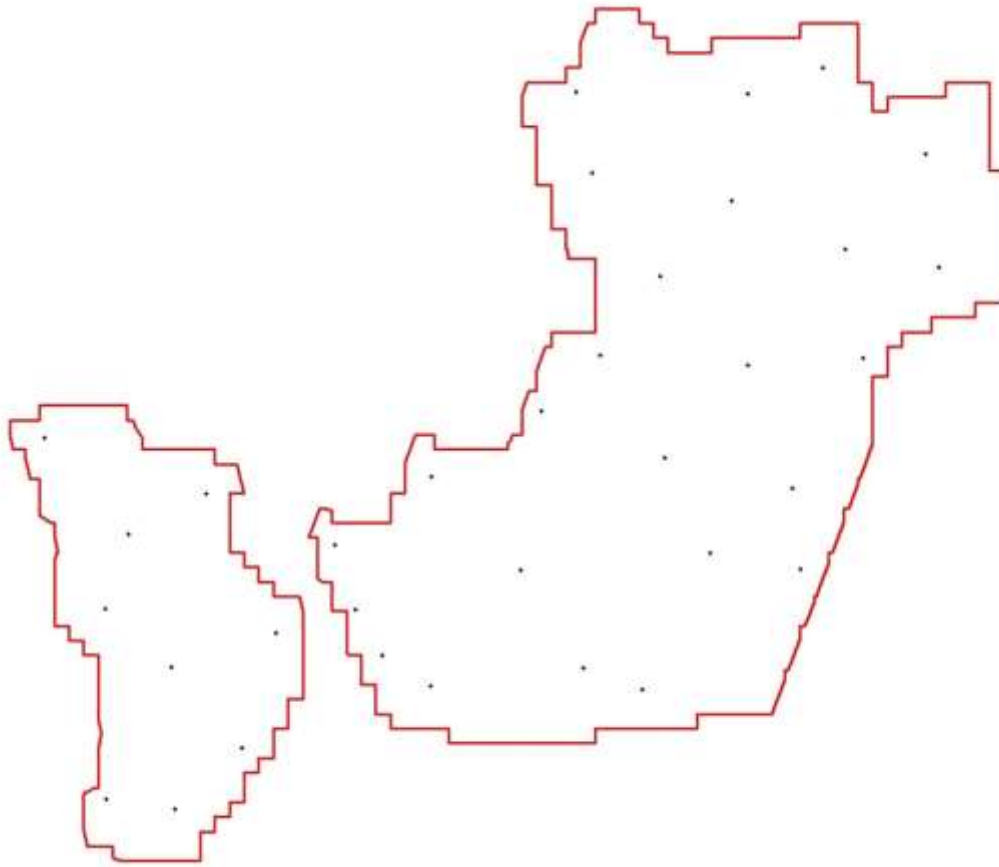
Checkpoint Distribution Image?

There are a minimum of 20 checkpoints for each land cover class represented. Points within each class are uniformly distributed throughout the dataset. USGS was able to locate independent checkpoints for this analysis. USGS accepts the quality of the checkpoint data for these LiDAR datasets.

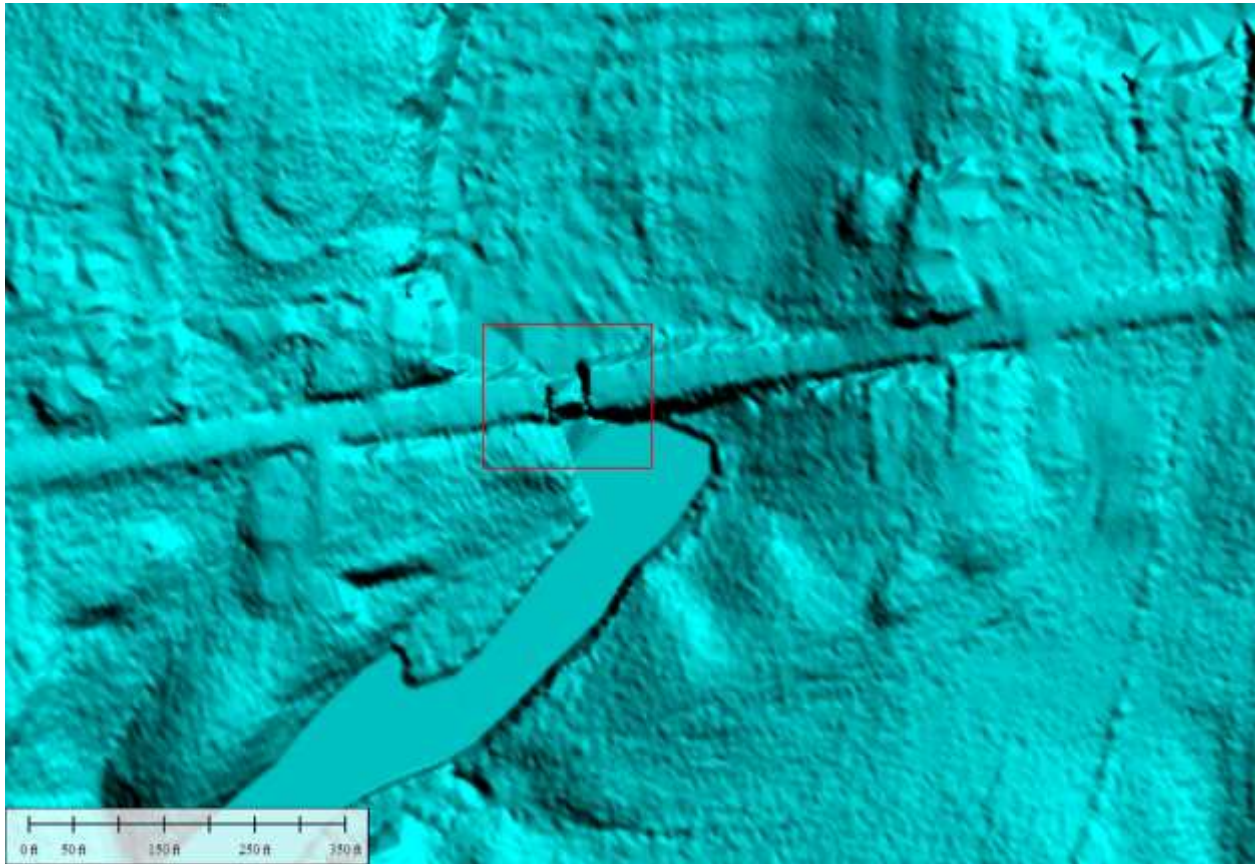
bridge\_1: Roadway identified as a bridge was not removed from the DEM; there is only one of this error-type.

\*\*Corrected by contractor.

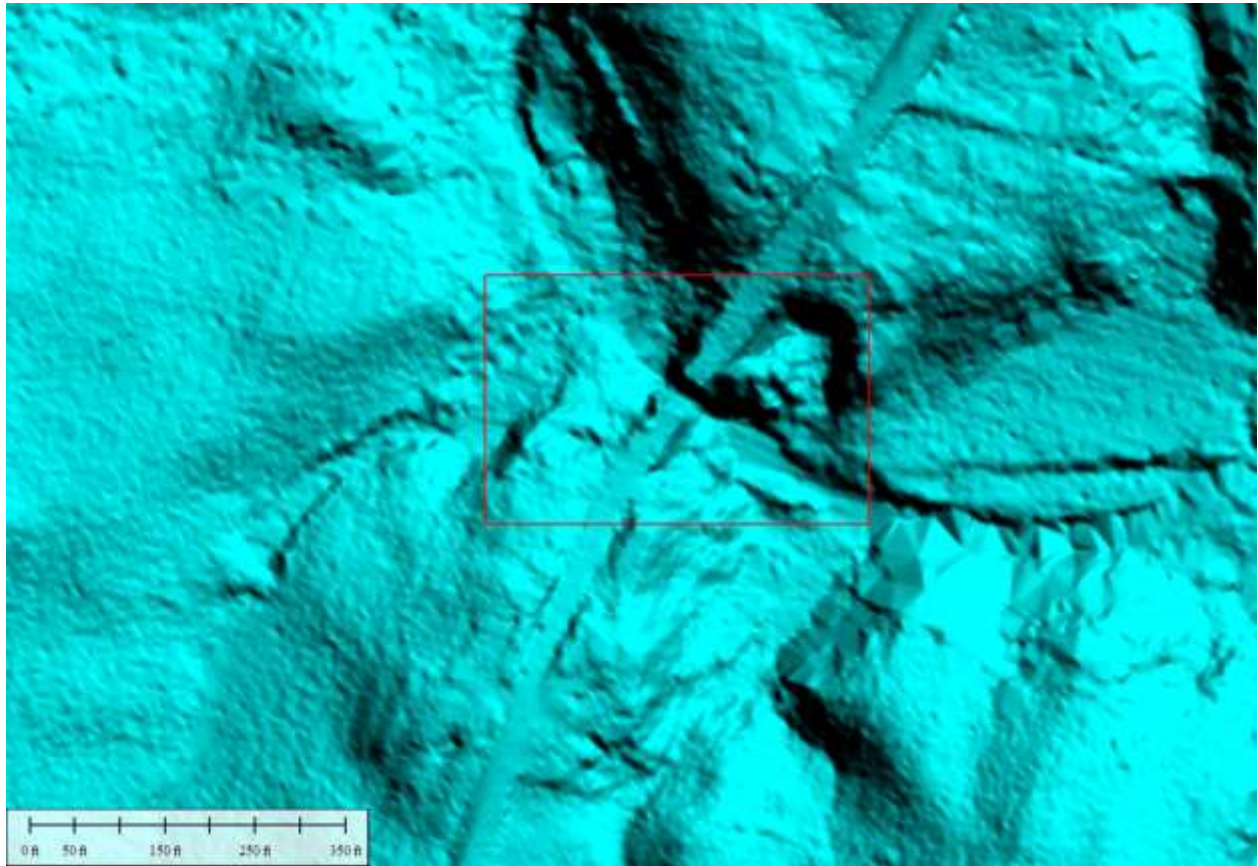
culvert\_1: Imagery suggests roadway above the stream is a culvert; there are three of this error-type.

\*\*All culvert-errors (3@) corrected by contractor.

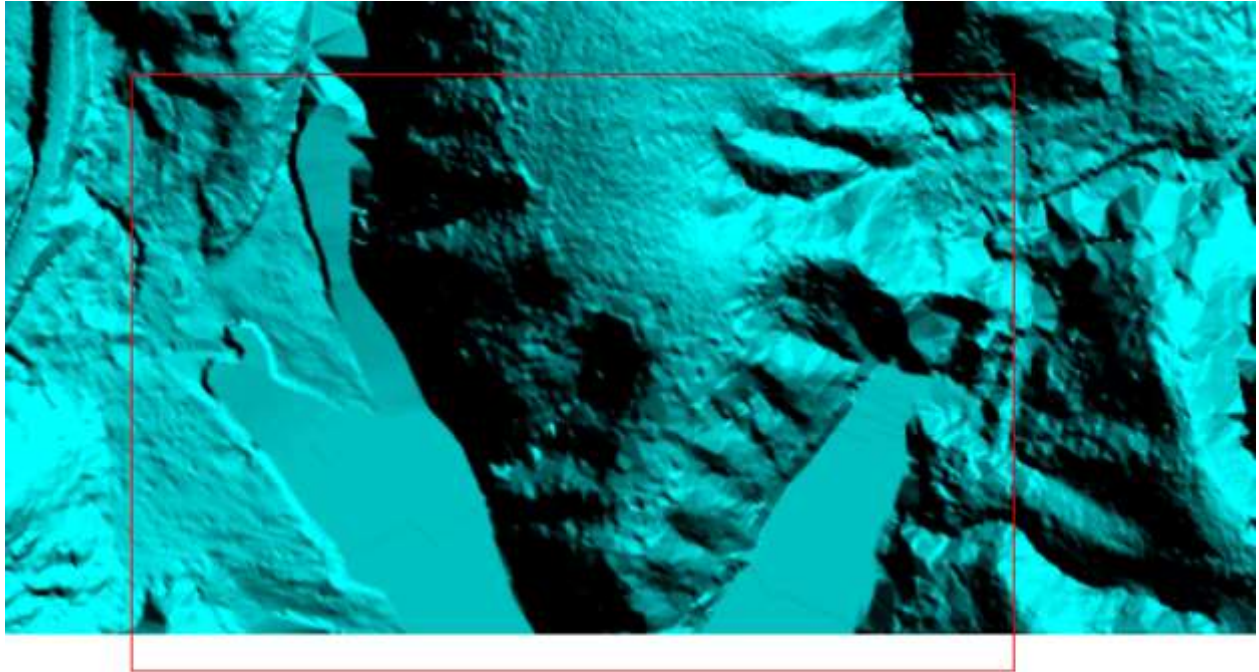
high\_water\_2: Portions of the waterbody has a surface elevation higher than the shoreline; 15 of this error-type have been identified in the DEM.

\*\*All high-water errors (15@) corrected by contractor.

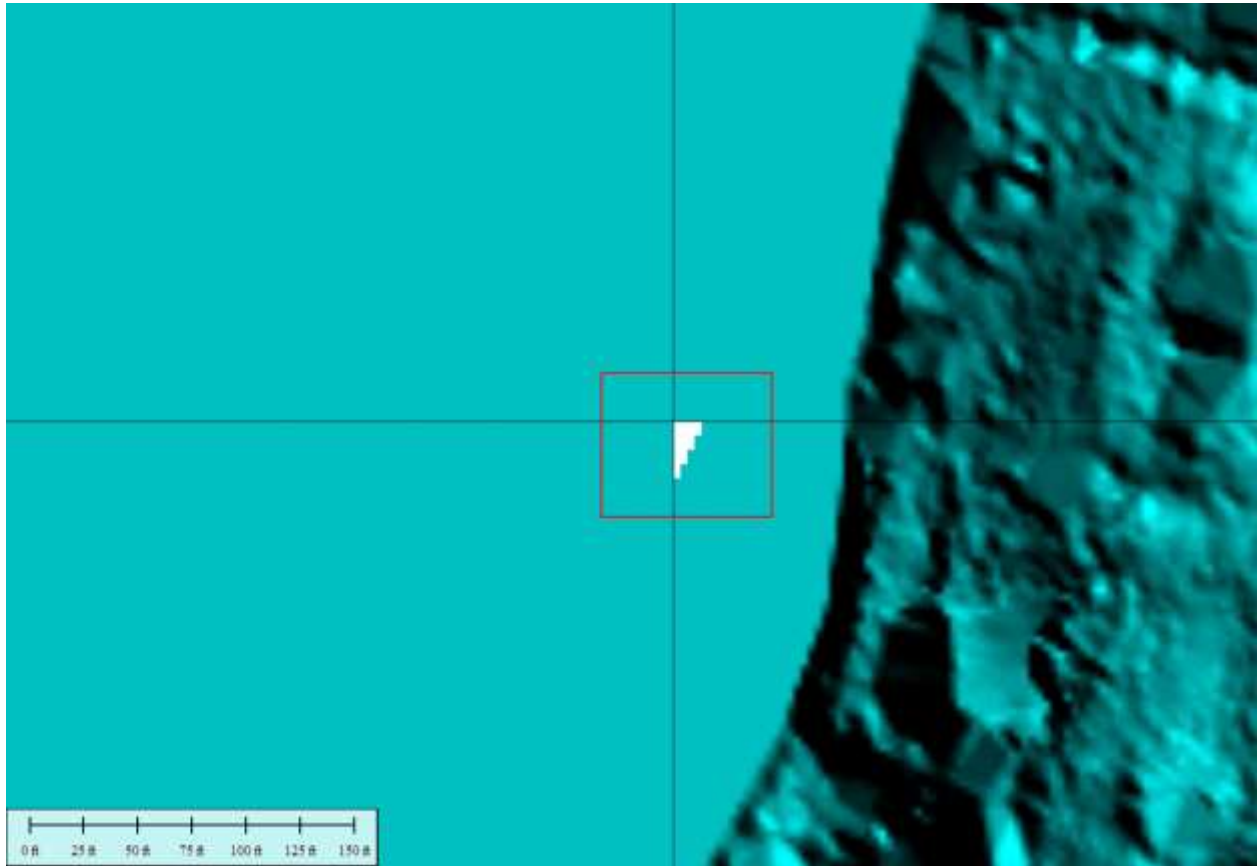
missing\_data\_1: Data is missing at the intersection of four DEM tiles; there is only one of this error-type.

\*\*Corrected by contractor.

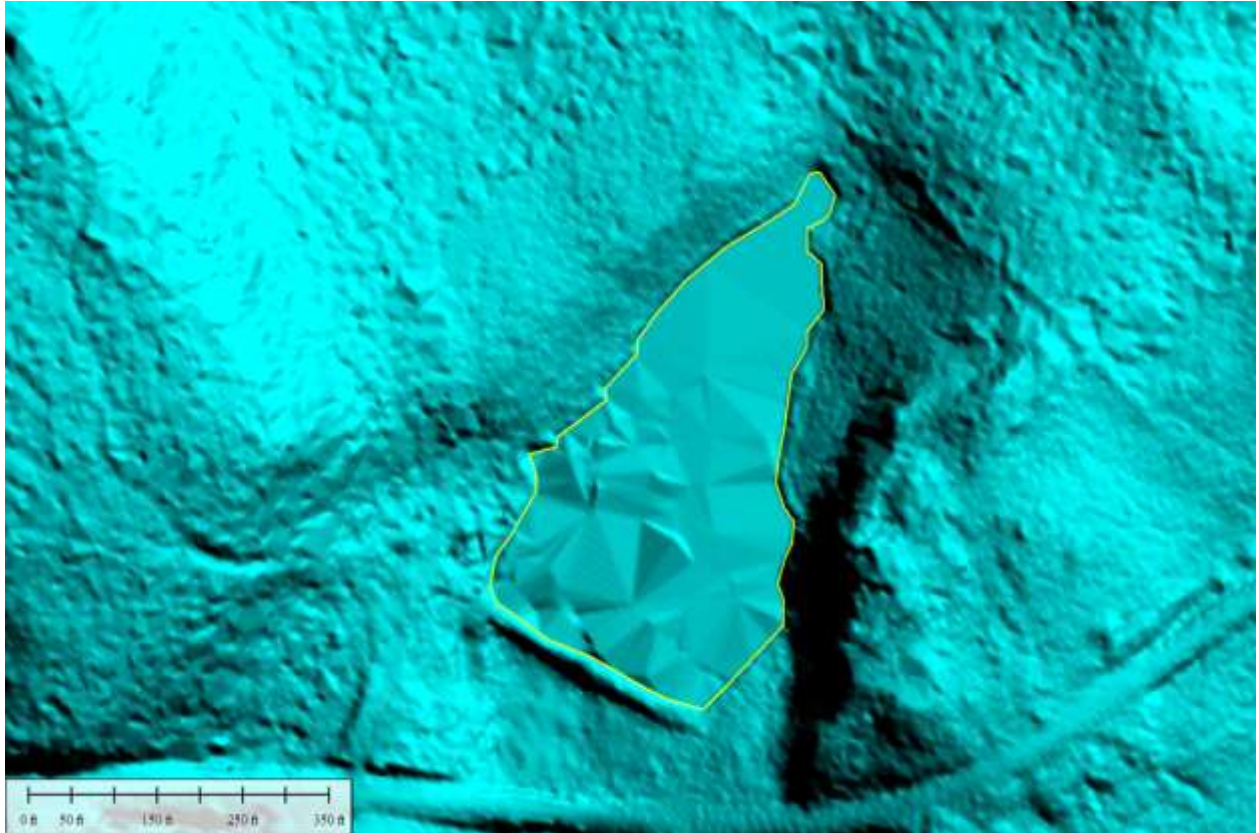
unflattened\_water\_1: This waterbody has not been flattened though breaklines have been provided for it (yellow line); there is only one of this error-type.

\*\*Corrected by contractor.

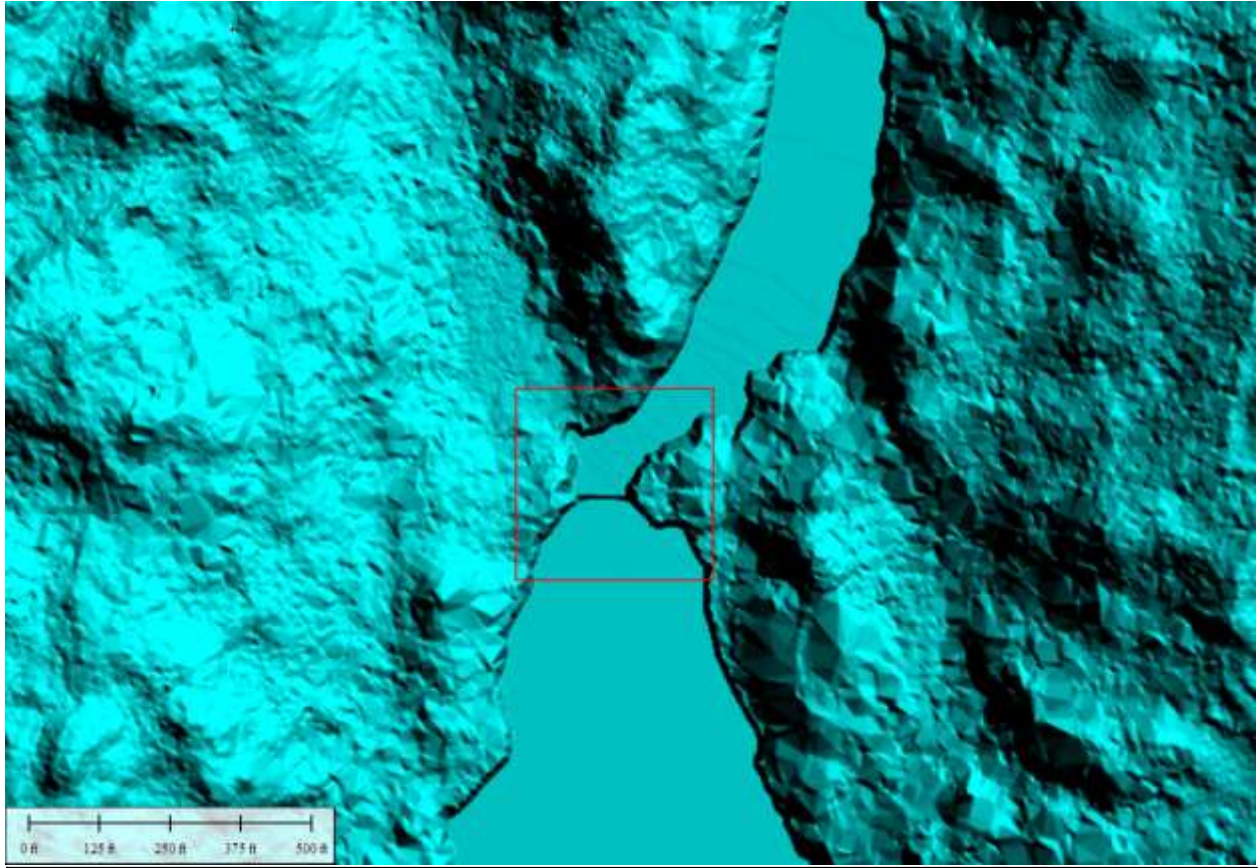
water\_2: Waterbody has a break in elevation; possible elevation difference due to rapids. See image below for 'image' detail.

\*\*Corrected by contractor.

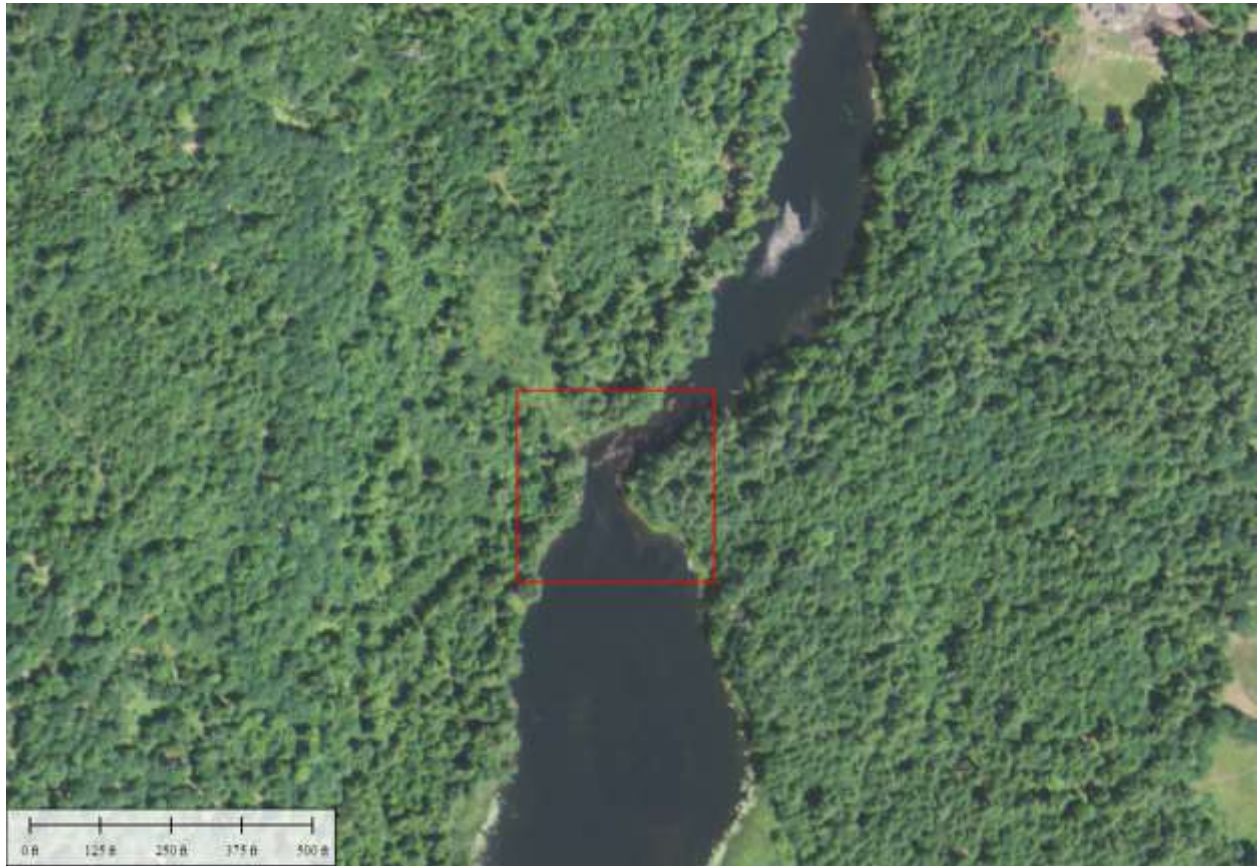
water\_2\_NAIP: This NAIP image is the same area as the DEM image above. The above DEM image shows a break in waterbody surface elevation.

\*\*Corrected by contractor; see previous image above.

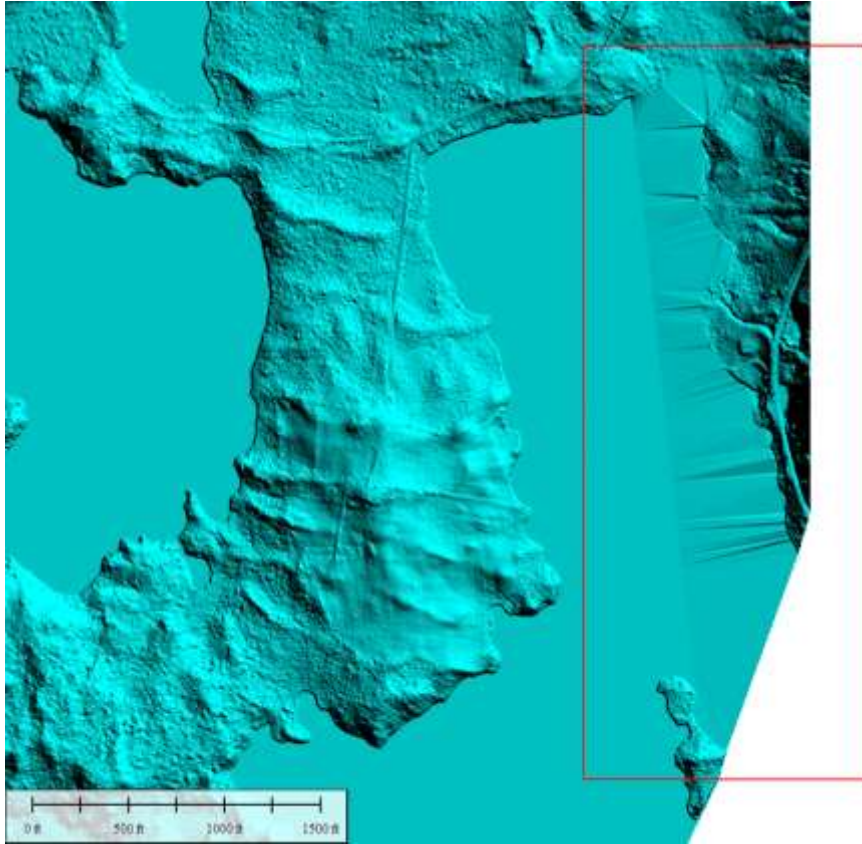
water\_3: This waterbody is not completely hydroflattened; there are three of this error-type.

\*\*Corrected by contractor.

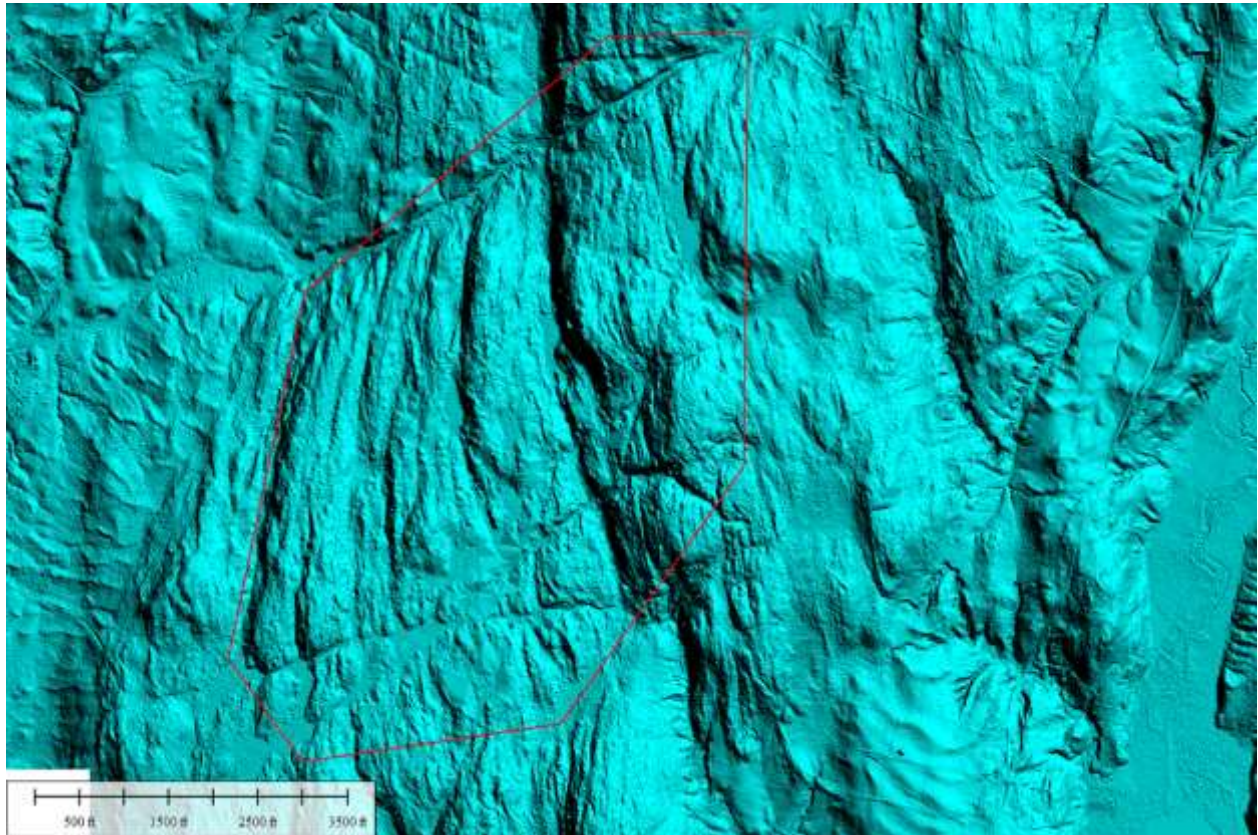
TIN\_1: The area bounded in the red polygon shows an error that is partially TIN'd.  
This is not an error; this region is just being pointed out.
