**Review of County Wide LIDAR Data**

**Martin County, FL**

**July 29, 2016**

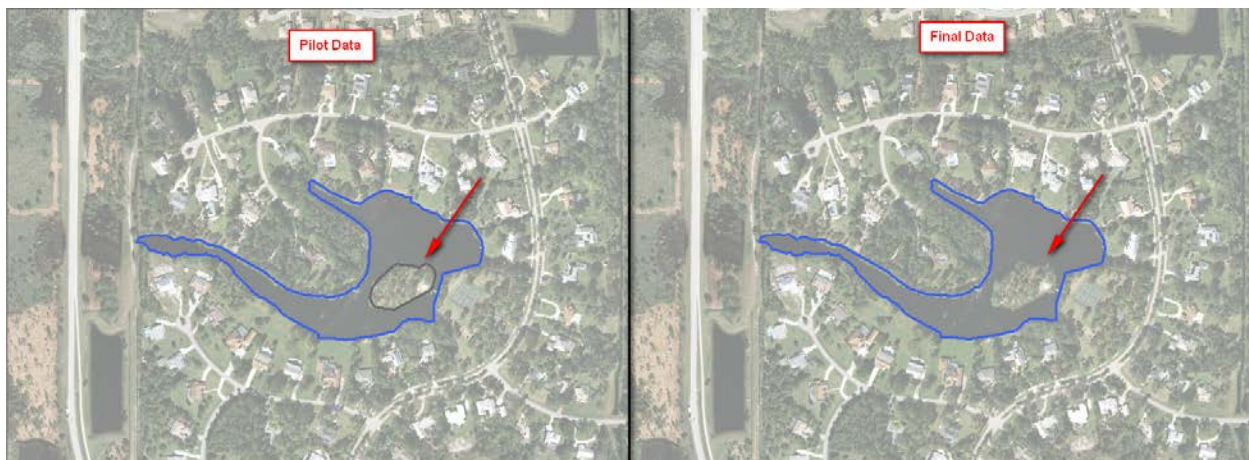
Below is an image of an island that was included with the pilot data and is missing from the final deliverable as shown below in Figure 7 Missing Island from Lake. There were 23 additional examples of islands like this example.

Figure 7 Missing Island from Lake

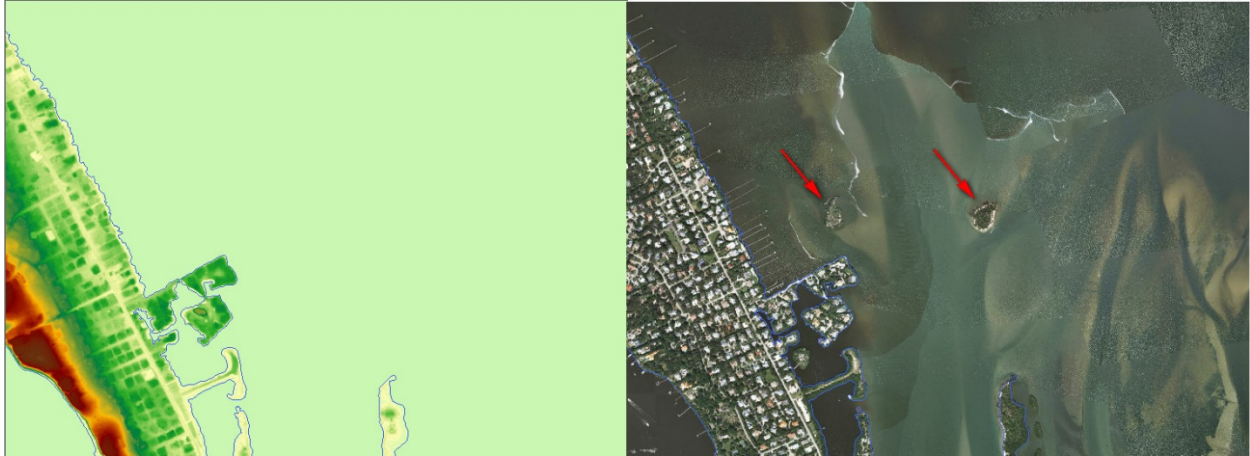
Two named islands were excluded from hydrographic layer including Boy Scout Island and Bird Island as shown below in Figure 9 Islands Missing from DEM.

*Figure 9 Islands Missing from DEM*

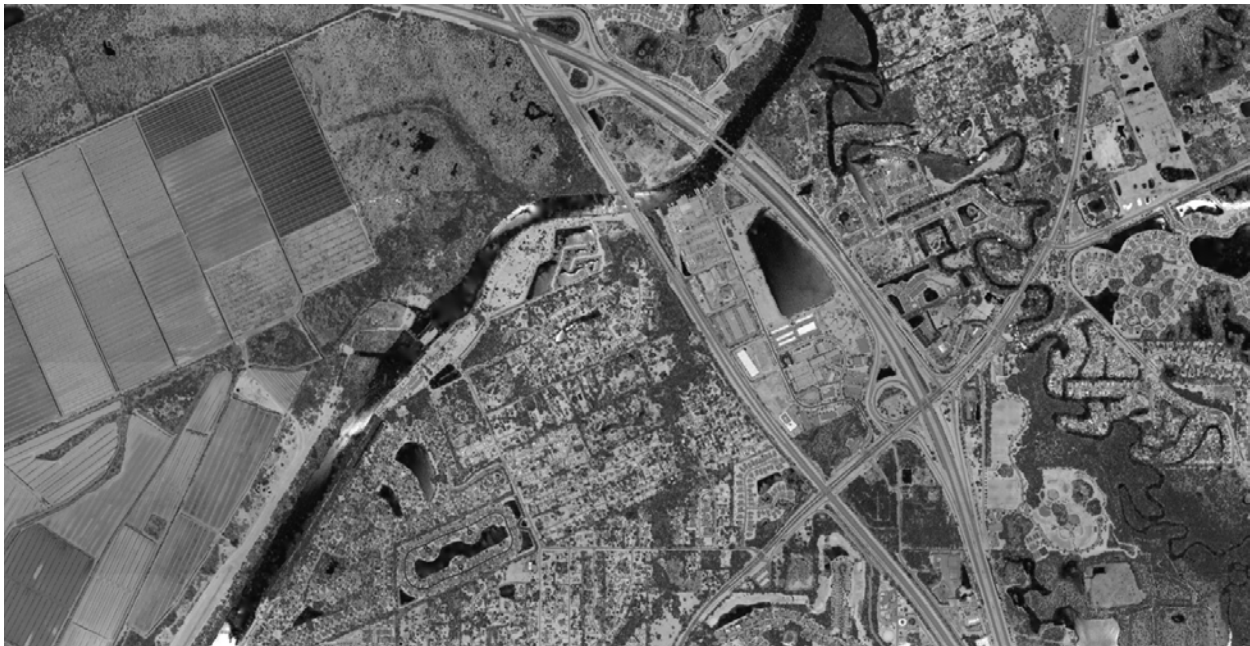
*Figure 10 Intensity*

The intensity is a product of the how much light was returned from the ground back to the LIDAR sensor and delivered as a raster image as shown in Figure 10 Intensity. The intensity raster appears almost like a black and white picture with bright areas returning more light and dark areas such as water returning almost no light. The intensity rasters were provided in 16-bit floating point TIF format with 3 bands of data and a pixel size of 4 feet. The intensity rasters have 3 bands of the same information.

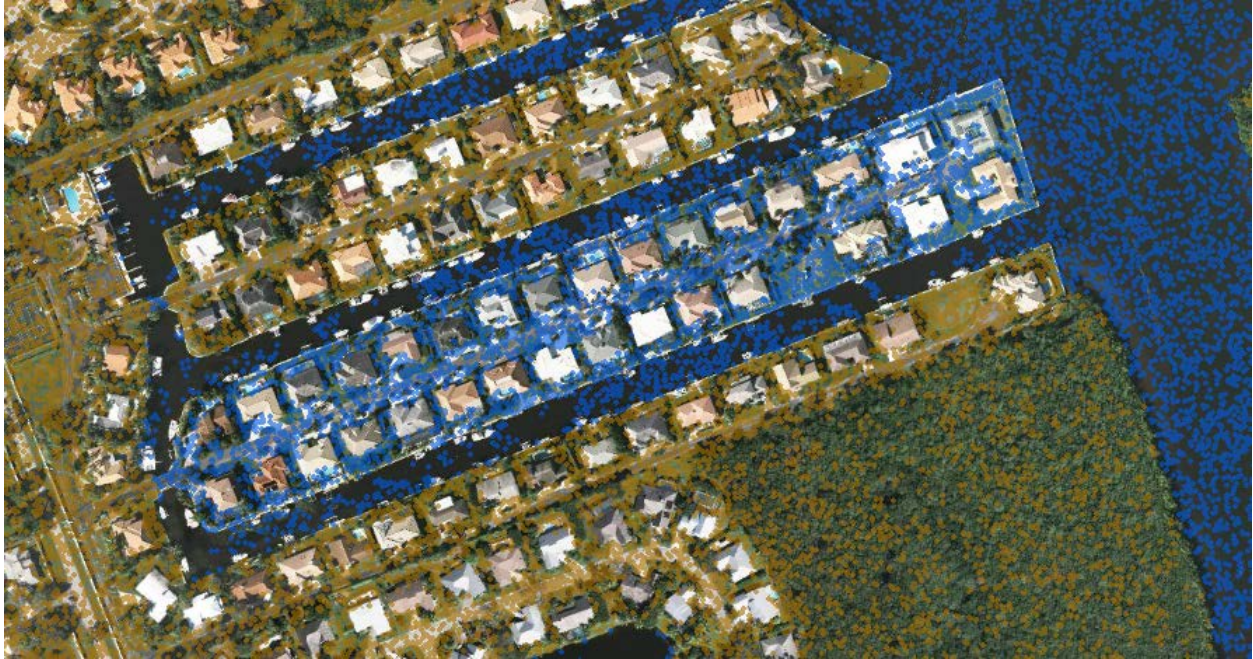
There were 33 areas where the LIDAR points seemed to be classed incorrectly. 23 of the problem areas are islands that are classed as water. 8 of the problems areas are portions of water bodies that are classed as ground. An entire street, SE Star Island Way, was classed as water as shown in Figure 13 SE Star Island Way classed as water.

*Figure 13 SE Star Island Way classed as water*

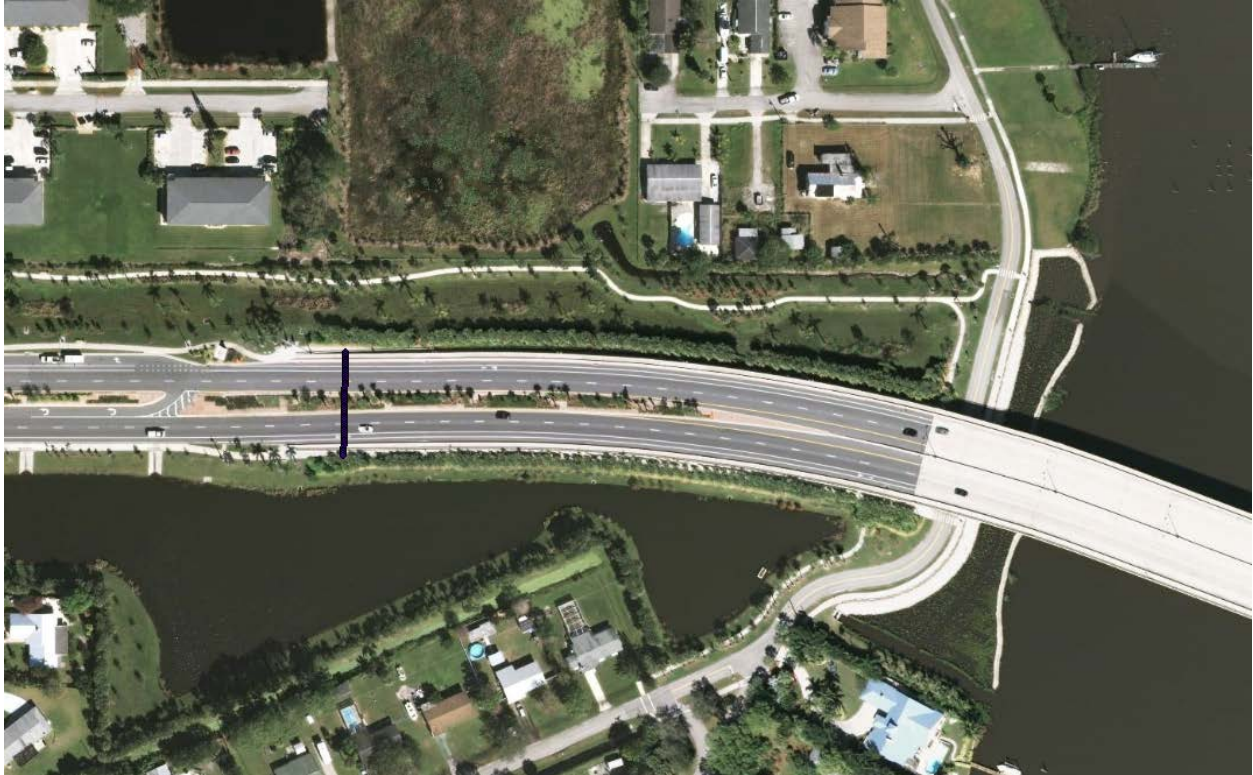
The most notable breakline problem is the West side of the Veterans Memorial Bridge. The breakline points are over 600 feet away from where the bridge deck starts as shown in Figure 15 Veterans Memorial Bridge Break Line Points. This issue affects the LAS Files and the DEM.

*Figure 15 Veterans Memorial Bridge Break Line Points*

All of the problem areas were captured in a shape file and will be included with this report.
