## North Carolina Floodplain Mapping Program

286-000030 ESP

POST PROCESSING REPORT

Delivery Order 35  
Phase 5 LiDAR Processing

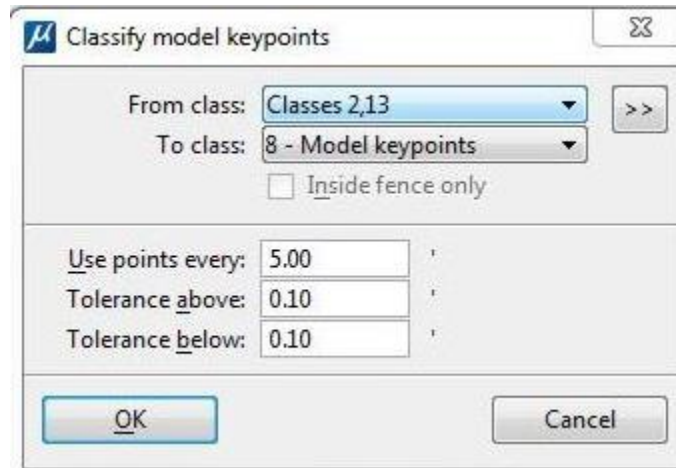
Figure 9: Terrascan parameters for generating model keypoints

ESRI terrain datasets were delivered for this project and were created for each county. The terrains were stored in individual File Geodatabase format in Arc version 10.4.1. The classified LiDAR bare earth points from the Class 2 (bare ground) and Class 13 (road) classifications first went through an automated process to determine model keypoints. Due to the high density of QL1 data a full bare earth model can be represented in a terrain as model keypoints, producing a much more manageable sized File Geodatabase. The model keypoint process using the parameters in Terrascan depicted in Figure 9:

The model keypoint generation process classified the points needed to create an accurate triangulated surface model, using points every 5 ft. derived from the high-density source Geiger LiDAR. The tolerance of the maximum allowed elevation difference between the keypoint model and a TIN surface of the original Class 2 (ground) and Class 13 (roads) was set at  $\pm 0.10$  ft.

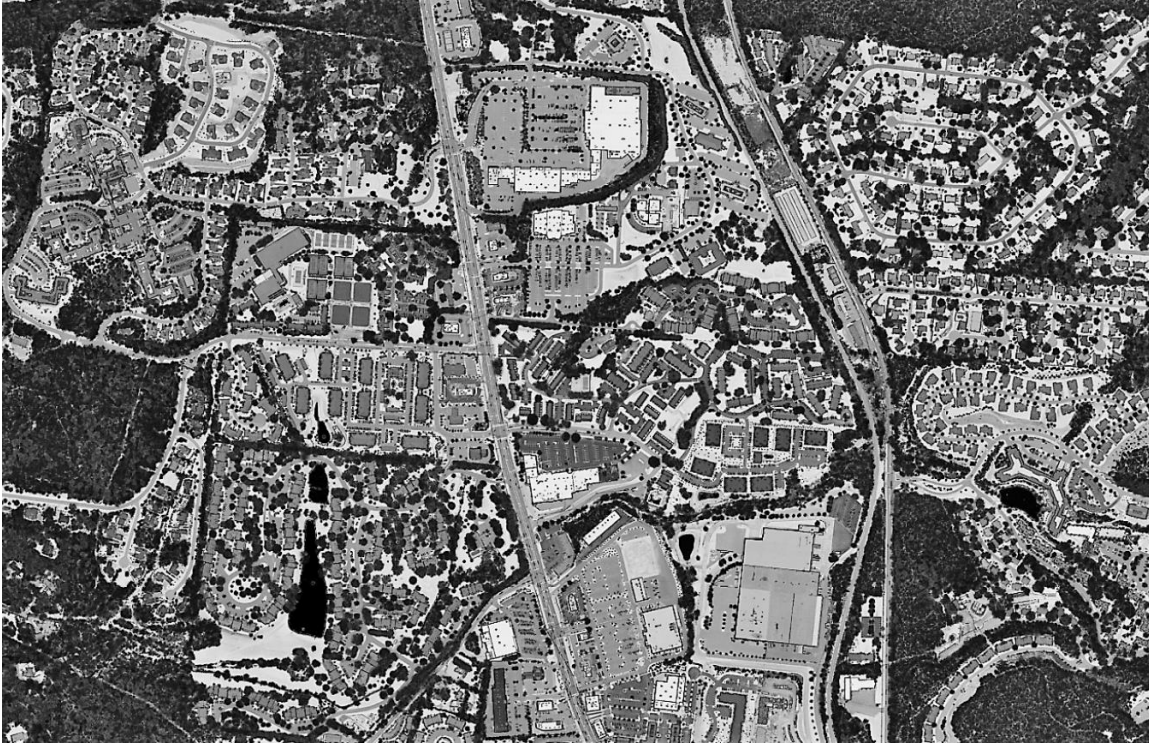
Figure 10: Intensity image example

LiDAR intensity images were produced for all LiDAR tiles once the LiDAR data was accepted and approved by the state. LiDAR intensity images were produced using all point classifications and returns, with the exception of Class 7 and Class 11 (noise classes). The intensity images were developed in grayscale, 8-bit format using the same tiling scheme as the other LiDAR data deliverables. A 5 ft. raster cell size was used for the product. The 8-bit format used was an unsigned 8-bit depth with 256 available bins. QA/QC of the LiDAR intensity images was conducted via a visual review using ESRI ArcMap to ensure completeness of the files and reasonable tone and contrast quality across the data.

Every attempt was made to achieve homogeneity across the project area in image appearance. There will, however, be some variance in the appearance, especially over water bodies and other features where the reflected signal is either absorbed or reflected to a degree greater than normal.
