**North Carolina
Floodplain Mapping
Program**

286-000030 ESP

Post Acquisition Report

**Delivery Order 22
Phase 4 LiDAR**

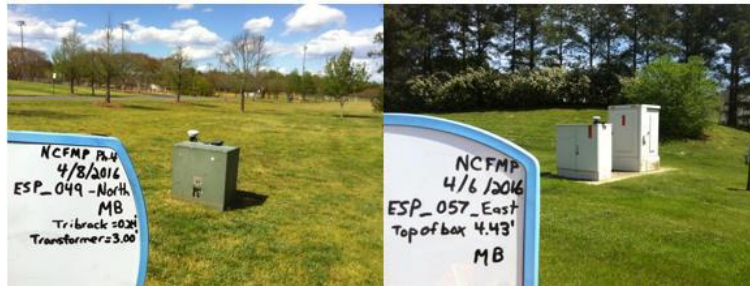
Figure 7: Elevated, photo-identifiable feature

An example of an above-ground, photo-identifiable points is provided in Figure 7.

- If elevated, photo-identifiable features are used they must follow the guidelines developed by ESP and Harris.
- When proving photo documentation of LiDAR calibration points:
