USGS – NE Cherry Brown Custer Partial (Weather conditions, 8-bit vs 16-bit intensity vs elevation color-ramp)

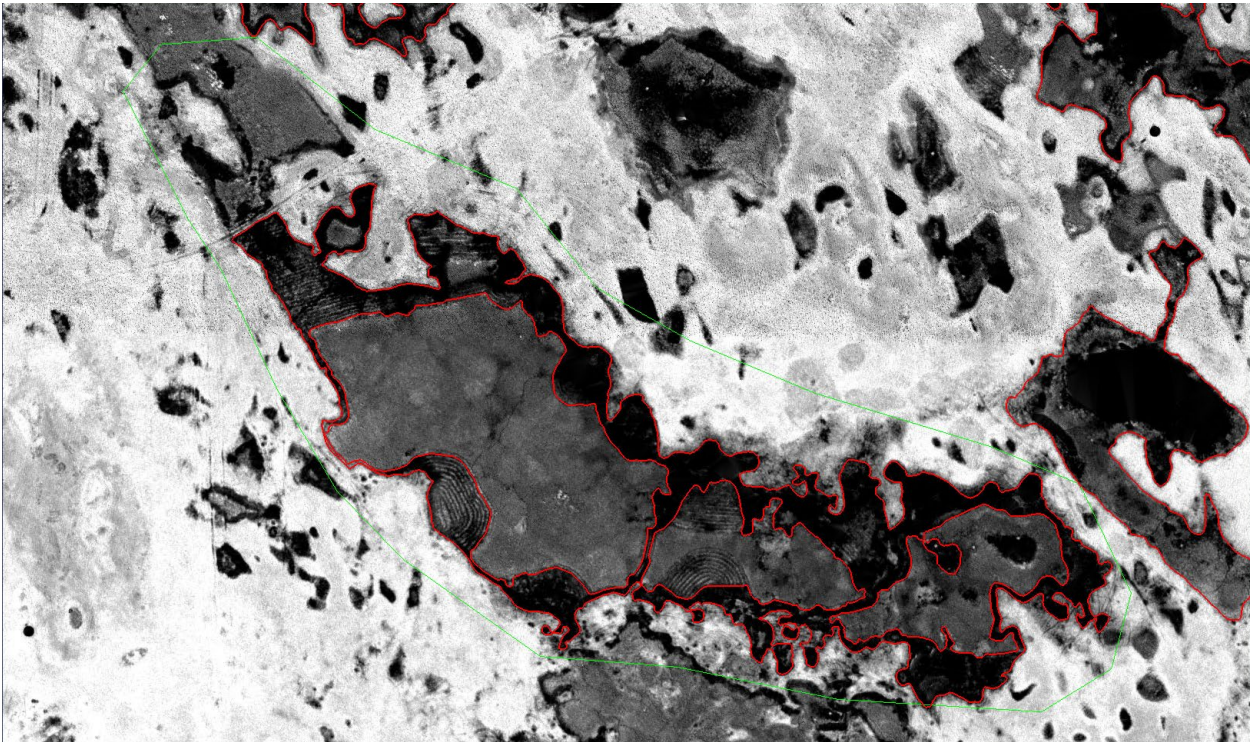
16-bit intensity – Reveals significant additional detail.

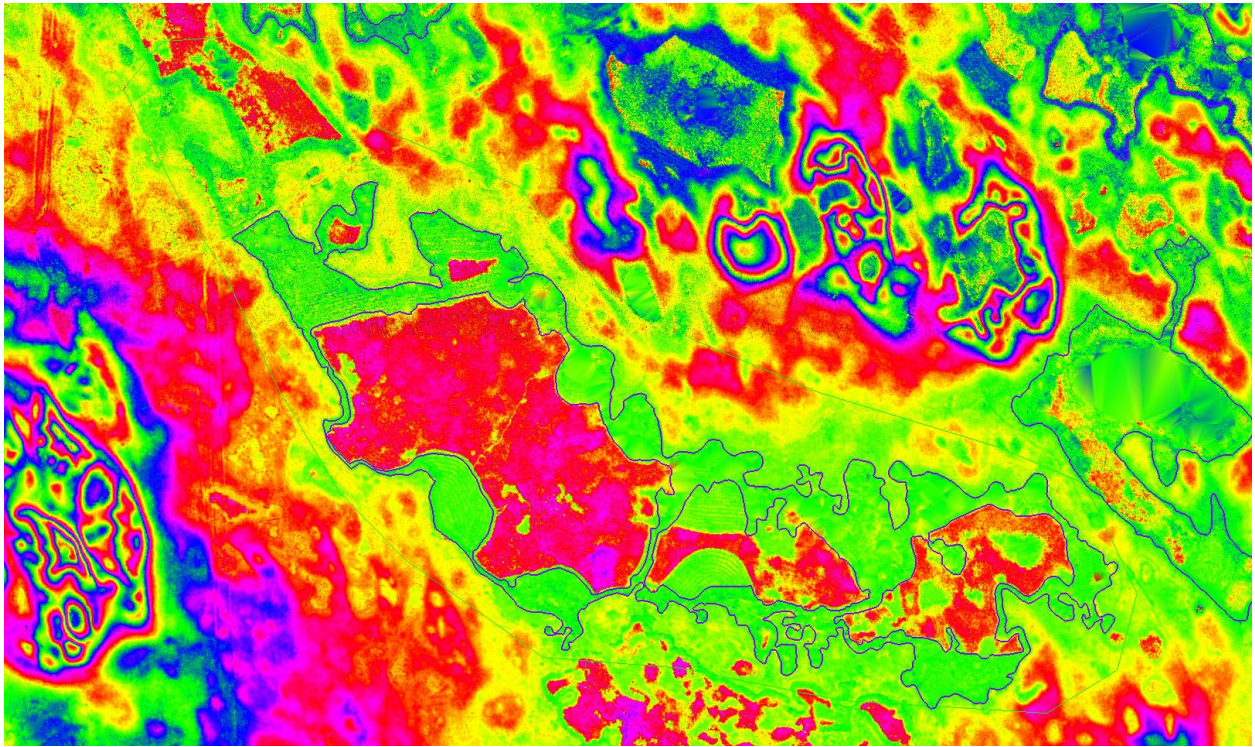
Color by elevation - Color gradient is 0.3m, approximately a foot, showing elevation differences.

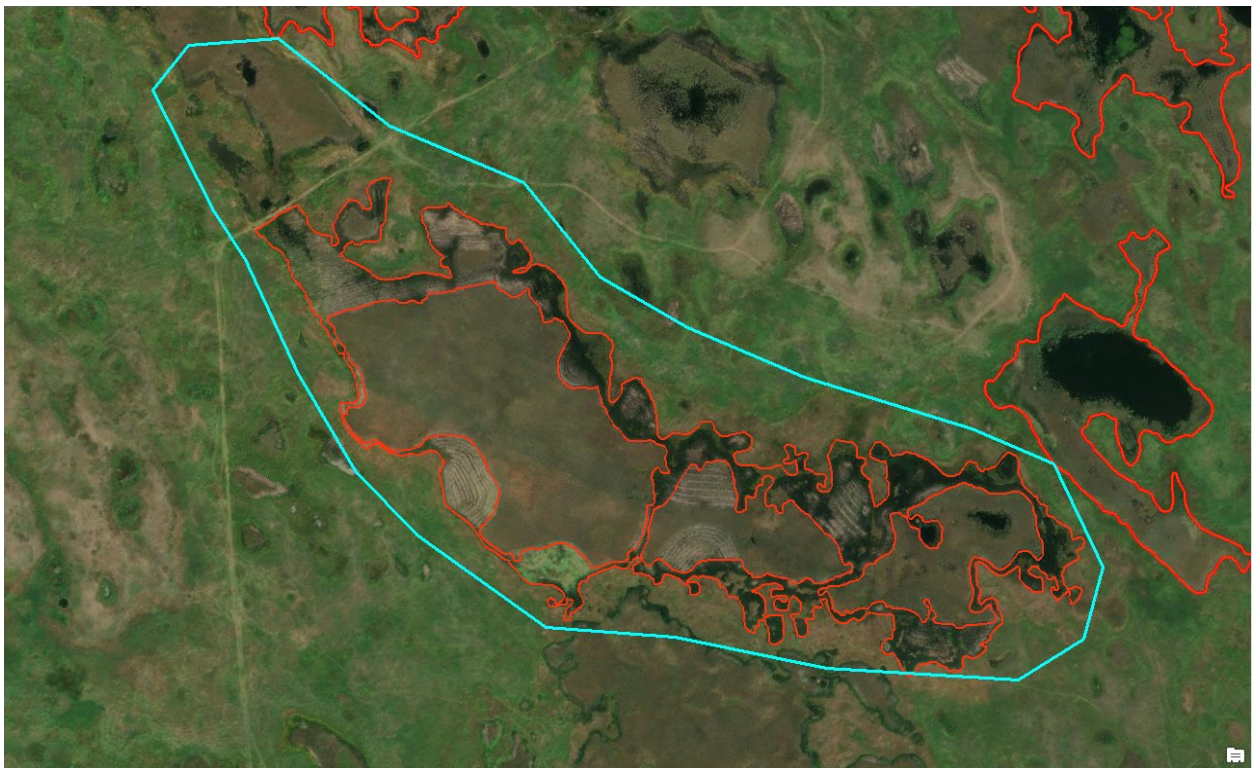
ArcGIS base map imagery (Imagery date - 8/27/2020)

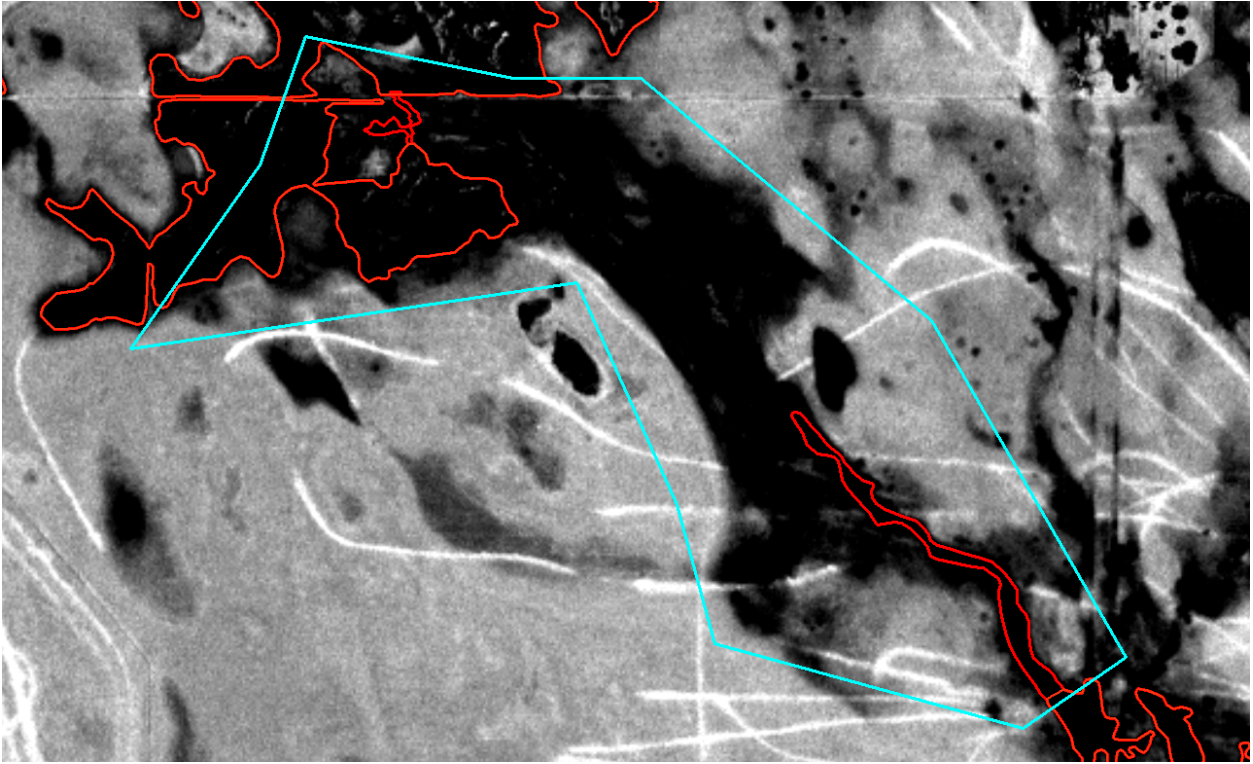
Error ID – 4529, # 5 – No additional breaks were added to join existing hydro.

8-bit intensity – Degrades the detail of the intensity image.

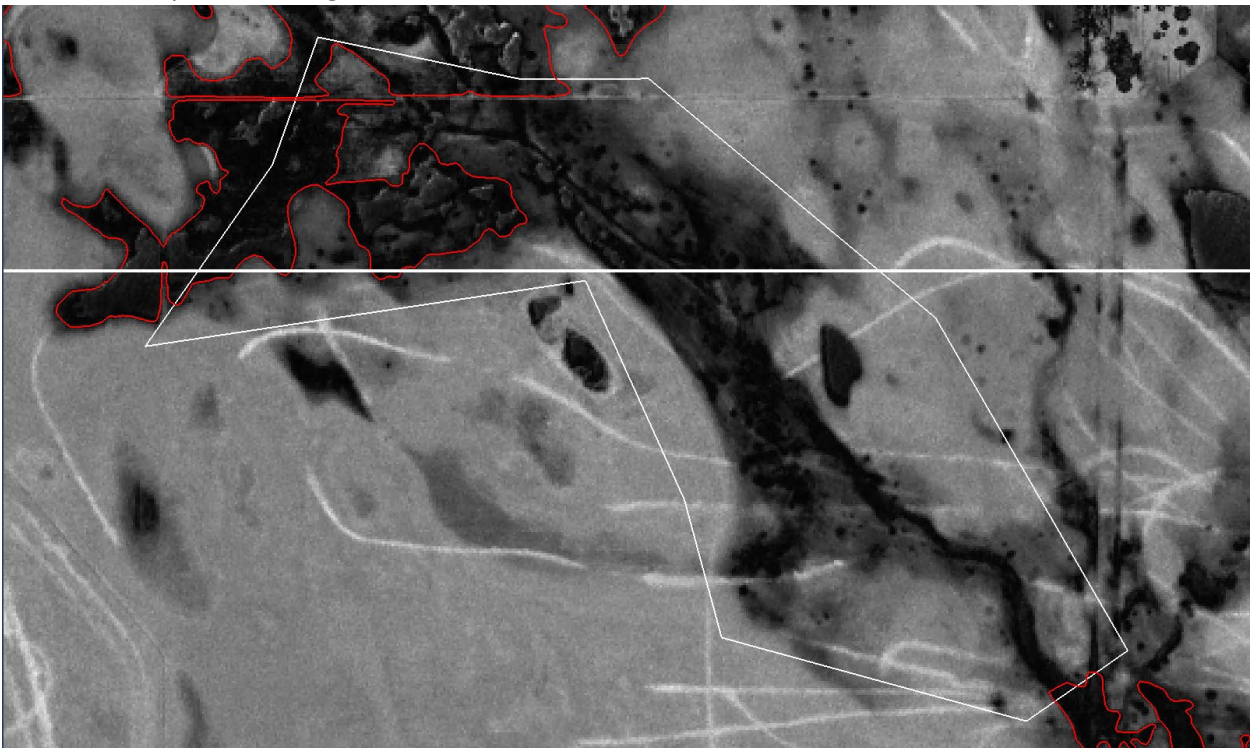
16-bit intensity – Reveals significant additional detail.

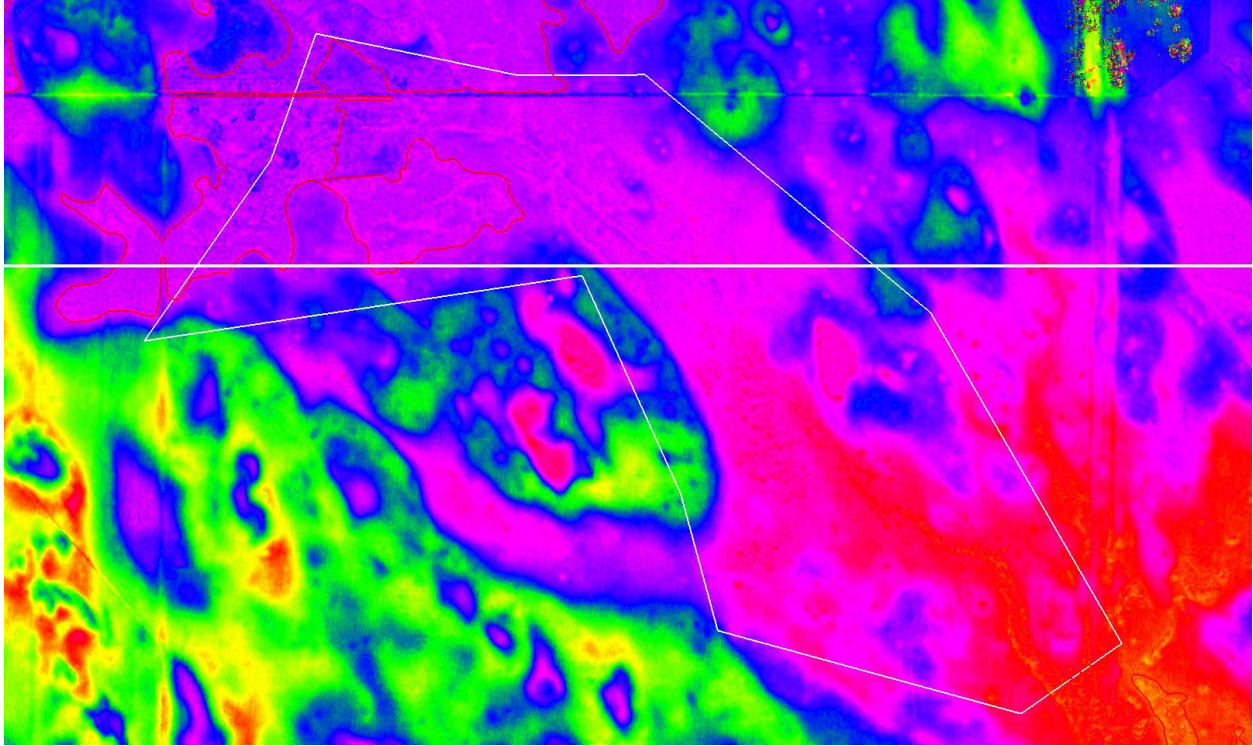
Color by elevation - Color gradient is 0.3m, approximately a foot, showing elevation differences.

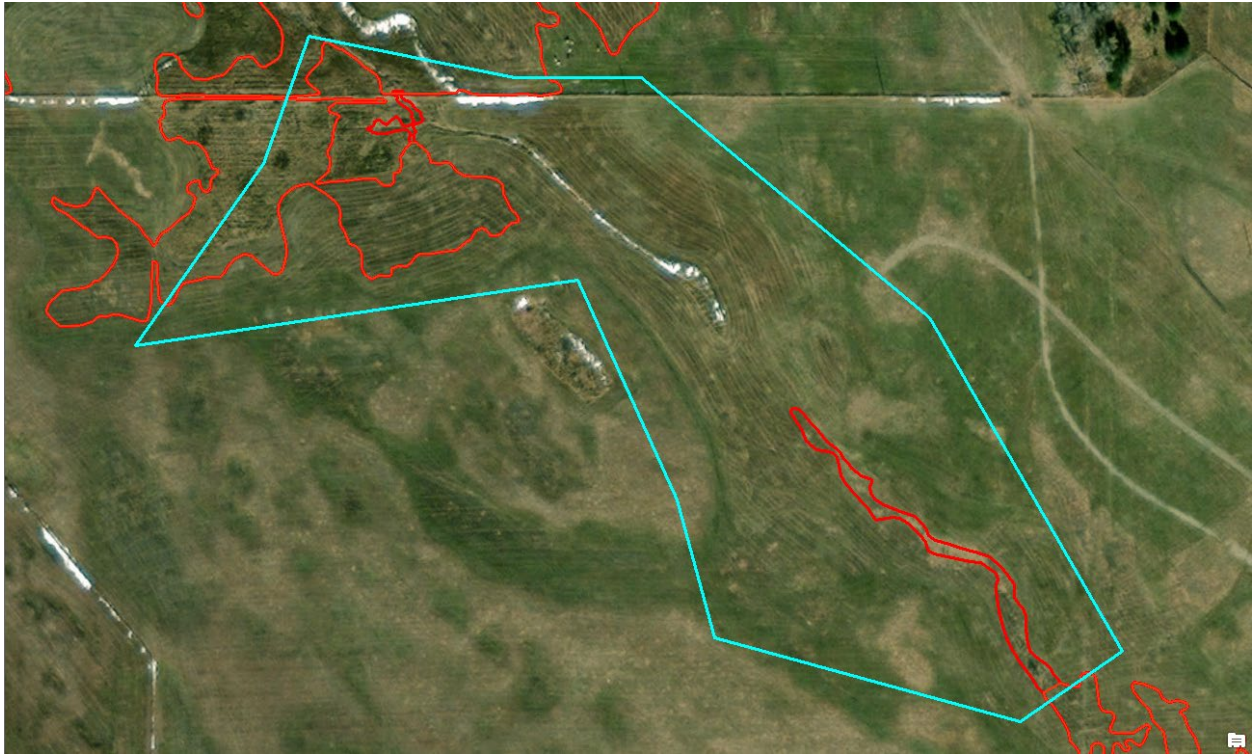
ArcGIS base map imagery. (Imagery date – 10/30/2020)

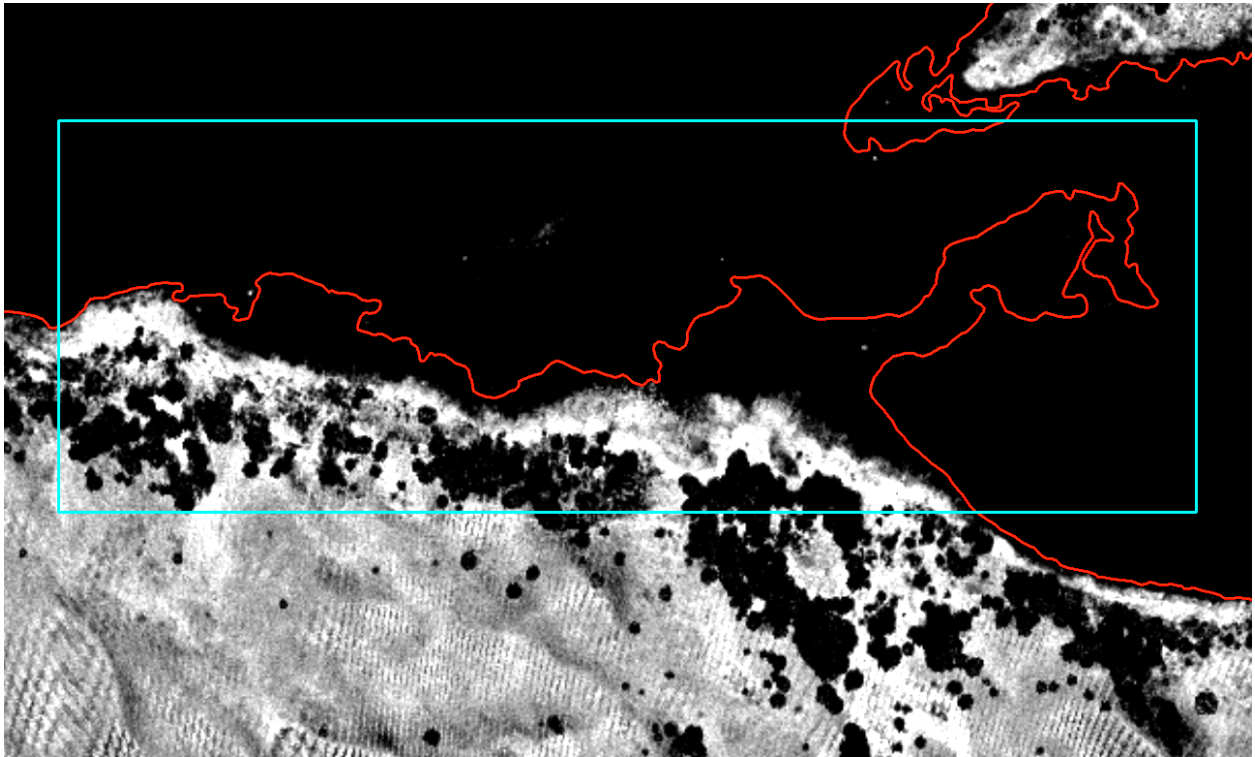
Error ID – 4529, # 4 – No change to the breakline was made

8-bit intensity – Degrades the detail of the intensity image.

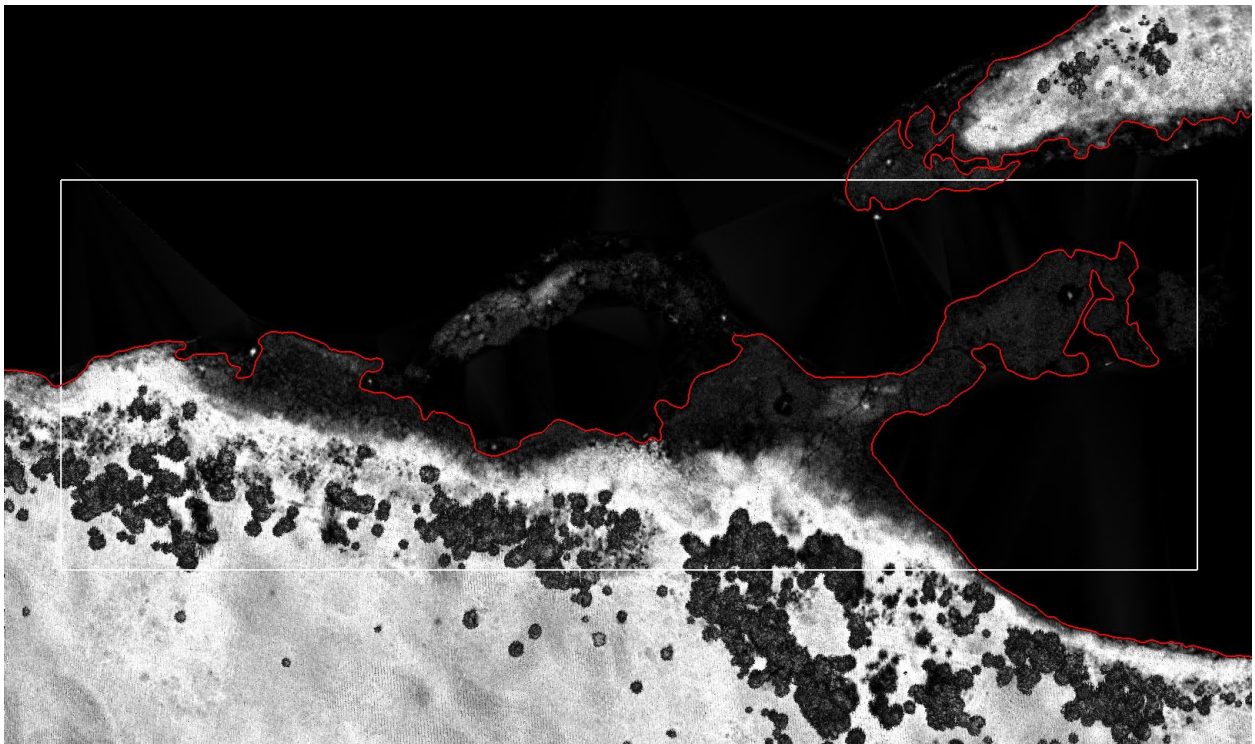
16-bit intensity – Reveals additional detail.

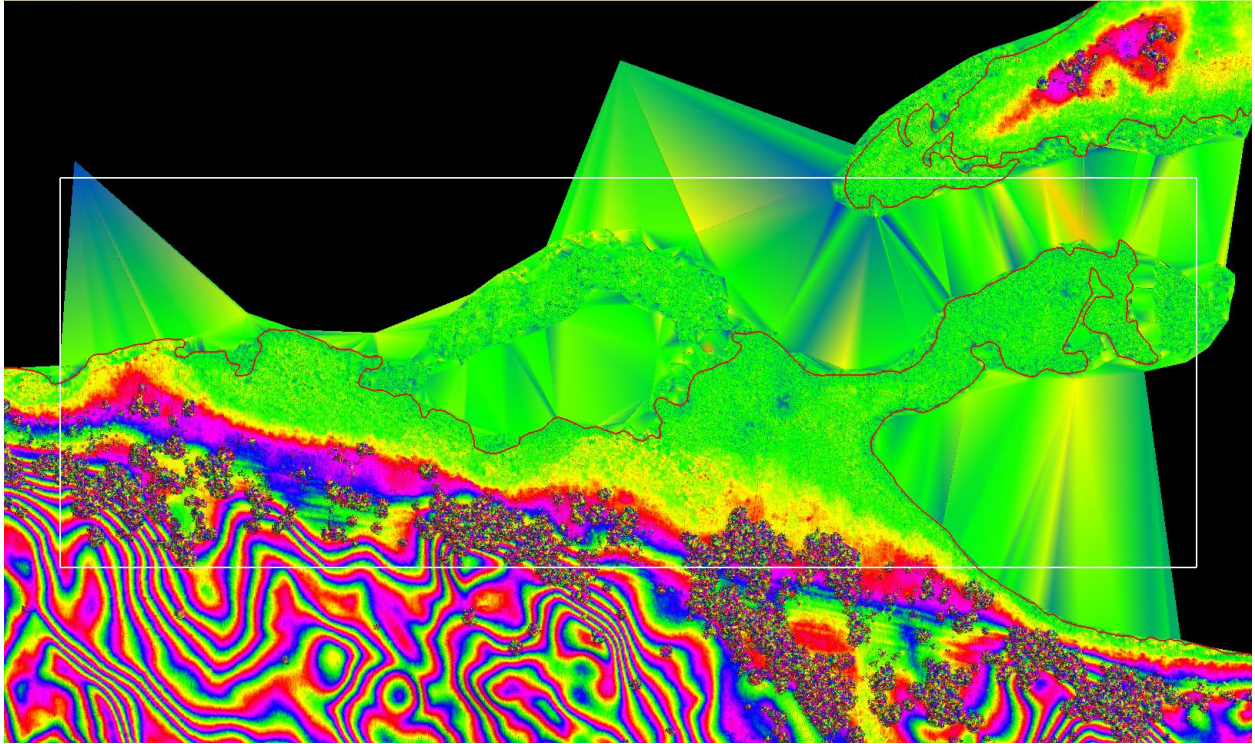
Color by elevation - Color gradient is 0.3m, approximately a foot, showing elevation differences.

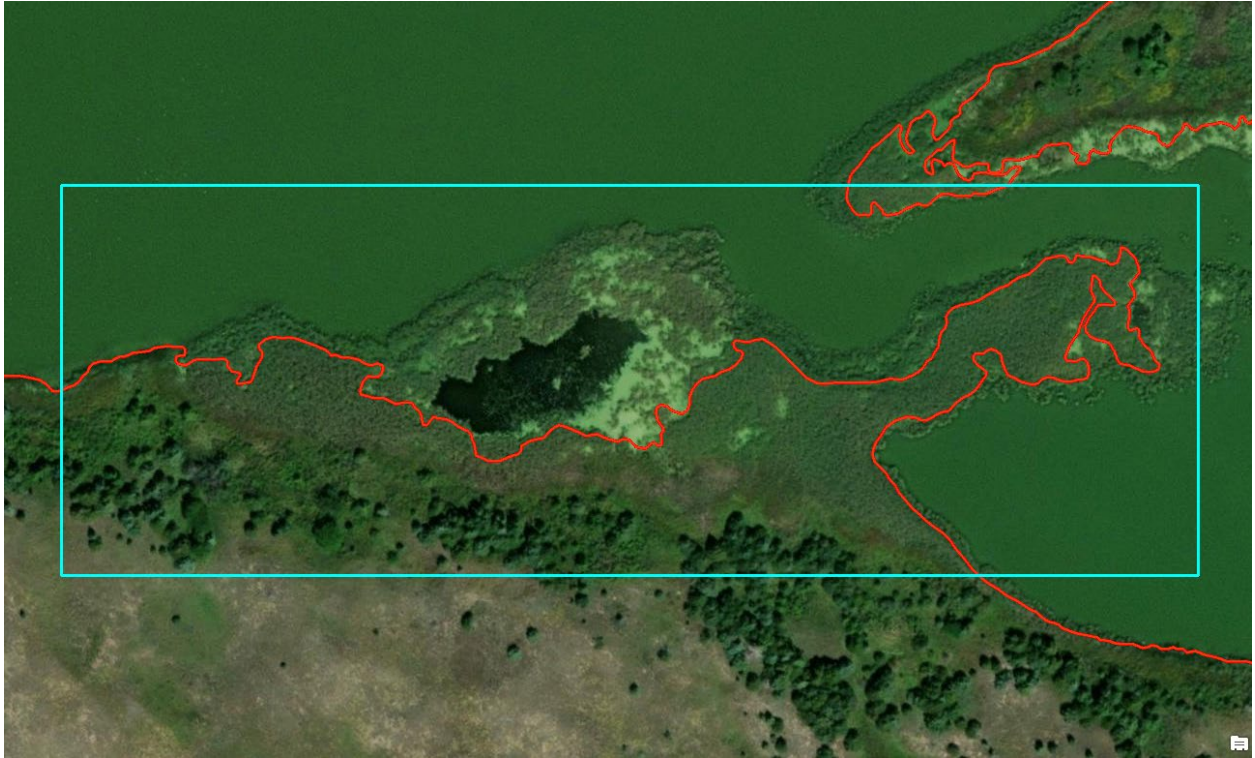
ArcGIS base map imagery. (Imagery date – 9/6/2017)

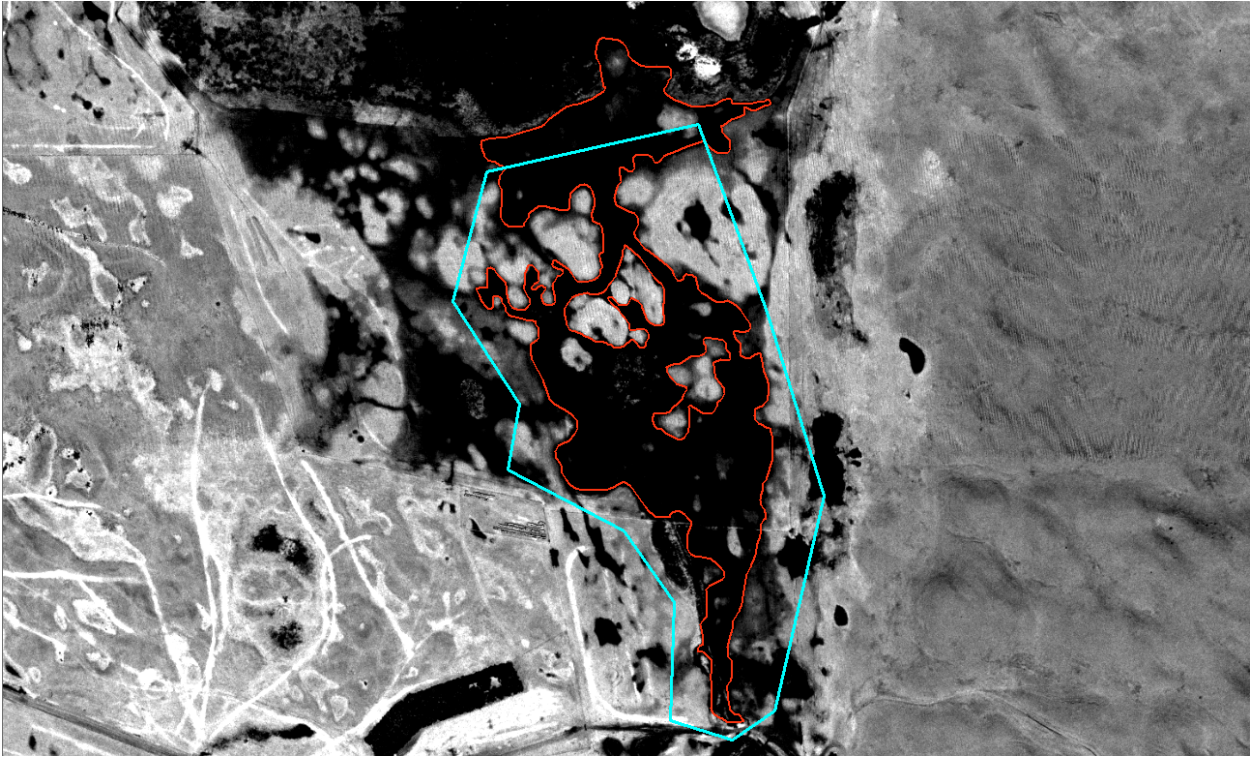
Error ID – 4528, # 1 – Breakline was removed from final delivery.

8-bit intensity – Degrades the detail of the intensity image.

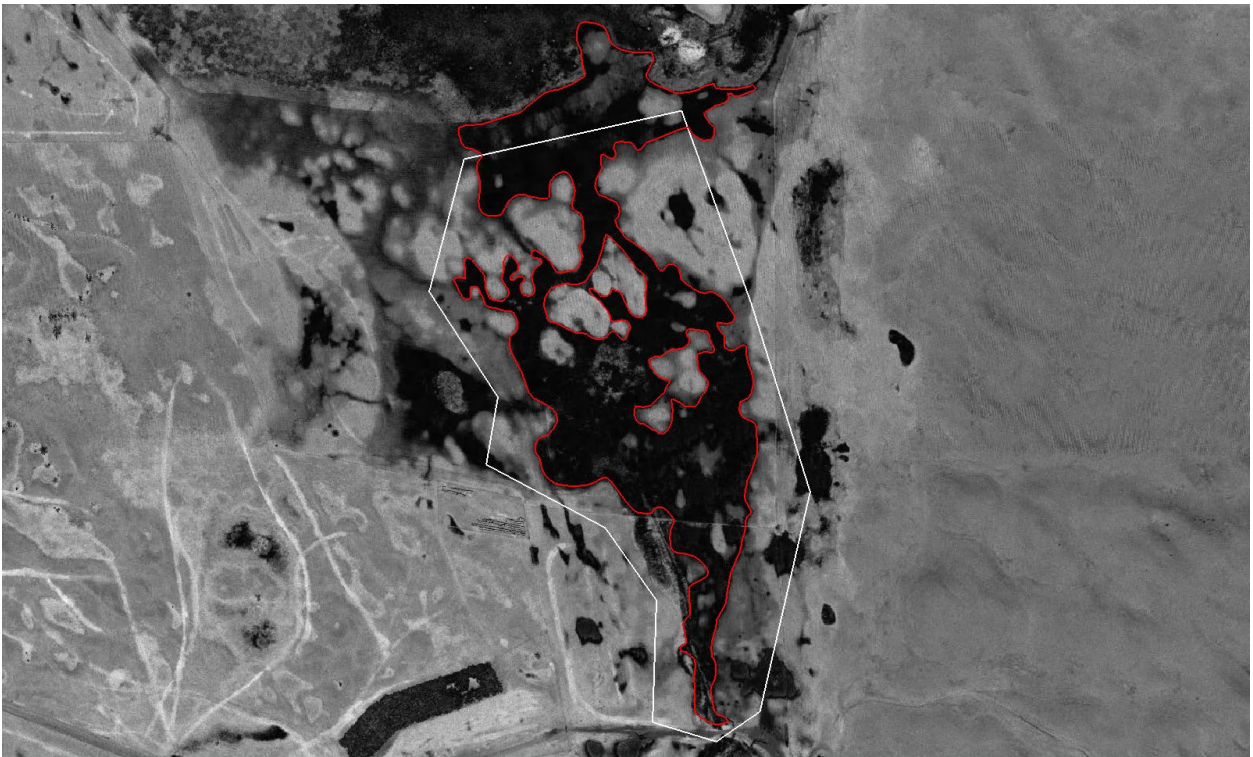
16-bit intensity – Reveals additional detail.

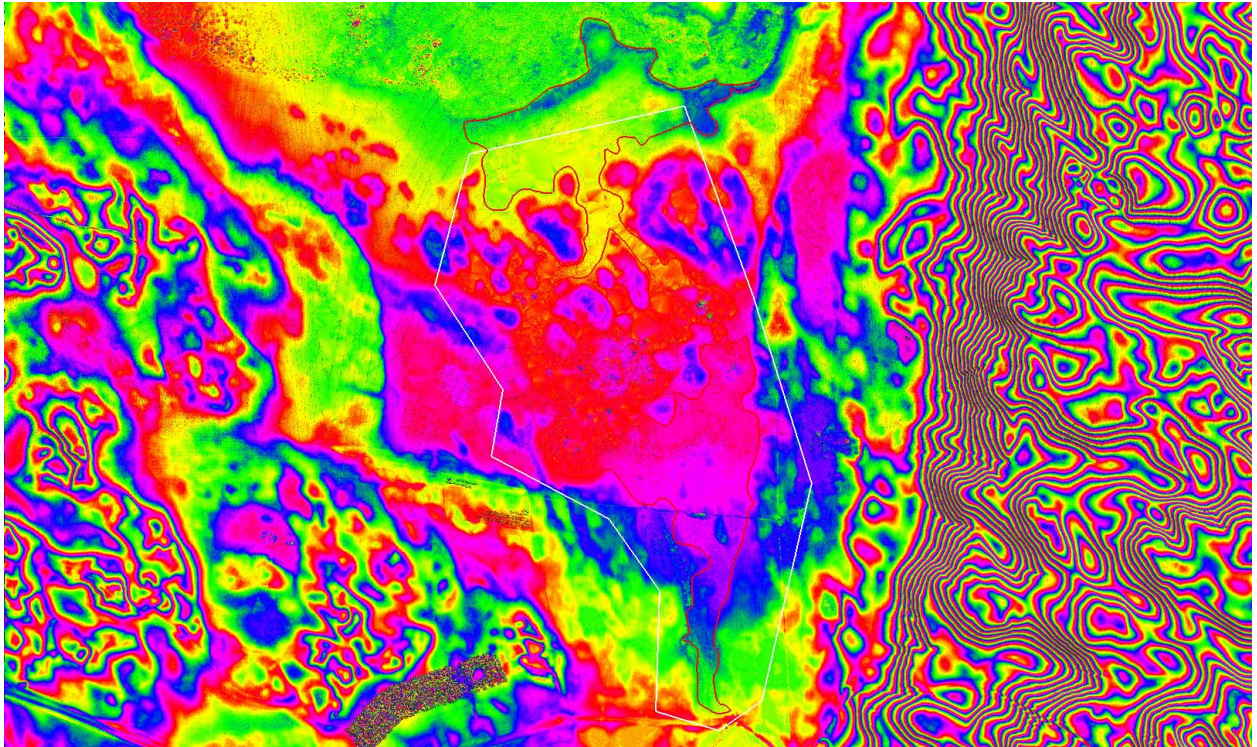
Color by elevation - Color gradient is 0.3m, approximately a foot. This is not a lake rather flooded area, draining to a river.

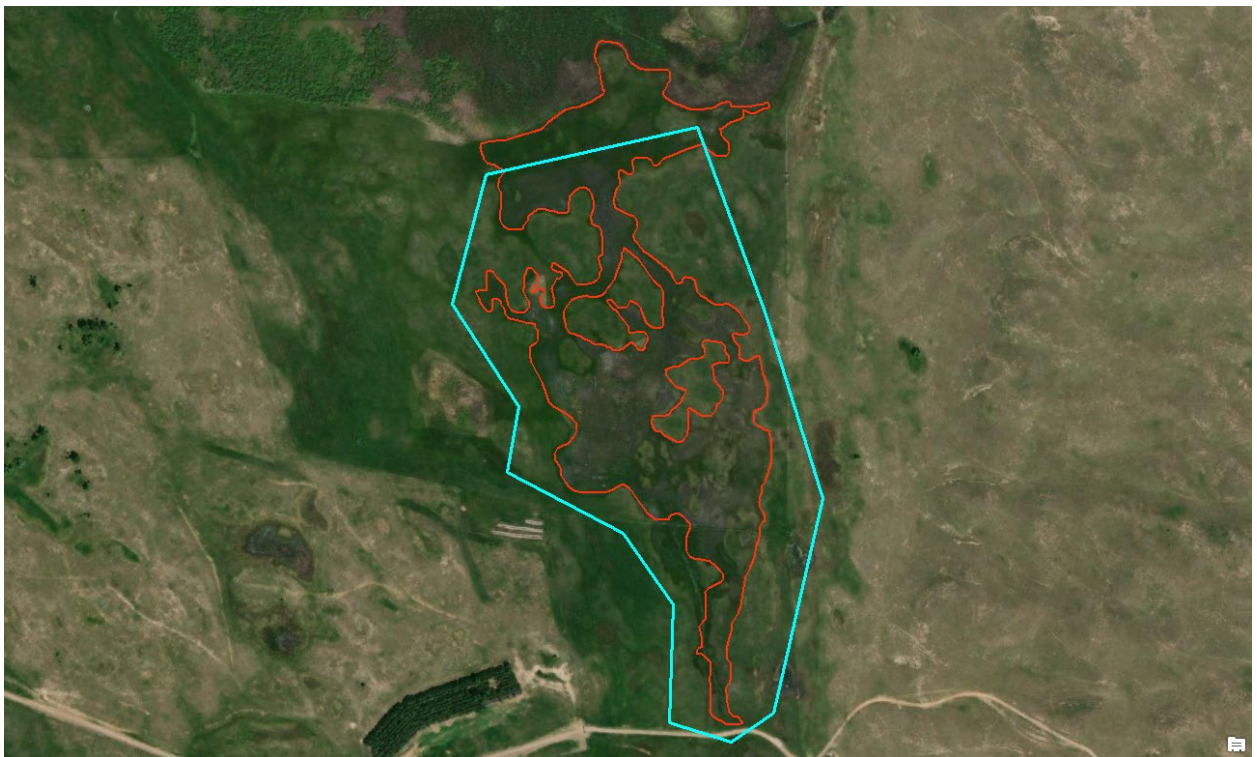
ArcGIS base map imagery. (Imagery date – 6/11/2017)
