New York State Airborne LIDAR

Final Review Report

**New York State QL2 LIDAR Collection (QL2) for Erie, Livingston and
portions of Genesee County, NY**

3DEP Project G19AC000123

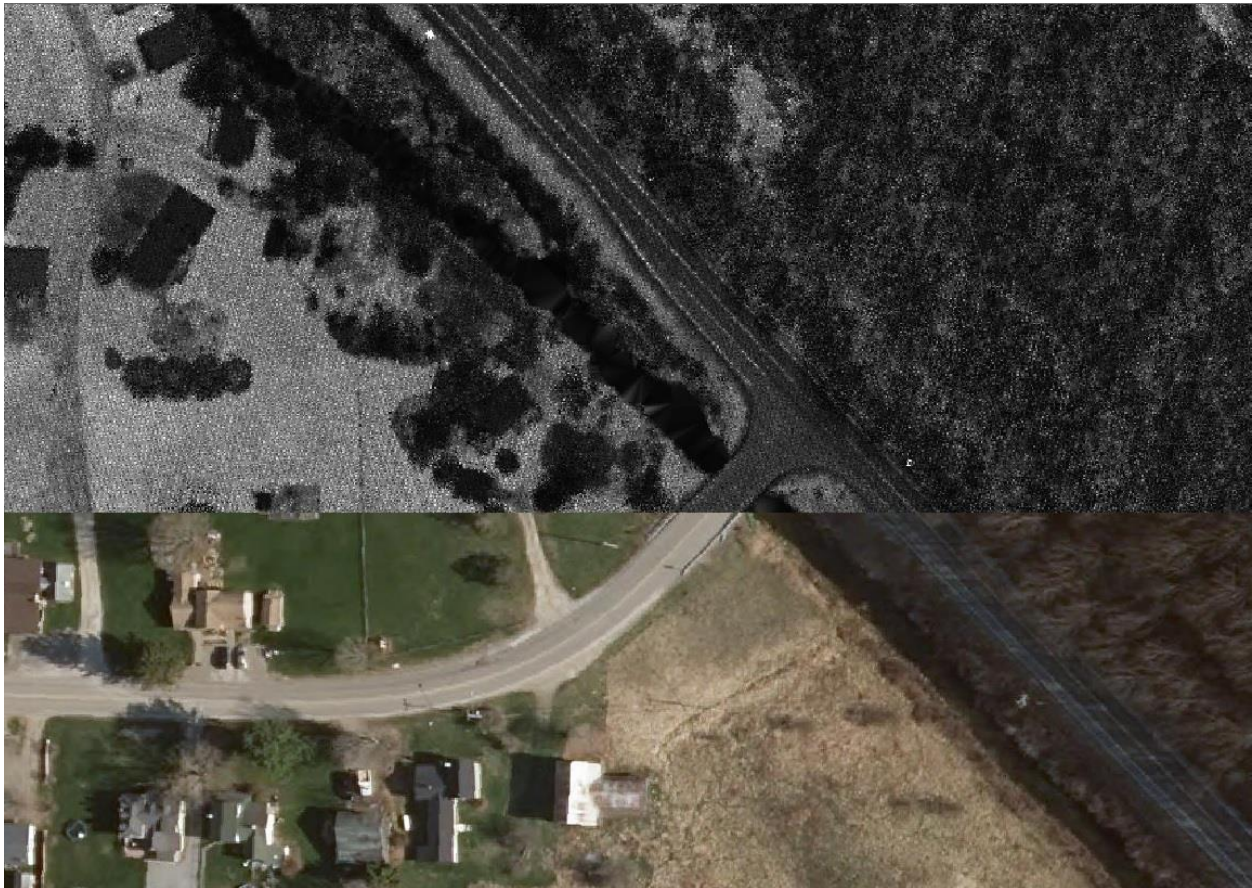
Below is an example where overlapping 1-ft resolution orthoimagery (horizontal accuracy better than ± 4 -ft at 95%) is shown with a 1-ft resolution intensity image created from the LAS point cloud.

Early in the review process, an intensity image was made from all tiles. In select areas, the horizontal position of features such as sidewalk corners, painted lines, and pavement intersections on this intensity image were compared to the locations of the same features on reference data. In most cases, the reference data were orthoimages or vector data digitized from the orthoimagery. In some cases, NYSDOT design scale mapping accurate to ± 6 cm was also used. Occasionally, the project's surveyed checkpoints also could be used. This check on the horizontal position of the LIDAR data was done to confirm a reasonable horizontal alignment before starting detailed vertical accuracy checks.

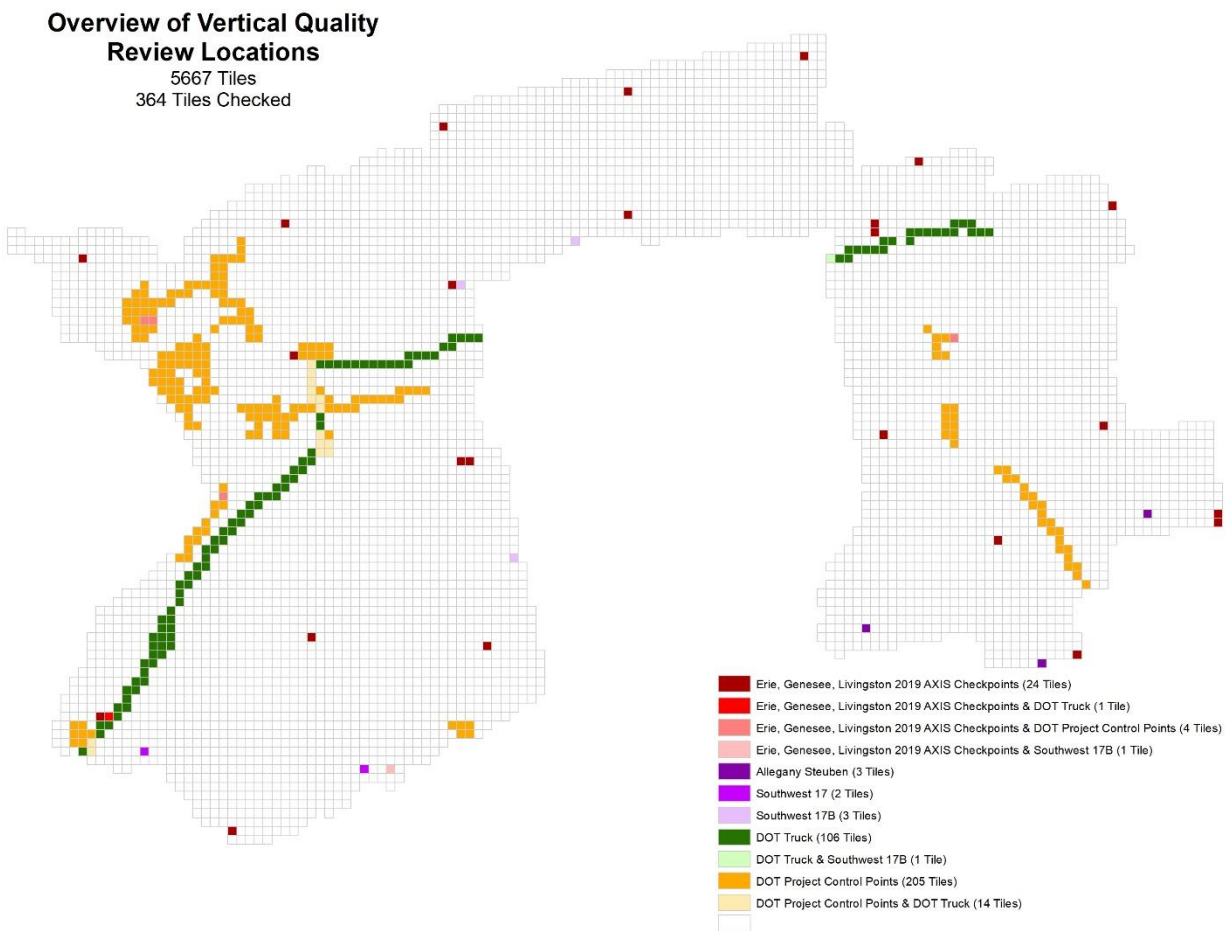
This project succeeded in producing high quality LIDAR point cloud data and bare earth DEMs. Final products were judged to meet 3DEP specifications. As stated earlier in this report, many of the review steps included all tiles. Given the specific locations of the check data for quantitative vertical review, the following graphic provides an overview showing good distribution of these checks.
