Fish Springs Topobathymetric Lidar

Report Produced for U.S. Geological Survey

Client Contract: 140G0222F0225

Report Date: September 7, 2023

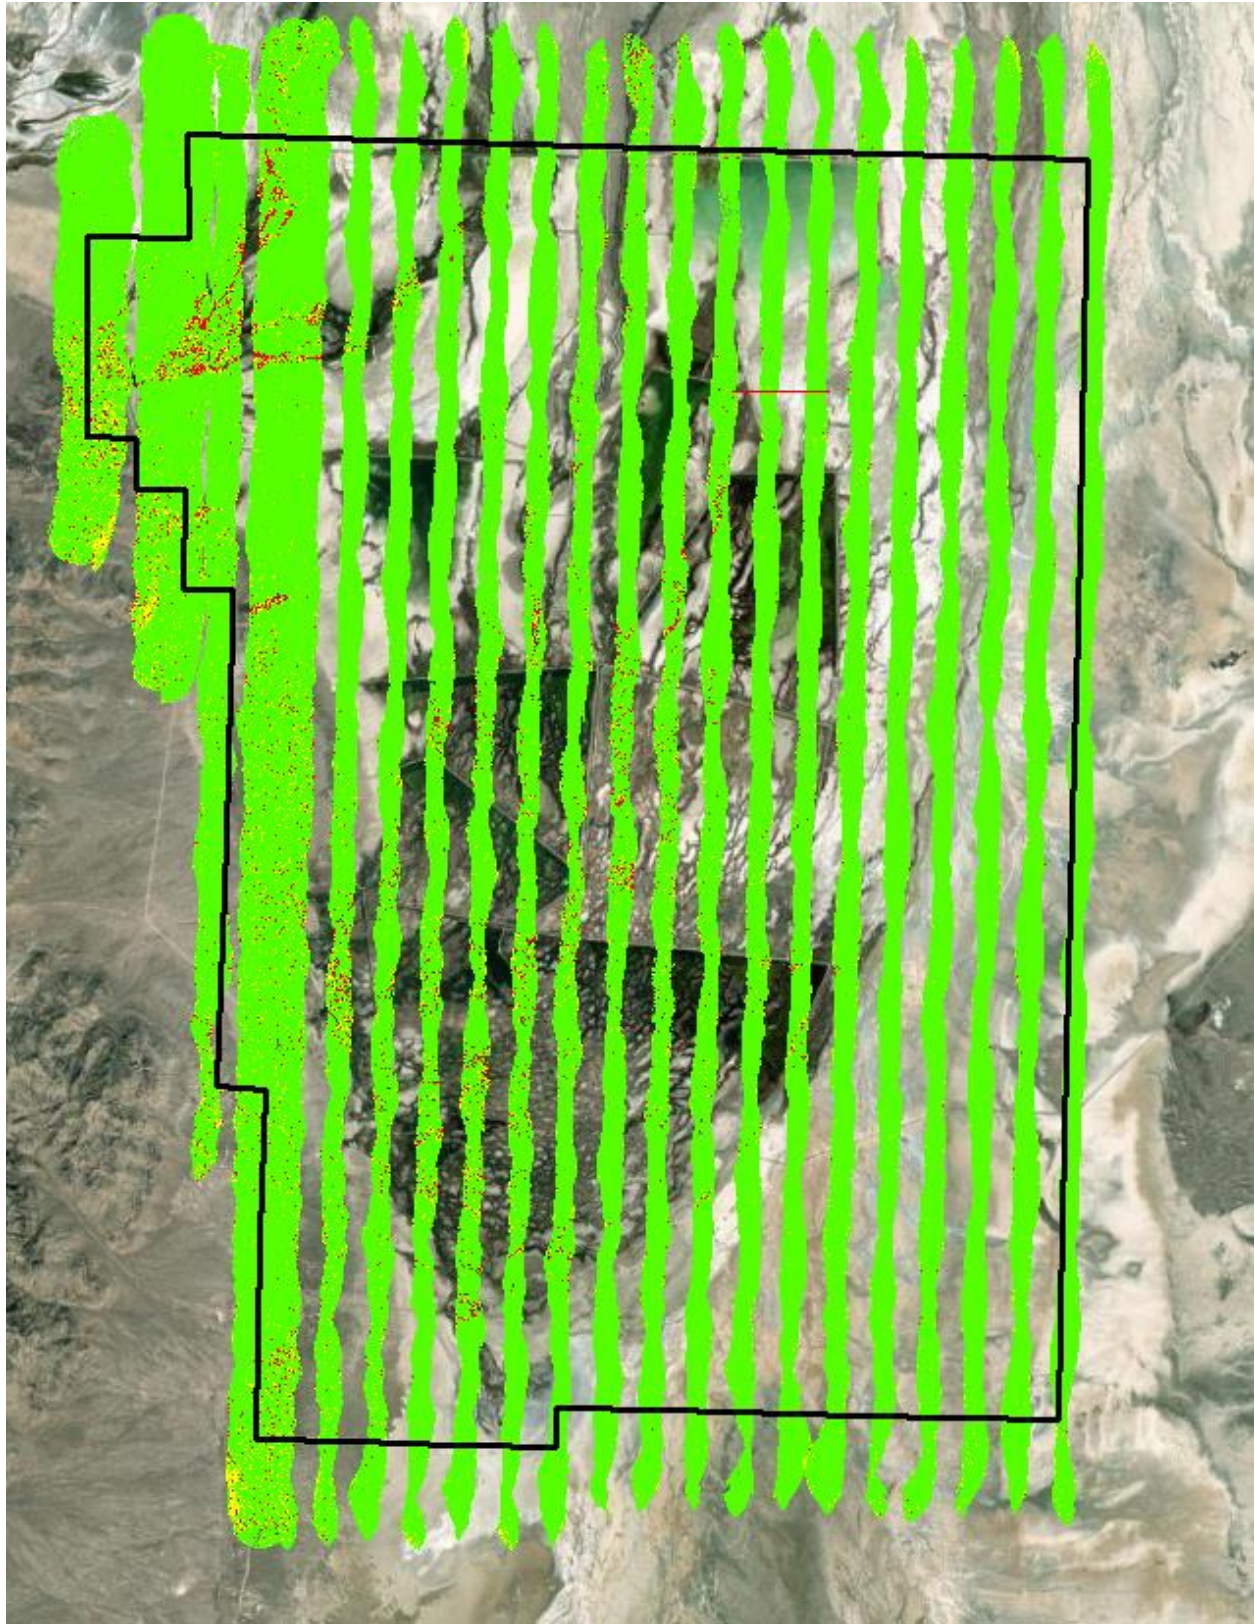
Figure 5. Single return interswath DZ rasters for the Fish Springs Topobathymetric Lidar Project.

Prior to classification, Dewberry validated the relative accuracy of the lidar calibration by creating delta-Z (DZ) rasters to visualize interswath accuracy. These rasters were generated with 1 m cell resolution based on the maximum difference in elevation between undifferentiated only returns in non-vegetated areas of overlap between flight lines. Each pixel of the raster was colored according to the resulting value. Cells where overlapping flight lines were within 8 cm of each other were colored green, cells where overlapping flight lines had elevation differences between 8 cm and 16 cm were colored yellow, and cells where overlapping flight lines had elevation differences greater than 16 cm were colored red. Pixels that did not contain points from overlapping flight lines were colored by intensity.

Areas of vegetation and steep slopes (slopes with 16 cm or more of valid elevation change across 1 linear meter) are expected to appear yellow or red in the DZ rasters. Bathymetric areas can also appear yellow or red due to factors like different tidal stages between missions. Large or continuous sections of yellow or red pixels following terrain features or land cover zones are typically reflective of variable or unfavorable (e.g., vegetated) conditions for DZ measurements, whereas large or continued sections of yellow or red pixels following flight line patterns can indicate acquisition or calibration issues. The interswath DZ rasters for Fish Springs Topobathymetric Lidar Project are shown in Figure 5. Based on visual inspection, no issues with swath-to-swath calibration were noted.

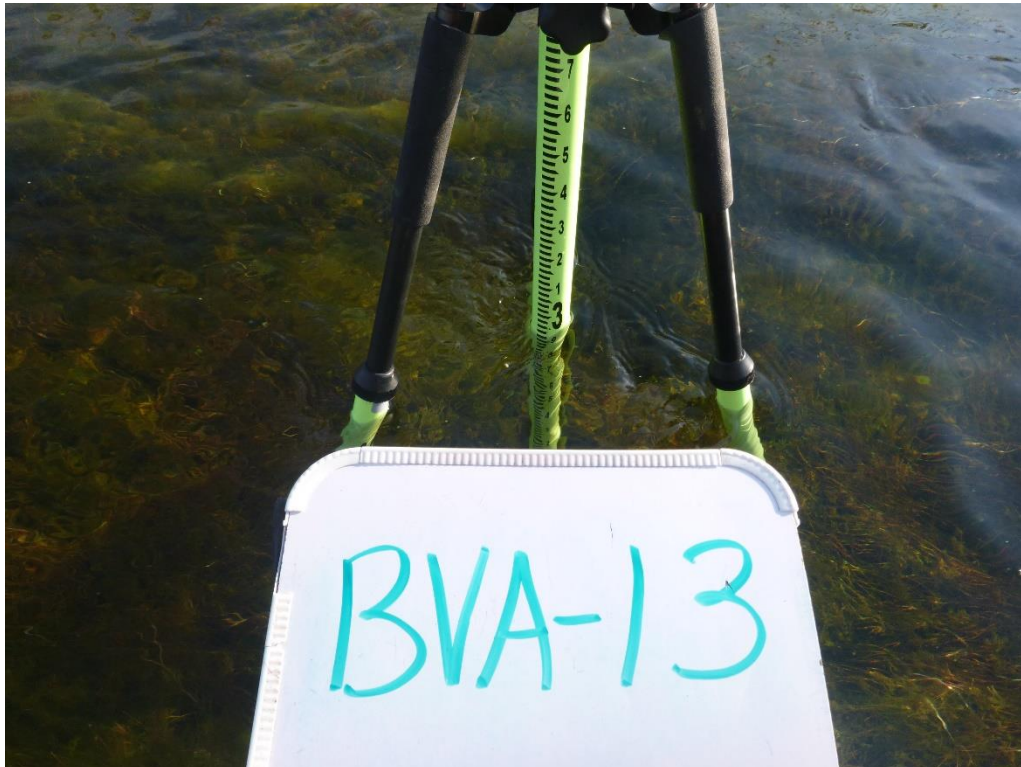
Figure 12. Checkpoint BVA_13 is located over heavy submerged aquatic vegetation. This checkpoint was removed from final classified vertical accuracy testing.

Six checkpoints (BVA_02, BVA_08, BVA_10, BVA_11, BVA_13, and BVA_17) were removed from the classified lidar vertical accuracy testing due to the low confidence being surveyed over heavy aquatic vegetation. Per the task order, checkpoints should not be located within 5 meters of a significant change in slope. Breaks in the terrain may cause erroneous vertical accuracy results due to interpolation of the surface. Points on such terrain do not adequately test how well a sensor or a vegetation filtering technique performed. The coordinates of these checkpoints are provided in Table 8 and photos showing checkpoints located near breaks in the terrain are shown in Figure 11 and Figure 12.

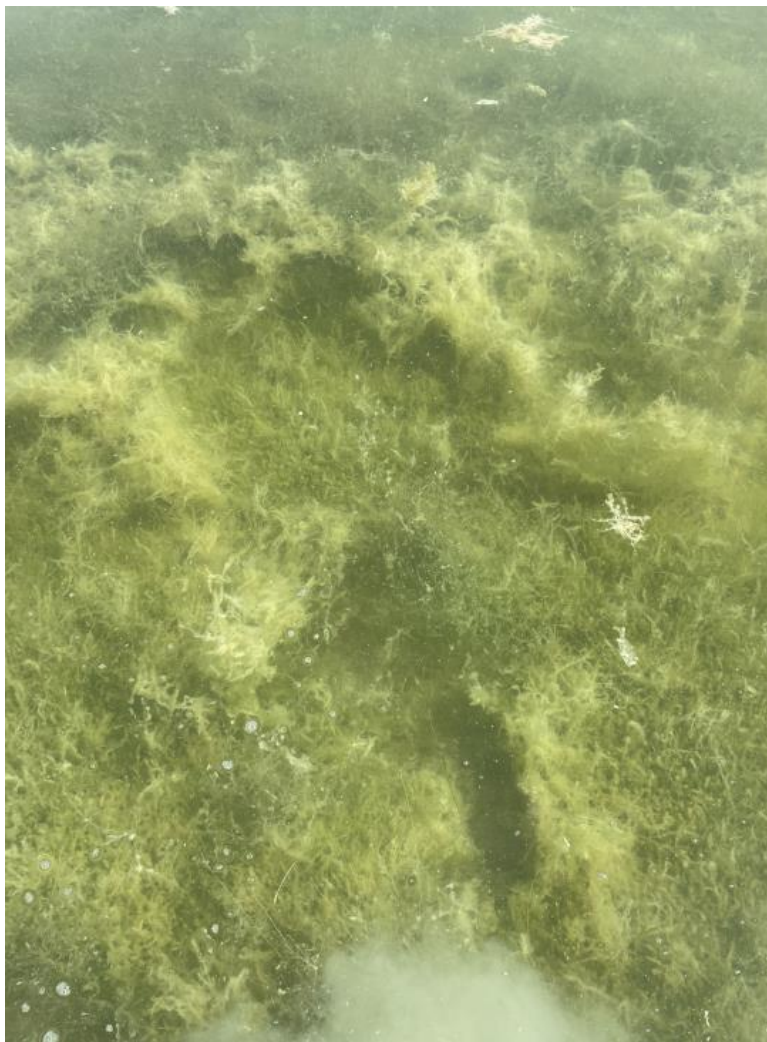
Figure 15. FWS image of spiral ditchgrass within the Gadwall drainage.

FWS went out to perform field verification for the feature in question, however, wind and wave action coupled with turbid water made it difficult to get eyes on the exact location in question. It was determined that the bulk of the feature was vegetated, mostly with spiral ditchgrass which is present throughout the refuge (Figure 15).

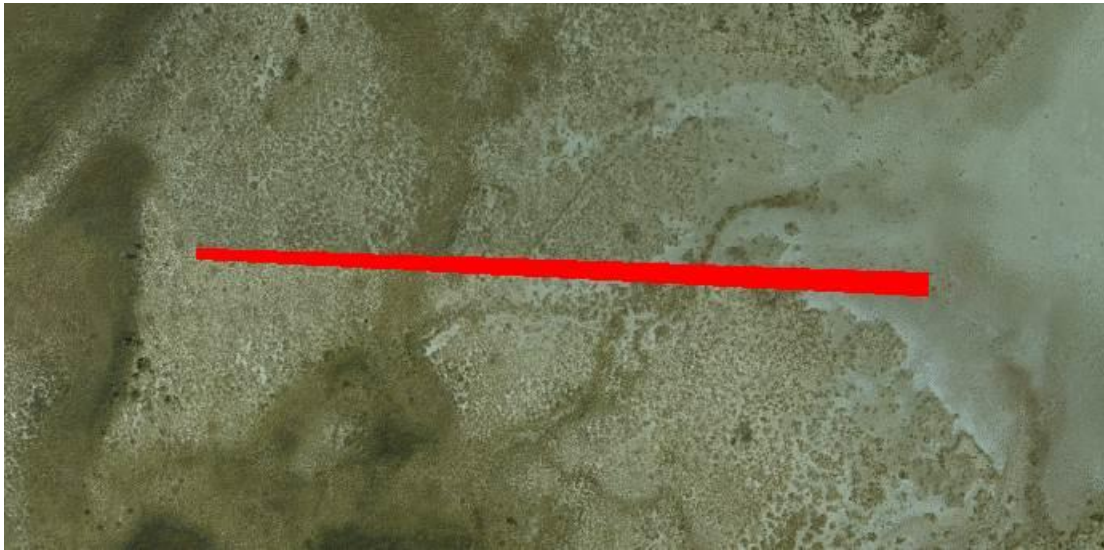
Figure 16. Data void in orthoimagery shown in red.

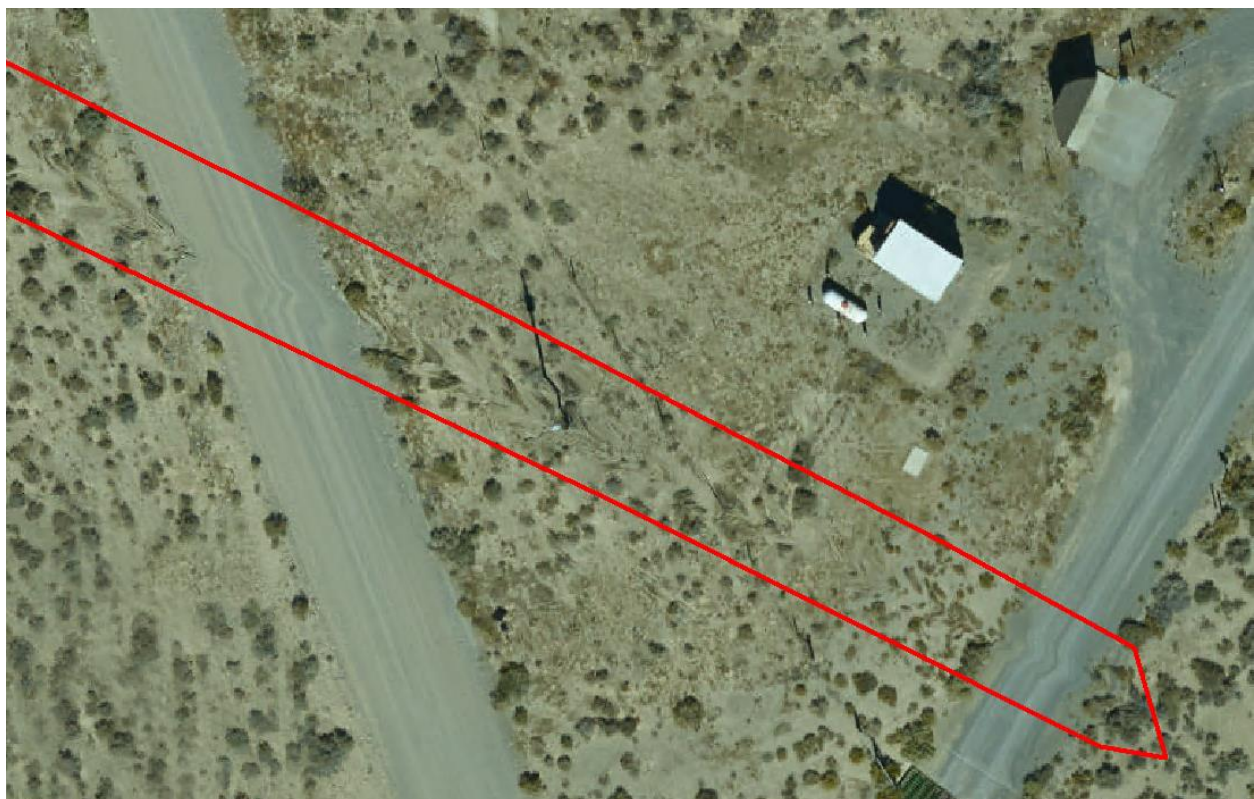
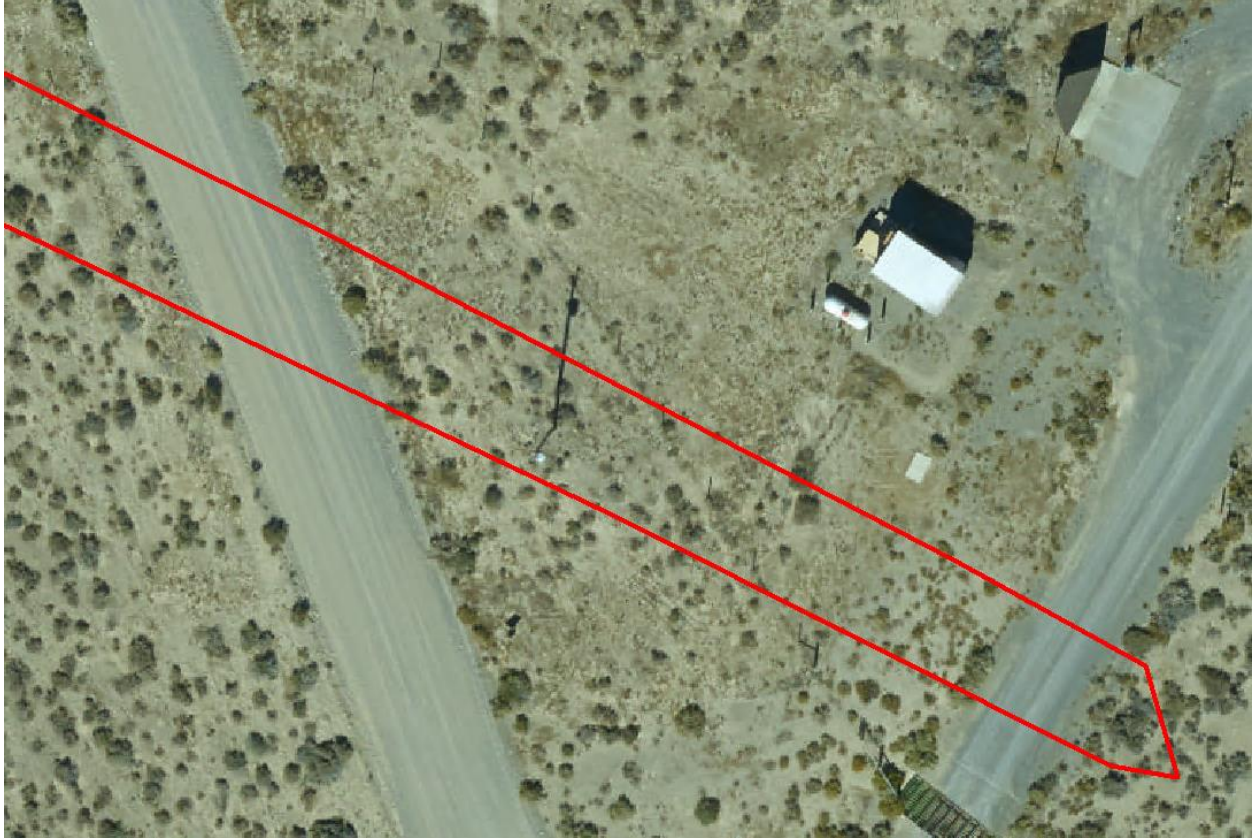
Figure 17. An example of area that was impacted by the surface anomaly. Top image shows the warp caused by the powerlines and in the bottom image it is repaired.

USFWS stakeholders noted several areas on the delivered orthoimagery that contained smearing or other anomalies. The original orthos were created utilizing lidar that was not 100% finalized in order to meet the delivery deadline. Some of the above ground features that had not been completely classified out resulted in a surface that caused these anomalies. All orthos were reprocessed with the finalized lidar, which corrected the noted smears and anomalies (Figure 17).

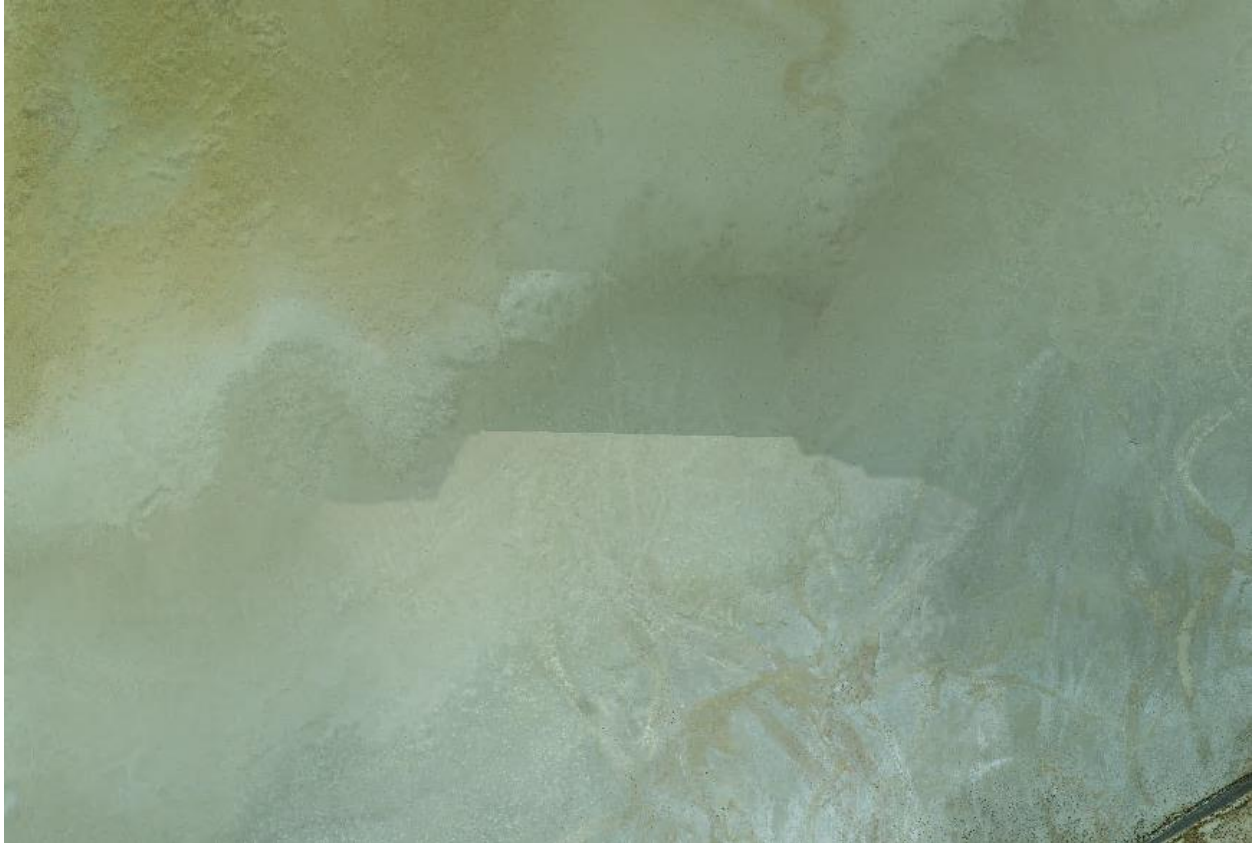
Figure 18. Area affected by seamline visibility.

There is one area of seamlines that did not color balance and blend as well in the reprocessing (Figure 18). Due to the nature of seamlines in such a vast open and flat area such as the desert or over open water there are often visible edges similar to this. Since all orthos were reprocessed it is also not possible to use the old tiles for this area as they would not match perfectly along the edges leading to visible pixel mismatch along the edges of the tiles.
