## LiDAR Quality Assessment Report

UT\_GSLSouth\_2011

This data set created using LiDAR points collected from airborne surveys completed between October 13, 2011 and October 18, 2011 and covers approximately 333 square miles contained in the following county(s): Salt Lake County, Utah; Davis County, Utah

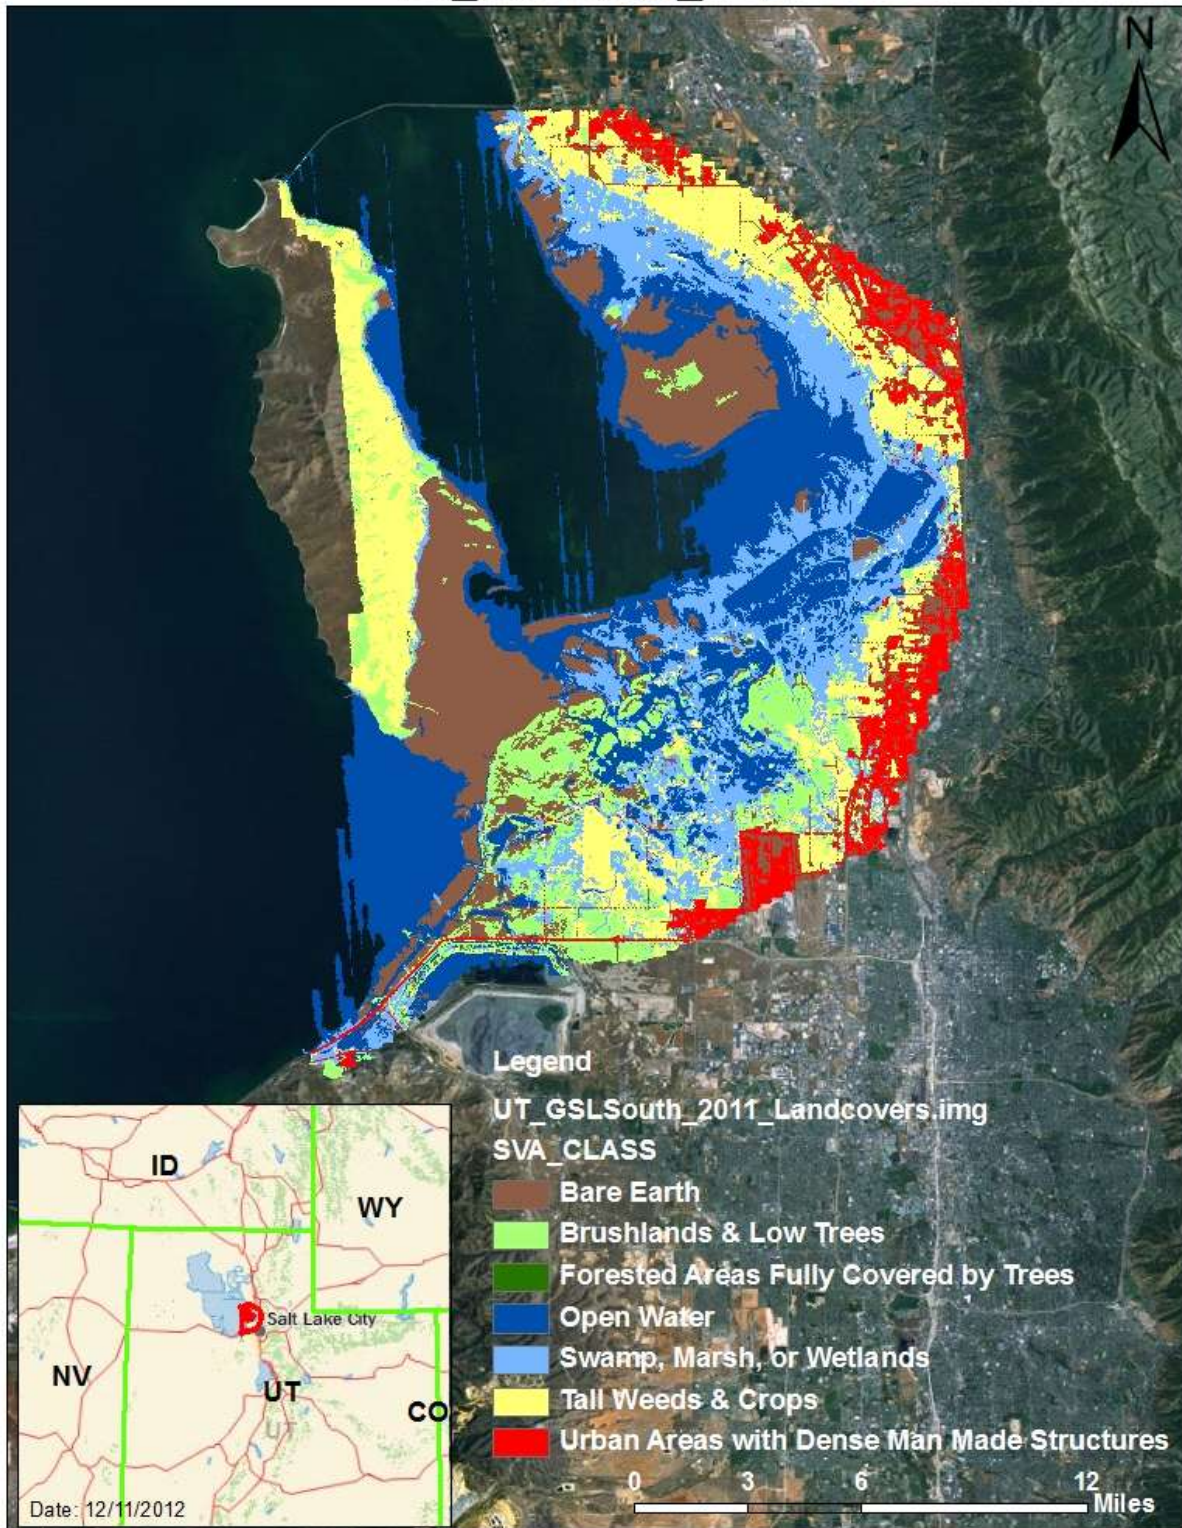
Project Landcovers (from aggregated NLCD 2006)

Other Significant Supplemental Landcover Categories include Swamp, Marsh, or Wetlands; as well as, a significant amount of Open Water.

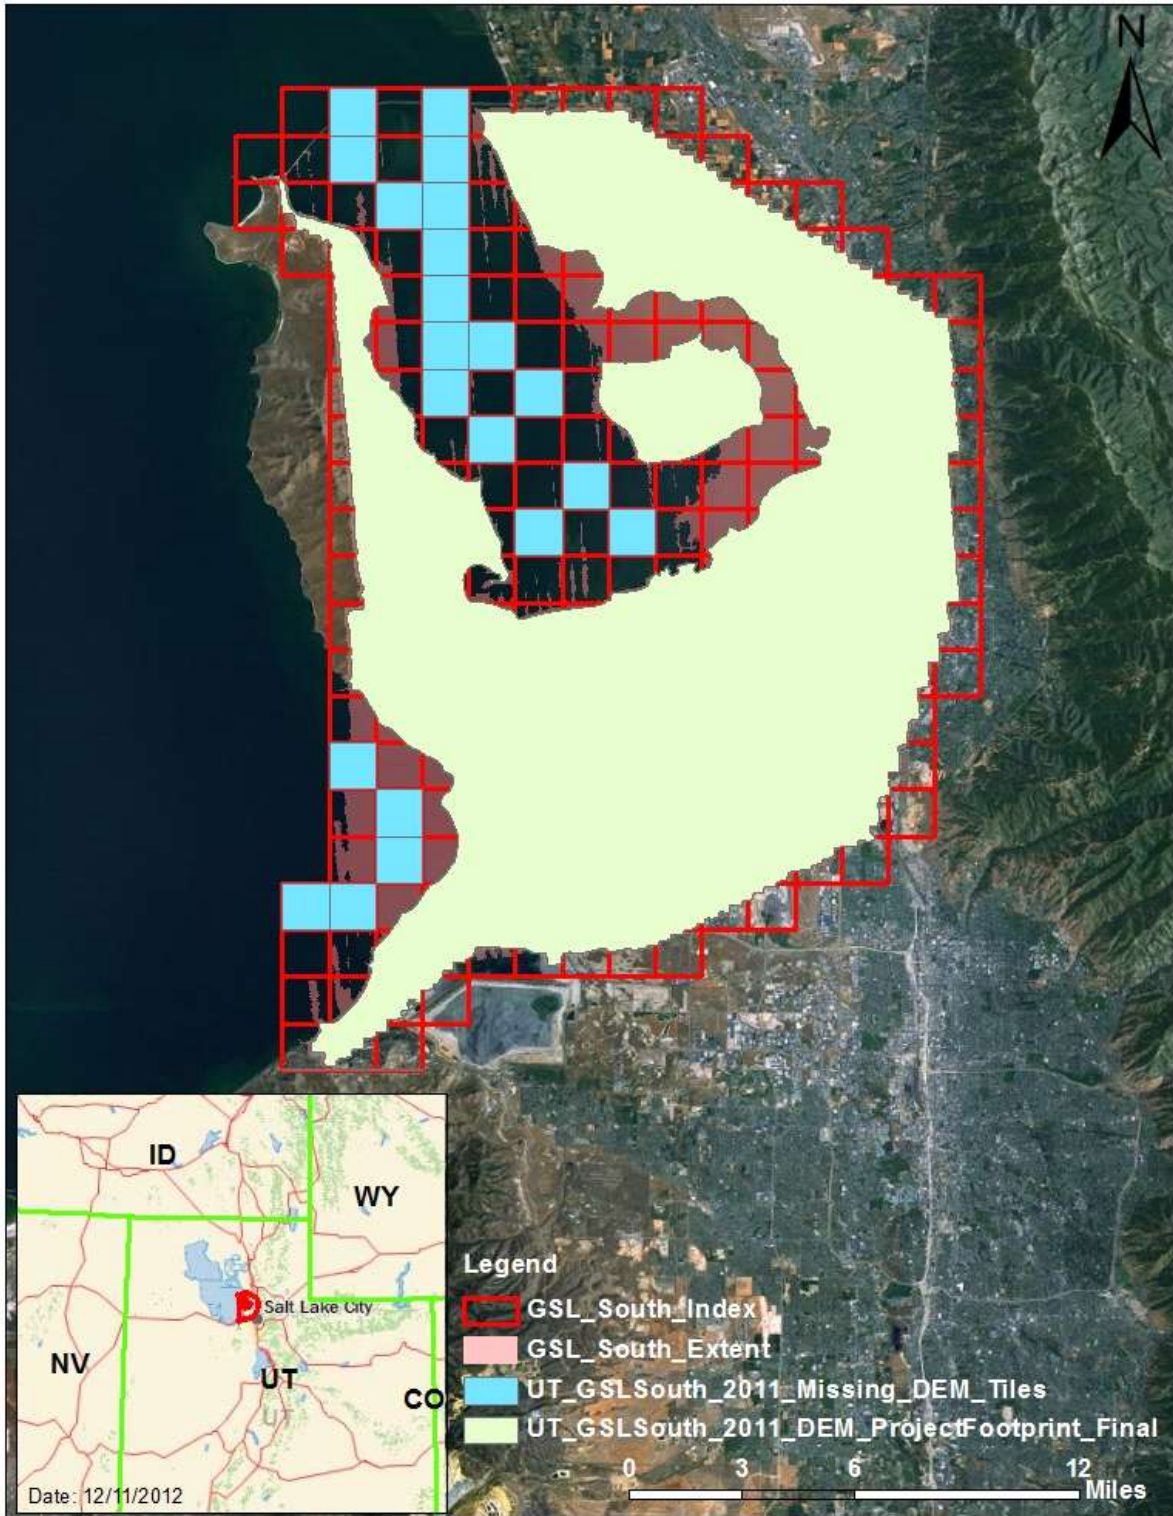
DEM Tiles do not Perfectly Conform to the Tiling Scheme in Terms of Quantity, i.e., 230 DEM Tiles out of a Tile Scheme of 251 Tiles. Missing tiles do not impact the project overall as they fall in areas outside the project extent or unusable data. See [UT\\_GSLSouth\\_2011\\_Missing\\_DEM\\_Tiles.shp's](#) attribute table for a list of missing tiles (pictured above).

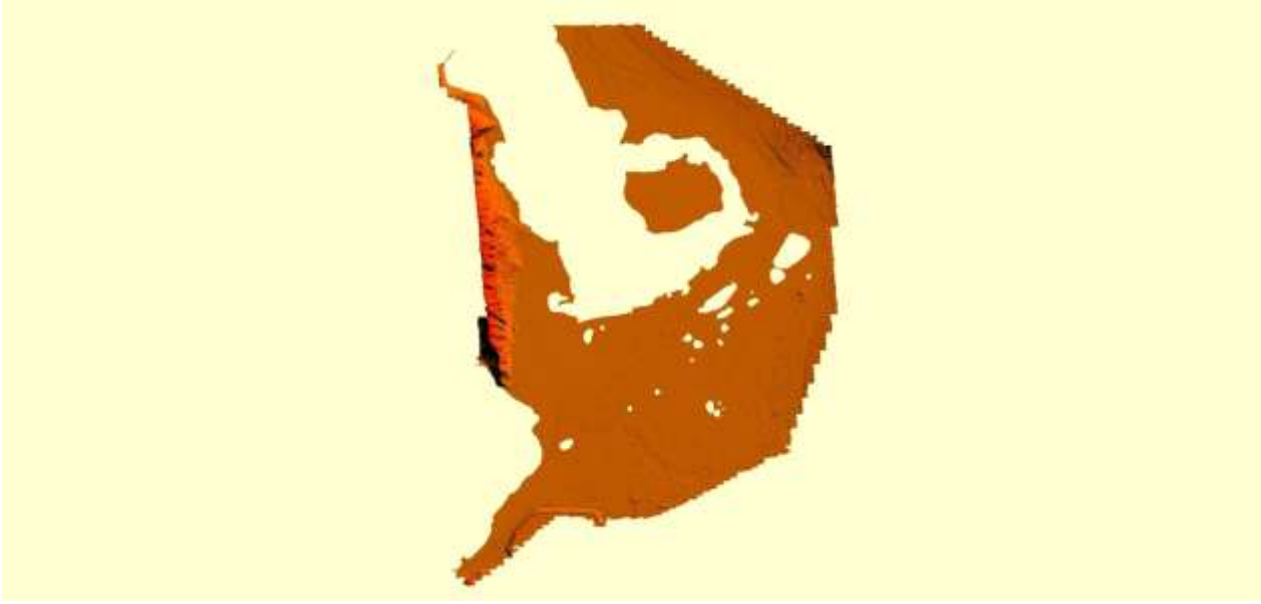
Mosaic of original DEM tiles above, many water areas gridded as "no data".

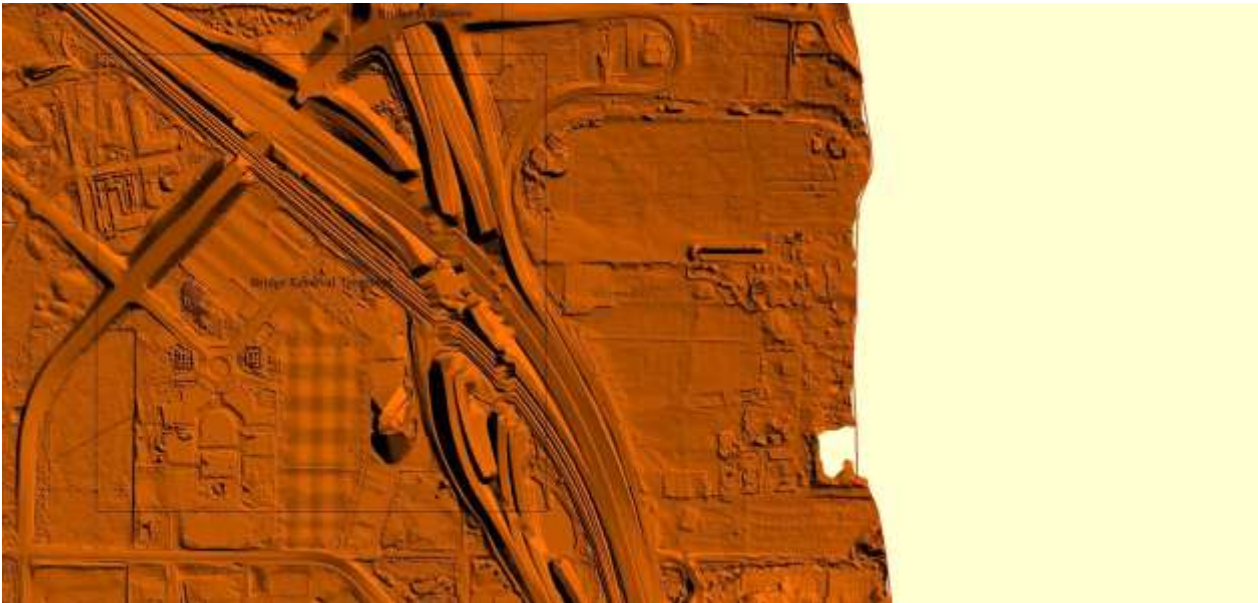
Several instances of bridge or overpass removal issues. Errors tagged as "Bridge" are highly suspect; whereas, errors tagged as "overpass" or "culvert" could not be determined if they needed to be removed or where culverts in the ground. The majority of these issues were corrected in the Final Mosaic DEM sent to the NED.

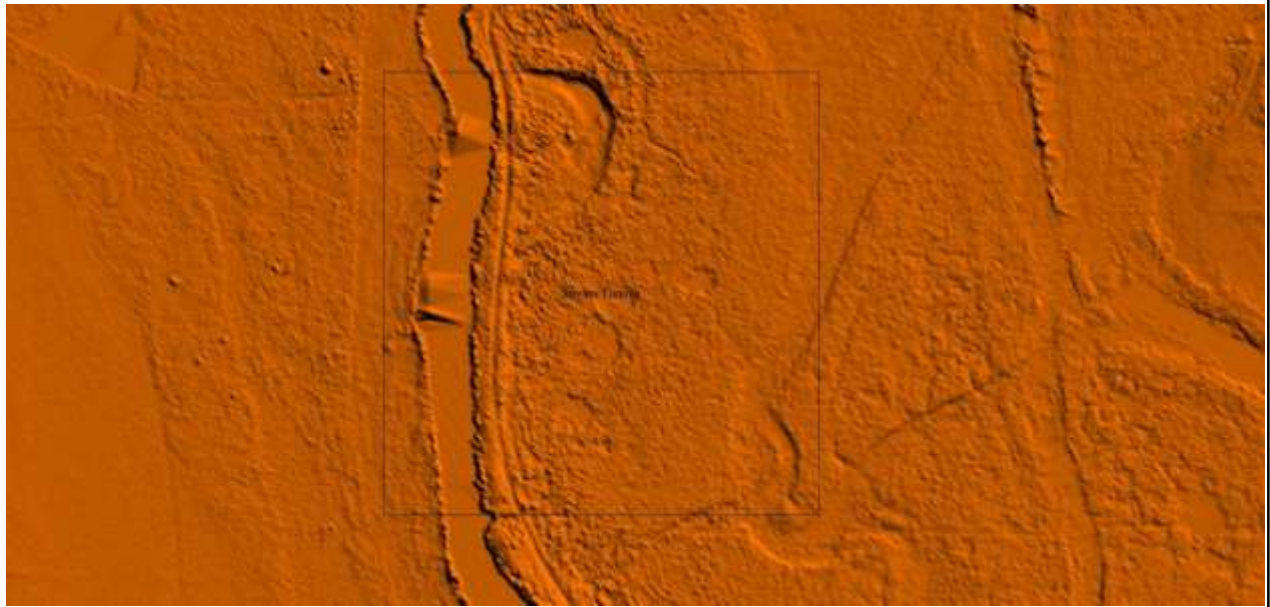
Greater than 100ft nominal width "double line streams" exhibit large amounts of tinning throughout the DEMs.

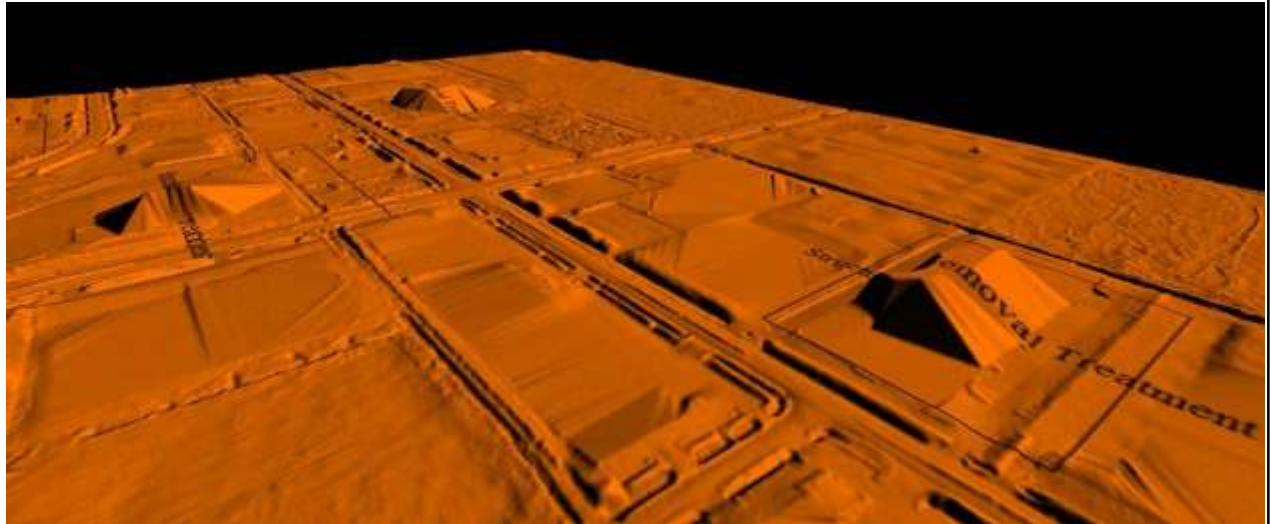
A few instances of questionable structure removal. Errors denoted with the tag "building removal". These artifacts were leveled in the final mosaic DEM sent to the NED.

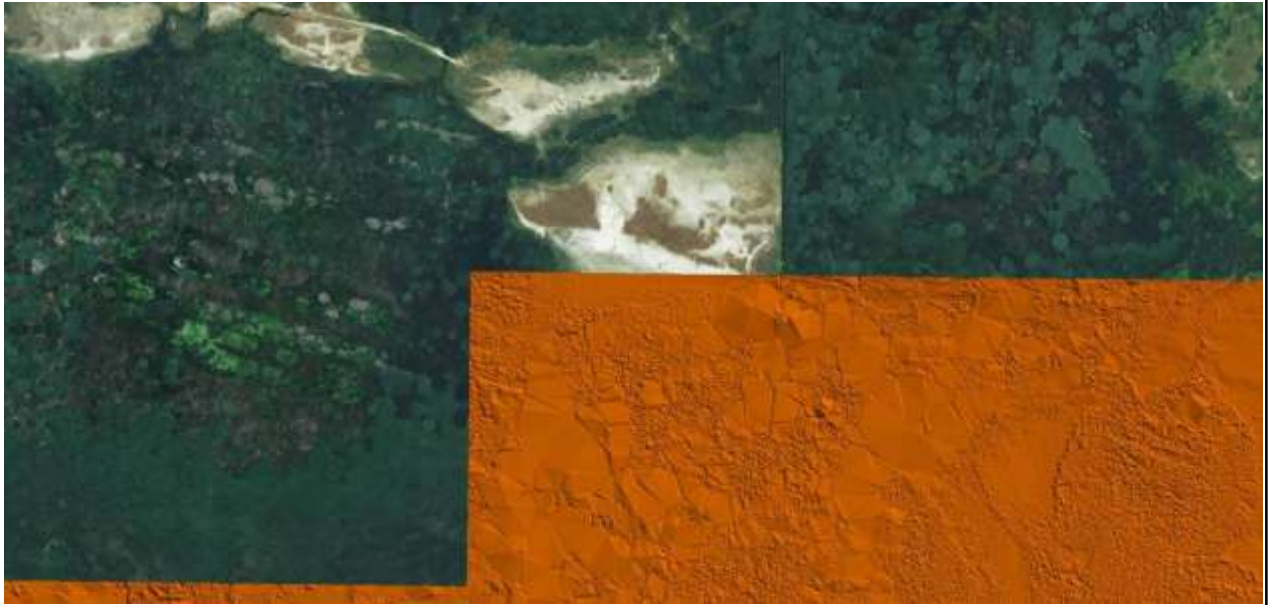
Many Water/Swamp areas, exhibiting heavy amounts of tinning throughout the project. Greater familiarity with the area would be required to make Swamp v. Water leveling treatment recommendations for the areas in question.

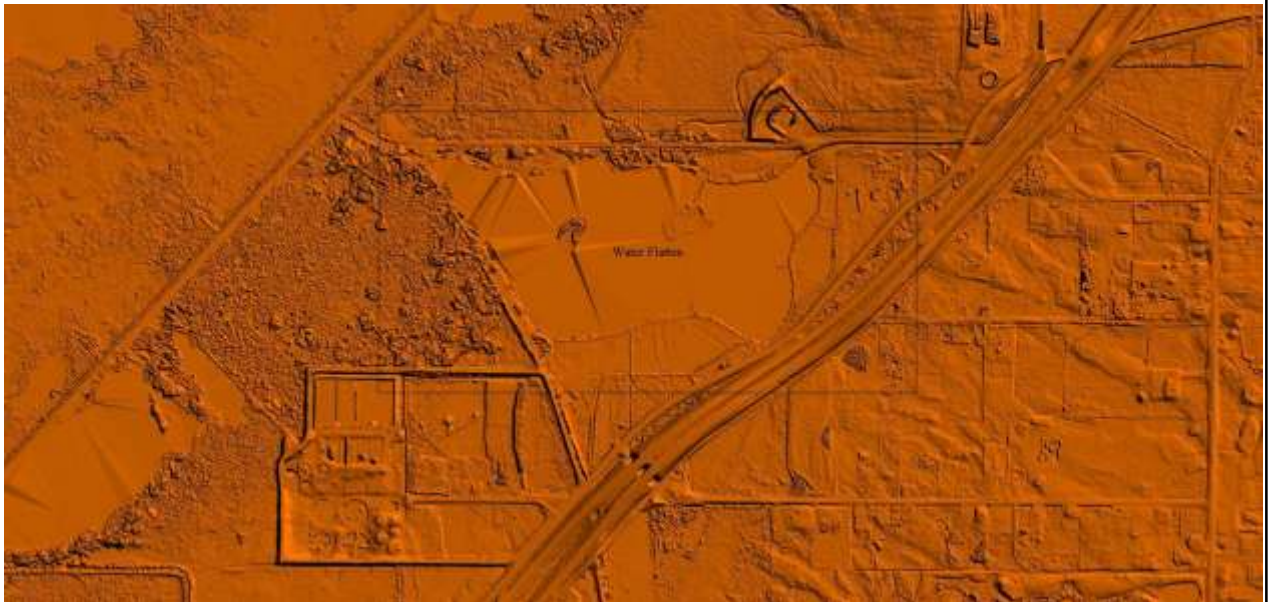
Several instances of distinct waterbodies larger than 2 Acres that could be flattened.

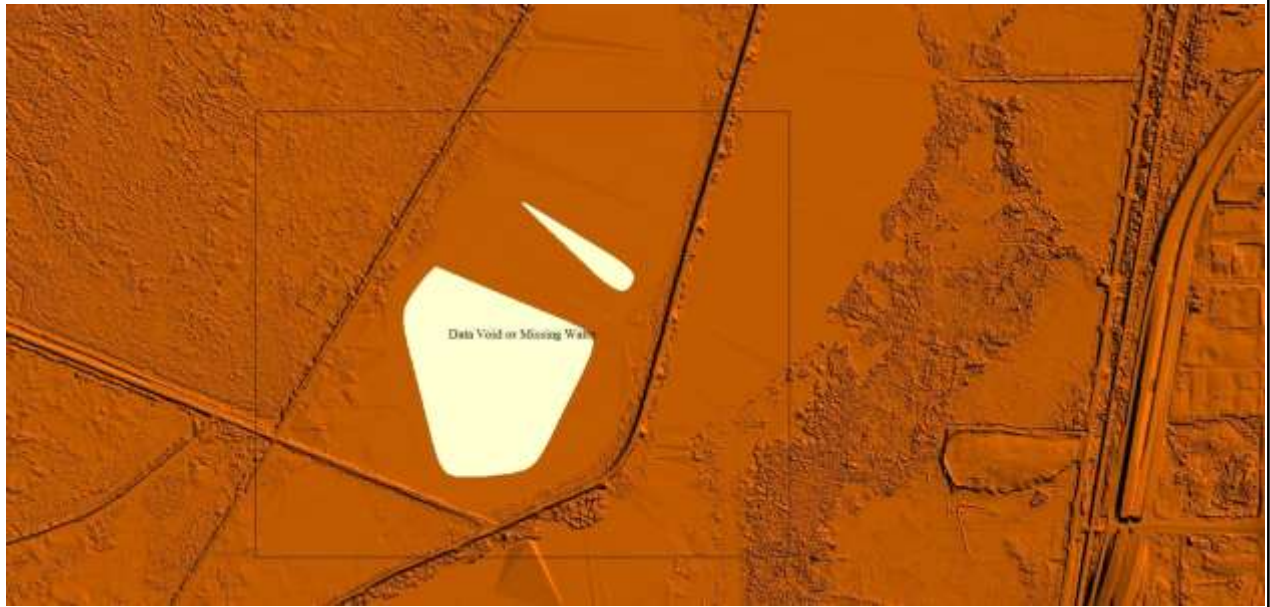
Several instances of waterbodies which have been gridded as no data in the interior of the project. These voids are filled in the final mosaic DEM with the minimum elevation value from the cells bordering the data void. USU has verbally stated that not gridding these areas was a conscious decision due to deal with sloping water.
