LiDAR Quality Assurance (QA) Report
Louisiana LiDAR ARRA Project - Region 2
October 11, 2011

Submitted to:
USGS

1 Executive Summary

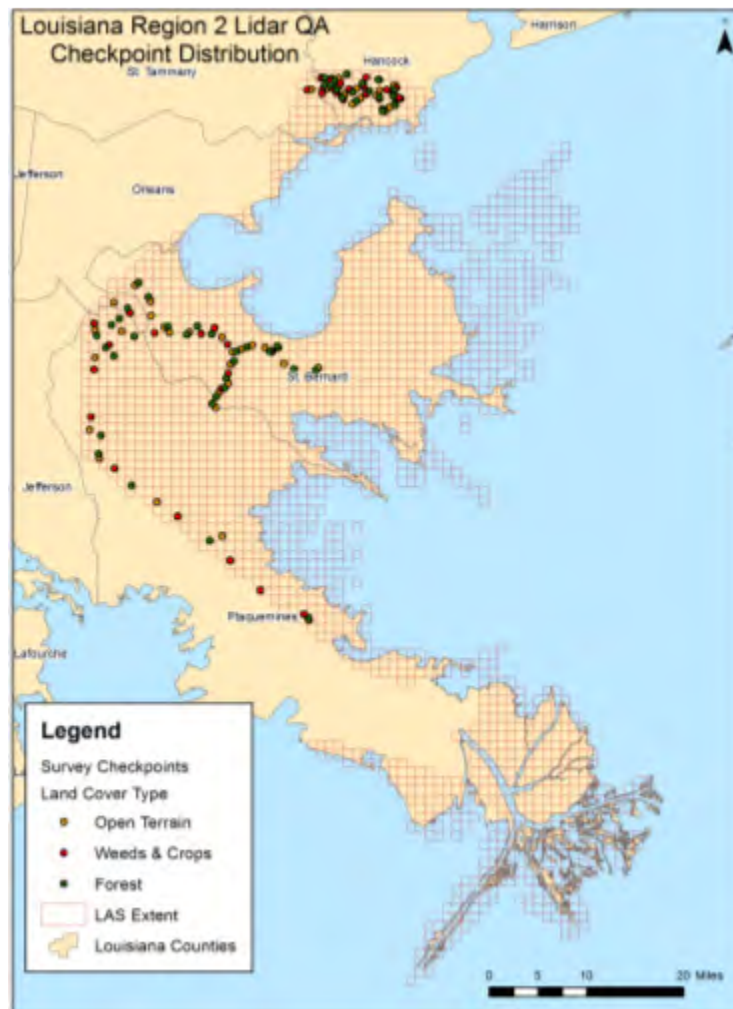
Figure 2: Checkpoints distribution for Louisiana Region 2

One of the first steps in assessing the quality of the LiDAR would be a vertical accuracy analysis of the ground models in comparison to surveyed checkpoints. Dewberry & Davis, LLC provided 119 checkpoints for the entire project area extent (Figure 2).

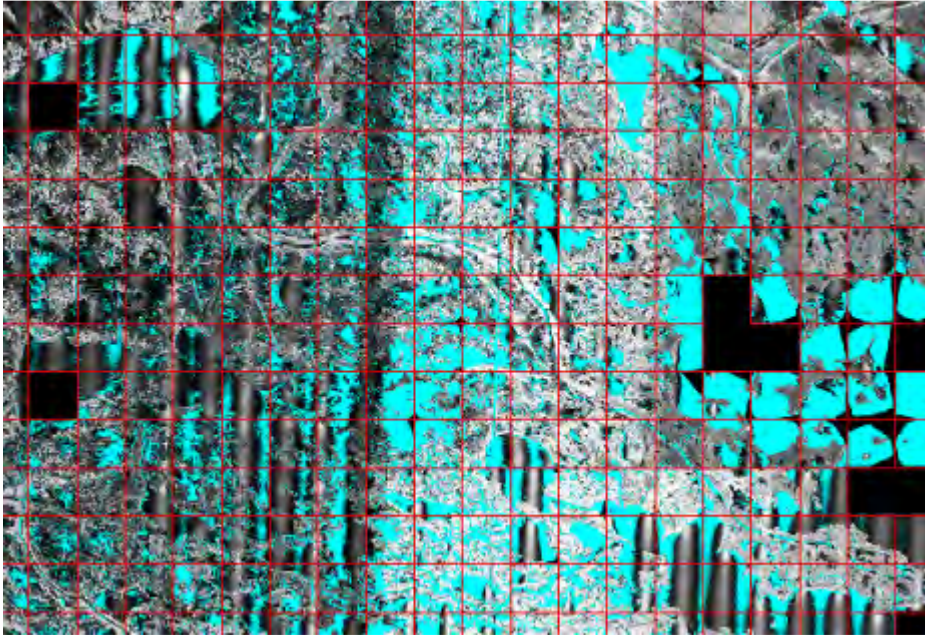
Figure 3 - Intensity images generated from full point cloud data. All areas that are bright blue indicate that there are no points in those areas because it is water. Large areas of water with no point returns will decrease the number of points per tile.

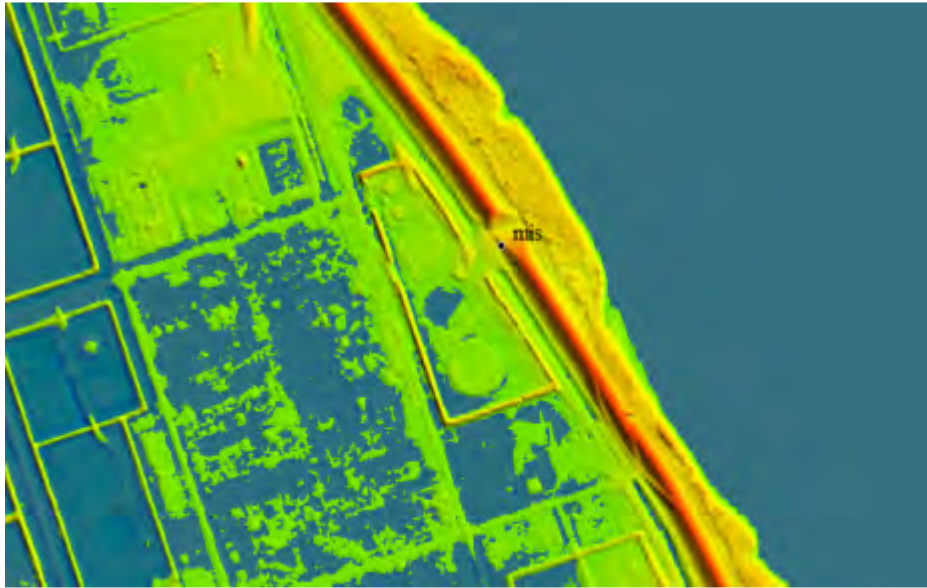
Figure 6 – 1st delivery. Ground elevation model DEM of tile 16RBT115865 showing an area that is misclassified (move Class1-unclassified to Class 2-ground).

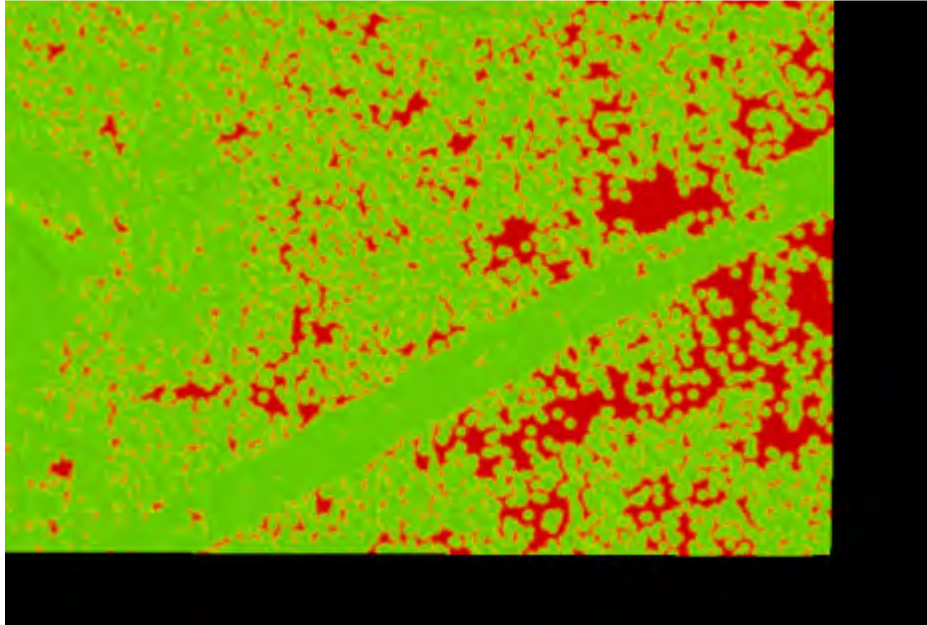
Figure 12 - Ground density model of tile 16RBU550480. The areas of red in this tile are data voids.

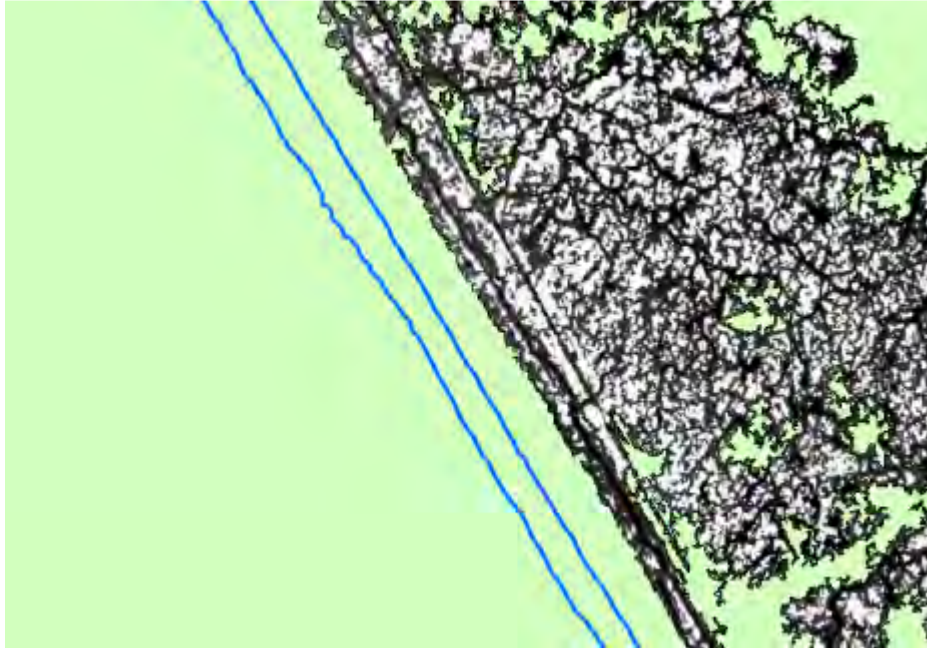
Figure 23 – 1st delivery. Full point cloud intensity image of tile 16RBU190135. The green area is the islands breakline and the two blue lines delineate a stream breakline. The islands should be clipped at the stream lines.

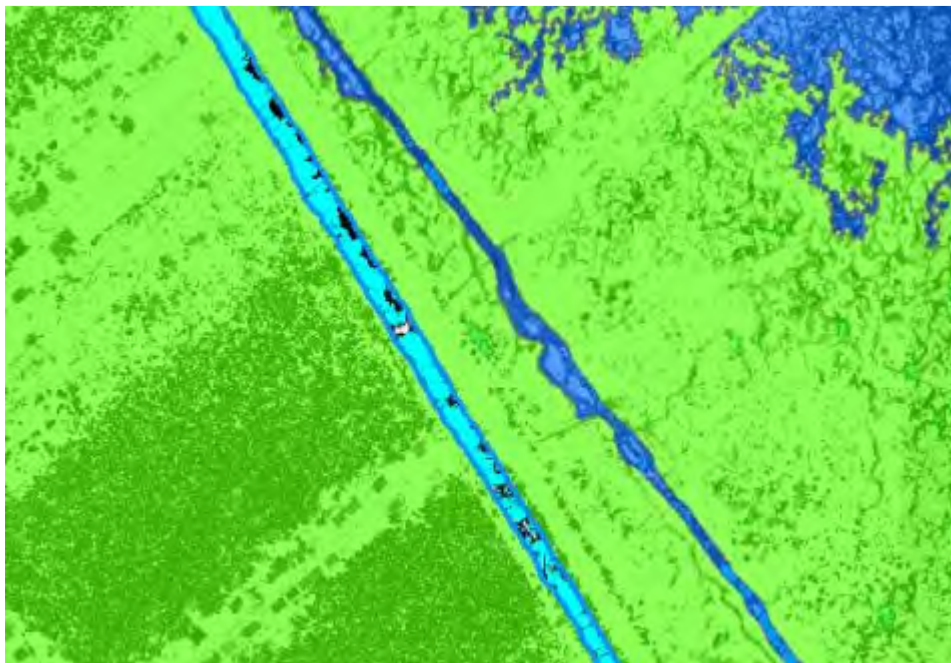
Figure 24- 2nd delivery - Corrected. Full point cloud intensity image of tile 16RBU190135 with the second delivery breaklines. The two blue lines delineate a stream breakline. The islands breakline has now been correctly clipped to the streams breakline.

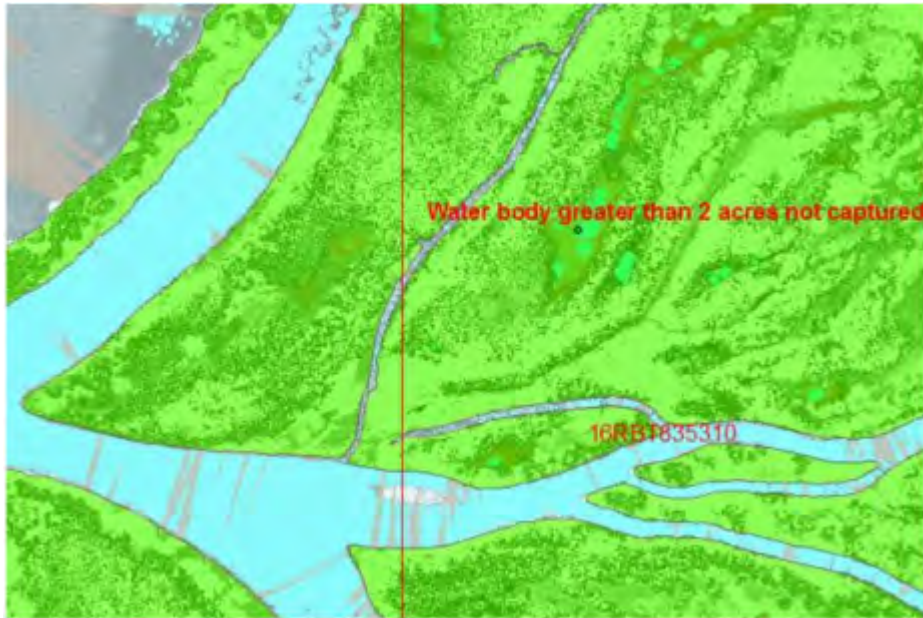
In the first review Dewberry identified 21 water bodies that are greater than 2 acres but not captured by the breaklines. During the second review all issues were addressed by Woolpert.

Figure 31 – 1st delivery. Full point cloud intensity image with tidal waters (blue) and islands (green) draped over showing a water body that was not captured.

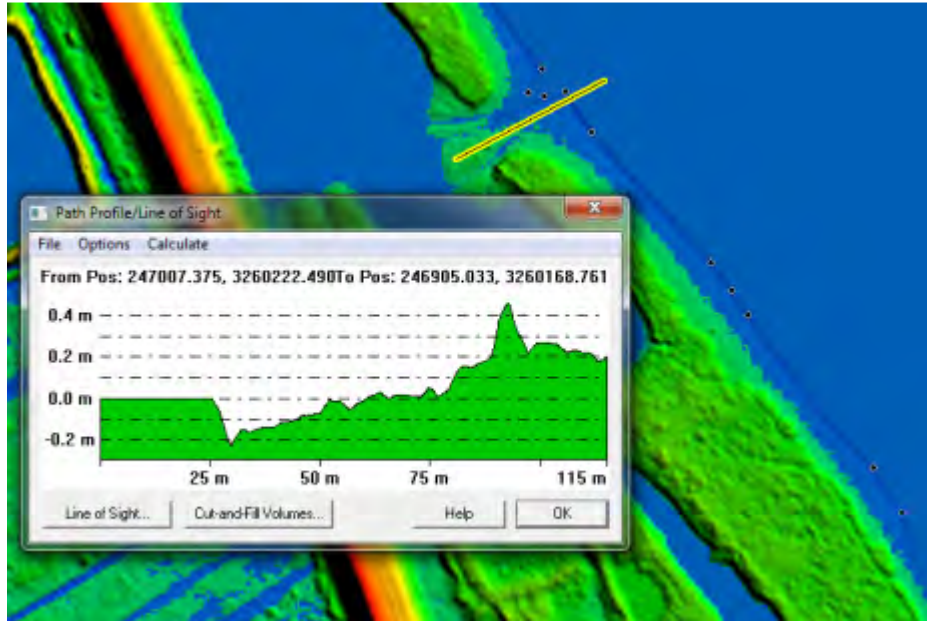
Figure 40 – Issue remains but no fix required. Ground elevation model of tile rbt475955 showing the tidal water breakline floats by ~22 cm.

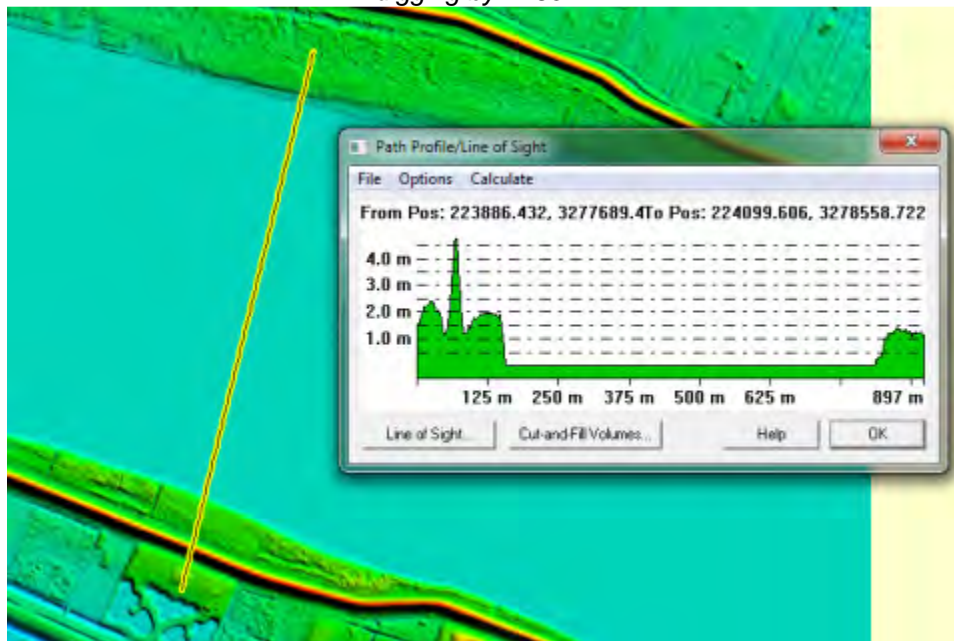
Figure 43 – 2nd delivery - Corrected. Ground elevation model of tile rbt235775, second delivery, showing that the digging water feature has been corrected in the second delivery.

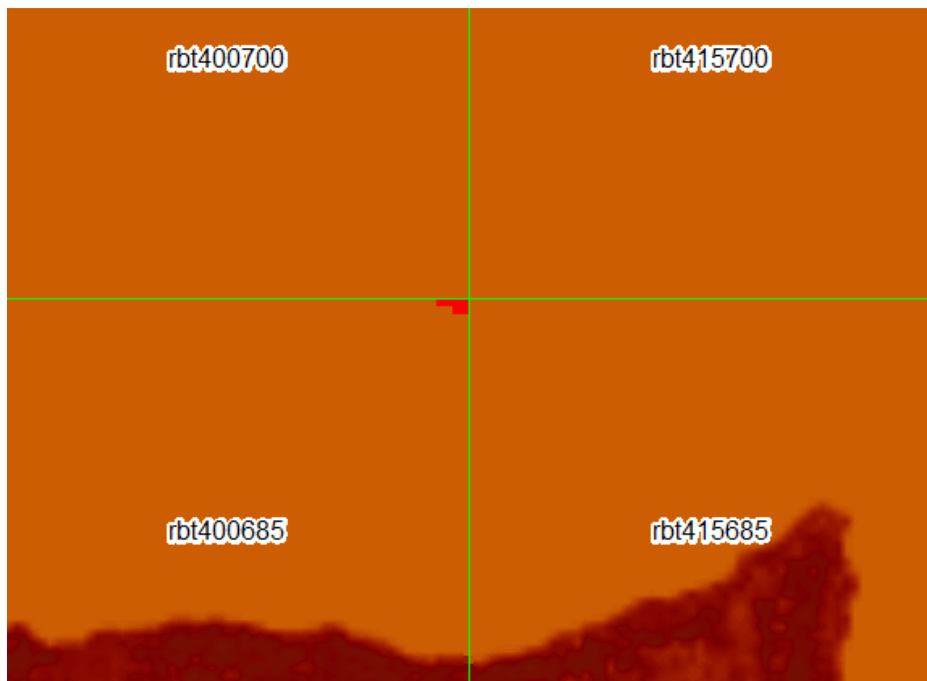
Figure 46 – 1st delivery. Ground elevation model of several first delivery tiles. Tile rbt400685 has several null pixel values in the upper-right corner (In red).

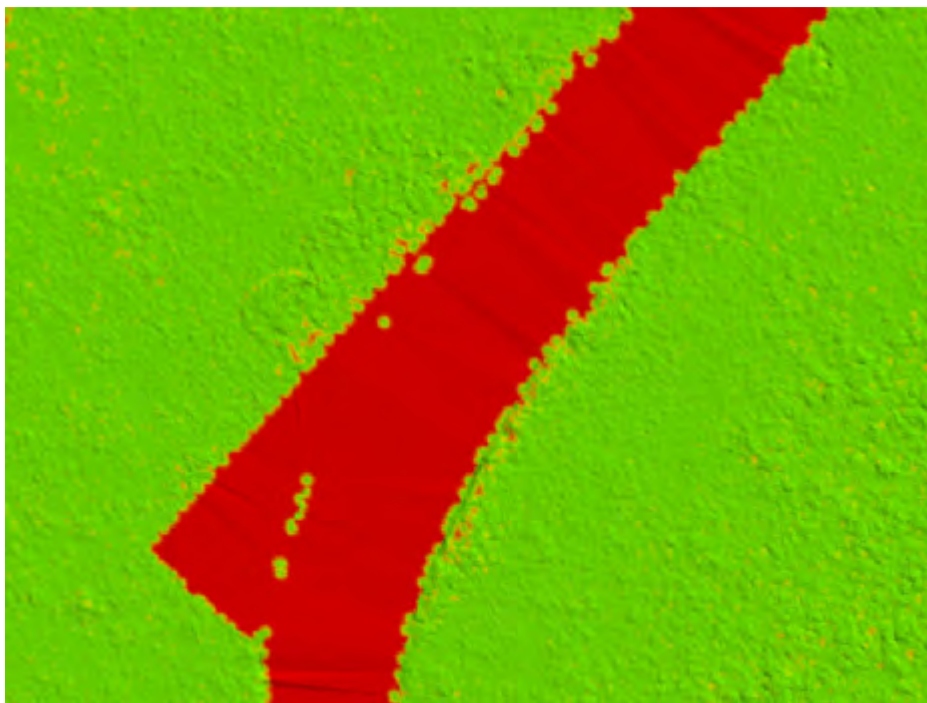
Figure 6 - Ground density model of Tile 15RXN615670 showing an area of ground (in red) that is currently unclassified (Class 1) and should be moved to ground (Class 2).

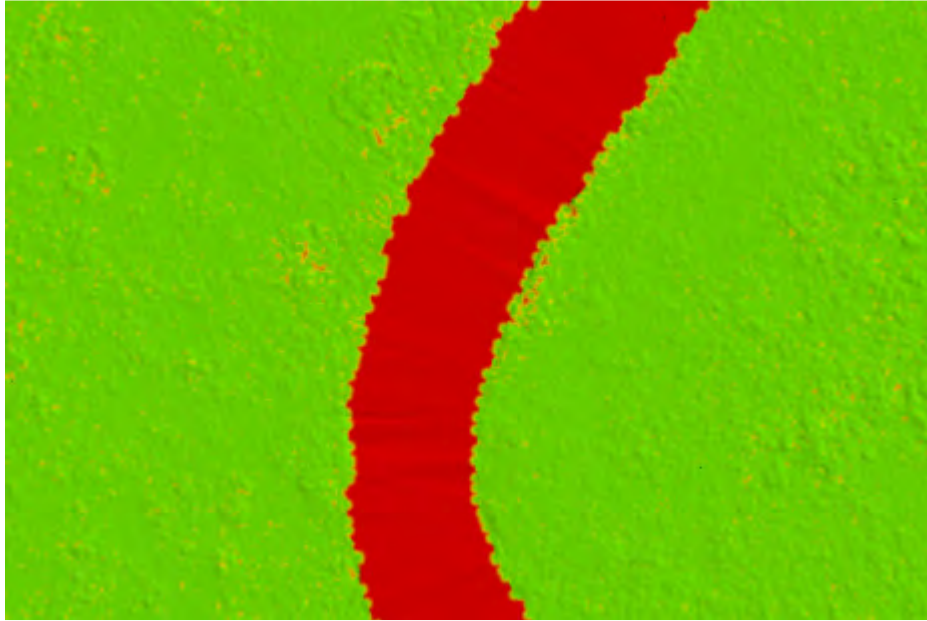
Figure 7 - Ground density model of Tile 15RXN615670 showing that the misclassification has been corrected in the second delivery.

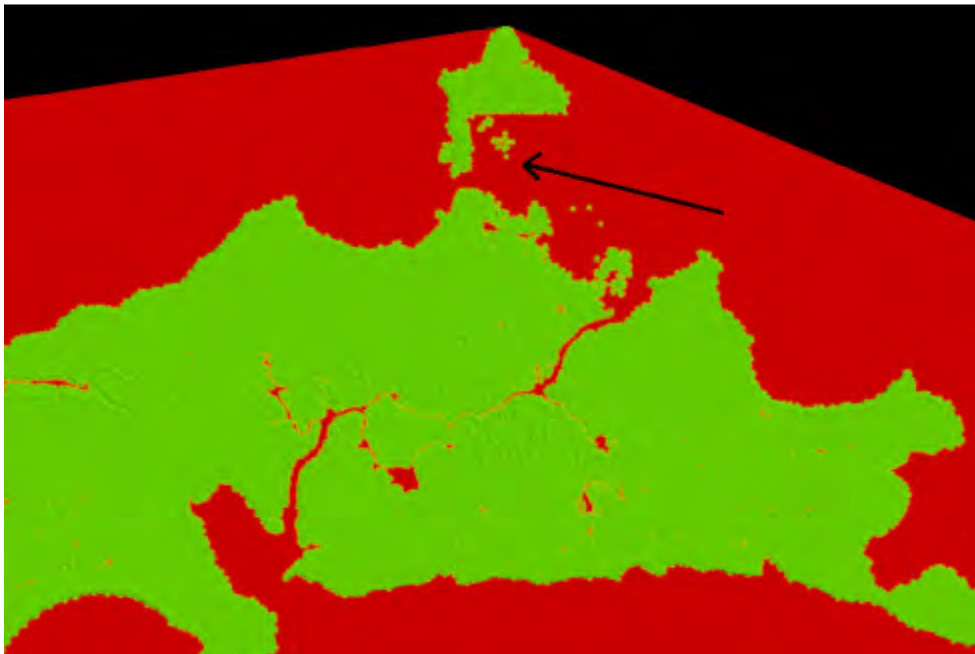
Figure 8 – A LiDAR ground density model showing low point density areas in red. The majority of red in the tile is water and not an error however the linear geometry of the void shown by the arrow implies that the void is legitimate. Tile 15RYN650295.

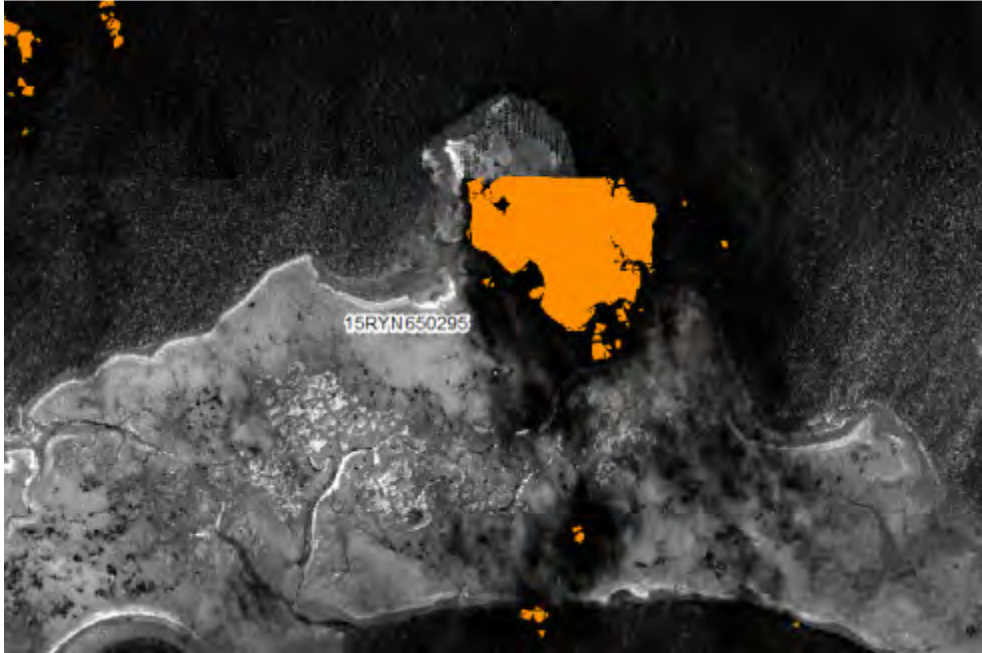
Figure 9 – LiDAR intensity image of the same ground feature shown in Figure 13. Voids areas where no points were collected are colored orange. The large void here intrudes on the geography in an unnatural way. The void measure approximately 5.3 acres.

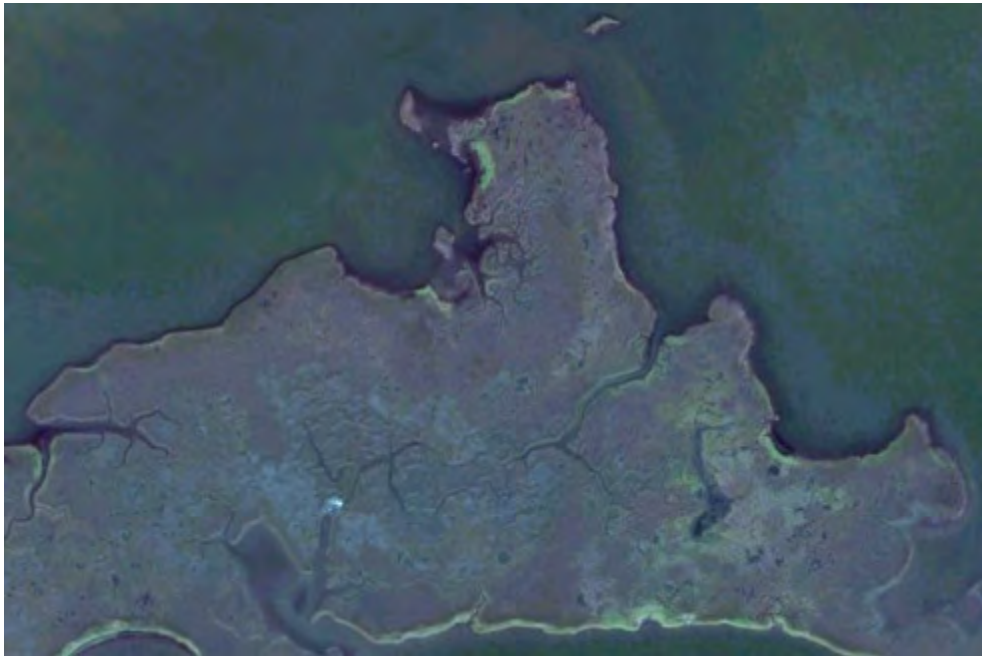
Figure 10 – Aerial photograph of the ground feature shows confirms the area identified in the previous two figures is a legitimate data void.

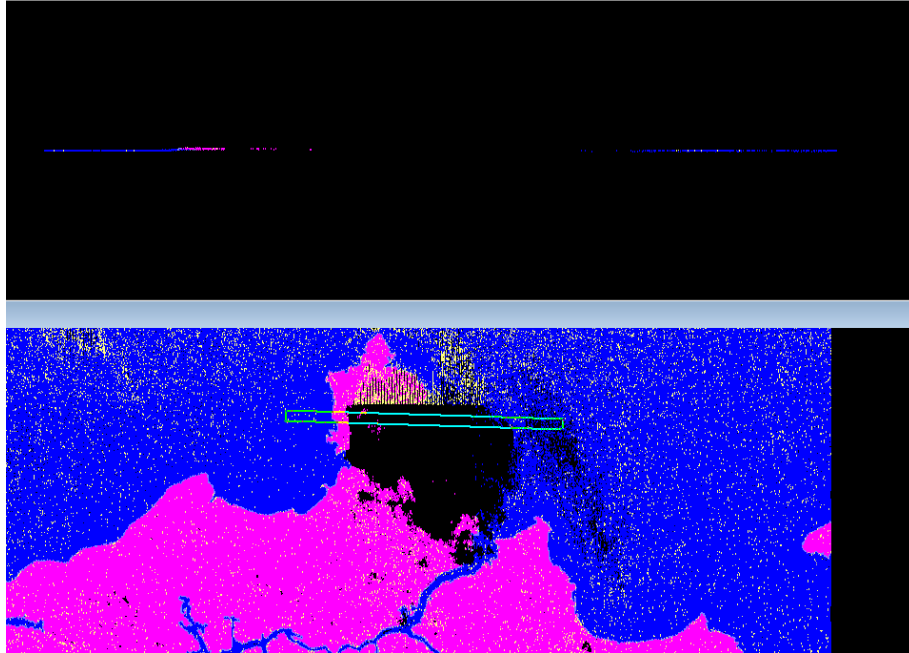
Figure 11 – LAS profile of tile 15RYN65029 colored by classification (where ground is shown in pink, water in blue and unclassified point in yellow.) No LiDAR points were collected in the void area.

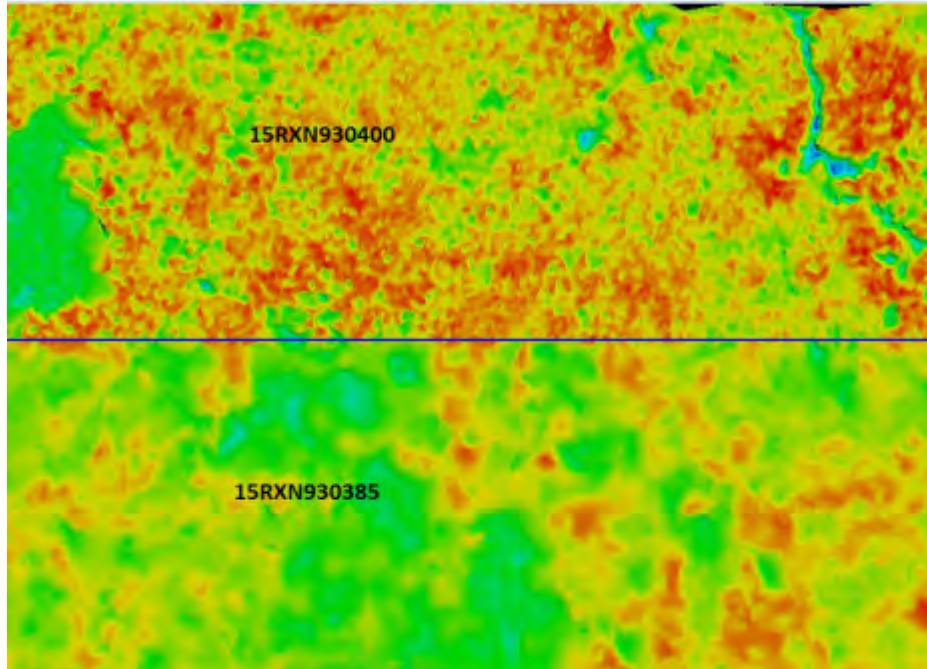
Figure 12 - Difference in ground model definition between the two tiles. The upper tile is well-defined compared to the tile below.

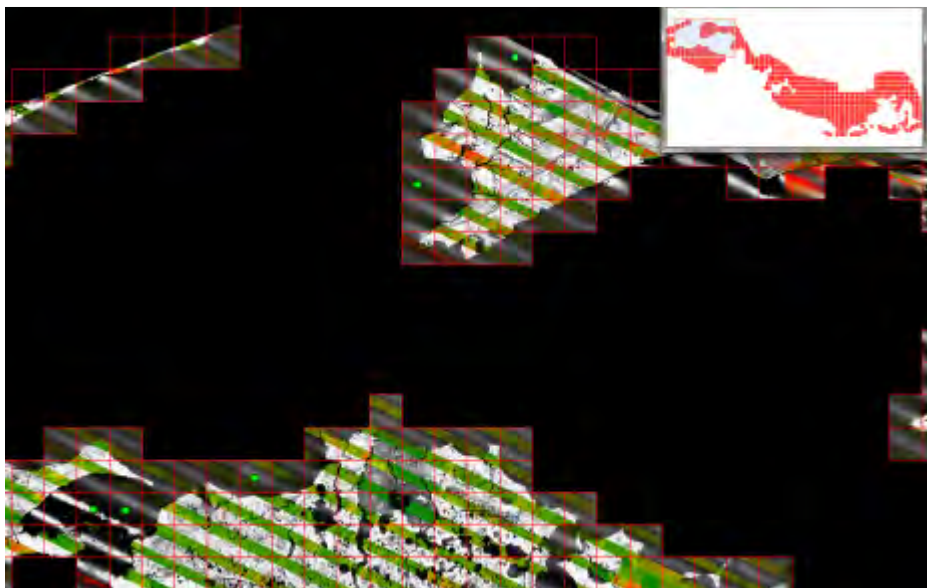
Figure 15 – The image above confirms that the missing tiles were delivered in the second delivery.

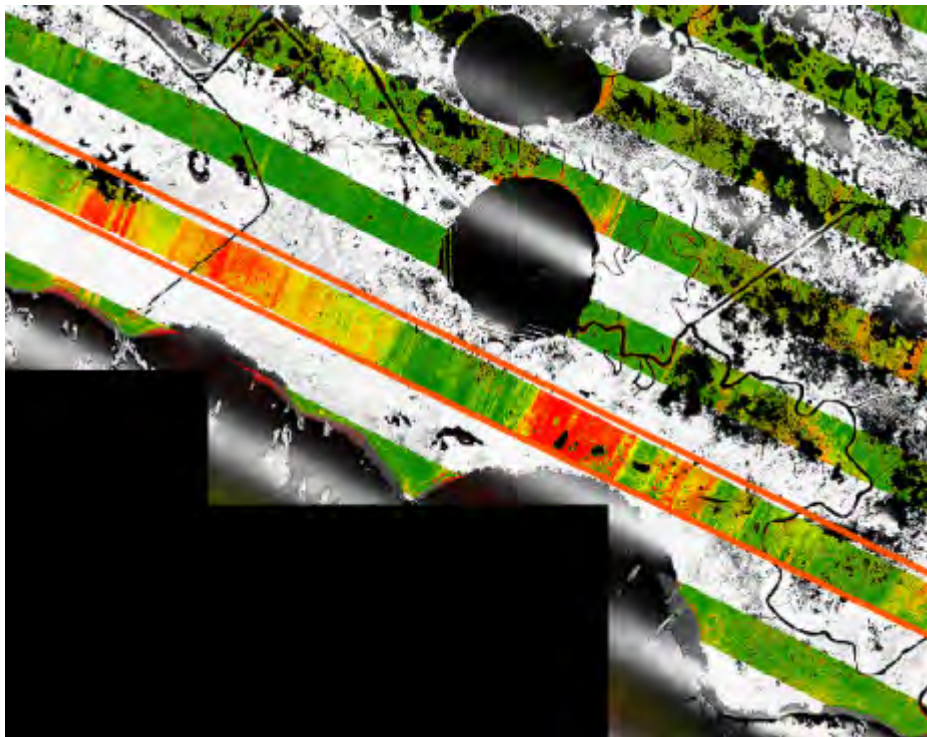
Figure 17 - DeltaZ image from project area, first delivery. Red and yellow areas represent places where the flight line overlap difference is greater than 10cm and is therefore out of project specifications.

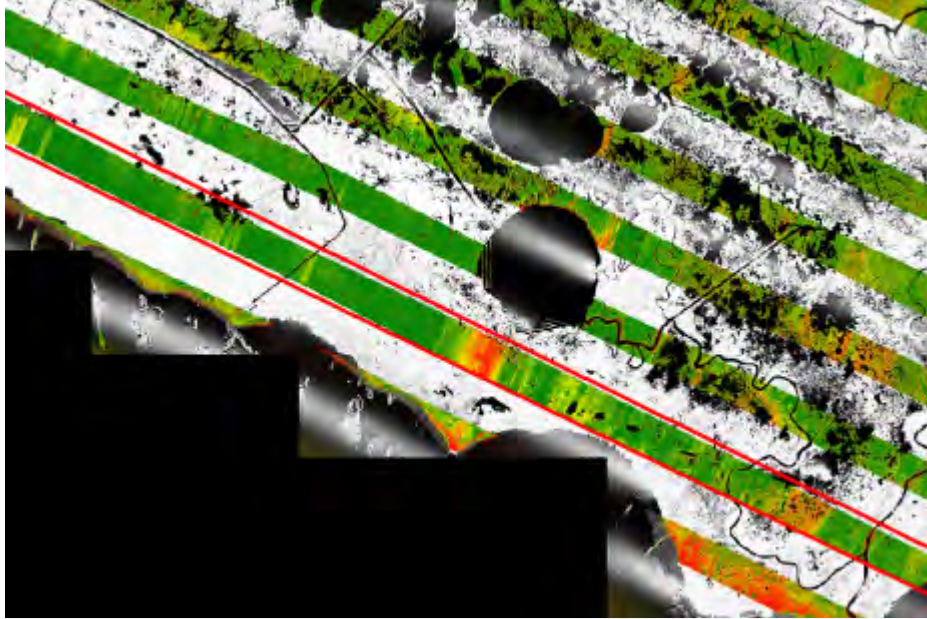
Figure 18 - DeltaZ image from project area, second delivery. Woolpert greatly reduced the flight line overlap in the dataset in the second delivery.

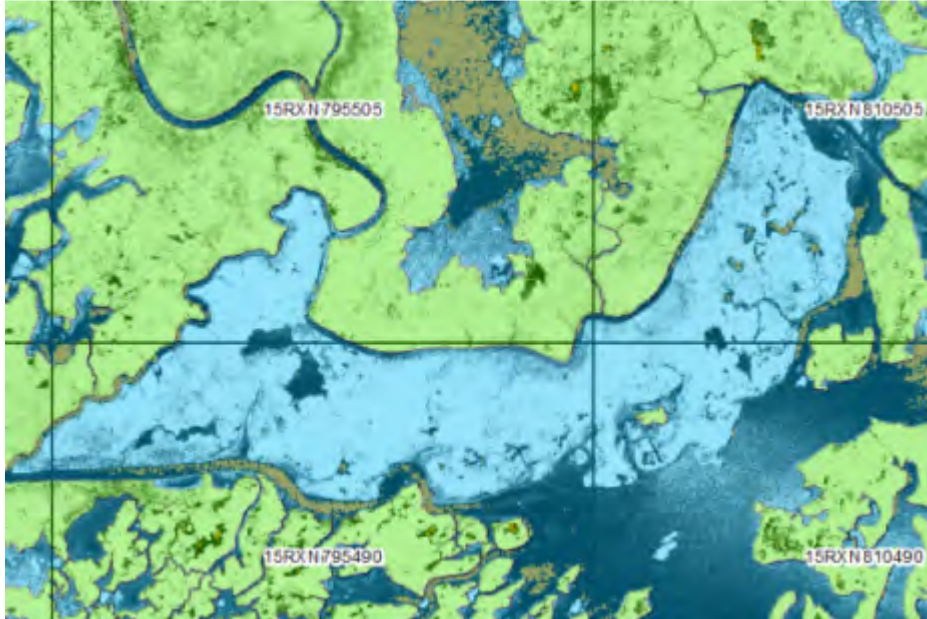
Figure 19 - Island breaklines are colored transparent green, Tidal water breaklines are transparent blue. The LiDAR intensity image is visible underneath the breaklines. A large land mass measuring approximately 250 square acres was not captured by the island breaklines. The island exists above the zero-elevation contour line.

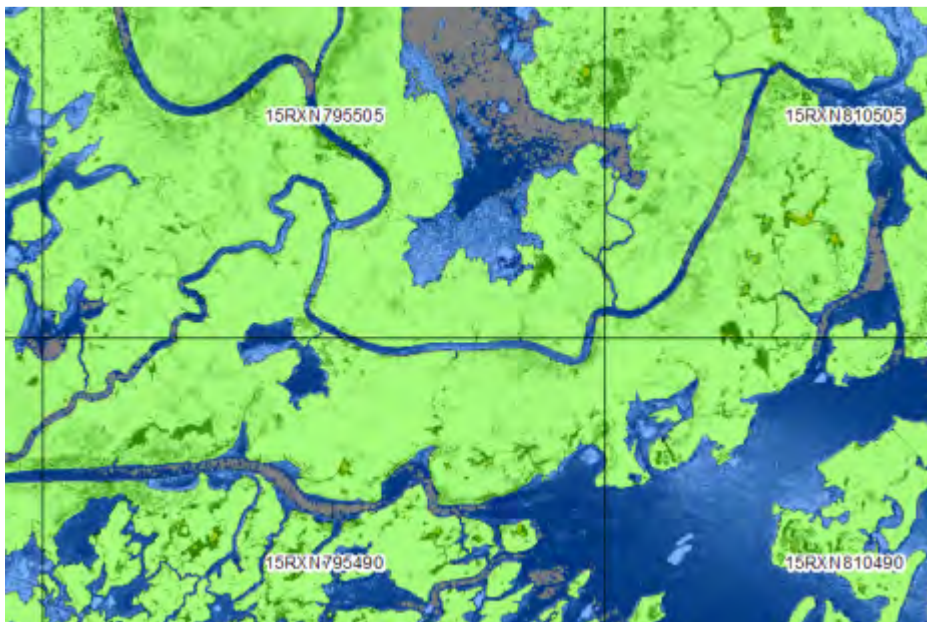
Figure 20 - Island breaklines are colored transparent green, Tidal water breaklines are transparent blue. The LiDAR intensity image is visible underneath the breaklines. The large land mass has now been correctly added to the island breaklines dataset.

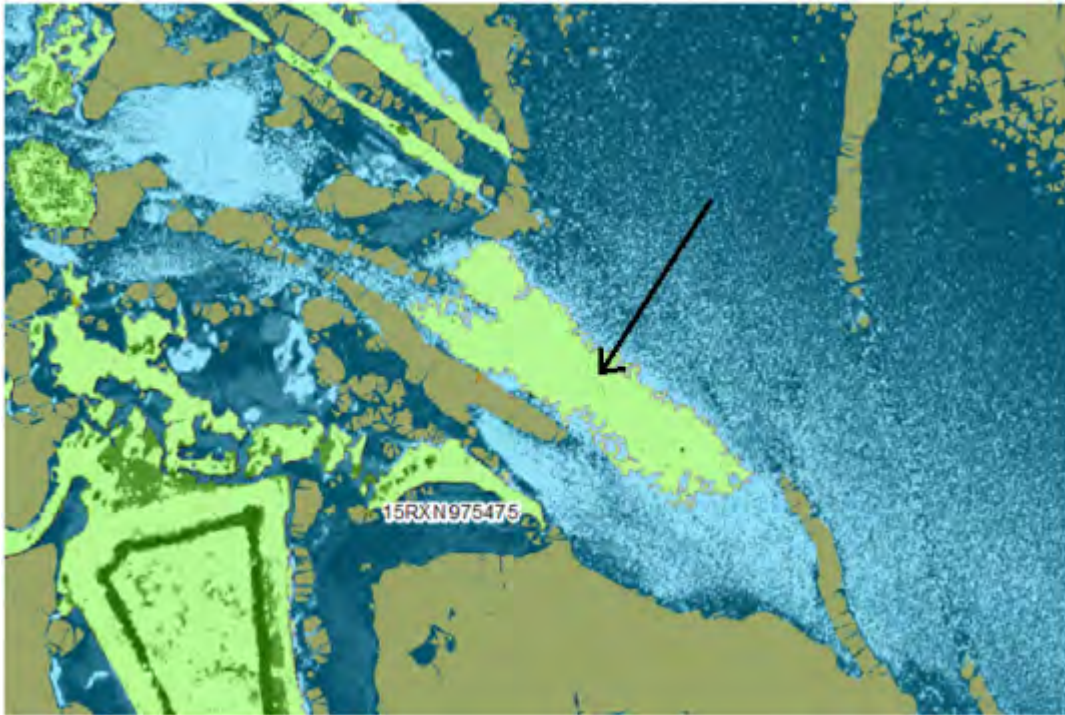
Figure 21 – Island breaklines are colored transparent green, Tidal water breaklines are transparent blue. The LiDAR intensity image is visible underneath the breaklines. Voids in the intensity image which represent water display in tan. A large portion of water has been mistakenly captured within an island breakline.

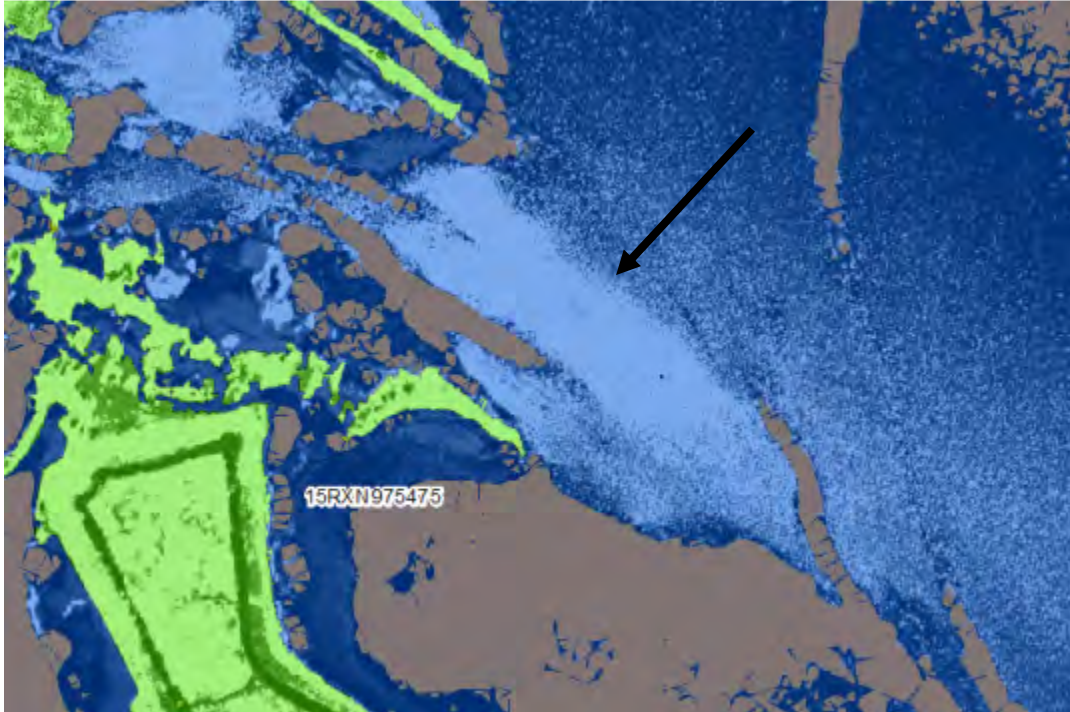
Figure 22 - Island breaklines are colored transparent green, Tidal water breaklines are transparent blue. The LiDAR intensity image is visible underneath the breaklines. Voids in the intensity image which represent water display in tan. The tidal water breaklines has been correctly adjusted to remove the issue.

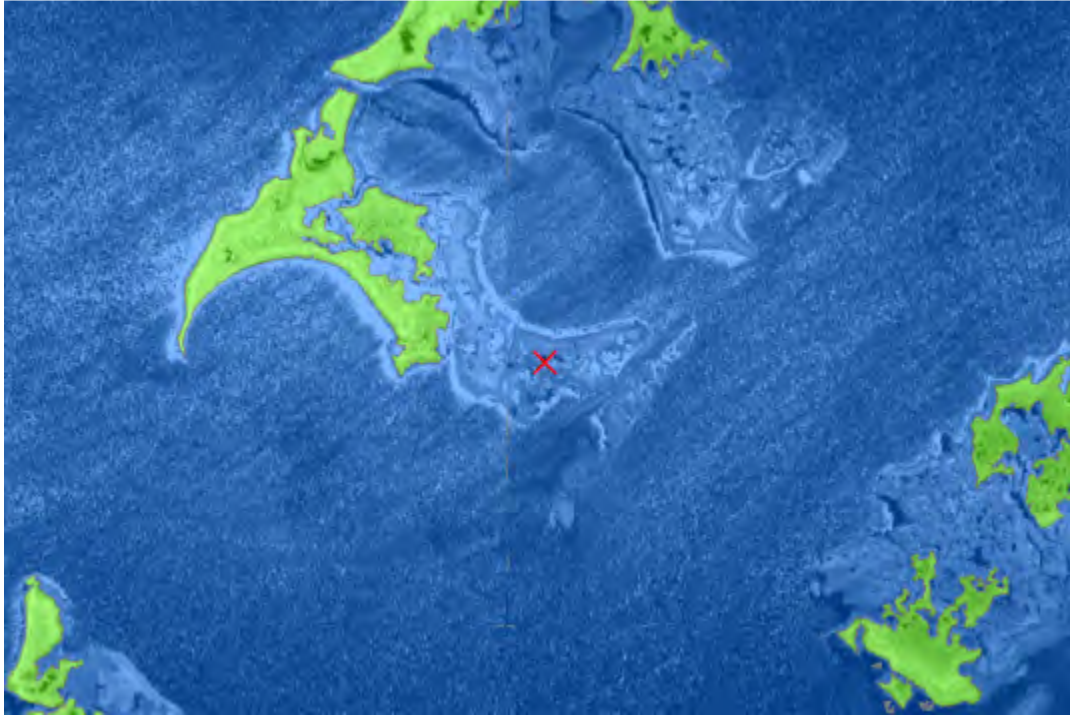
Figure 25- Tile 15RYN11265, first delivery. Island breaklines are colored transparent green, Tidal water breaklines are transparent blue. The LiDAR intensity image is visible underneath the breaklines. The image above shows ground that was captured as part of the tidal water breaklines.

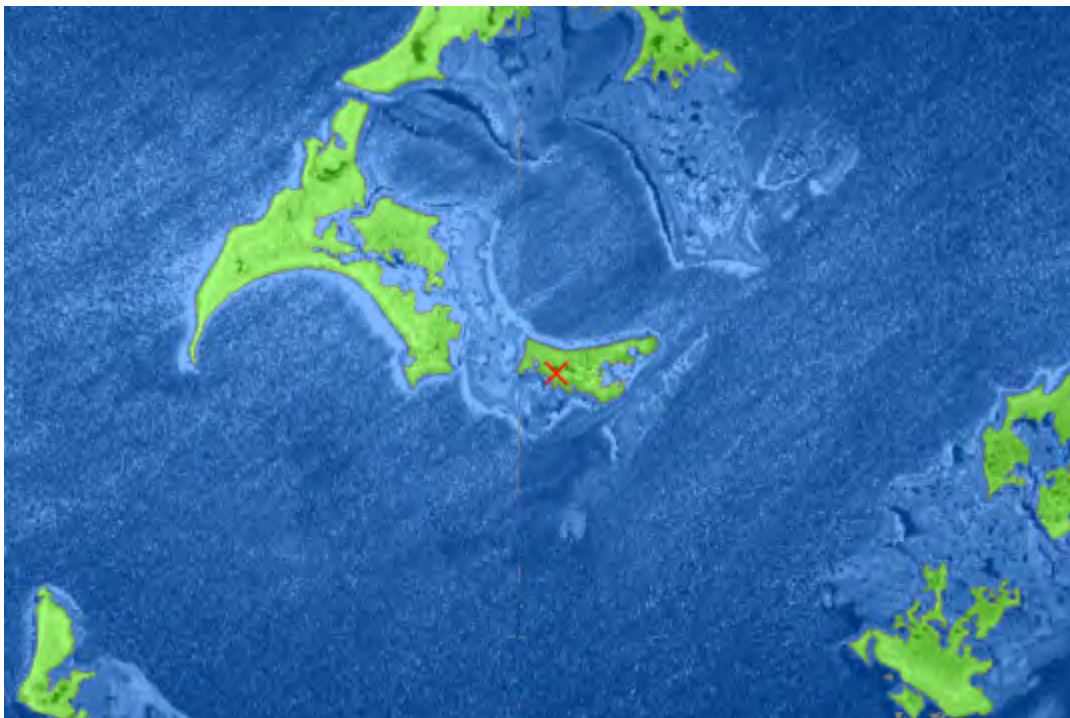
Figure 26- Figure 27- Tile 15RYN11265, third delivery. Island breaklines are colored transparent green, Tidal water breaklines are transparent blue. The LiDAR intensity image is visible underneath the breaklines. The image above shows that the ground was appropriately changed to the island breakline feature class.

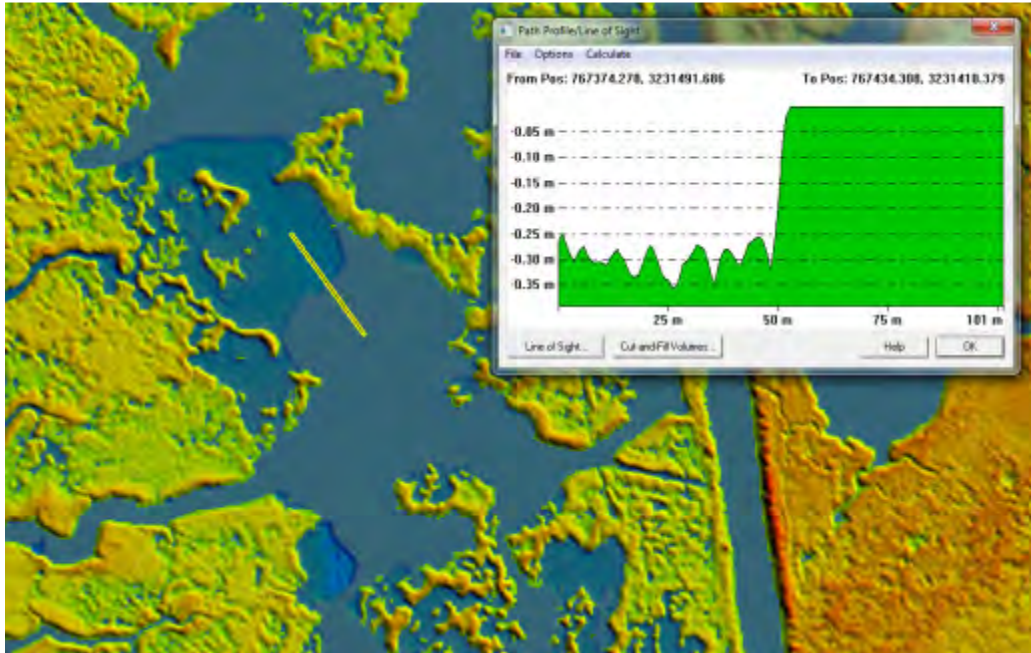
Figure 30 - An area of tidal waters which float 30 cm above the surrounding terrain. Tile 15RYN665310, first delivery.
