LiDAR Quality Assessment Report

Materials Received: 2/14/2012	Project Type: ARRA Partnership
Project ID: G10AC00103	Project Description: ARRA-WA_PierceCounty_2011
Project Alias(es):	Year of Collection: 10/2010 - 09/2011

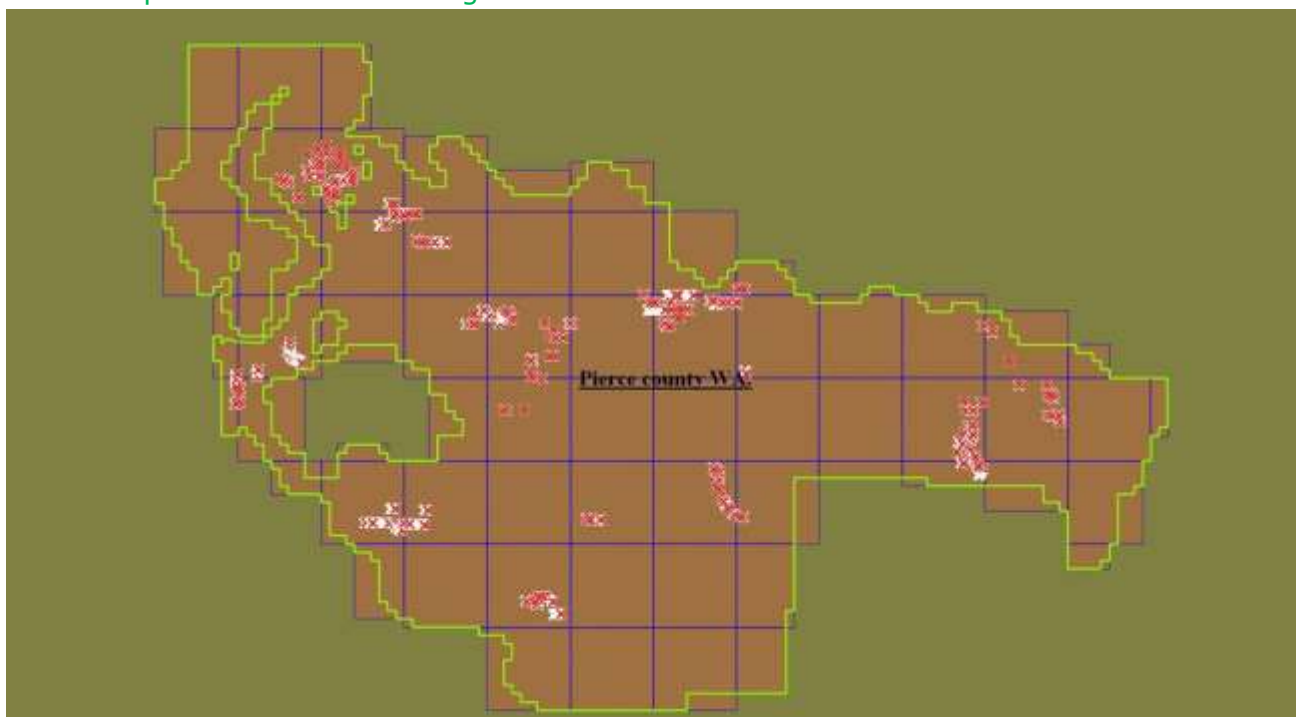
Checkpoint Distribution Image?

There are a minimum of 20 checkpoints for each land cover class represented. Points within each class are uniformly distributed throughout the dataset. USGS was able to locate independent checkpoints for this analysis. USGS accepts the quality of the checkpoint data for these LiDAR datasets.

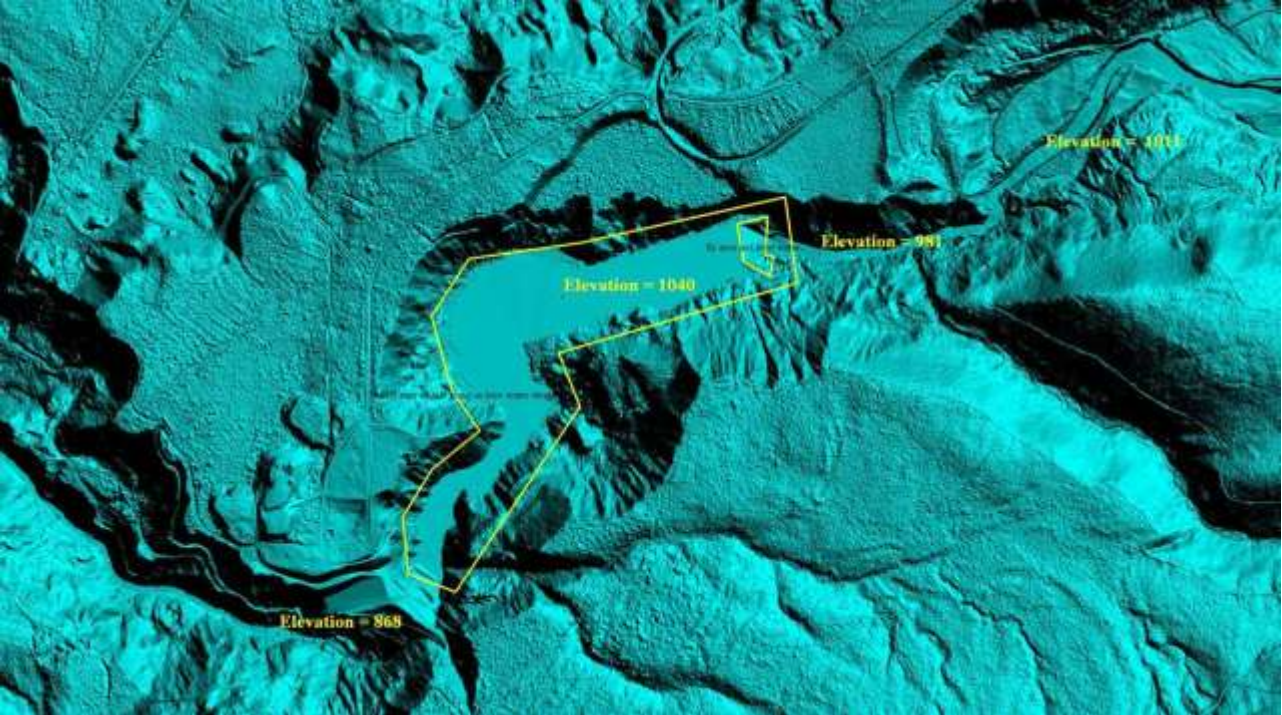
River elevations are different due to flying times, one flown in 2010 and one flown in 2011. Not fixed but reported here.

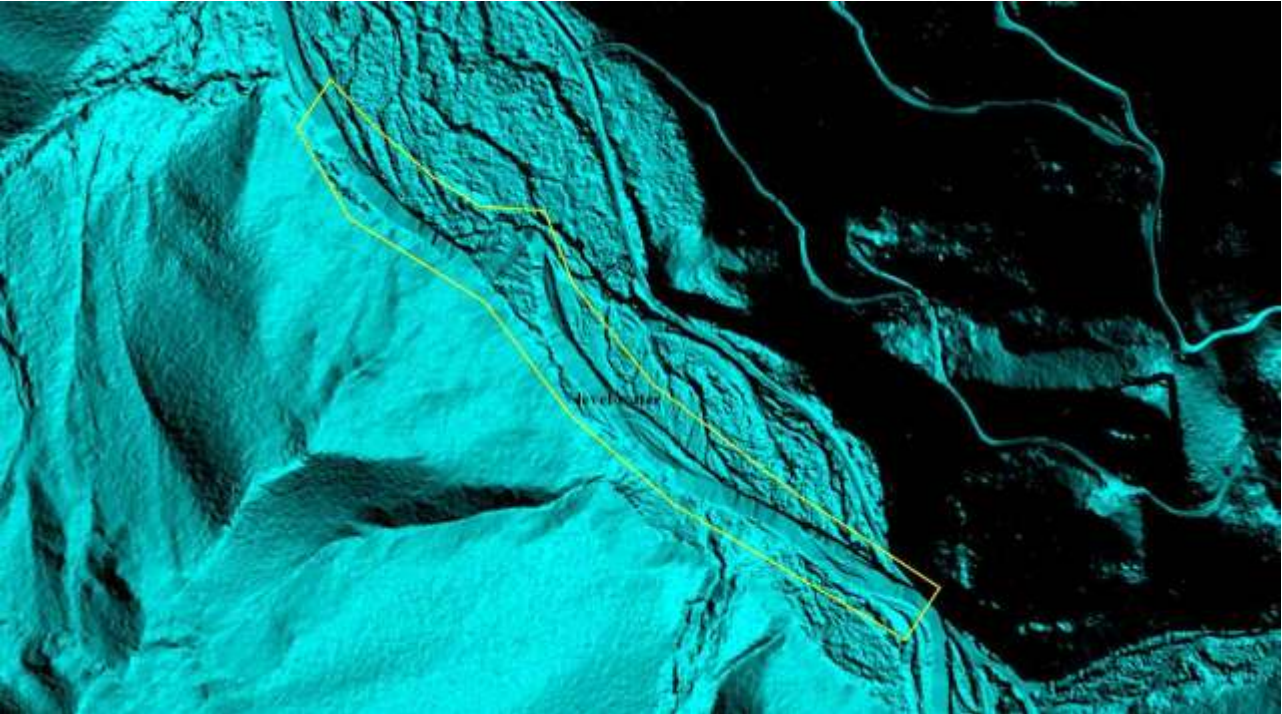
Some rivers were not properly leveled or stair stepped in areas we will accept these.
