# LiDAR Quality Assessment Report

CA\_OrangeCo\_2011

The primary purpose of this project was to develop a consistent and accurate surface elevation dataset derived from high-accuracy Light Detection and Ranging (LiDAR) technology for the USGS FEMA IX Orange County, California Project Area.

Orange County, CA

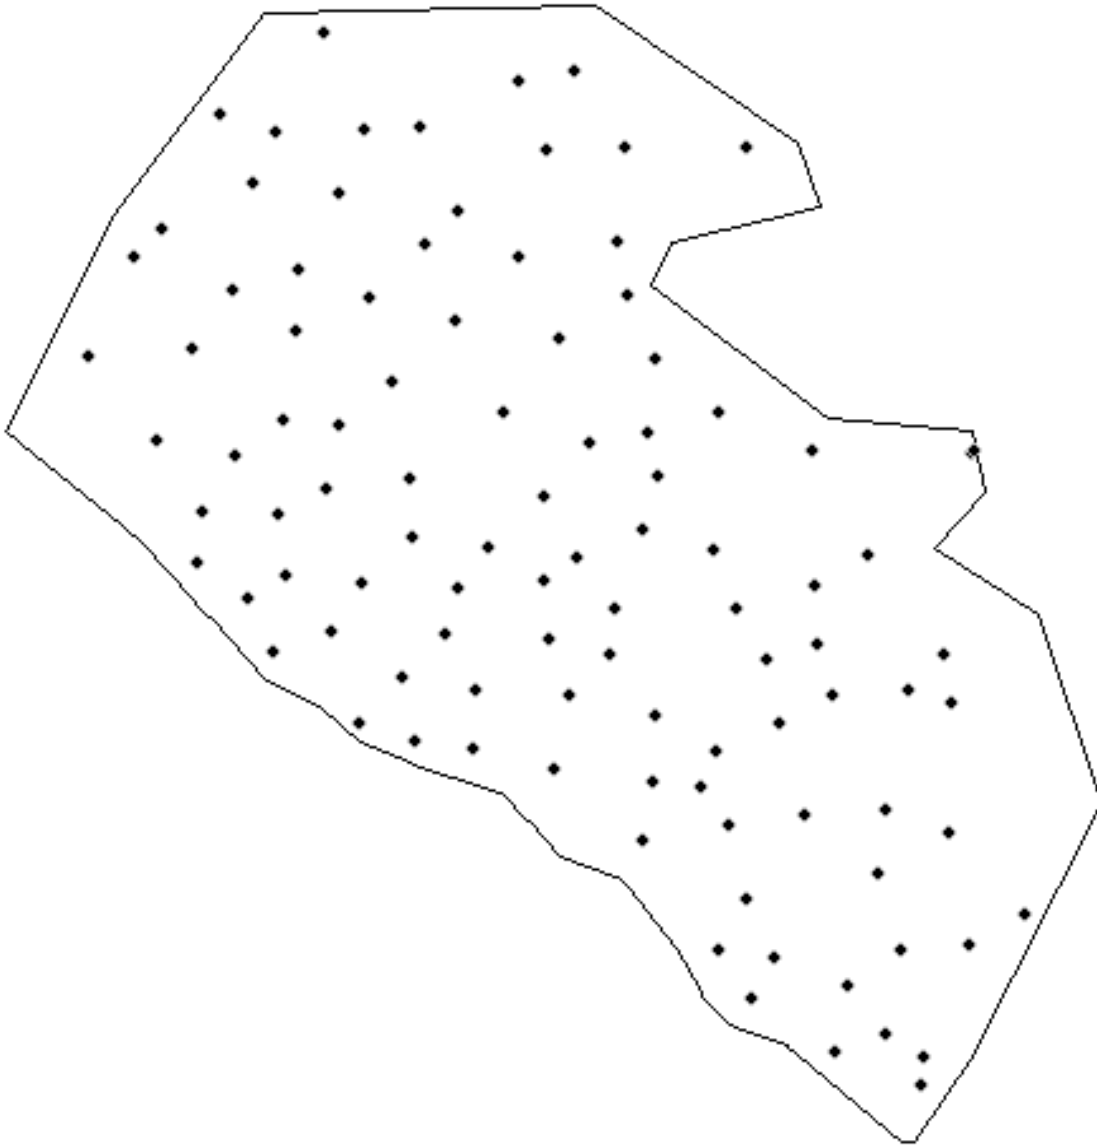
Checkpoint Distribution Image?

There are a minimum of 20 checkpoints for each land cover class represented. Points within each class are uniformly distributed throughout the dataset. USGS was able to locate independent checkpoints for this analysis. USGS accepts the quality of the checkpoint data for these LiDAR datasets.

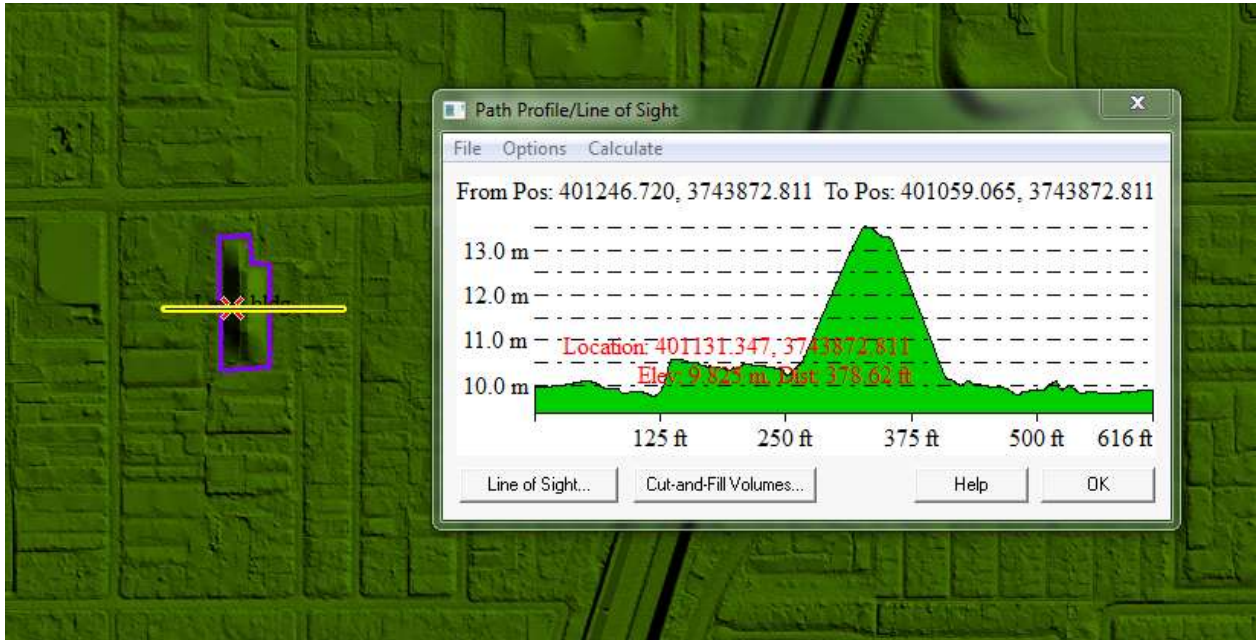
Reviewer identified buildings remaining in bare earth surface that need further removal. These errors are documented in a shapefile created by the reviewer at NGTOC named errors.shp. In the pdf, "Dewberry Response to USGS Review Orange County 10012012" Dewberry explains the common occurrence of homes built into hillsides, reviewer accepts this response.

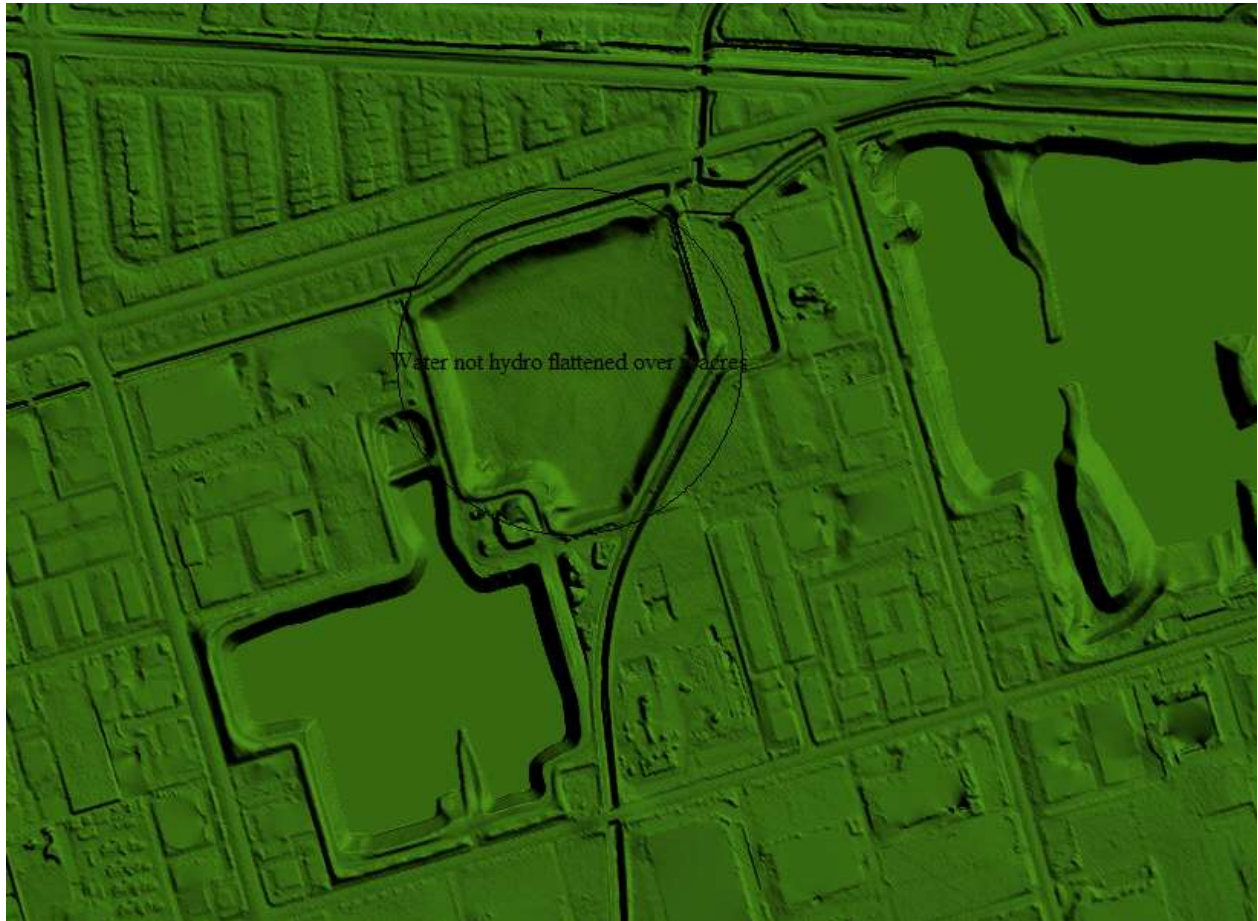
Reviewer identified a minimum of 3 waterbodies greater than 2 acres not hydroflattened. These errors are documented in a shapefile created by the reviewer at NGTOC named errors.shp. In the pdf, "Dewberry Response to USGS Review Orange County 10012012" Dewberry explains that one of four calls regarding breaklines/waterbodies was incorrect, from viewing the intensity images it can be determined that no water existed at the time of acquisition. The other three calls were addressed, corrected, and new DEM and LAS files were redelivered to the reviewer via ftp site on 10/02/12. Reviewer visually inspected the redelivered DEMs and found them acceptable.

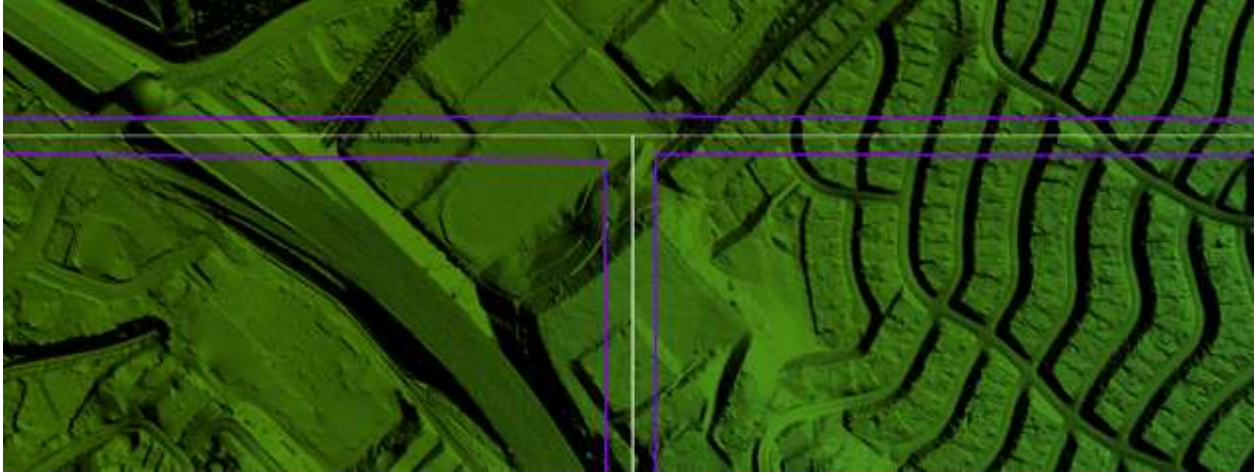
Reviewer identified 4 areas where data voids exist between tiles. The voids are located near the North, South, East and West extents of the project boundary. These errors are documented in a shapefile created by the reviewer at NGTOC named errors.shp. In the pdf, "Dewberry Response to USGS Review Orange County 10012012" Dewberry explains that these gaps were due to processing errors that occurred with the partial tiles along the project boundary. The 21 tiles where this error occurred have been reprocessed and redelivered. Reviewer visually inspected the redelivered DEMs and found them acceptable.

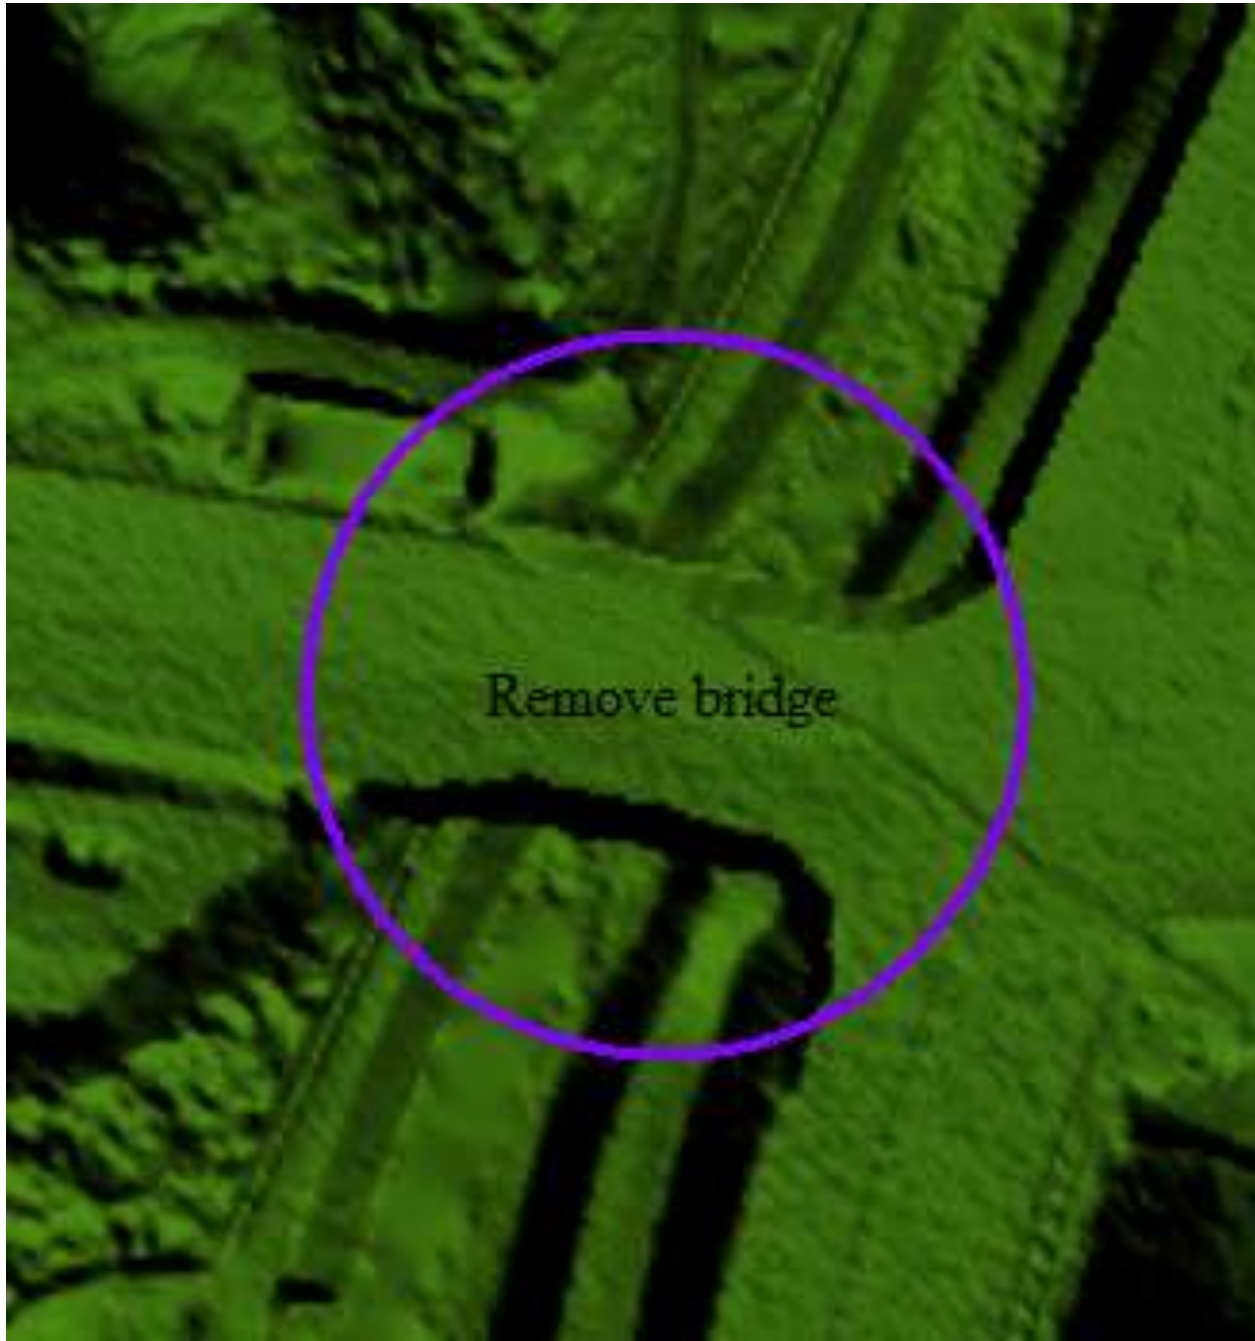
Reviewer identified bridges remaining in bare earth surface. These errors are documented in a shapefile created by the reviewer at NGTOC named errors.shp. See following image and comments for updated information.

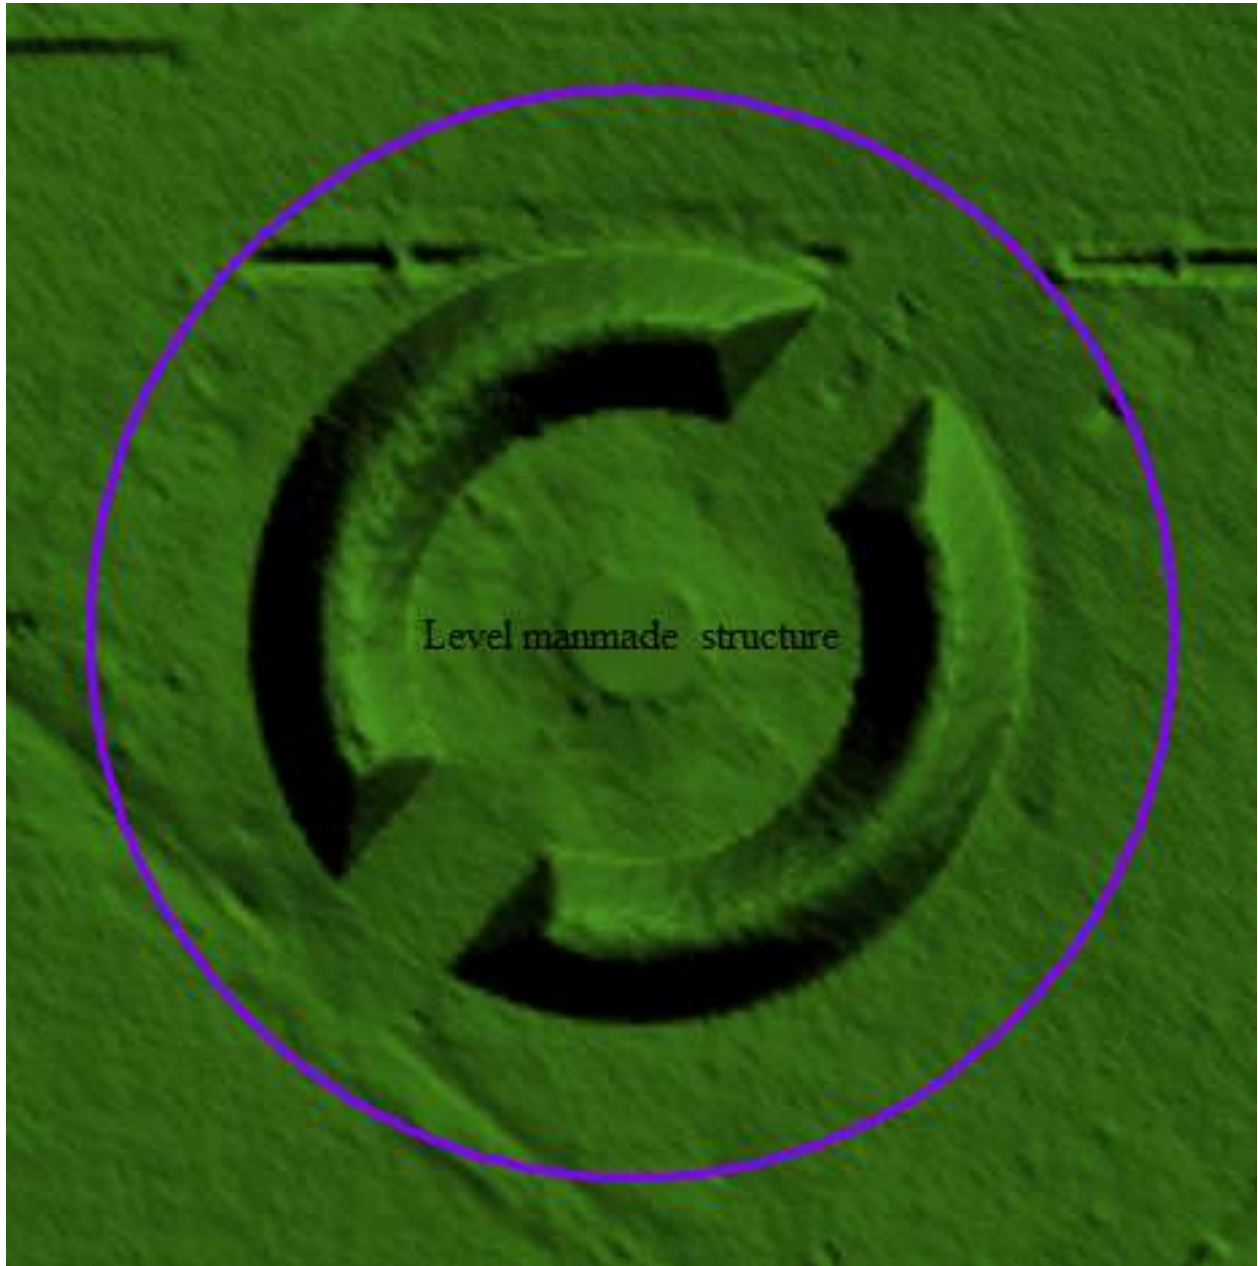
Reviewer identified a man-made structure in bare earth surface. This error is documented in a shapefile created by the reviewer at NGTOC named errors.shp. In the pdf, "Dewberry Response to USGS Review Orange County 10012012" Dewberry explains that in this instance earthen mounds have been formed around the feature and have been correctly included in the ground classification. Reviewer accepts this response.

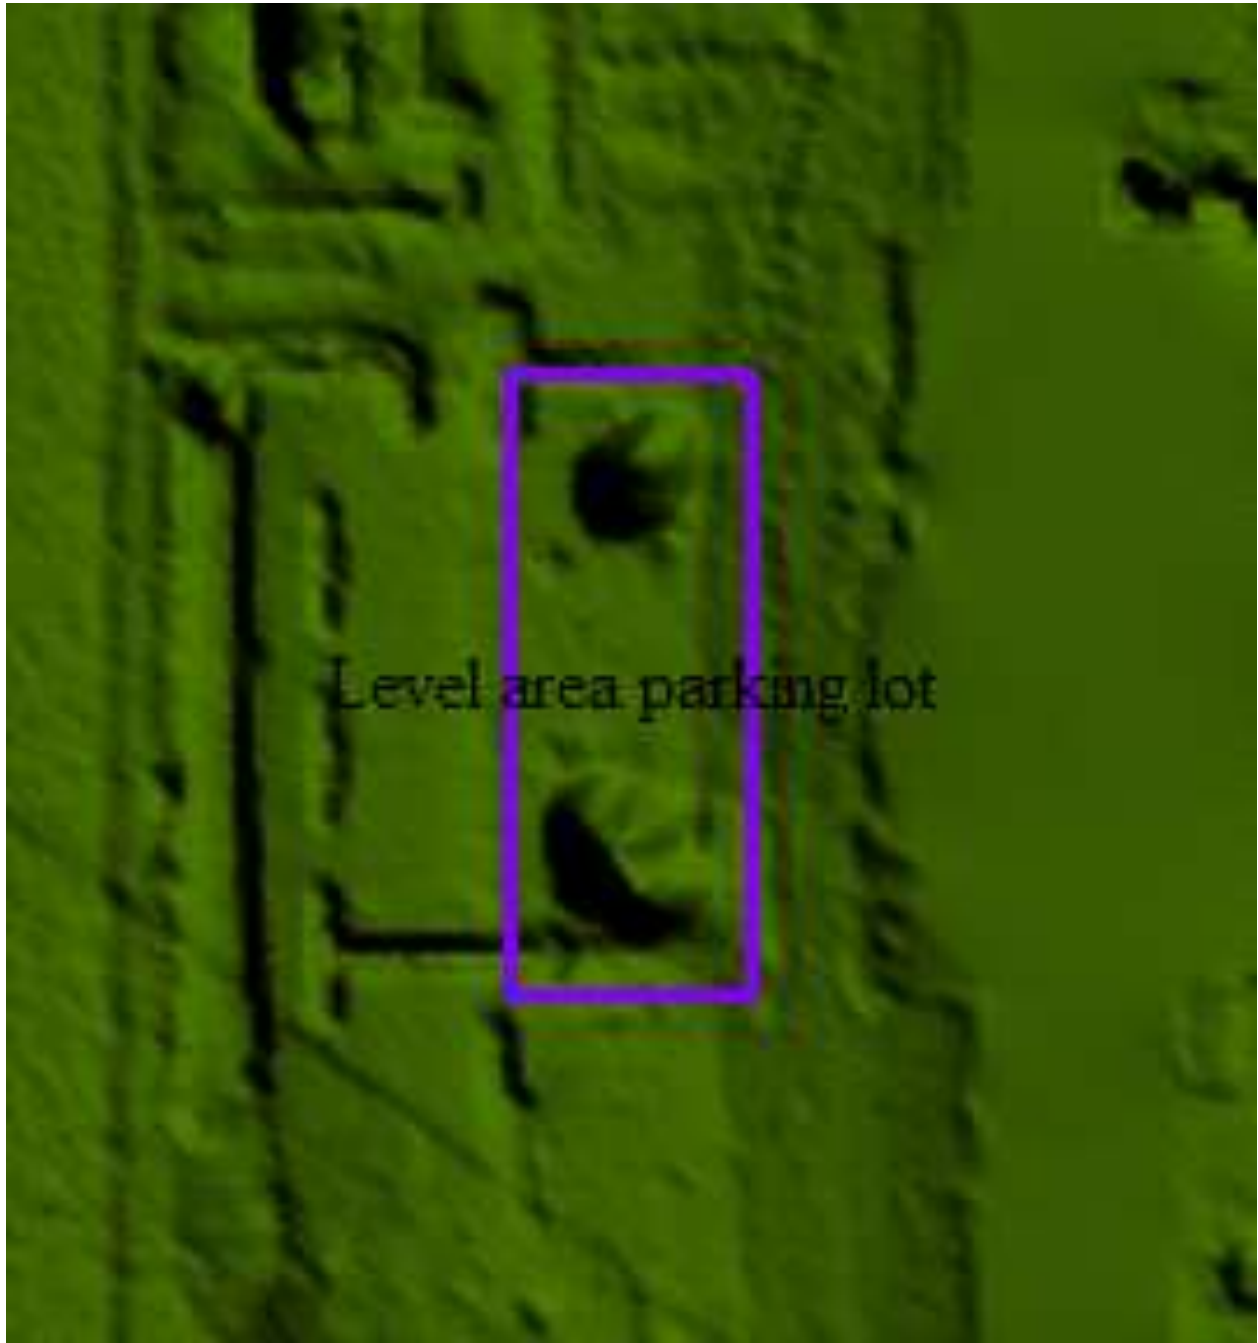
Reviewer identified areas of extreme elevation change within man-made parking lot that needs further removal. This error is documented in a shapefile created by the reviewer at NGTOC named errors.shp.
