LiDAR Quality Assessment Report

CA_PlacerCo_2012

This task order is for planning, acquisition, processing and derivative products of lidar data to be collected at a nominal pulse spacing (NPS) of 1.0 meters. Specifications listed below are based on the “*U.S. Geological Survey National Geospatial Program Base Lidar Specification, Version 13 (ILMF)*”, of which sections I through IV are incorporated by reference to this task order. This task is for lidar for a high resolution data set of lidar to support the FEMA Risk MAP program covering approximately 303 square miles of Placer County in California.

FEMA IX - Placer County CA LiDAR

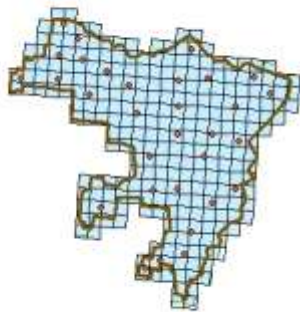
- Checkpoint Distribution Image?

There are a minimum of 20 checkpoints for each land cover class represented. Points within each class are uniformly distributed throughout the dataset. USGS was able to locate independent checkpoints for this analysis. USGS accepts the quality of the checkpoint data for these LiDAR datasets.

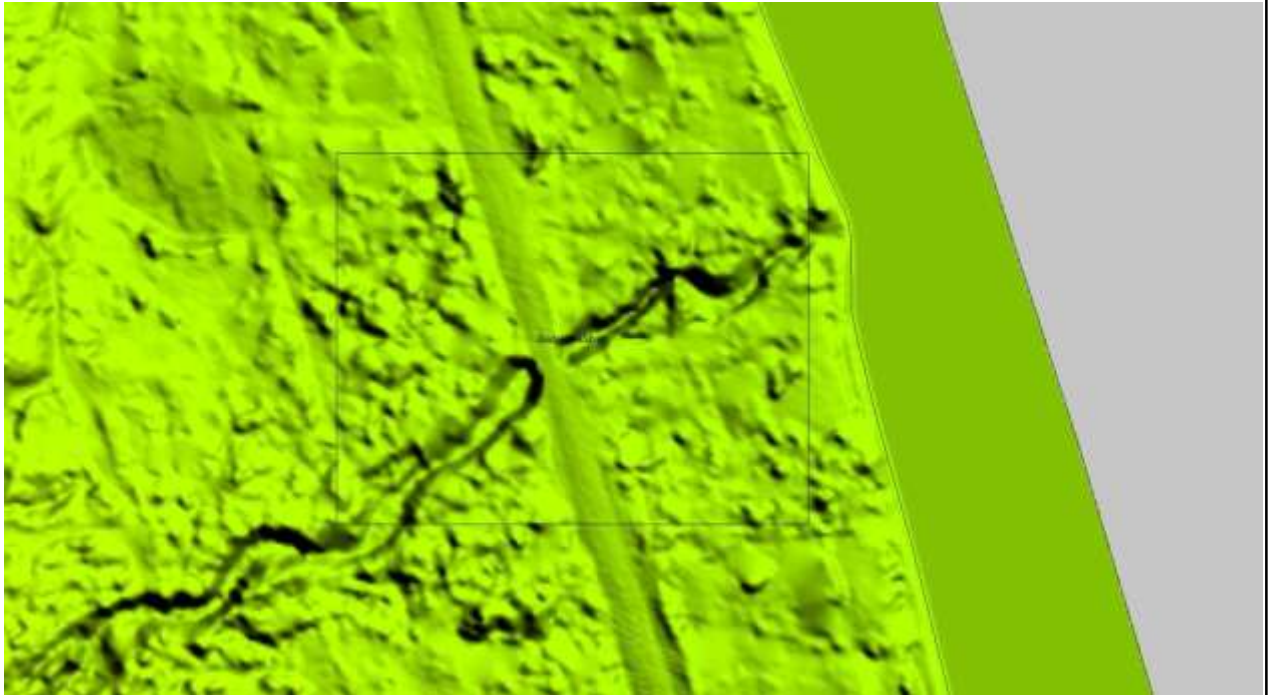
A few Areas where it was difficult to determine if a feature was a Culvert or Bridge. Dewberry states in their delivery report: "Culverts and Bridges: Bridges have been removed from the bare earth surface while culverts remain in the bare earth surface. In instances where it is difficult to determine if the feature is a culvert or bridge, such as with some small bridges, Dewberry erred on assuming they would be culverts especially if they are on secondary or tertiary roads".

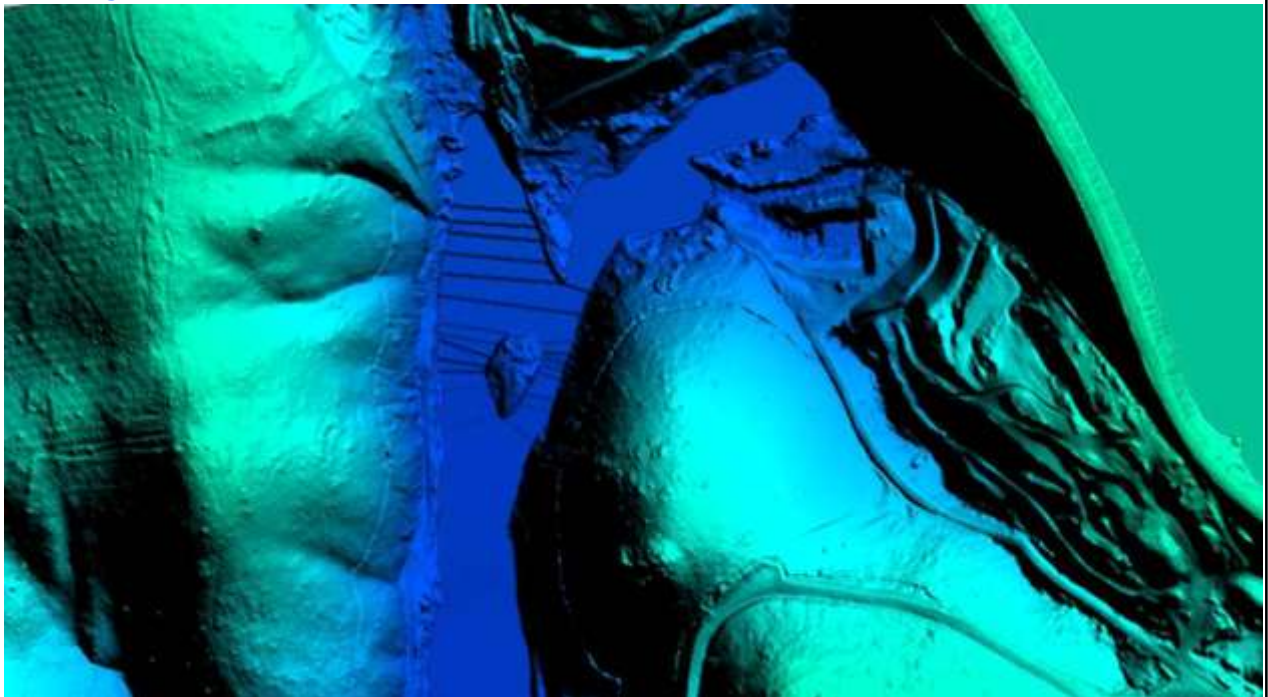
In the Western DEMs river elevation is flattened in a stair step manner, water flows downhill correctly. This is noted in the delivery report.

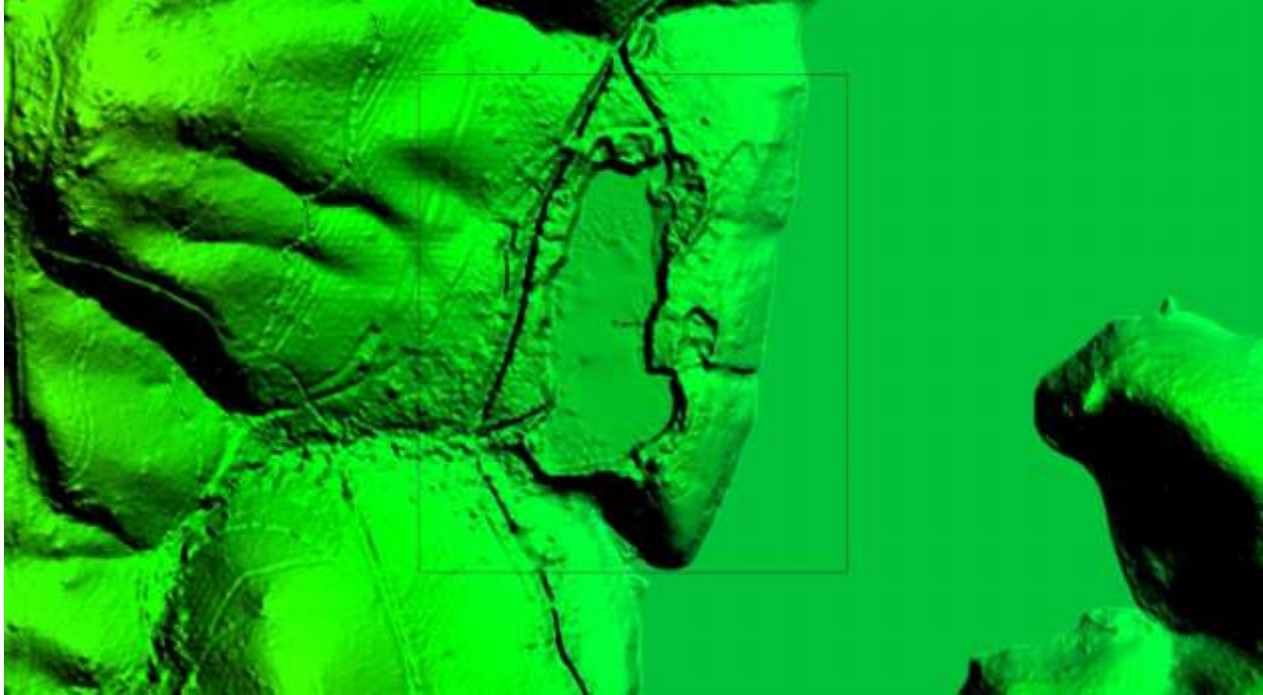
A couple waterbody flattening calls, the majority of 2 Acre or greater water is well flattened.

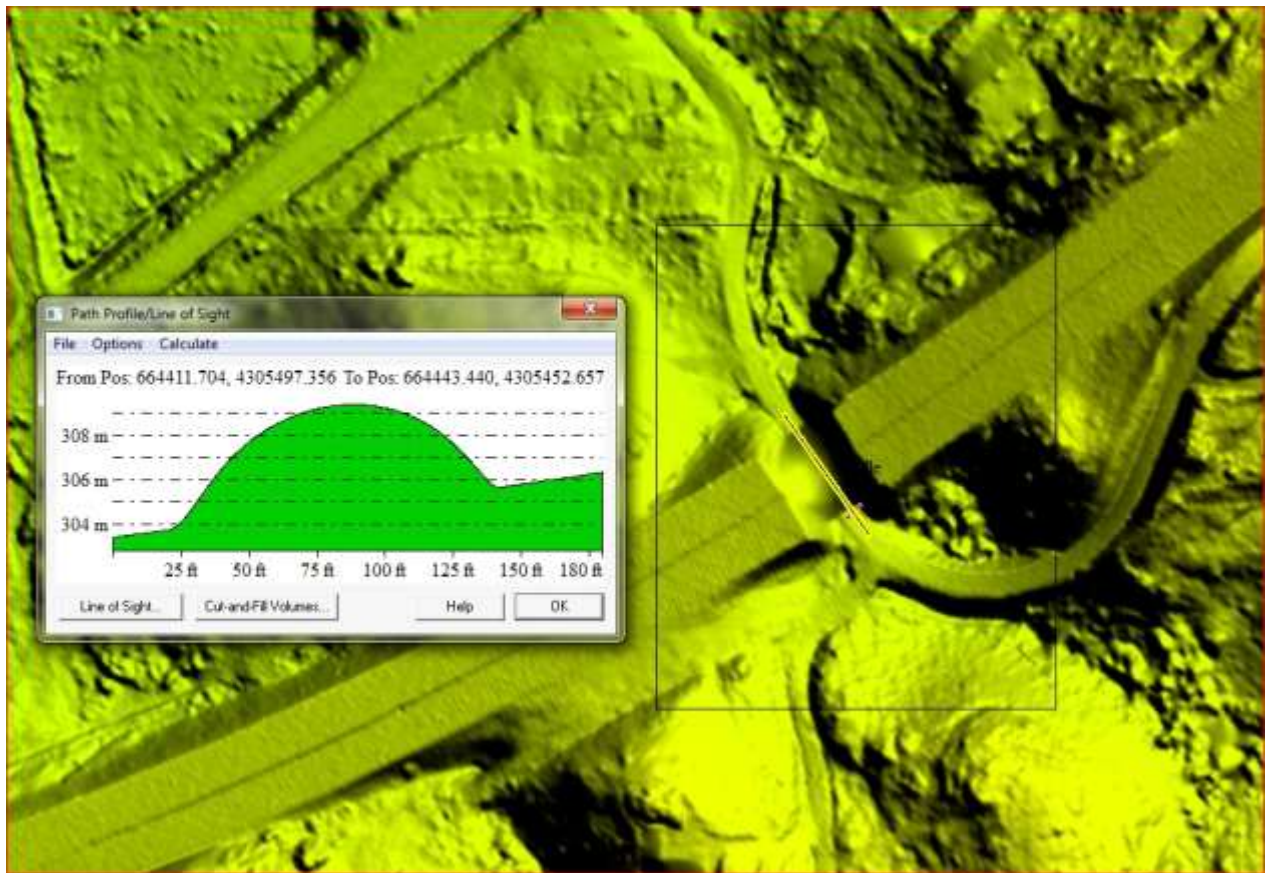
When viewed and profiled in a hillshade several bridge removal areas exhibit a "saddle" artifact. Dewberry states that "Because a continuous surface is being created, the TIN or Terrain will use interpolation to triangulate across a bridge opening from legitimate ground points on either side of the actual bridge. This can cause visual artifacts or "saddles." These "artifacts" are only visual and do not exist in the LiDAR points or breaklines". (see page 26 of the Dewberry Project Report for more information). While the point cloud classification is correct, the use of breaklines or raster techniques could have been used to create a more level area under the bridge.
